## **INVESTIGATION REPORT**

**Fog signal activation in DART driving cab,  
Bray, 6<sup>th</sup> March 2012**

**RAIU Report No: R2013 – 003**

**Published: 19/09/2013**

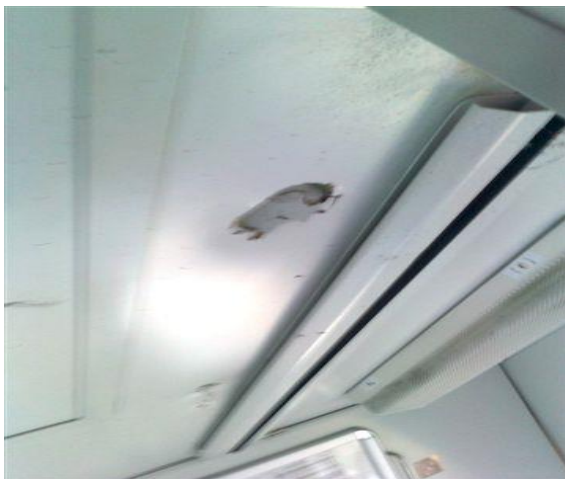
- 11 The rear wall, floor and ceiling (see Figure 2) of the interior of the driving cab were damaged.
- 12 The leather bag, carried by the driver, was badly damaged as were the contents consisting of signal flags and rule books, see Figure 3.

Figure 2 – Damage to driving cab ceiling

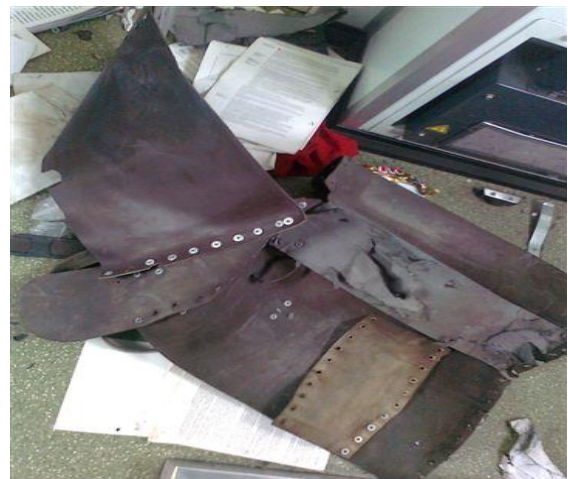
Figure 3 – Damage to driver's bag

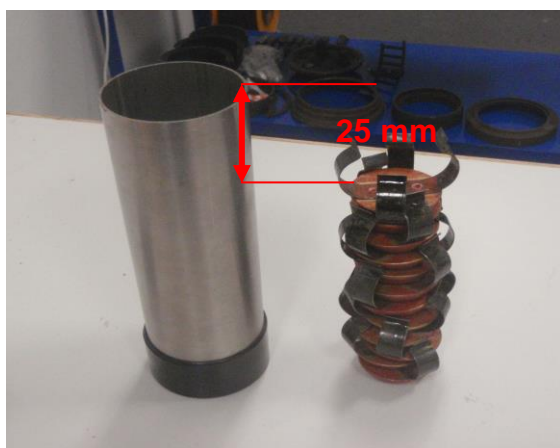
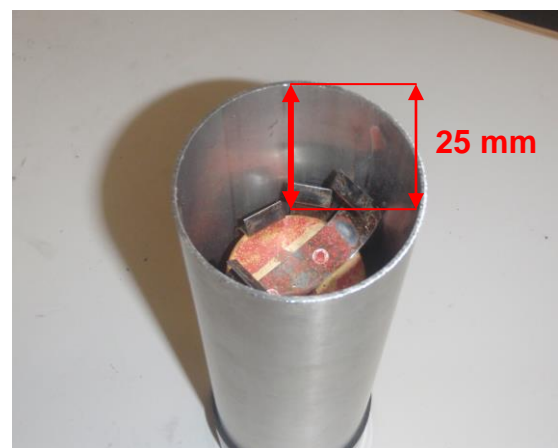
- 36 When the fog signals are placed into the carrying tube there is a gap between the end of the clip and the end cap of 25 millimetres (mm) allowing the fog signals to move up and down within the container, see Figure 16.

**Figure 16 – Photographs illustrating the gap in the tube when the fog signals are stacked**

- 67 In relation to the stainless steel tubes, the fog signals are free to move within the tube as there was 25 mm free space in the tube (paragraph 64) when the fog signals were stacked may have contributed to the activation of the fog signals. This action appeared of no consequence with the Lacroix fog signal but with the less rugged initiation system in the Alsetex device it is within the balance of probability that the movement within the carrying tube was sufficient to degrade one or more of the fog signals over time resulting in the explosion within the DART cab in Bray when the driver dropped his bag onto the floor as he commenced driving duties.

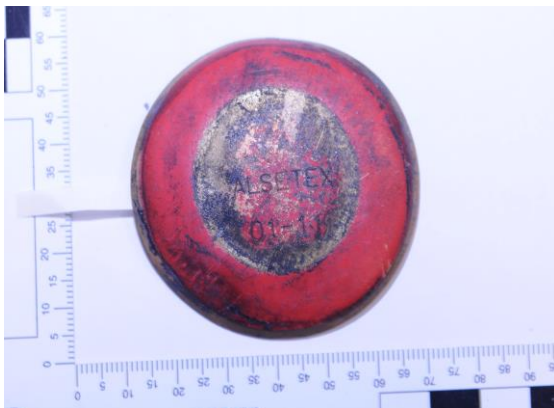
- 40 Eleven of the twelve fog signals exploded. The eleven exploded fog signals were marked as 'Irish Rail Alsetex' while the remaining unexploded fog signal was marked 'Irish Rail Lacroix'. The Lacroix fog signal was out of date at the time of the explosion; the date on the case was 01-06 (indicating this was the first batch of 2006), meaning that it should have been replaced five years later, in January 2011.
- 41 An examination of the carrying tube revealed that the majority of its down facing edge had been burnt in the explosion; also the fog signals at the bottom of the tube had rubber burnt onto its surface, see Figure 20; and the rim of the tube was burnt, Figure 21.

**Figure 20 – Fog signal that was found at the bottom of the tube**

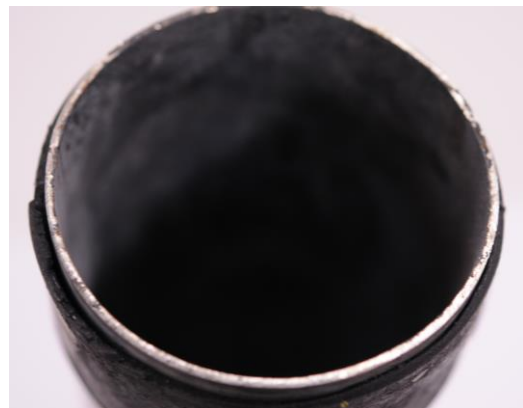
**Figure 21 – Rim of the tube**

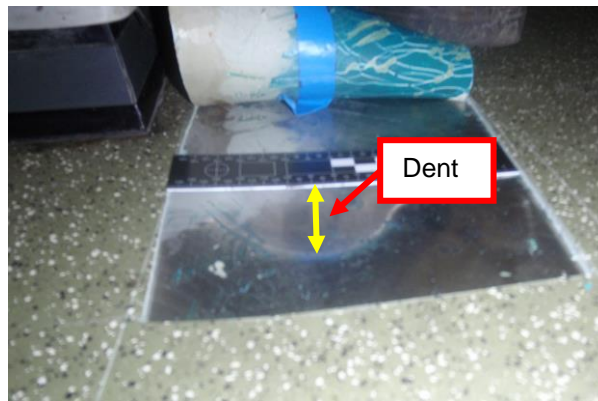
- 43 The source of the explosion was within the drivers cab to the right of the driver's seat, indicating that the initiation occurred where the bag had first been put by the driver.
- 44 When the linoleum covering was removed from the floor, the stainless steel underneath had a large dent at the point of the explosion, see Figure 22. The shape of the dent matched the shape of the fog signal container. Fragments of the fog signals were also embedded into the sides and roof of the driving cab.

**Figure 22 – Dent in the floor**

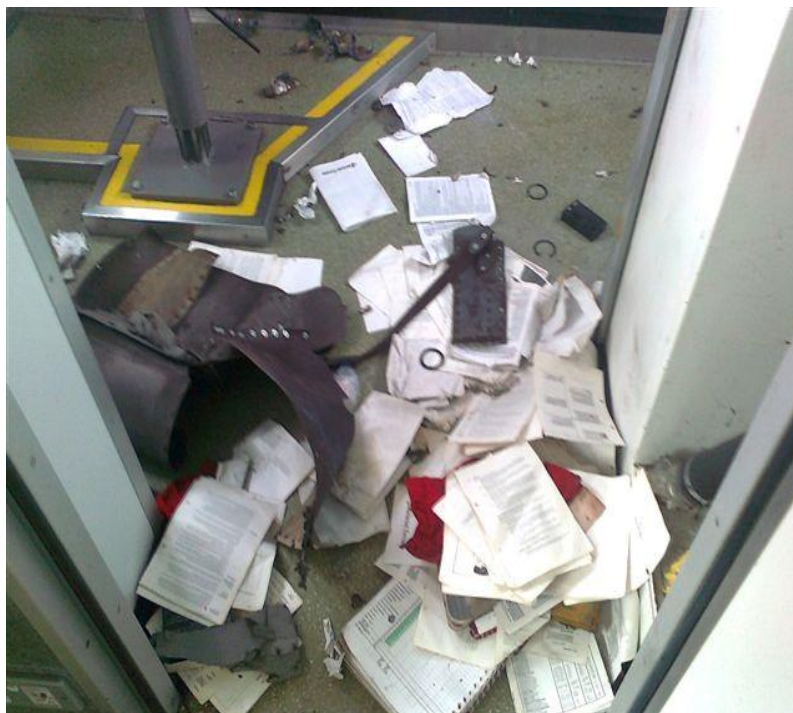
- 50 When the bag was dropped onto the floor of the driving cab there was an explosion from fog signals within the bag.
- 51 The driver was dazed but was able to immediately exit the driving cab back on to the platform, see Figure 23 for a view inside the driving cab.

**Figure 23 – Inside the driving cab**

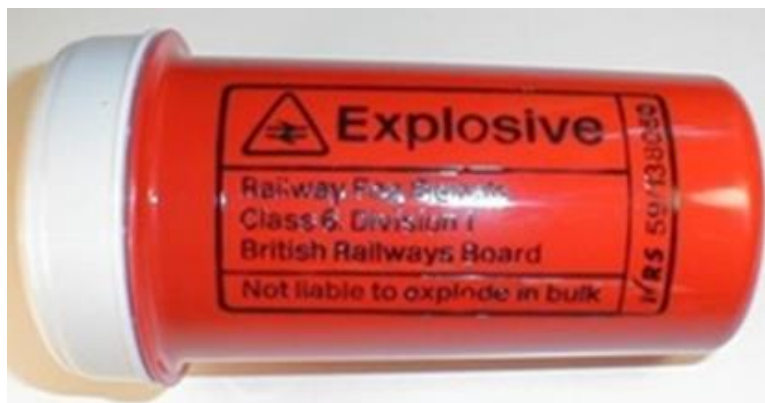
Figure 28 – New fog signal storage container

- Have withdrawn all Alsetex for signals from IÉ service;
- Have sourced fog signals from a supplier in the United Kingdom, which conform to British Standards;
- Have Developed a new procurement process, where all orders for replacement fog signals will request the manufacturer to notify IÉ of any change to the specification, these orders will be accompanied by a safety data sheet and all new stock arriving to IÉ will be quarantined until a check is performed;
- Have purchased a new storage container to meet guidance from the British Railways Safety Standards Board, see Figure 28;
- Have produced a risk assessment on all aspects of fog signal use, storage, transportation procurement and disposal;
- Have begun developing a procedure for use and storage of fog signals;
- Are introducing a system where the drivers are no longer required to carry fog signals in their driver's bag.
