# Railway Accident Investigation Unit

## **INVESTIGATION REPORT**

**Fog signal activation in DART driving cab,  
Bray, 6<sup>th</sup> March 2012**

**RAIU Report No: R2013 – 003**

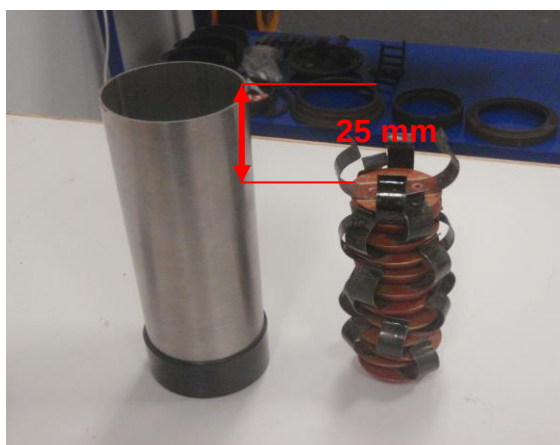
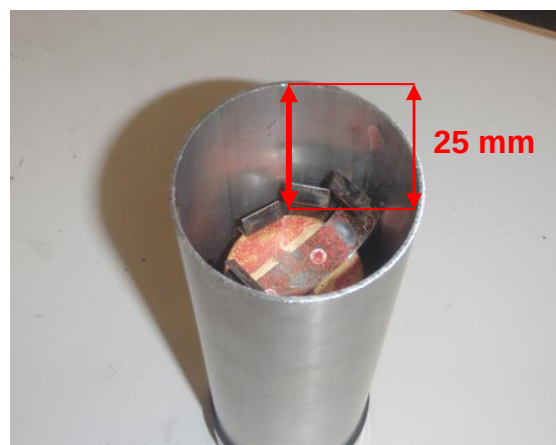
- 36 When the fog signals are placed into the carrying tube there is a gap between the end of the clip and the end cap of 25 millimetres (mm) allowing the fog signals to move up and down within the container, see Figure 16.

**Figure 16 – Photographs illustrating the gap in the tube when the fog signals are stacked**

- 67 In relation to the stainless steel tubes, the fog signals are free to move within the tube as there was 25 mm free space in the tube (paragraph 64) when the fog signals were stacked may have contributed to the activation of the fog signals. This action appeared of no consequence with the Lacroix fog signal but with the less rugged initiation system in the Alsetex device it is within the balance of probability that the movement within the carrying tube was sufficient to degrade one or more of the fog signals over time resulting in the explosion within the DART cab in Bray when the driver dropped his bag onto the floor as he commenced driving duties.

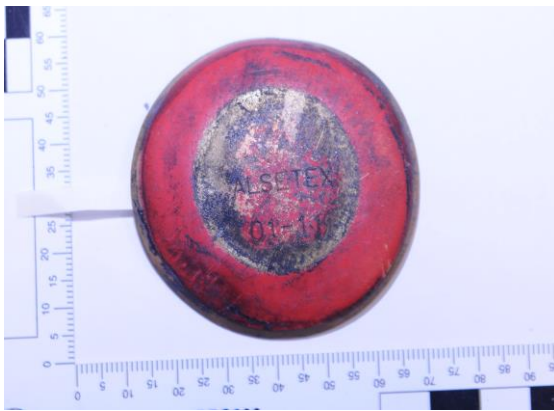
- 40 Eleven of the twelve fog signals exploded. The eleven exploded fog signals were marked as 'Irish Rail Alsetex' while the remaining unexploded fog signal was marked 'Irish Rail Lacroix'. The Lacroix fog signal was out of date at the time of the explosion; the date on the case was 01-06 (indicating this was the first batch of 2006), meaning that it should have been replaced five years later, in January 2011.
- 41 An examination of the carrying tube revealed that the majority of its down facing edge had been burnt in the explosion; also the fog signals at the bottom of the tube had rubber burnt onto its surface, see Figure 20; and the rim of the tube was burnt, Figure 21.

**Figure 20 – Fog signal that was found at the bottom of the tube**

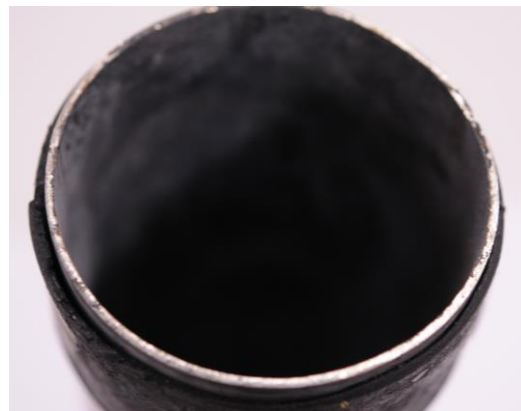
**Figure 21 – Rim of the tube**

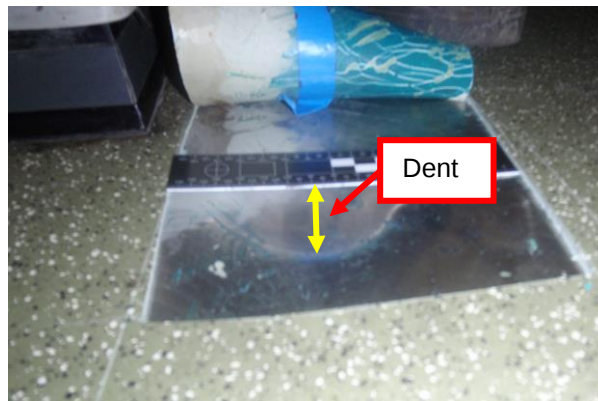
- 43 The source of the explosion was within the drivers cab to the right of the driver's seat, indicating that the initiation occurred where the bag had first been put by the driver.
- 44 When the linoleum covering was removed from the floor, the stainless steel underneath had a large dent at the point of the explosion, see Figure 22. The shape of the dent matched the shape of the fog signal container. Fragments of the fog signals were also embedded into the sides and roof of the driving cab.

**Figure 22 – Dent in the floor**
