AGENȚIA DE INVESTIGARE FERROVIARĂ ROMÂNĂ - AGIFER

INVESTIGATION REPORT

of the railway accident happened on the 8th April 2017,
in the railway county Timișoara, track section Livezeni – Simeria (electrified double-track line),
between the railway stations Bănița and Merișor

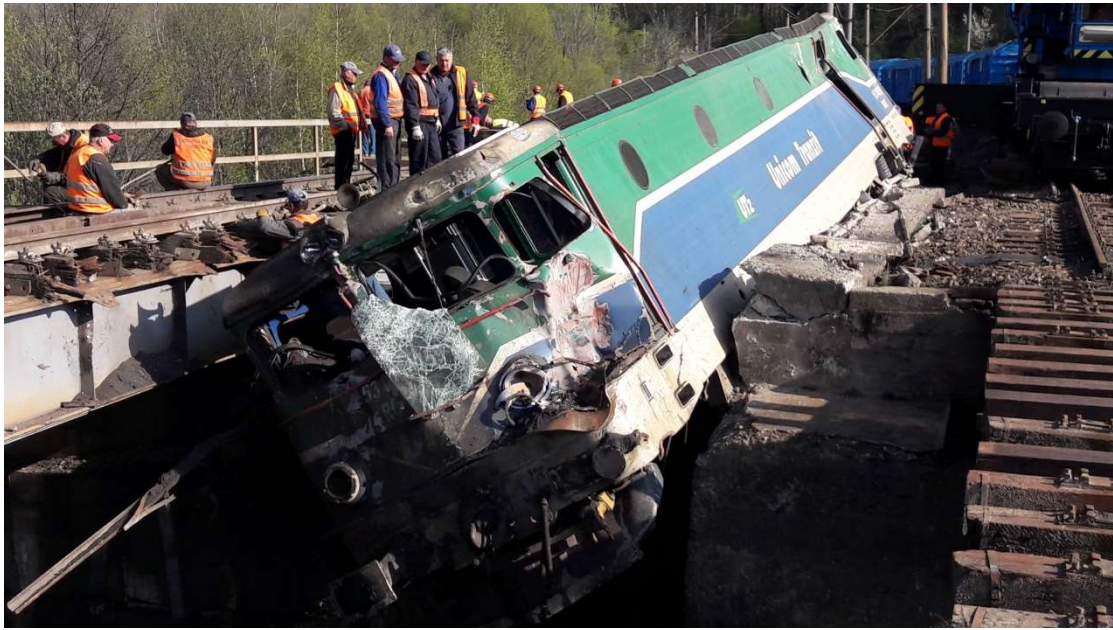
Picture no.1

All axles of the locomotive EA 759 were derailed, it being between the guideway beams of the bridges corresponding to the tracks I and II – *picture no.1*;

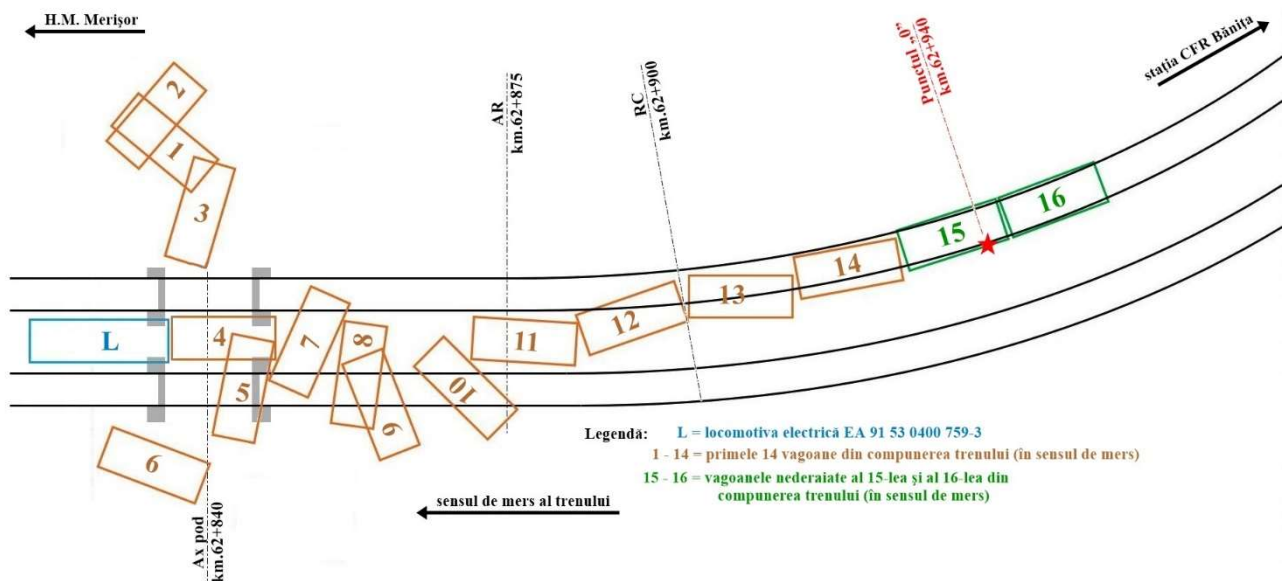
Sketch no.2 – Position of the rolling stock after the derailment

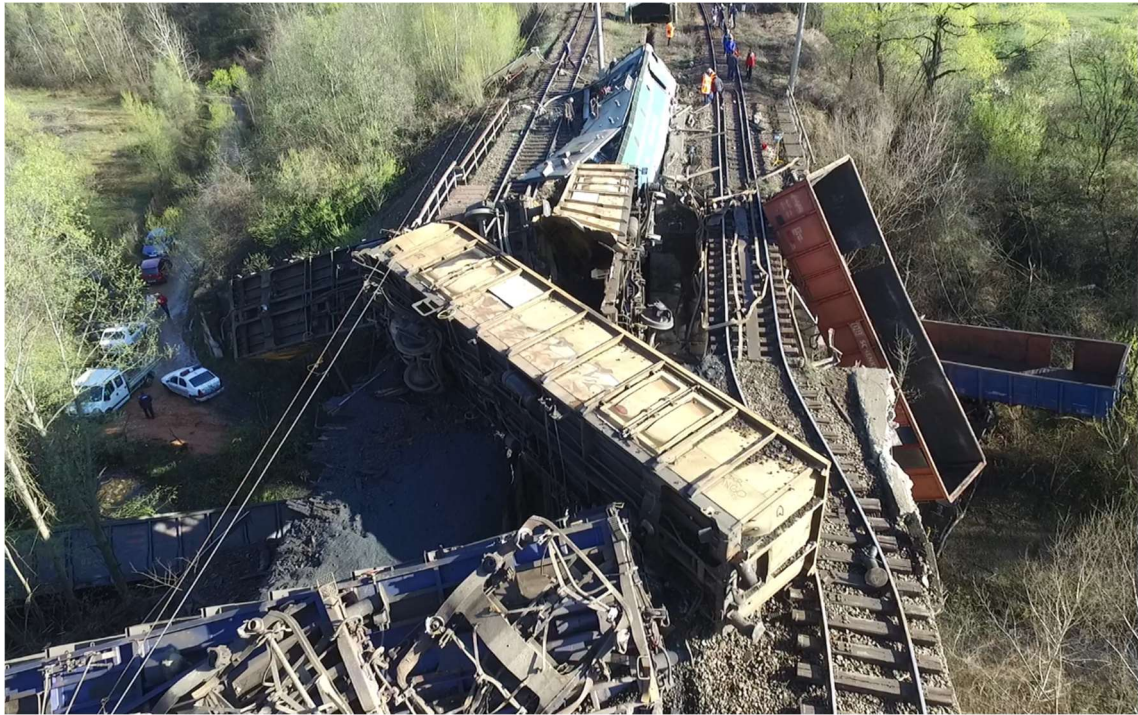
Picture no.4

- The right side (on the train running direction) of the top of the abutment lateral wall that support the embankment from the railway station Bănița;

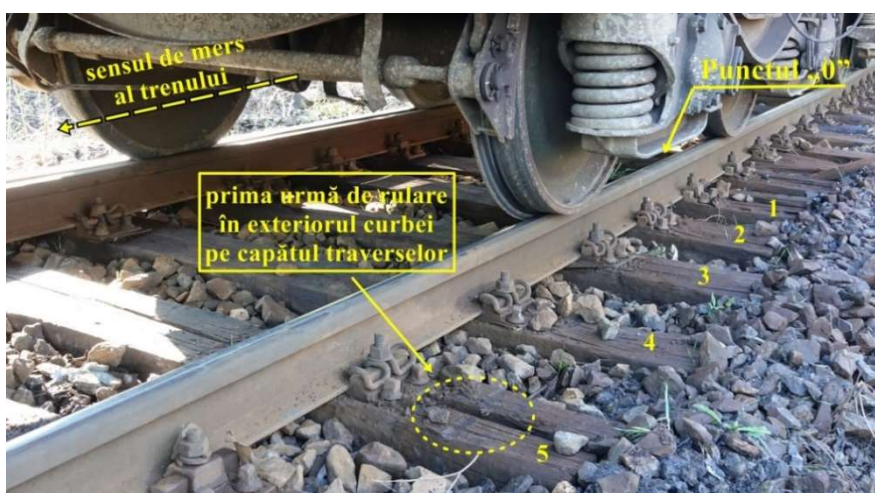
Picture no.7 Sleepers 1-4 - ends of the sleepers from the curve exterior rail
 Sleeper 5 - first mark of fall and running outside the running track, to the exterior of the curve

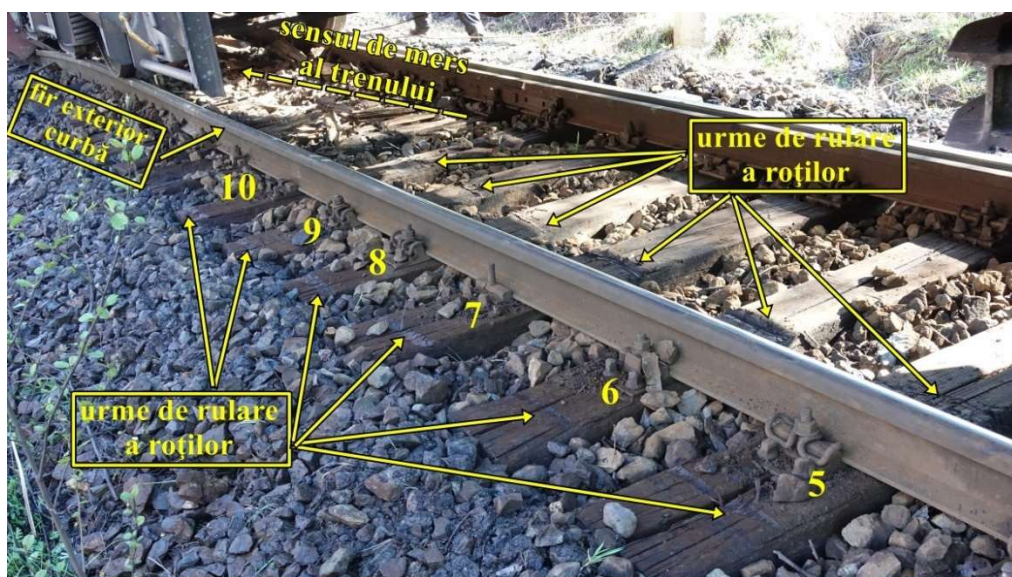
On the next consecutive 6 sleepers, on both sides of the curve exterior rail, there were identified marks of the the wheels flange running on the upper faces of the sleepers.

Picture no.8 Group of 6 sleepers (sleepers 5-10) – marks of wheel running, on both sides of curve exterior rail

The marks left on the upper faces of the sleepers between the rails, by the wheels flange, are directed to the centre of the track, and those outside the track are on the ends of the sleepers and directed to the track II.

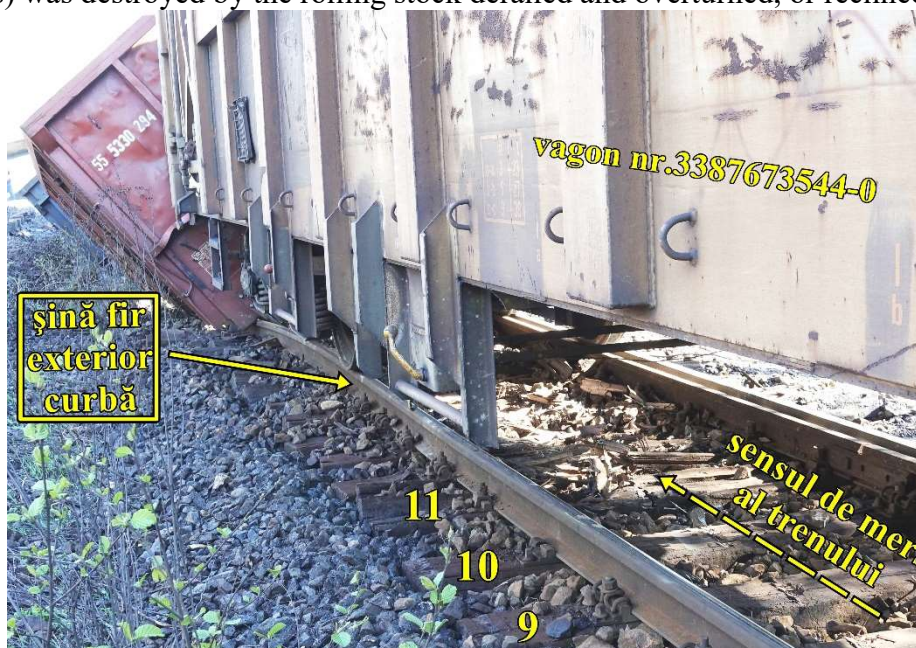
Picture no.9 Group of sleepers 9 - 11

Starting with the 11th sleeper, the track superstructure (sleepers, rails, joint ensembles, small track materials) was destroyed by the rolling stock derailed and overturned, or reclined to the track II.

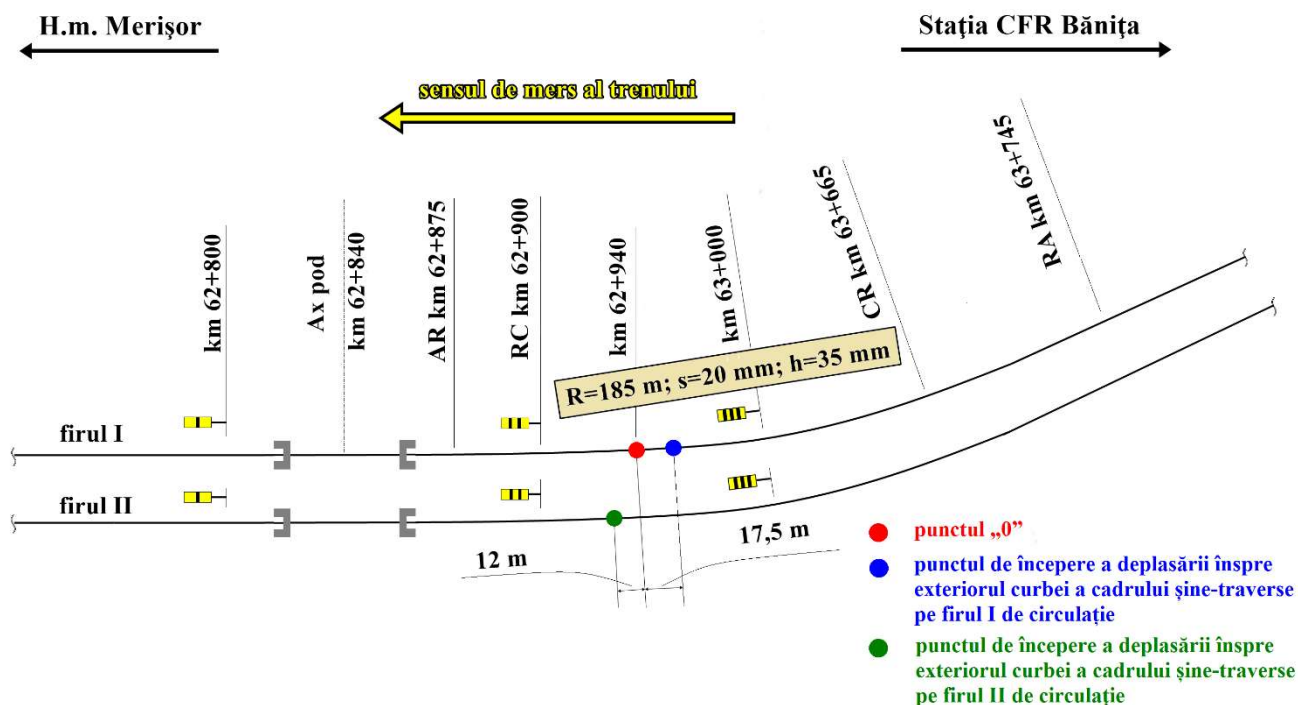
Sketch no.4

In the train running direction, to the point marked with „0”, the frame rails – sleepers was buckled to the exterior of the track, on a length of about 17,5 m.

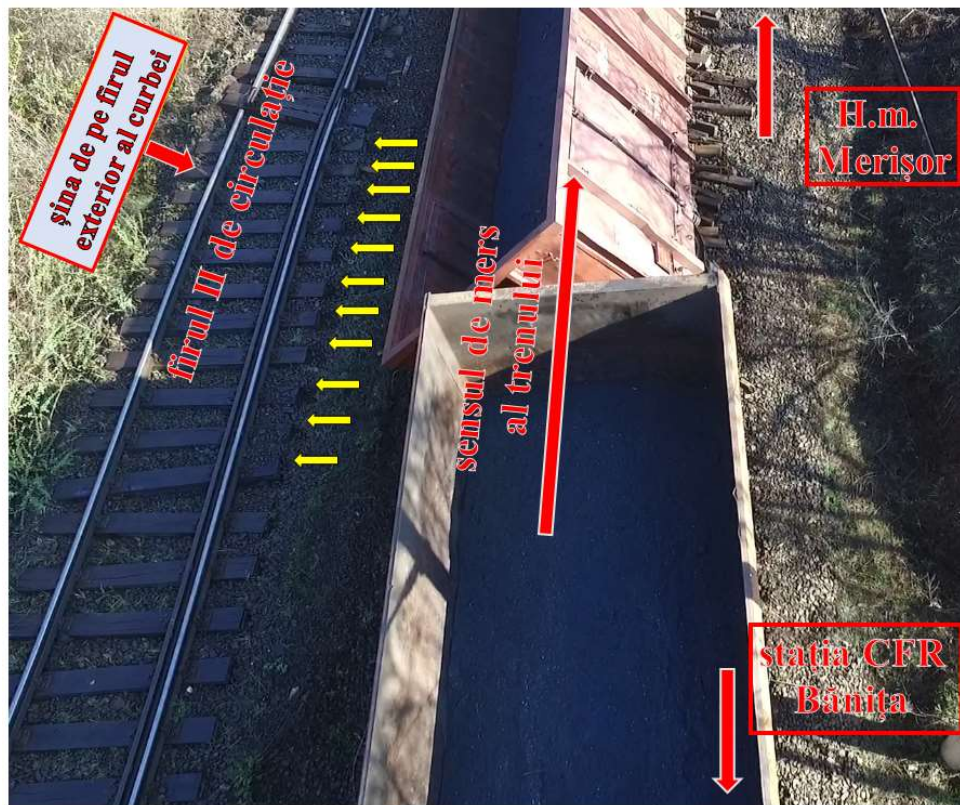
Picture no.10 Rail II Bănița-Merișor – at the ends of the sleepers inside the curve, there are hollows generated by the movement of the frame rail-sleepers to exterior of the curve

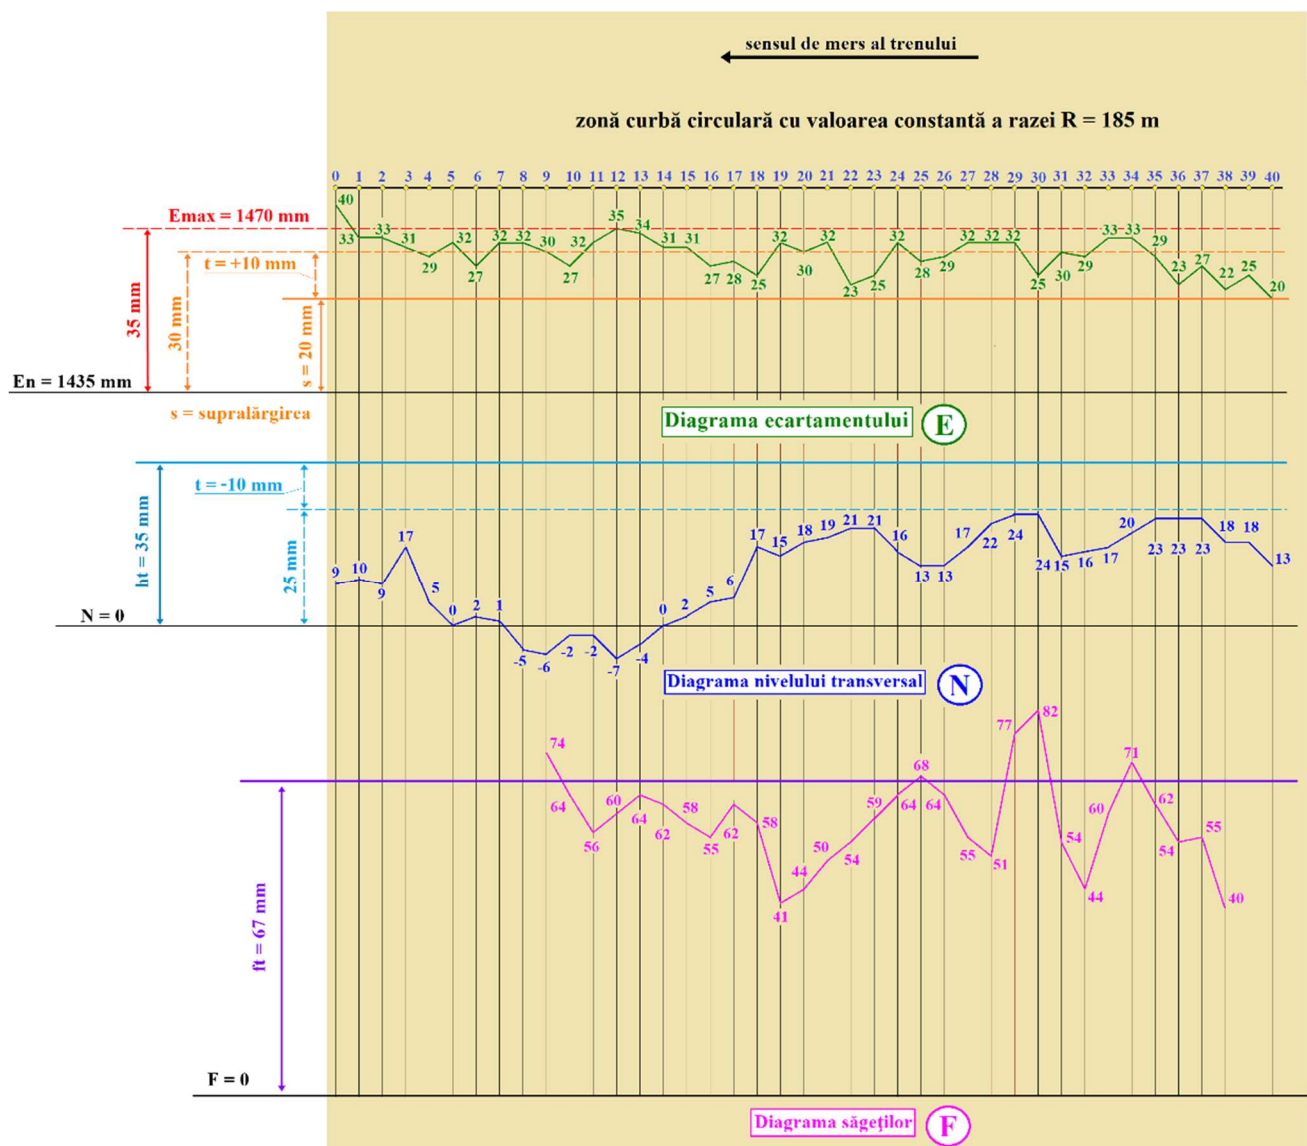
Taking into account that the lateral movement of the frame rails-sleepers to the exterior of the curve (the track was buckled) was starting at 17,5 m before the point „0” (reported to the running direction of the train), the measurement of the track versine in the middle of the chord of 10 m, on the marked area, was performed at the end of the chord, starting with the point 7.

Picture no.5 – Values of the track geometry parameters

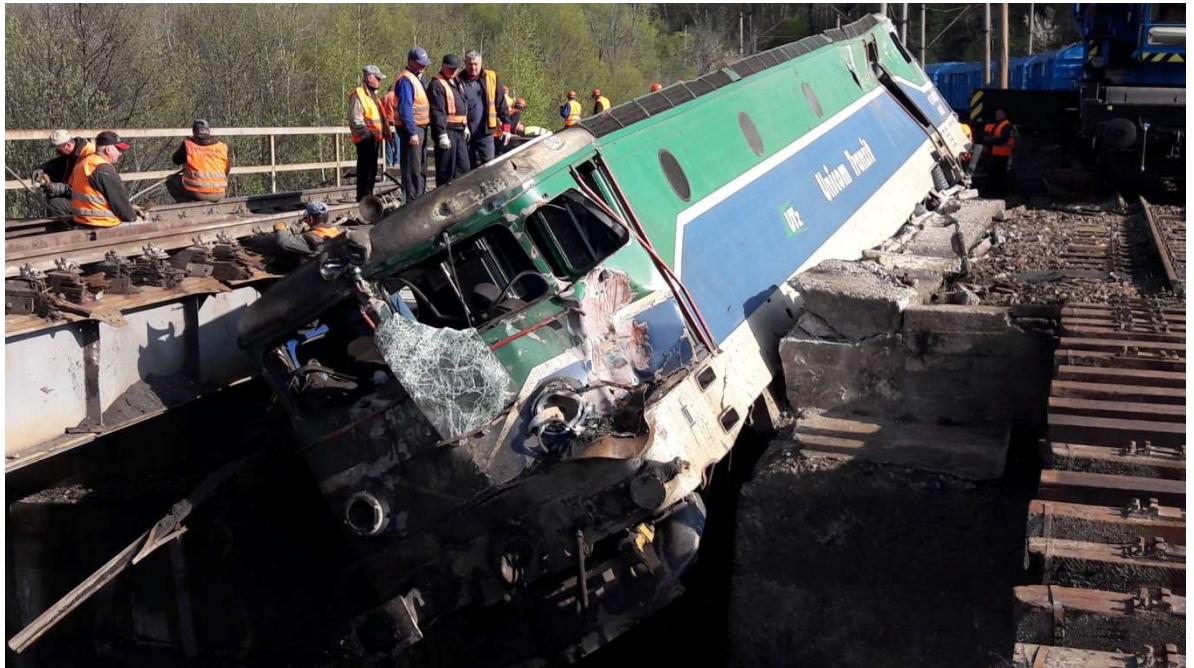
Picture no.11

- the loocomotive was between the guideway beams of the bridges from those two tracks from km 62+840, reclined at 30°,leant on the bridge abutments from the railway station Merișor;

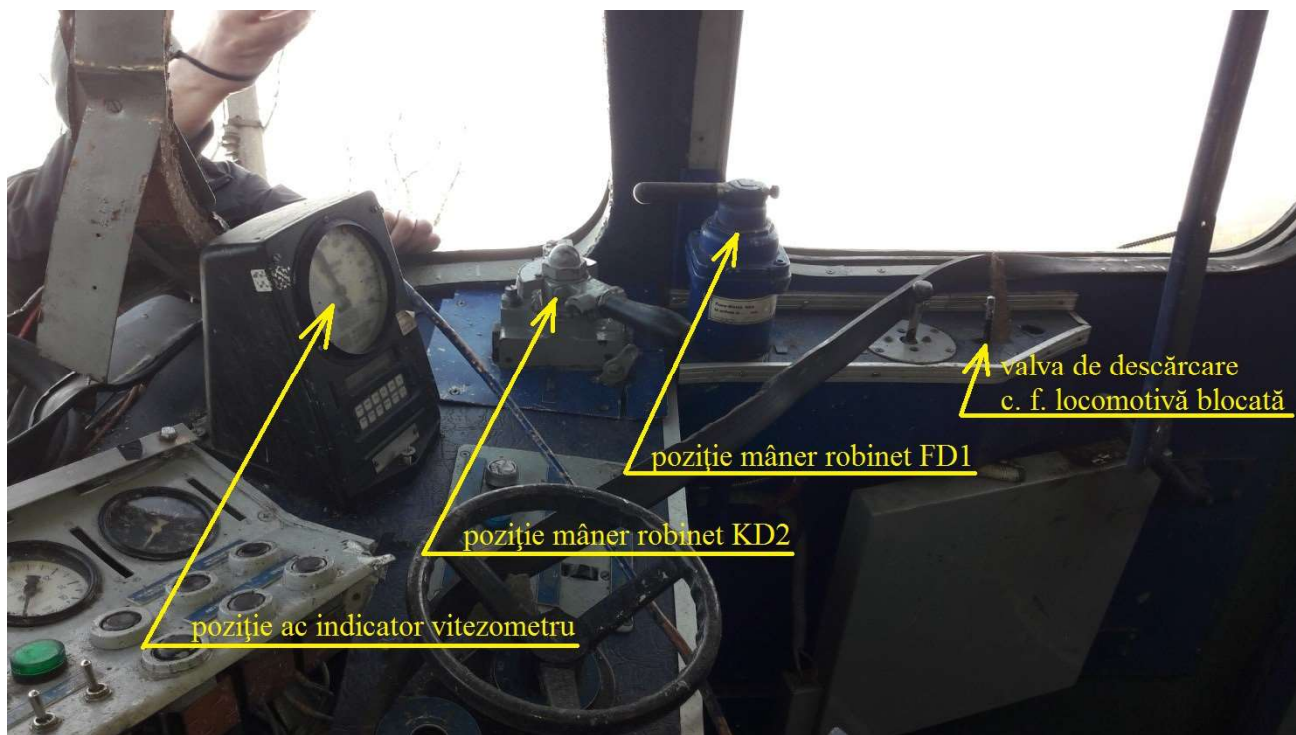
Picture.no.12

- the speed recorder with the hand of analog speedometer, blocked at the speed of 86 km/h;

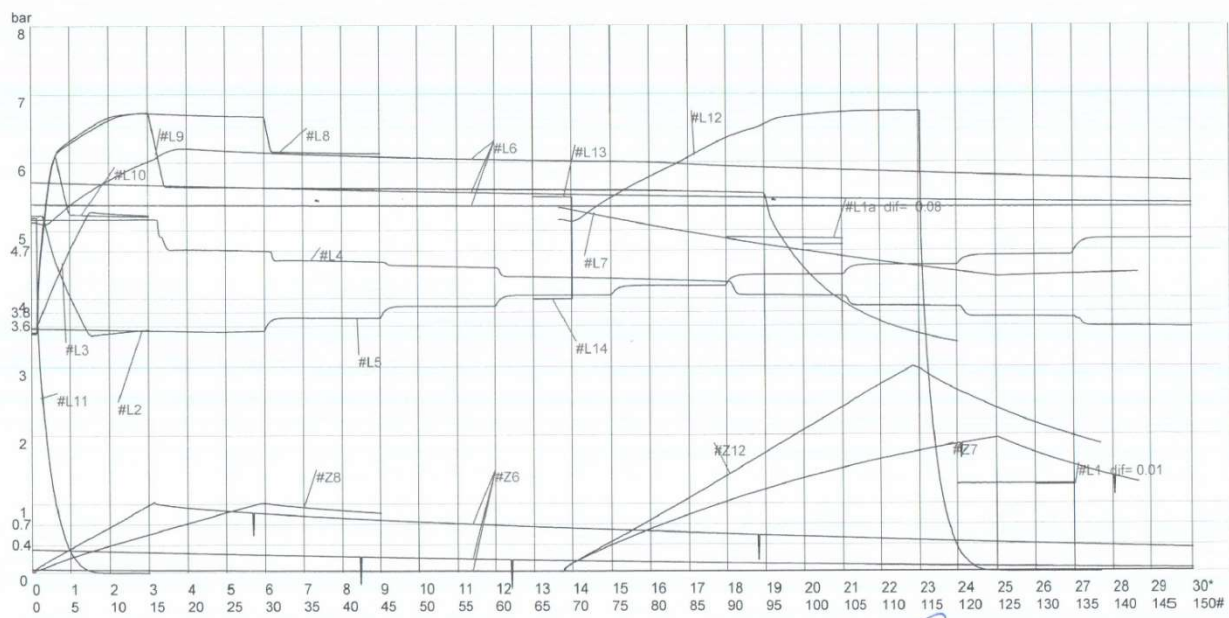
Picture no.6

- **the driver's automatic brake valve KD2** of both driving cabs were checked on the testing bench, the diagram of each driver's automatic brake valve was represented. As for the the driver's automatic brake valve KD2 from the driving cab I of the locomotive (driving cab where the locomotive was driven in the hauling of the freight train no.50457) curves L₄ and L₅ from the diagram, presented the working in operation, position IV, application of the brake and its release,gradually, they coresponded without the level 5, at the application of the brake, respectively the level 1 at the brake release – *picture no.6*

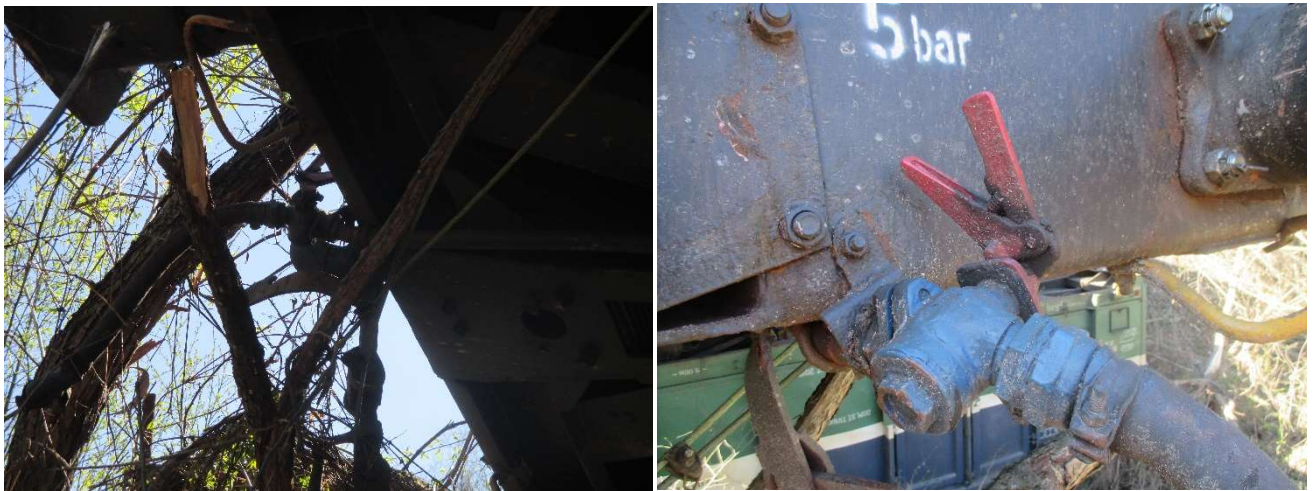
- Wagon no.31535494448-2, 1st one of the train:
 - derailed and overturned on the right side, in the train running direction, fallen in the stream under the bridge, above the second wagon, perpendicular on the track centre (with the wagon body up);
 - the angle air cock being at the opposite end against the track (upstream) was on the wagon, on position „closed”, without finding hit marks on the operation handle;

Pictures no.15–16 – angle air cock from the first wagon

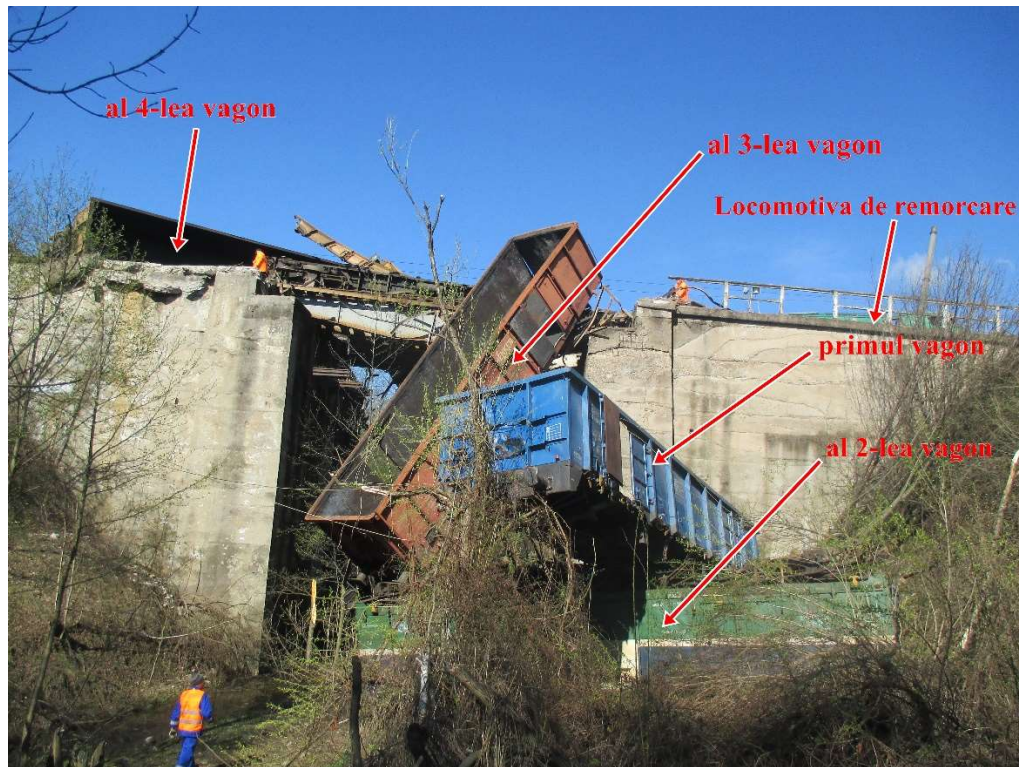
- derailed, overturned at 90° behind the locomotive and leant between those two guideway beams of the bridge;

Picture no.17 - Position of the first 4 wagons derailed

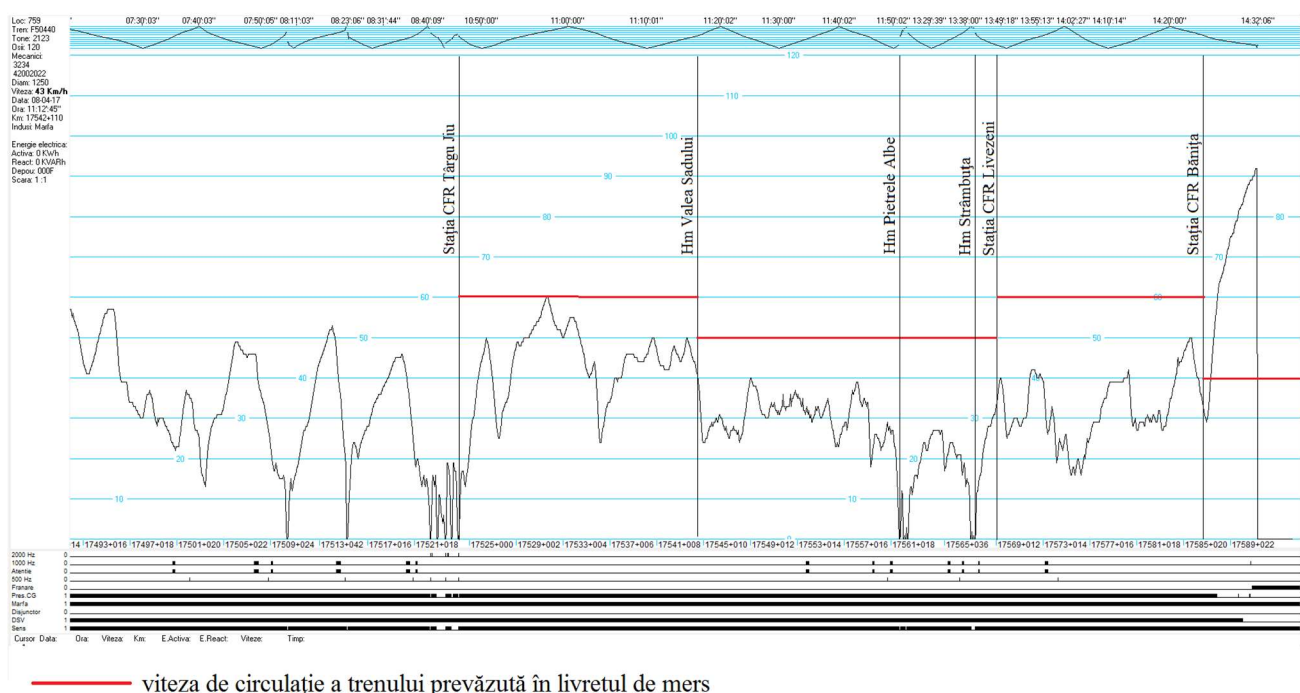
Picture no.7

From the reading and interpretation of the data supplied by the speed recorder, taking into account the train speed from the working timetable, one could find out vigilance in the locomotive driving, generated both by the speed restrictions on site and by the train running upon automatic section block. The real speed of the train, after the railway station Valea Sadului, was smaller with over 10 km/h against the speed stipulated in the working timetable, and after the railway station Pietrele Albe, the real speed of the train was smaller with over 20 km/h against the speed stipulated in the working timetable – *picture no.7*.

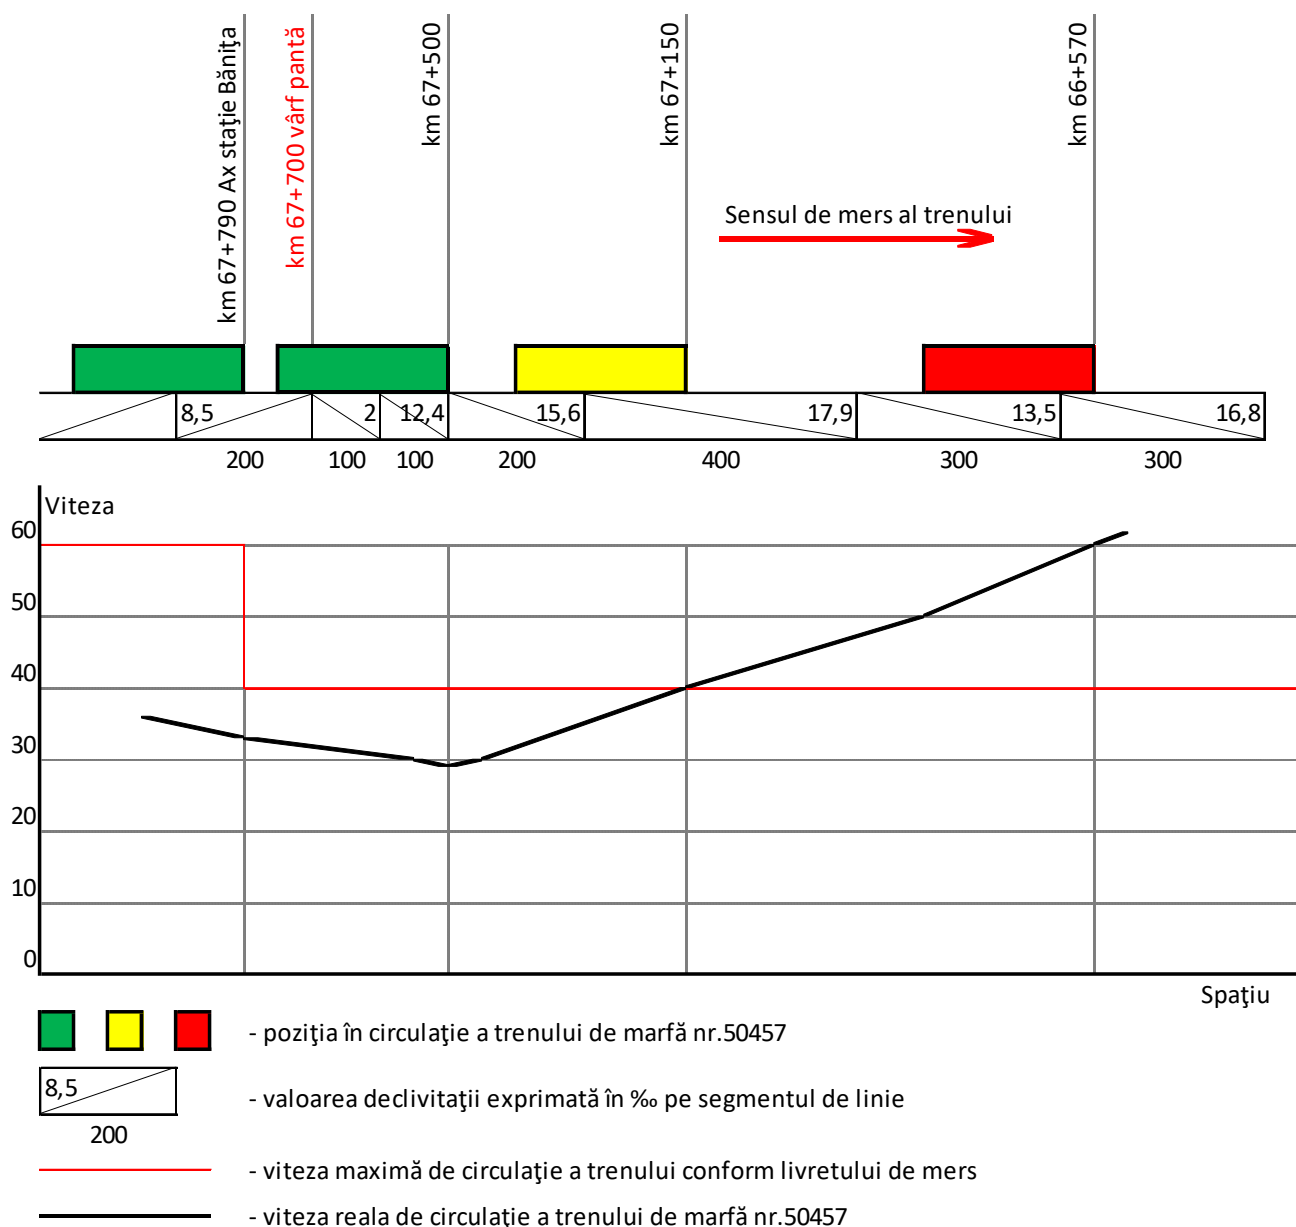
Picture no.8

Close to the railway station Bănița (up to the railway station Bănița the maximum speed stipulated in the working timetable is 60 km/h, and from the railway station Bănița 40 km/h), the driver took the measures to decrease the train speed, so, the train passed through the railway station with a speed of 33 km/h. At that moment the train ran on slope, continuing this running still 90 m. After passing the slope peak, the train speed decreased continuously on 200 m, to 29 km/h, in that point 80% of the train being on slope (train length was 249 m) – *picture no. 8*.

- applied the brake and released it at short times through the operation of the automatic brake (the driver's automatic brake valve KD2), without braking the train because the general air pipe was interrupted (because the front cock from the first wagon, after the locomotive, was closed), and the release valve of the locomotive brake cylinders was blocked;
- operated the straight brake (driver's straight air brake FD1) and the automatic brake (the driver's automatic brake valve KD2);
- used simultaneously the pneumatic brake (locomotive straight brake) and the electric one, overlapping the effects of those two braking systems, it favouring the blocking of the locomotive wheels.
