Presentation of the railway accident

On the 22nd December 2018, the freight train no.69498S, got by the railway undertaking SC TIM RAIL CARGO SRL, was dispatched from the railway station Grădinari Caraș to the railway station Timișoara Nord.

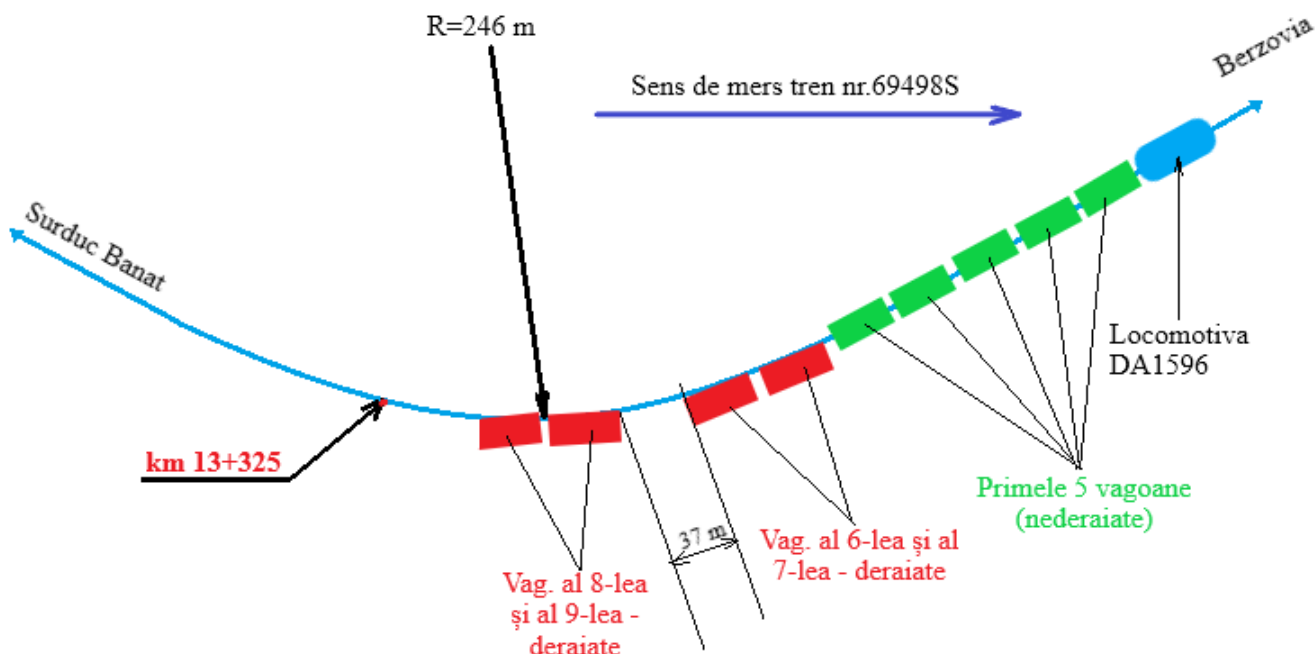
Drawing no.2 –position of the rolling stock after the derailment

Between the halts Doclin and Tirol, km 13+270, on a constant-radius curve with left deviation, in the running direction, the train speed being about 41 km/h, the wagon no.33539334603-6, the 6th one of the train, derailed, the left wheels falling inside the track, respectively the right ones outside the line.

In its derailment, the wagon led to the derailment of the next three wagons of the train (the 7th, 8th and 9th wagons).

Following the running of the wagons in derailment condition, the fish plates of the coupling equipment between the 7th and the 8th wagons broke, it leading to the discontinuance of the general air pipe of the train, followed by the application of the emergency braking.

Distance run by those 4 derailed wagons is about 130 m, from the first to the last derailment mark (between km 13+325 and 13+195).

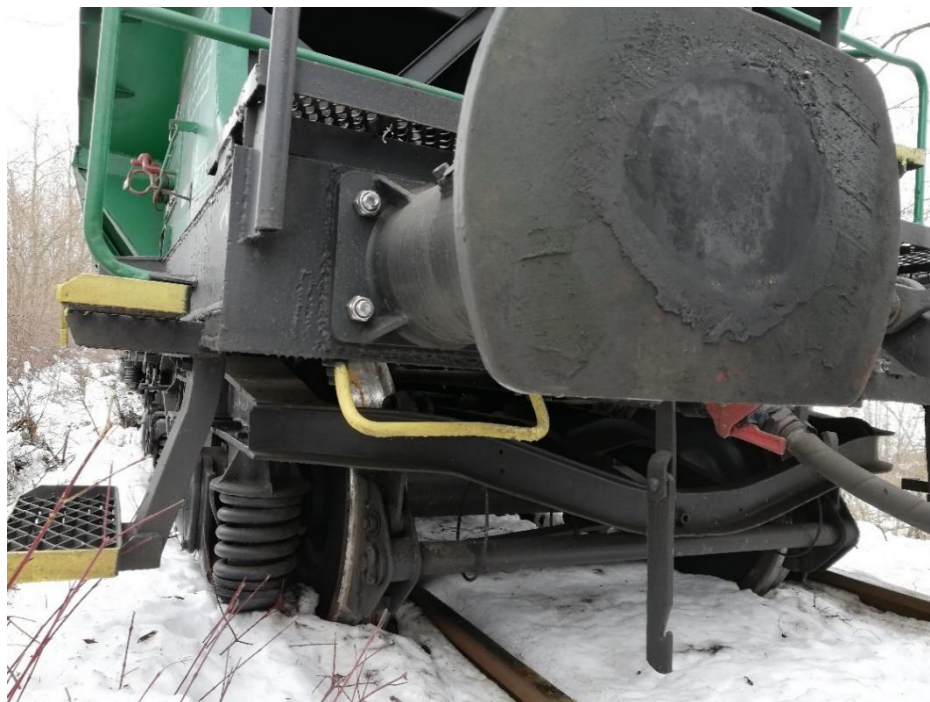
- all axles of the 6th wagon (no.33539334603-6) derailed;

Picture no.3 - wagon no.33539334603-6 (the 6th one)

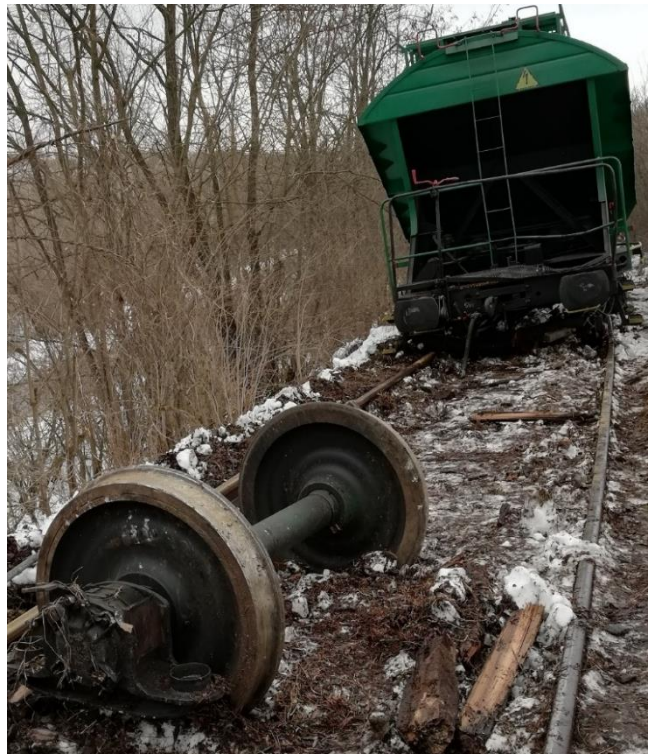
- all axles of the 7th wagon (no.33539335758-7) derailed, and the last axle in the running direction (corresponding to the wheels 1-2) out from the bogie frame and situated behind the wagon at about 5 m. On the suspension part, being from the suspension of this axle, taken from the accident site, no hit or other marks were identified, excepting those generated by the normal working of this part.

Picture no.4 -wagon no.33539335758-7 (the 7th one)

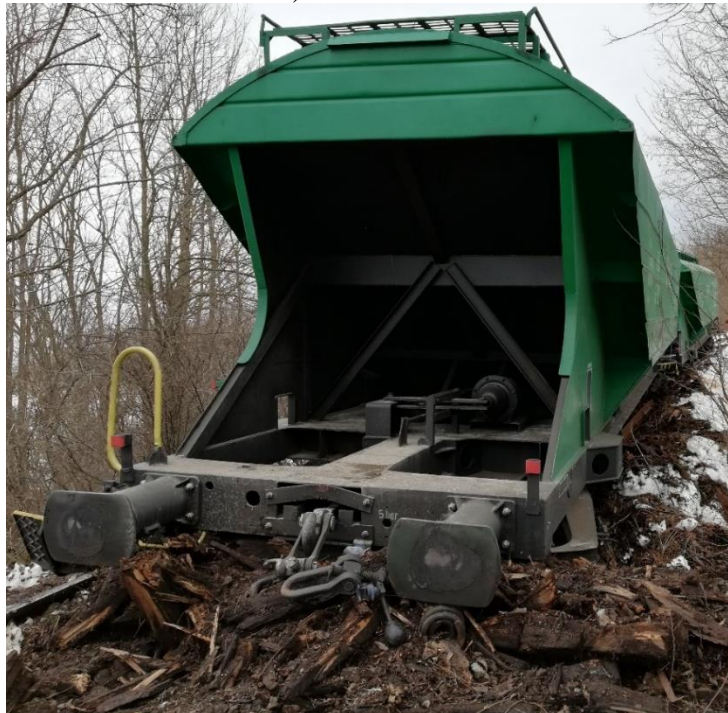
- all the axles of the 8th wagons derailed (no.33539332142-7) and stopped at about 37 m distance from the front wagon;
- the first bogie of the 9th wagon (no.33539335082-2) derailed in the running direction (the bogie corresponding to the wheels 5-6 and 7-8).

Picture no.5 - wagons no.33539332142-7 (the 8th one) and n.33539335082-2 (the 9th one)

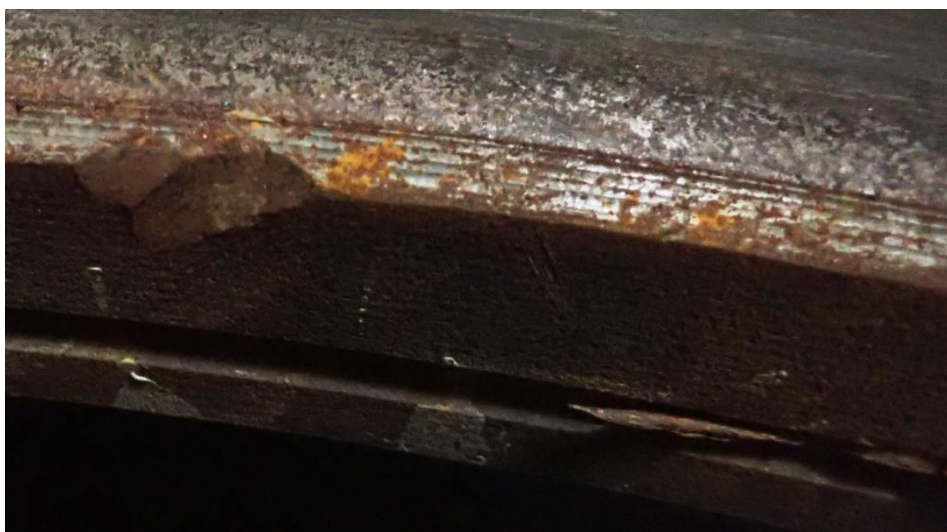
- on the wheels of the wagon no.33539334603-6, the 6th one of the train, one found out the next:
 - at the wheels 2 and 4 (the left wheels of the first two axles, in the running direction), hit and friction hits on the exterior chamfer and in the area of the wear limit channel;

Picture no.6 -marks of hit and friction on the exterior chamfer and in the area of the wear limit channel from the wheel 2.

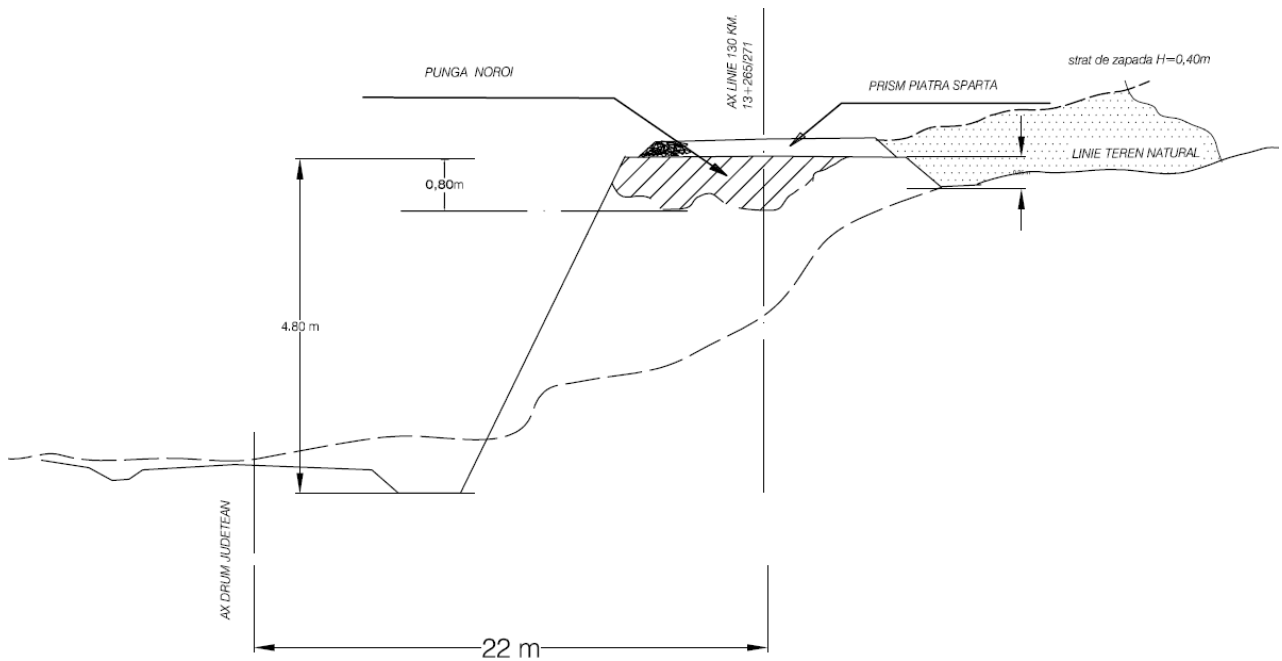
Drawing no.7 –track transversal level

The railway accident happened at km13+270, between Surduc Banat and Berzovia railway stations, on the constant-radius curve with left deviation, in the train running direction, with radius $R=246$ m, cant $h=90$ mm, over-widening $s=20$ mm.

The track superstructure at the accident site consists in rail type 49, non-welded track, wooden sleepers, indirect fastening. The track bed is type embankment, with variable height from 5,20 m to 1,20 m on the right side, respectively from 0,40 m to 0,80 m on the left side, in the km direction.

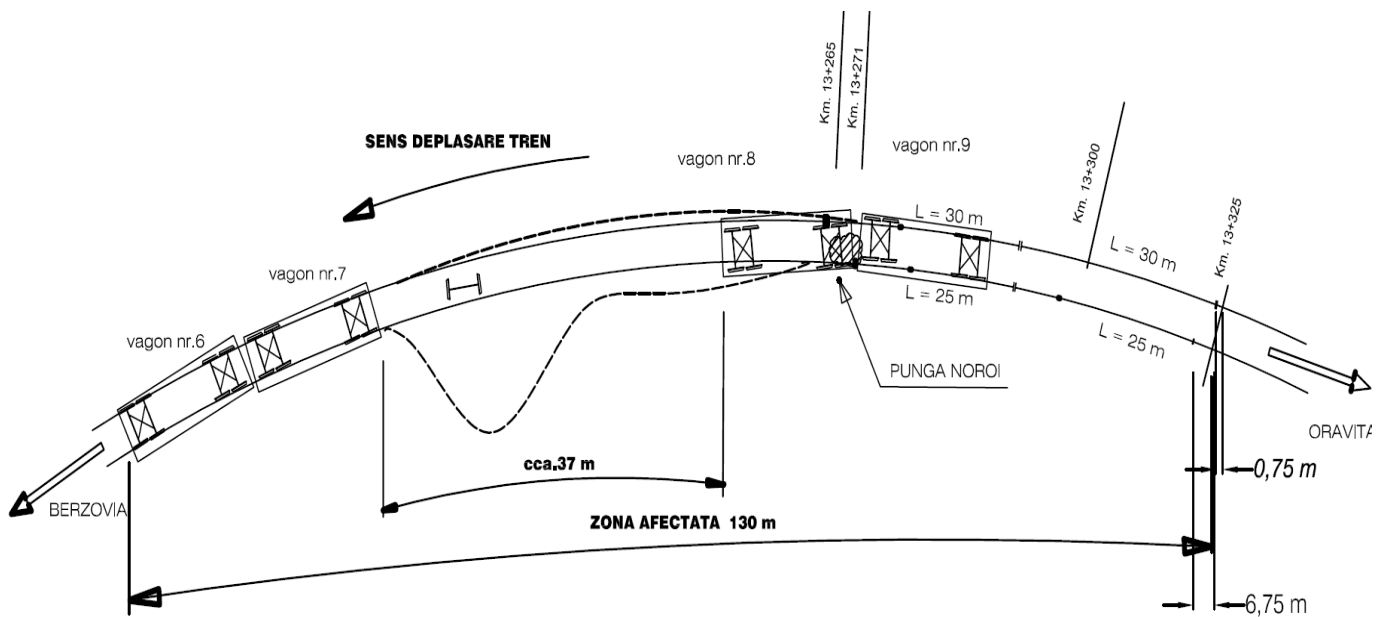
Drawing no.8 – derailment site

Having like reference the train running direction, the first running marks of the flange of wheel on the upper surface of the rails and then of derailment were identified at km.13+325. From the analysis of the findings from the accident site (marks left by the running of the wheels of the derailed wagons, wagon position after their stop, etc), of the track geometry and technical condition, as well as of the findings at the wagons involved in the event, the investigation commission concluded that the identified marks at km.13+325 are generated by the wheels of the wagon no. 33539335082-2, the 9th wagon of the train, following the shocks induced by the derailment of the wagon no.33539334603-6, being the 6th one in the train composition.

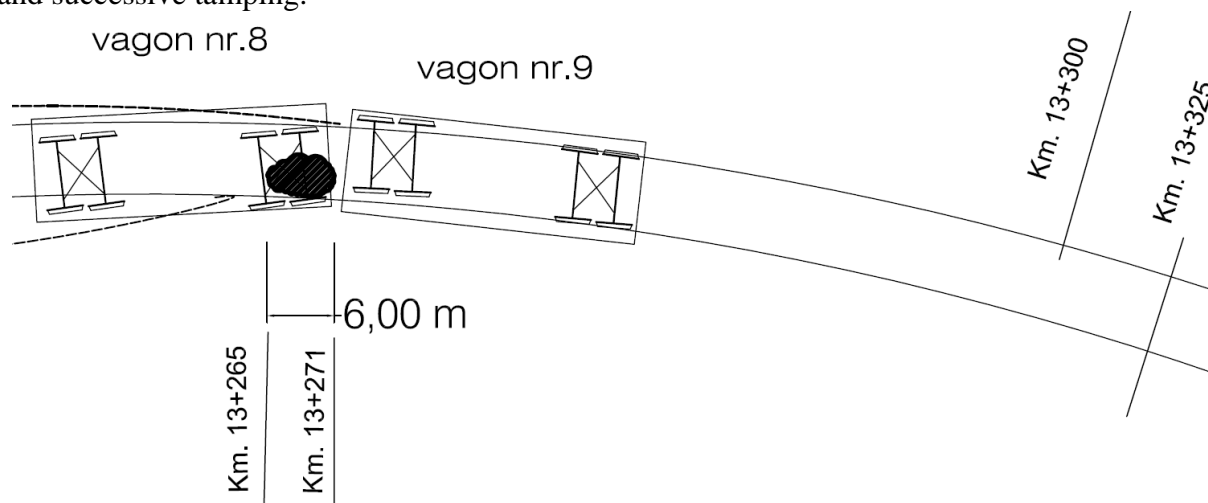
Drawing no.9 – mud pocket position

no.3/3/6/85/11.02.2019, of the railway county Timișoara, AGIFER was informed that, during the works, one found out that at km 13+265÷13+271, there were some horizontal mud pockets unstable, sizes of about 6x4 m, thickness of about 0,80 m, situated on the right side against the track centre, having like reference the direction of km increase. This mud pocket led to the ducking of the vehicle wheels (Colmar), used for work, up to the cabin.

The area where this mud pocket was, against he derailed wagons, was under the 8th train wagon. In this area the whole part was pickled in order to remove the mud and the embankment was remade filling with ballast and successive tamping.

The appearance of these mud pocket happened following the natural land configuration, layout of materials the embankment is made off, the abundant snow falls before the event, together with the sudden melting of a part of the snow level existing in that area.

Following the finding of the mud pockets at km 13+265÷13+271, the railway county Timișoara took a series of measures for the prevention of similar situations, respectively:

- resuming of the traffic with speed restriction of 15 km/h, between km 13+150 and km 13+350;
- between km 13+150÷13+300 periodical inspections and measurements shall be performed at the transversal and longitudinal level;
- the measurements made shall be reported fortnightly at the technical office of the Track Section L1 Caransebeș by the local district line inspector;
- monthly the technical staff of the track section L1 Caransebes shall perform measurements at the longitudinal level;
- according to the values of the measured geometric parameters of the track, one shall take measures for: limitation of the train traffic, inclusion of the area in the evidence of the dangerous points and the proposal for the performance of some works for consolidation or rehabilitation of the line in the respective area.

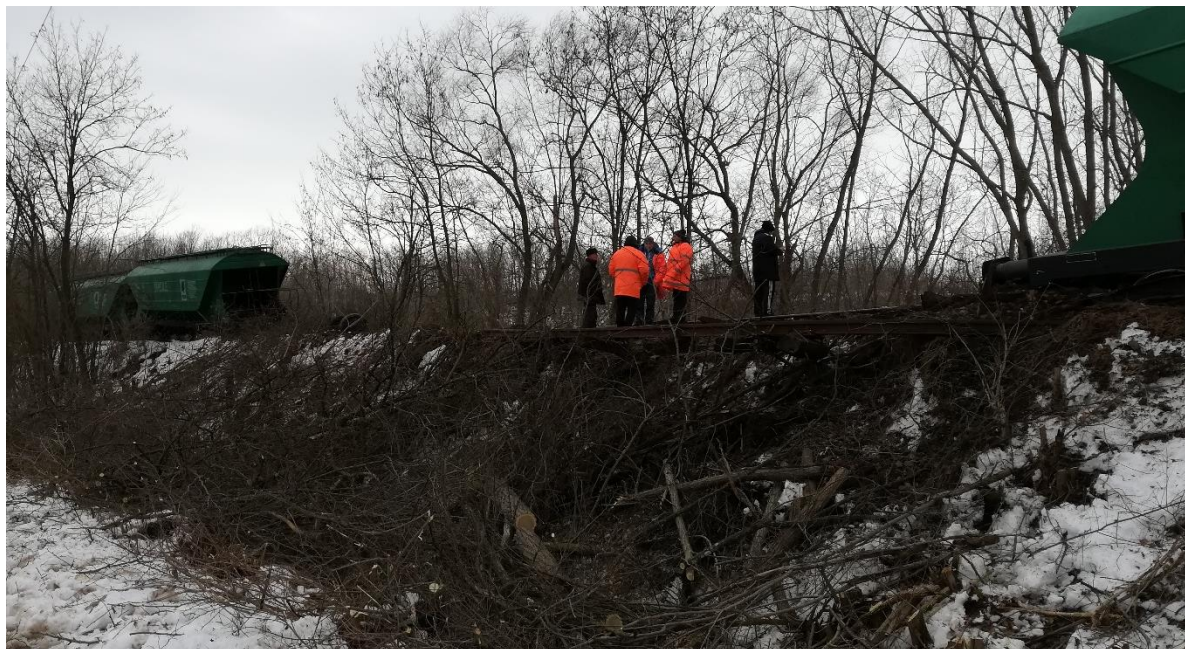
Picture no.10 – derailment area

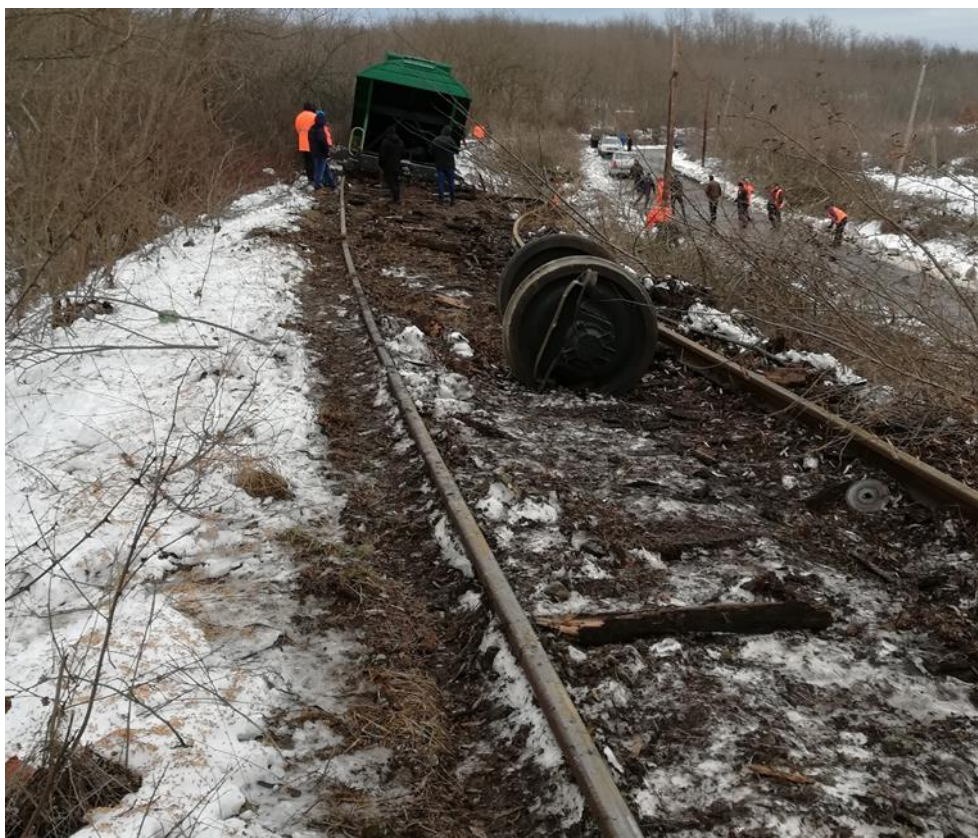
Picture no.11 – aspect of the track after the derailment
