INVESTIGATING REPORT

of the railway accident
occurred on the 24th of September 2014, in the railway station Halmeu, in the running of the freight train no. 3651/48651, through the derailment of the second bogie in the running direction, from the wagon no. 52623642 (last from the train)

Final edition
December 2014

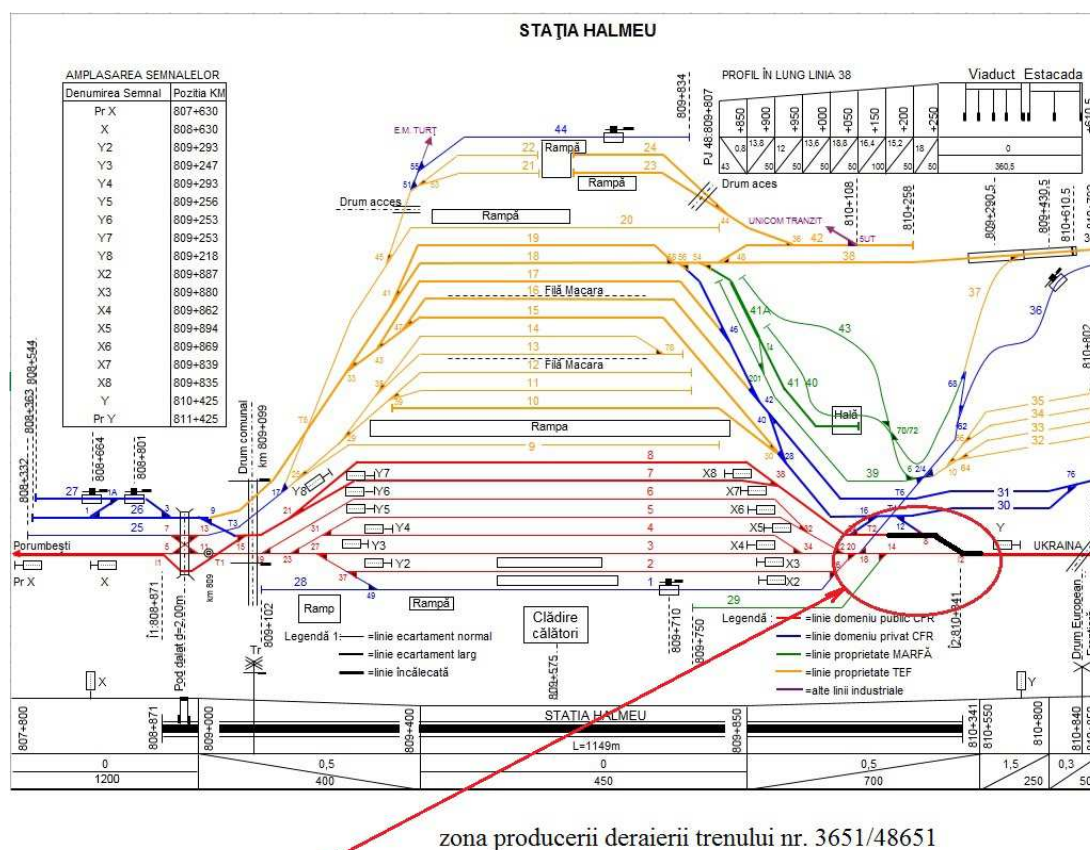
Train no. 3651/48651 derailment occurrence place

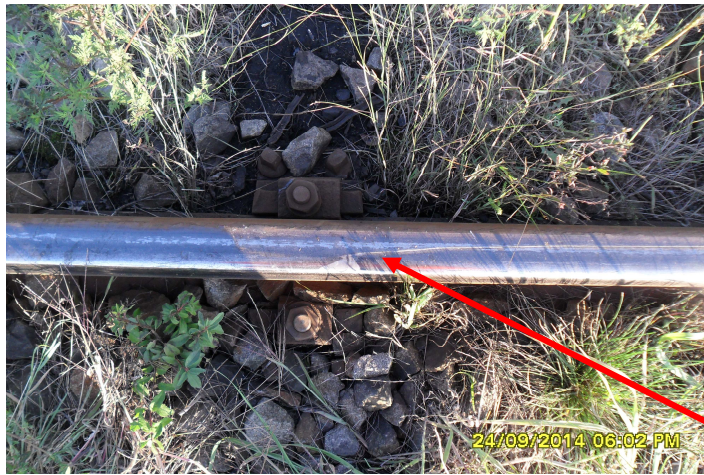
Photo no.1 The first derailment trace

The first climbing trace was found on the exterior curve rail with a right deflection at about 7,6 m before the switch crossing nose no. 2 between the line with broad gauge and the line with standard (at km 817+941). The wagon run derailed on a distance of about 53,7 m, stopping at km 817+887.

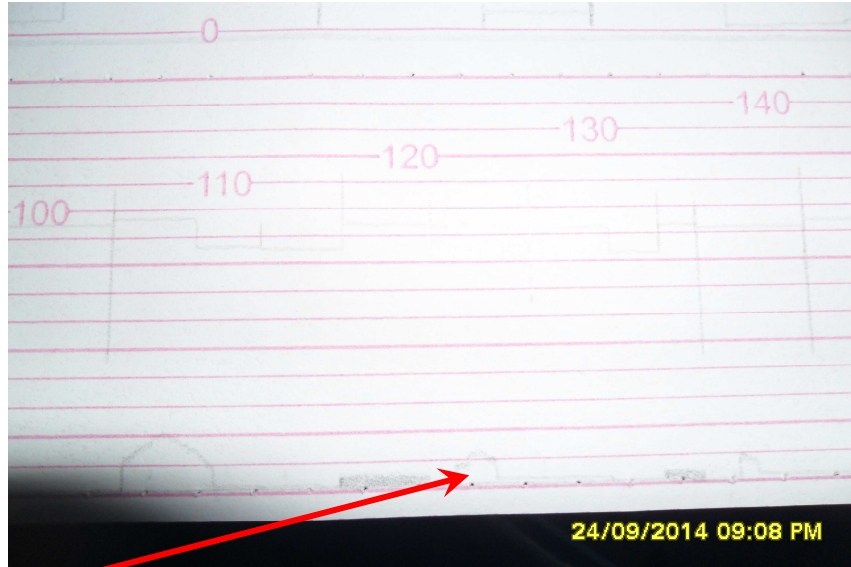
Photo no. 2 The speed recorder band with the recorded speed at the derailment place

The locomotive staff belongs to the Ukrainian railways administration (UZ) and didn't allowed the removing of the speed recorder band, allowing just its photography (Photo no. 2).

After analyzing the photo taken at the speed recorder was found that the train running speed at the moment of the derailment occurrence moment was of about 12 km/h.

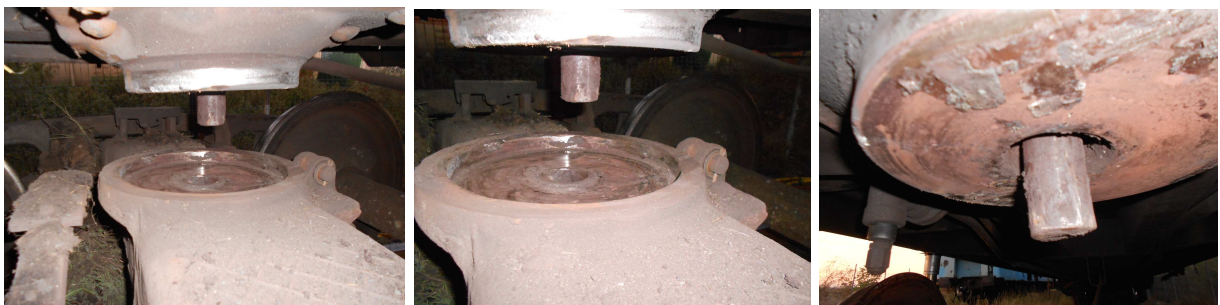
Photo no. 3 The upper and lower centre castings of the wagon

With the occasion of lifting and rerailing on the line of the wagon, works performed with hydraulic jacks from the equipment of the specialized intervention train, were found rust traces and pronounced wear due the lack of lubricants between the upper and lower centre castings of the wagon, as can be seen in Photo no. 3.
