## NOTE

*for the railway incident happened on the 24th June 2019,  
in the railway county Iași, on the running line Dărmănești – Cacica,  
at the level crossing from km 4+925, flooded dangerous point,  
consisting in the derailment of all 4 axles of the locomotive EC 078,  
hauling of the passenger train no.5731*

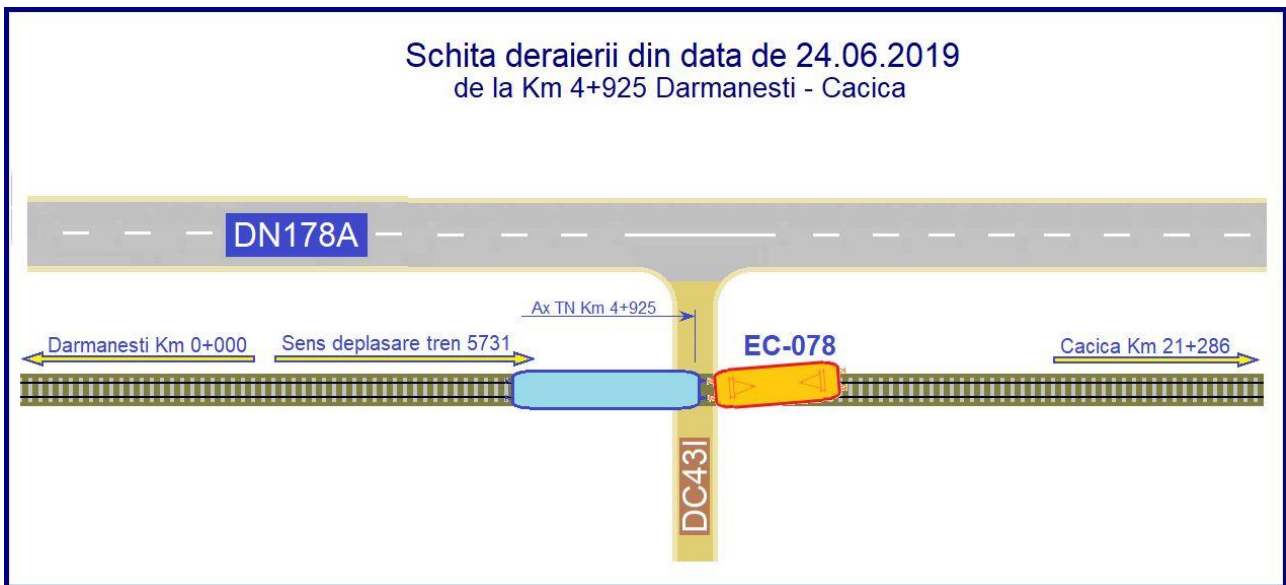
*Drawing no.2 – position of rolling stock after the derailment*

After running through the railway station Părhăuți, at about 03:30 o'clock, at the level crossing DC 43 I from km.4+925, all the axles of the hauling locomotive EC078 derailed. The derailment happened at a speed of 32 km/h, following its decrease as a result of the driver action that noticed late the deposits of stones and alluviums on the level crossing.

Distance run by the locomotive EC 078, in derailed condition, is of about 20 m. after the level crossing.

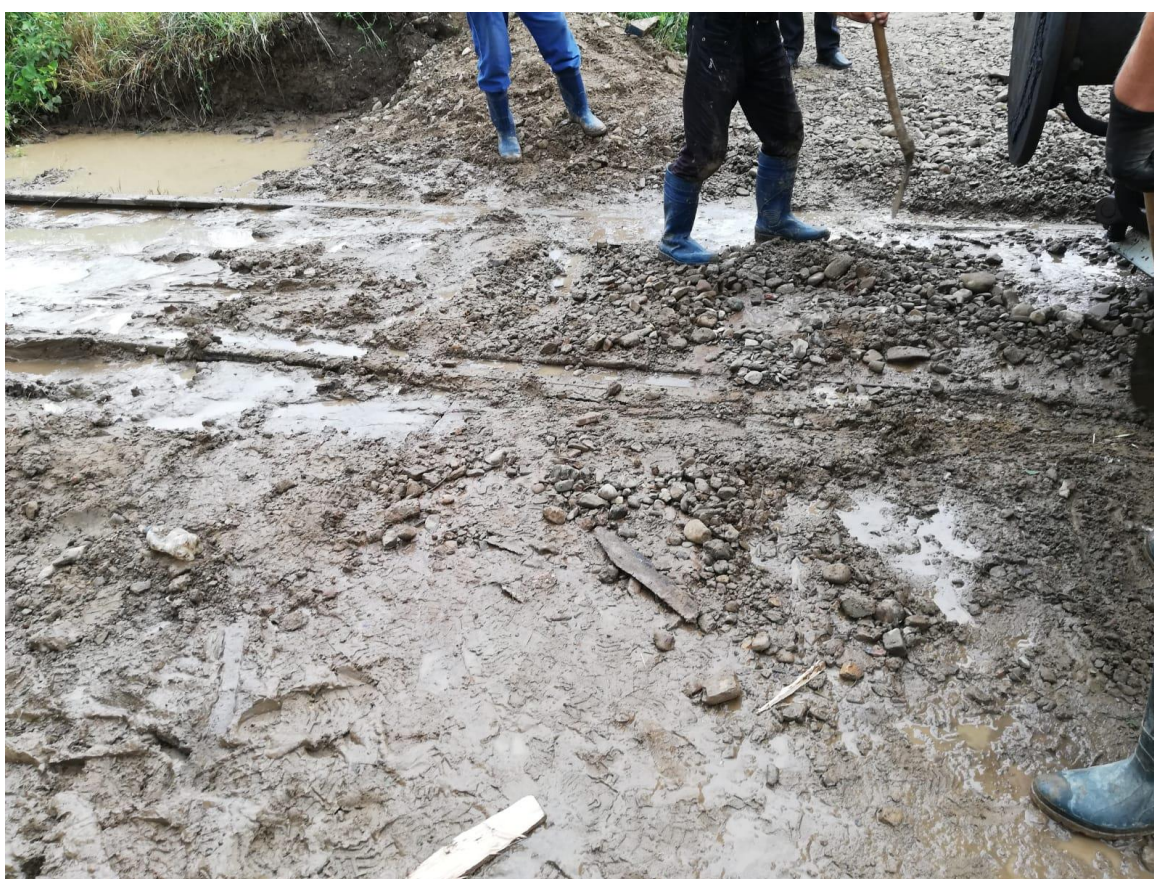
*Photo no.1 – removal of the ballast from the level crossing*

The structure clearance was cleared out, removing the ballast from the level crossing and the line was open for traffic at 11:30 o'clock, with speed restriction of 10 km/h, between km 4+900 and km 4+950.

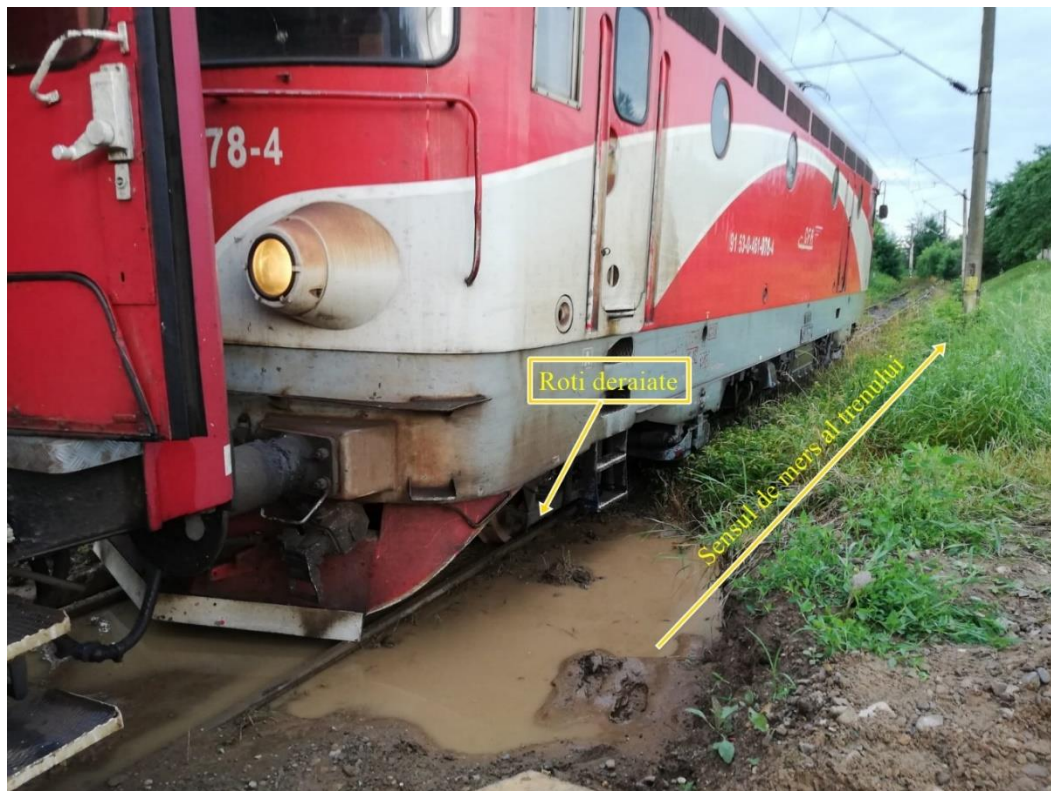
Following this incident, the train locomotive EC 078 was damaged. The tyres of those 4 axles had deep marks of hit (5-6 mm) on the flange of the wheel and on the running surface, and for the remediation there was necessary the turning of the wheels.

*Photo n0.2 – locomotive after the derailment*

Having like reference the train running direction, the first marks of running of the wheel flange on the upper surface of the rails and then the derailment marks were identified at the level crossing from km.4+925. Analysing the findings from the incident site (marks left by the locomotive wheels in derailed condition and its position after stop etc), the track geometry and technical condition, as well as the findings at the locomotive involved in the event, the investigation commission concluded that the marks identified at the level crossing from km.4+925 are of the wheels of the locomotive EC 078, following the climbing of the active shoulders of the rails by the flanges of the wheels, their running on the gravel layer, covering the rails and the concrete slabs of the level crossing, followed by the fall outside the track of the left wheels simultaneously with the fall of the right wheels inside the track.

For resuming the traffic, a breakdown train was routed from the railway station Pașcani. The lifting and re-railing of the locomotive EC 078 were made on the 24th June 2019, at 09:25 o'clock.

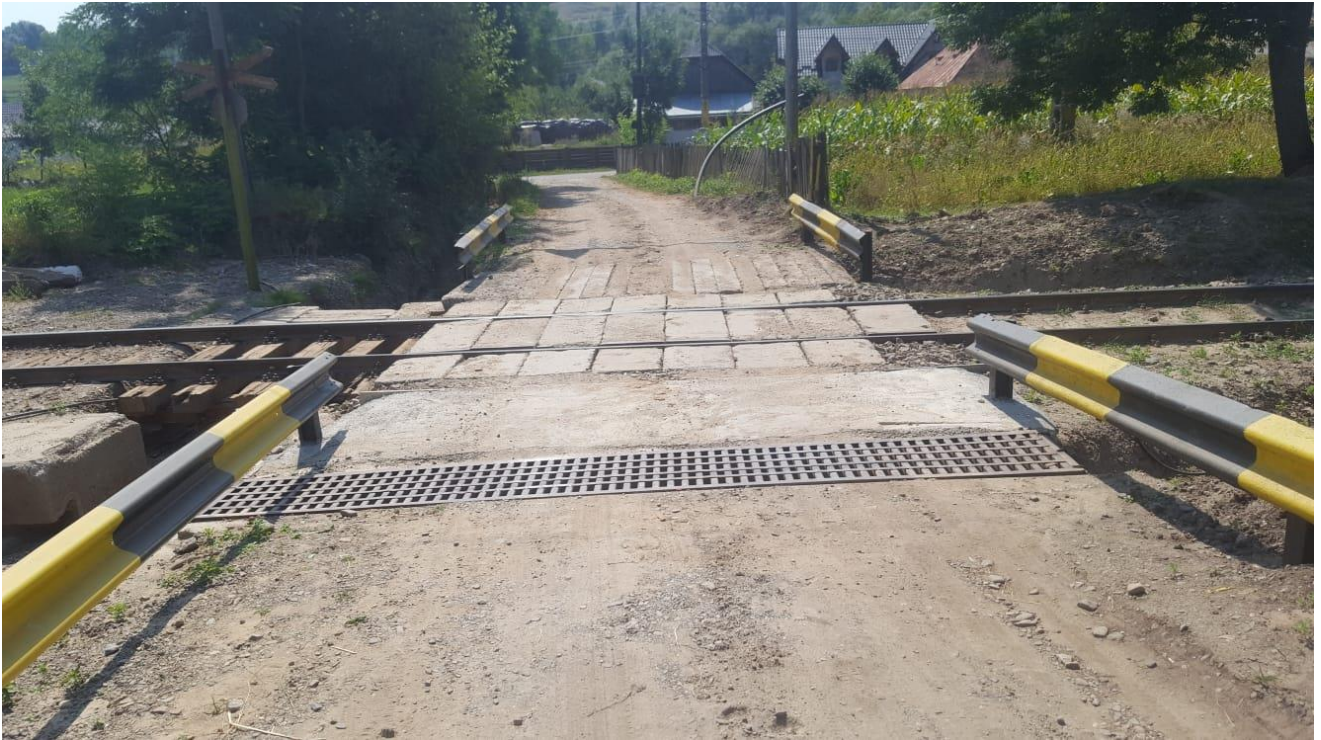
*Photo no.3 – level crossing km 4+925, after finishing the rearrangement works*

On the 16th July 2019, they began the works with own staff, for reducing the risk factors in the flood dangerous point from the level crossing of the km.4+925.

The drainage channel from the side of the road was re-making and concreted. The slope of the village road was reduced DC 43 I under 2% on 17 m ditches with grid were fitted, parallel to the line, at 2,5 m and at 18 m against the edge of the slabs from the level crossing. The channel under the footbridge from the km.4+920 was unclogged. The channels from the line left and right borders, km 4+850÷950, were unclogged. The tubular footbridge, crossing the road, from the left side of the line, was replaced with a footbridge made from sleepers.
