INVESTIGATING REPORT

of the railway accident
occurred on the 08th of May 2013, in the activity of the Branch of the Regional Center for Railway
Operation, Maintenance and Repairs Cluj, between the railway stations Fiad and Telciu, at km
21+300

Final edition
28th of March 2014

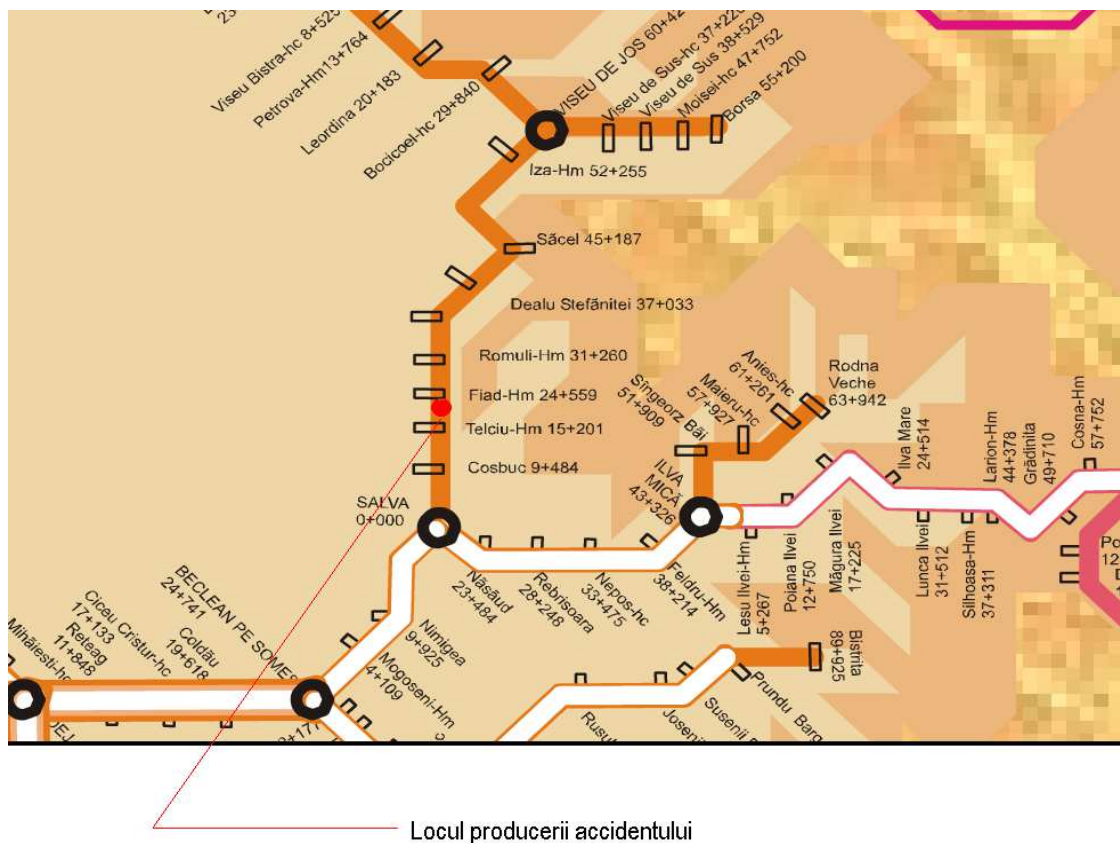
Image no. 1 The place of the accident occurrence

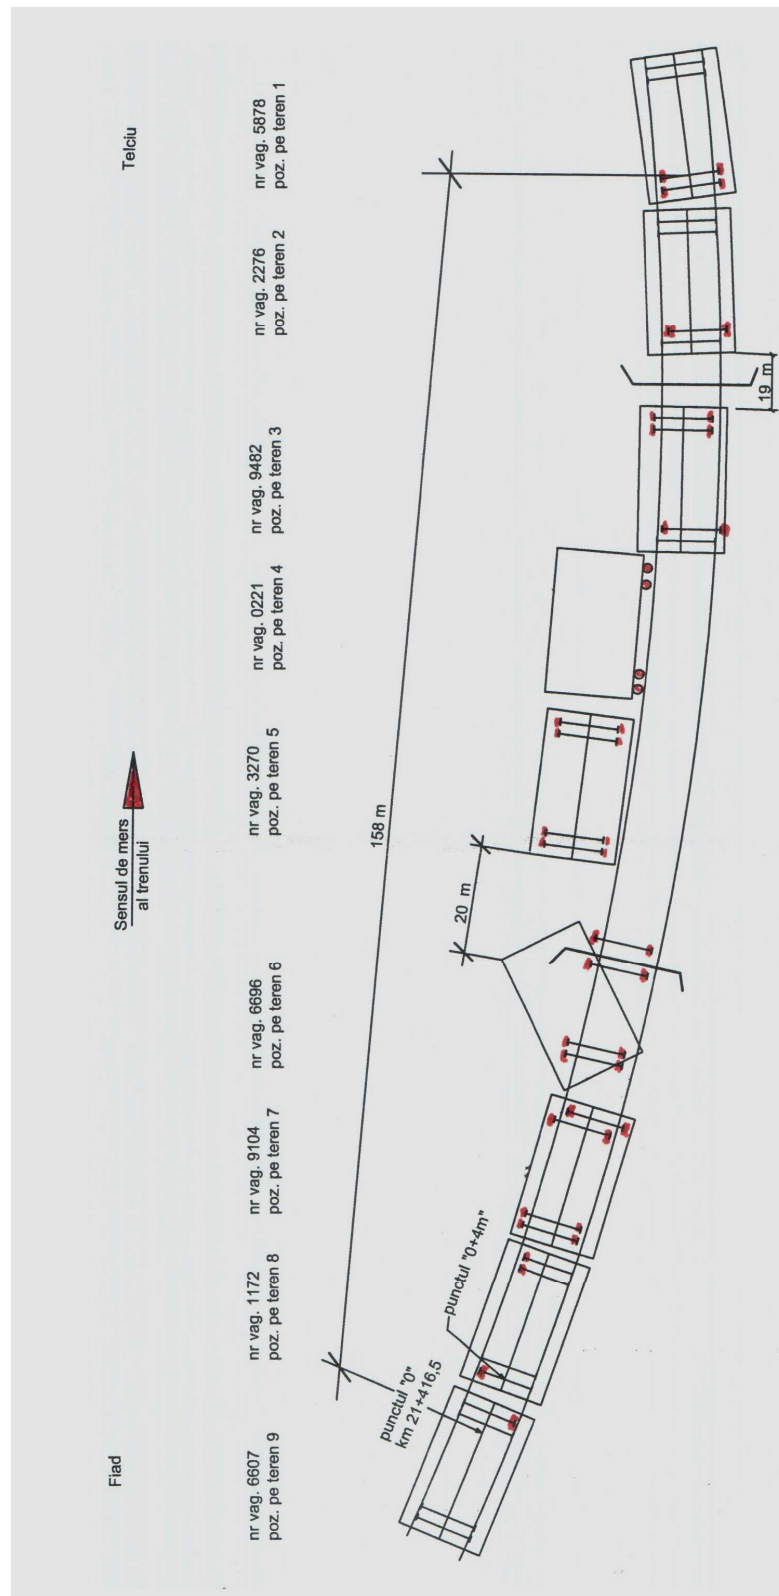
Image no. 2 Positioning on the site of the derailed wagons

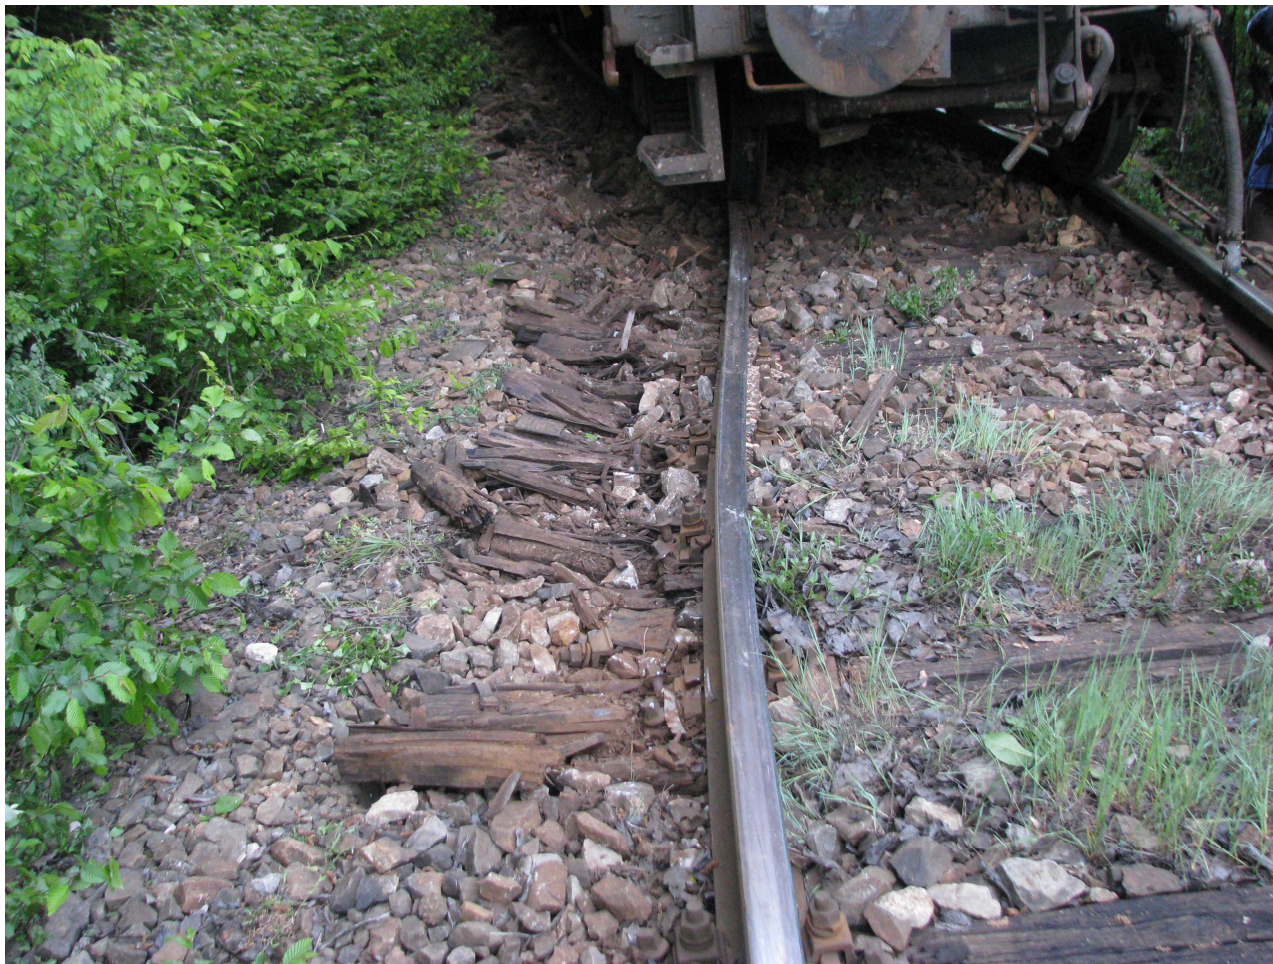
It could not be done the relevant measurements to determinate the geometrical elements of the track on the line between point "0" and to the end toward Fiad of the guideway beam, in the running direction of the train, because of the deformations caused at the line by the wagons in the derailment – **Photo 1**.

Photo no. 3 Deformations caused on the line by the wagons during the derailment

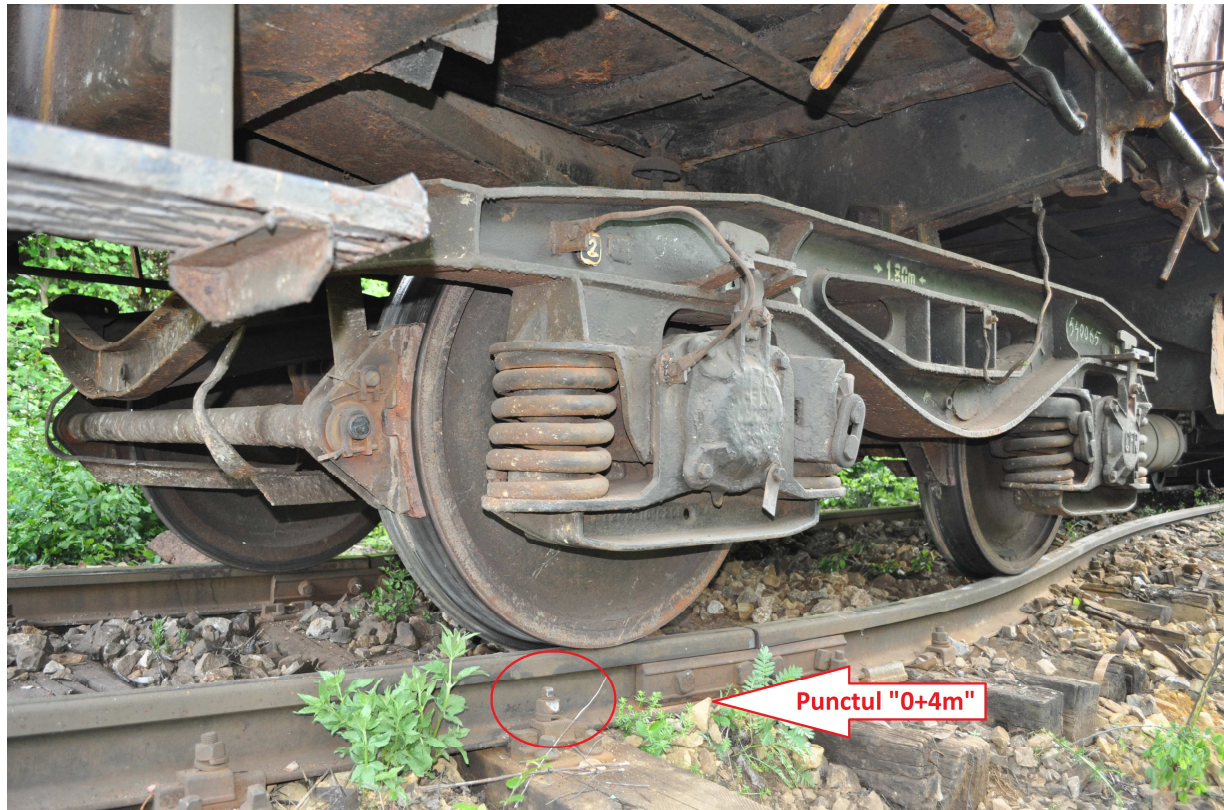
Analyzing the evidences from the site it was found that at the end of the bridge toward the railway station Fiad it was identified on the sleepers, fastening material and embankment traces of derailment to the exterior of the curve, continuing to the railway station Fiad to a distance of 8 sleepers from the point "0". The mentioned derailment trace to the exterior, situated to a distance of 8 sleepers from point "0", was identified in the front of the last axle of the 8th derailed wagon (1172) and is presented in the form of a hitting trace on a vertical bolt.

The mentioned derailment trace was called point "o+4m" and is presented in **Photo 2**.

Photo no. 4 The derailment trace called Point "0+4m"

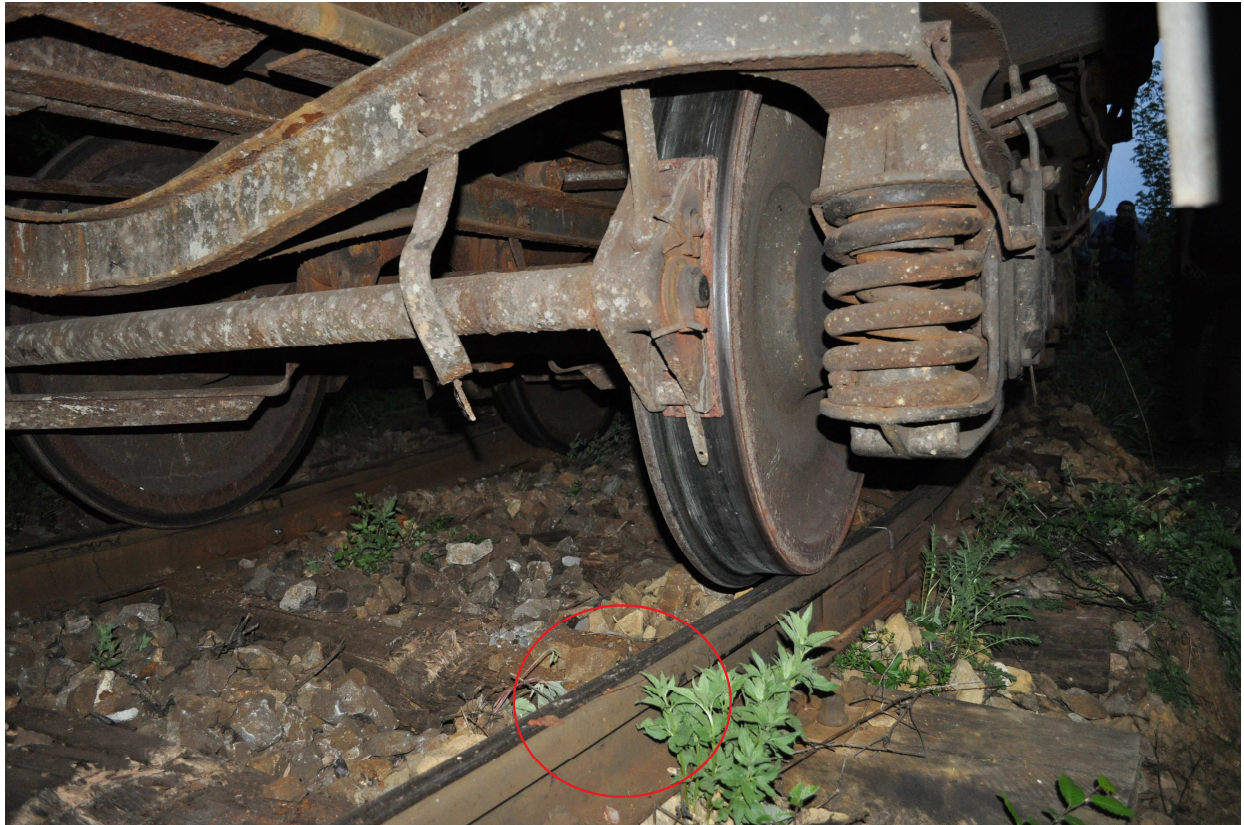
In the area of the point "0+4m" were identified a number 3 derailment traces on the right side in the running direction (the falling of the wheel from the head of the rail), presented in **Photo no. 5** and **Photo no. 6**.

Photo no. 5 - A derailment trace on the right side

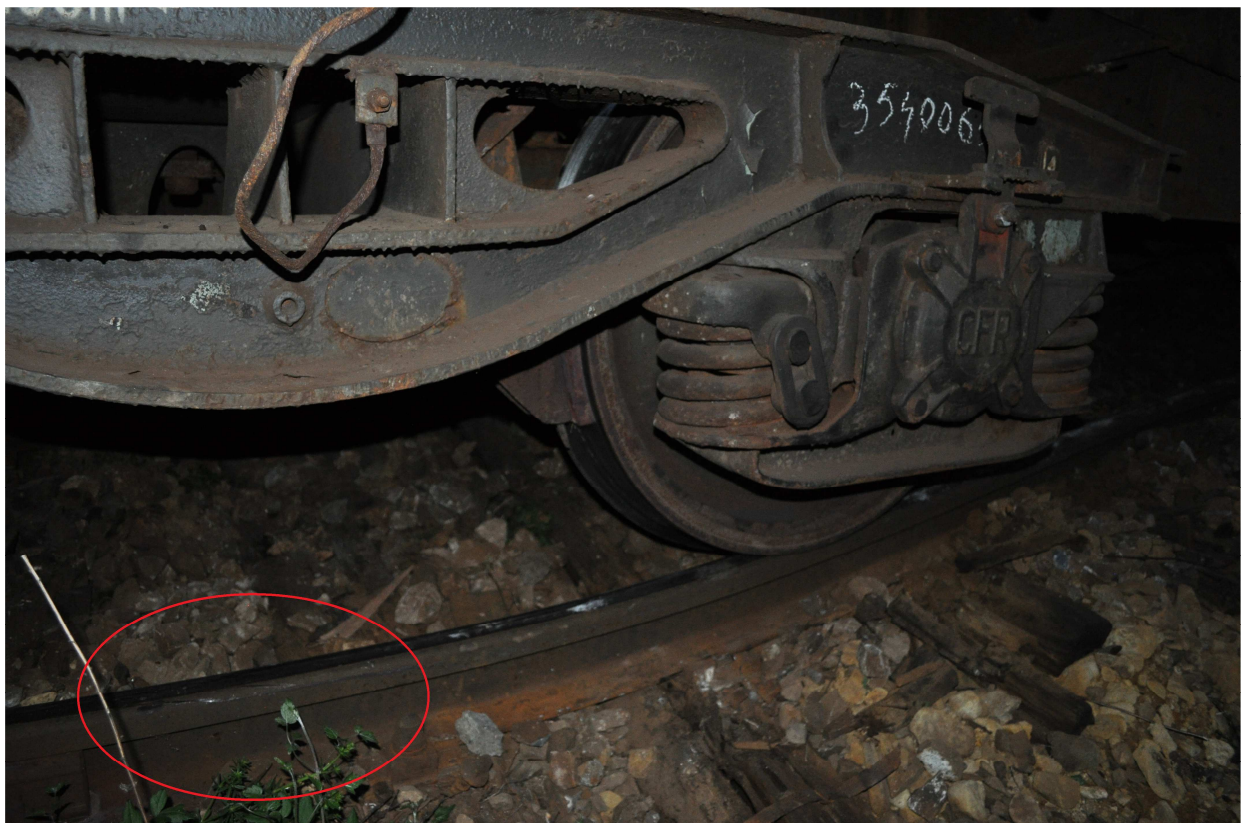
Photo no. 6 - 2 derailment traces on the right side

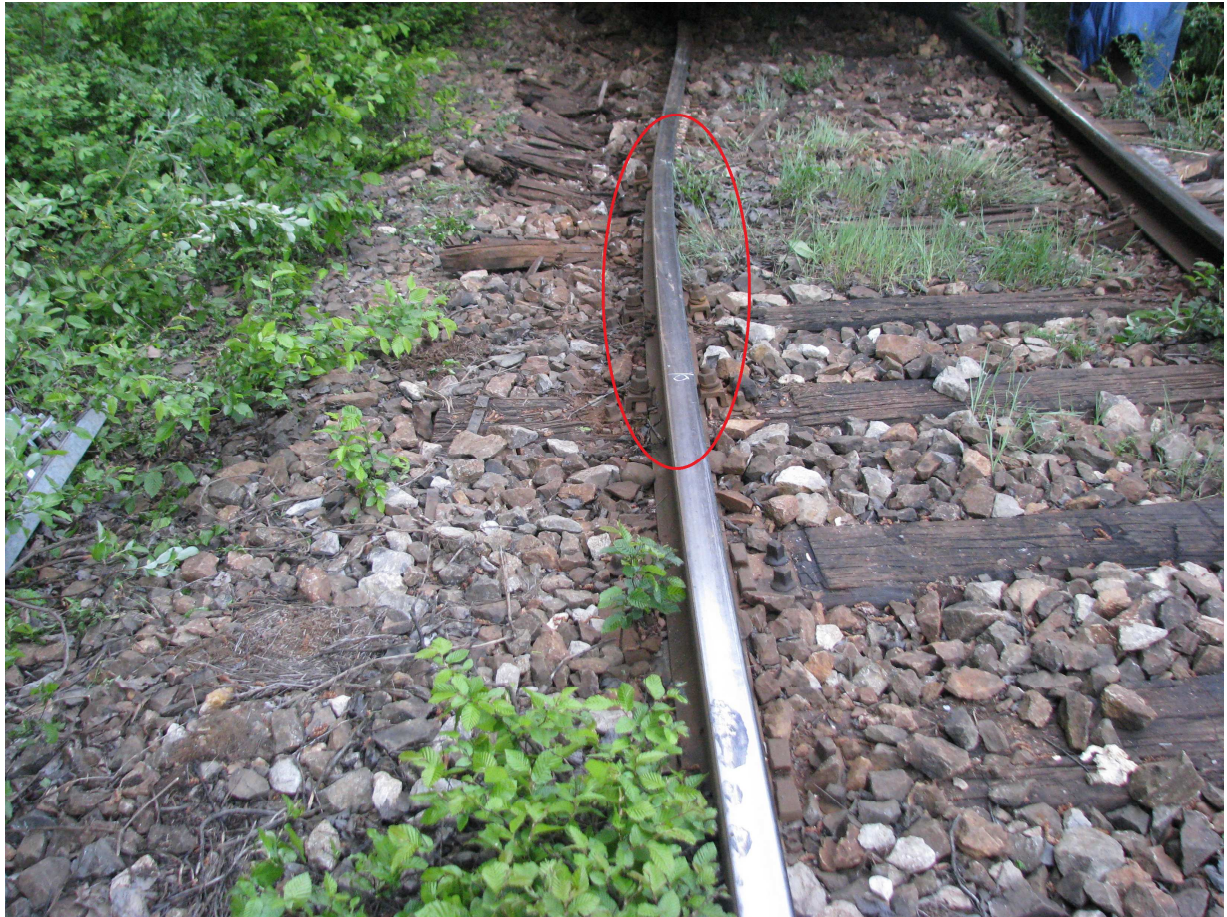
Photo no. 7 – The four derailment traces from the left part

Also it was identified in the area of point “0” a number of 4 derailment traces on the left part in the running direction (the falling of the wheel from the head of the rail) **Photo no. 7**.

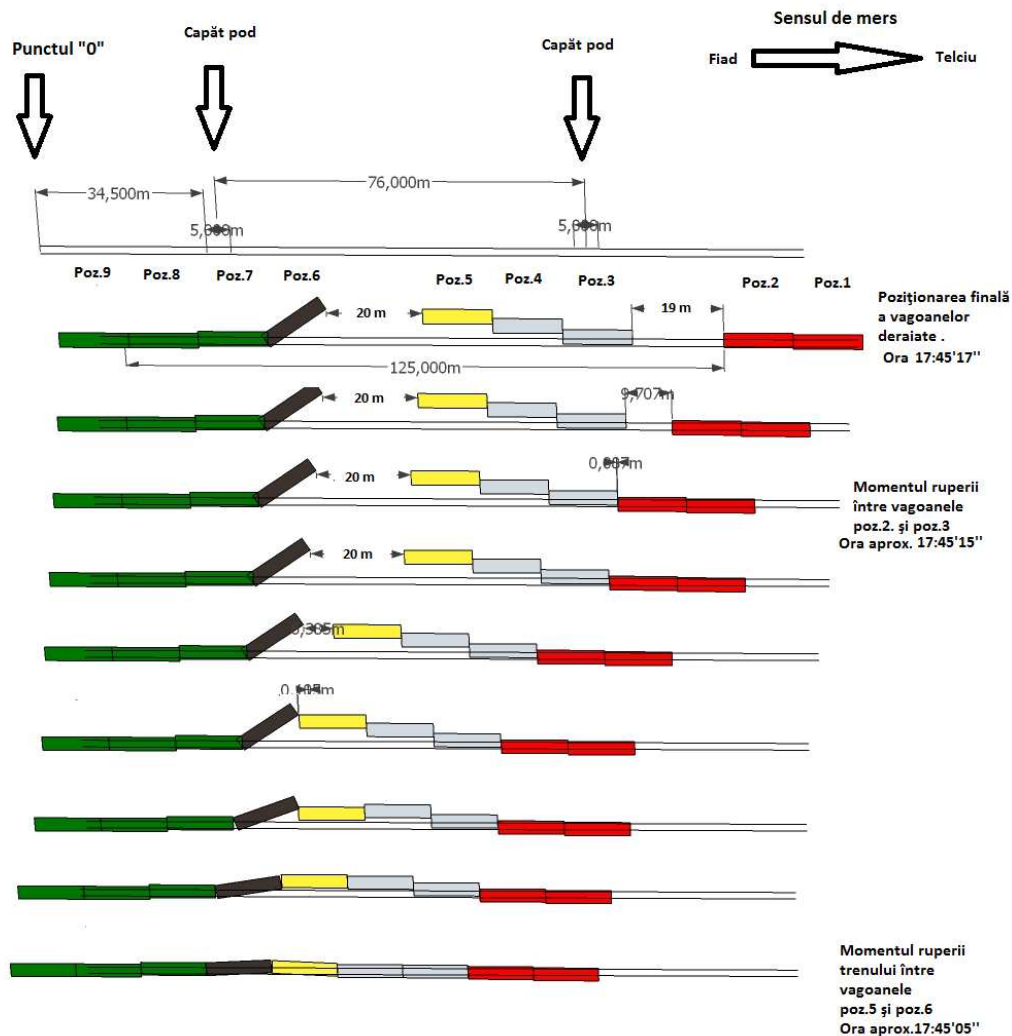
To establish the succession of the train breakings after the train derailment were analyzed recordings of the locomotives and the clues found at the wagons and infrastructure. With this in mind it was concluded that the succession of 2 train breakings between the derailed wagons occurred first between the wagons 5 and the 6 and later between position 2 and position 3. Graphical representation of these train breakings is presented in Figure. 3.

Image no. 8 The succession of the train breakings with the representation of the 9 derailed wagons

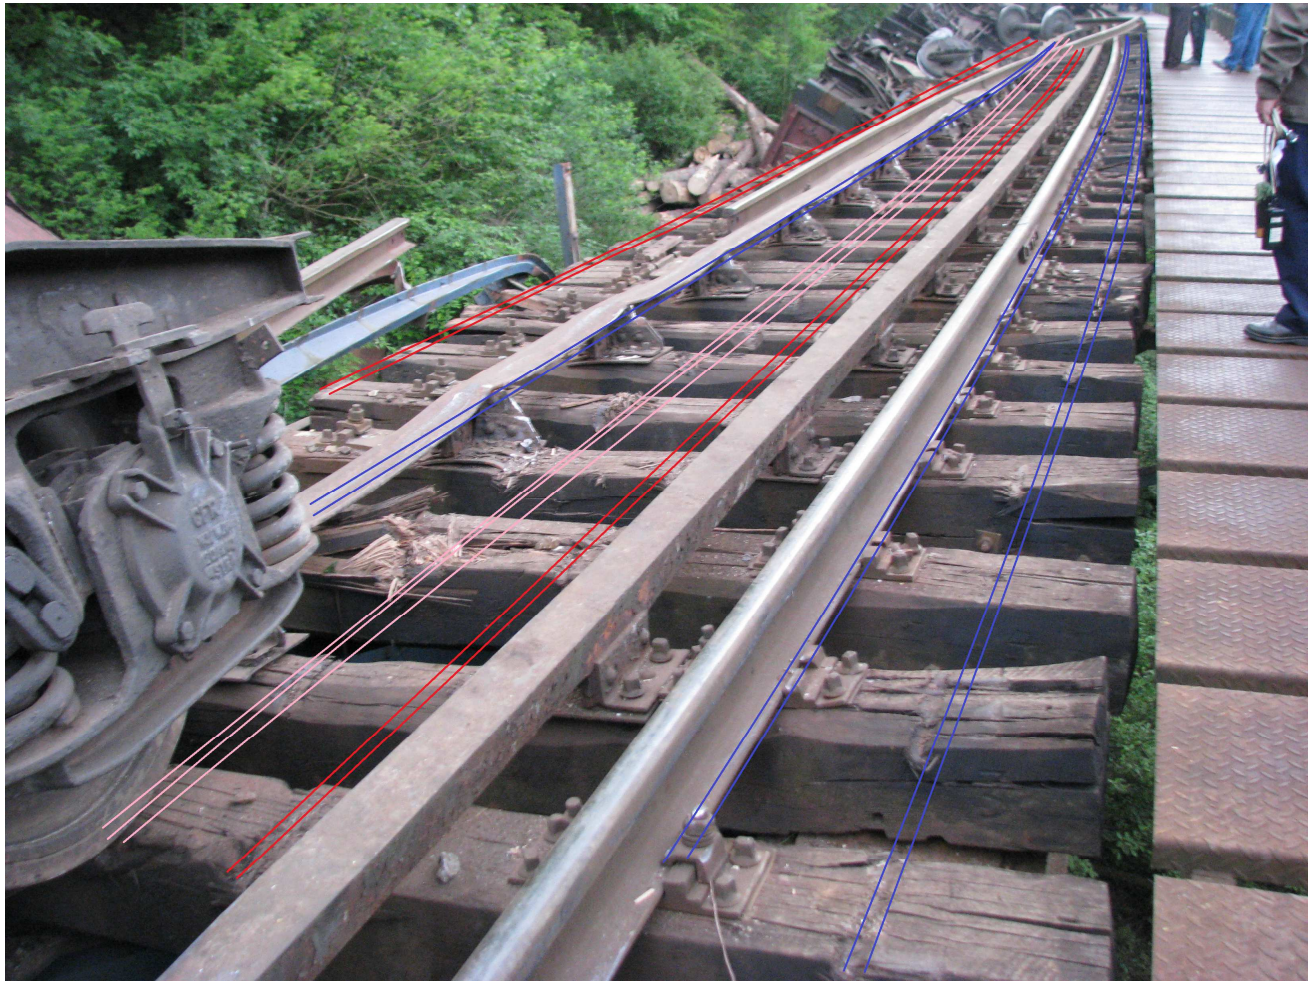
On the bridge passing of the derailed wagons, those let more traces sets printed on the sleepers, on the fastening elements of type K and on the check rails shown on Photo no. 9.

Photo no. 9 The traces left on the bridge by the derailed wagons
