INVESTIGATING REPORT

on the fire occurred on the 11th of May 2011 on the range of activity of CF Timisoara Regional Branch, in current line wire II (double line electrified), between hm Merisor and the railway station Banita km. 66+500 at the locomotive EA 40-0791-0 (belonging to SC CARGO TRANS VAGON SA Bucharest) hauling the freight train no. 20936.

Final edition

The 16th of December 2011

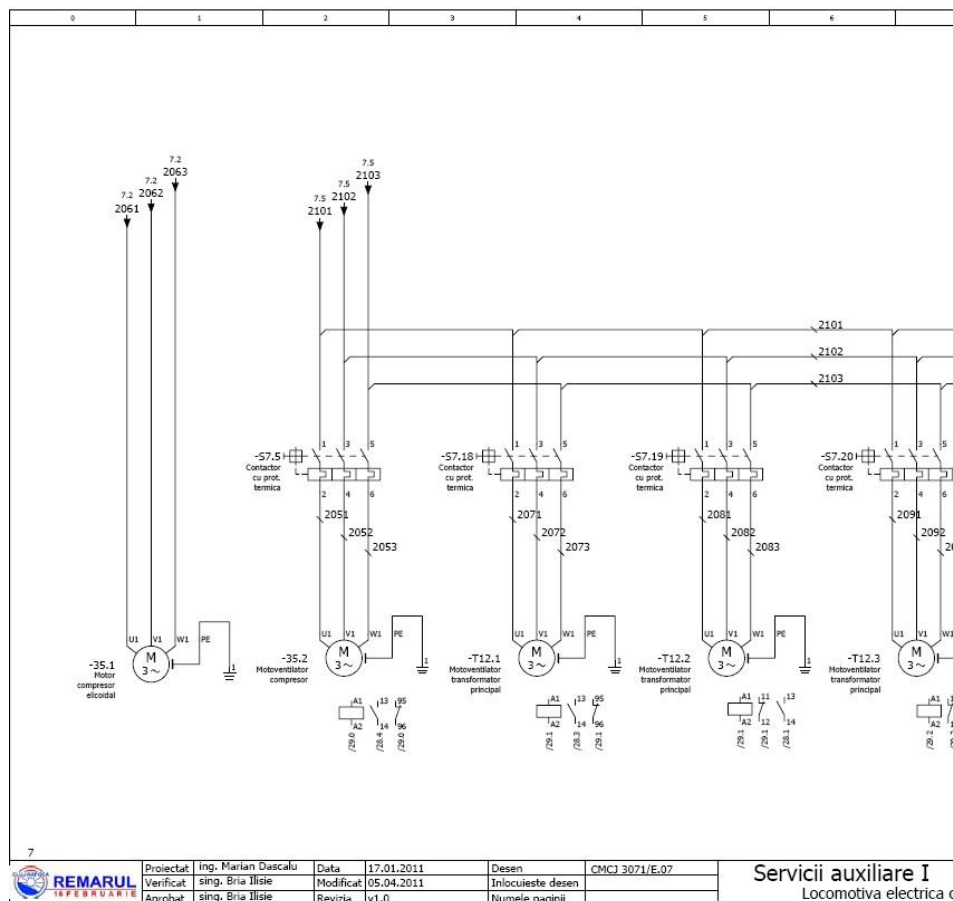
Wiring diagram of the electrical circuit supplying the electric motor of the compressor

NOTE: According to the diagram, the electric motor driving the screw compressor is electrically connected directly to the output terminals of the static converter. Thus, it appears that the electrical circuit of the screw compressor motor is not provided with contactor with thermal protection or other type of safety at over-current or short-circuits.

There are missing the protection devices at over-current and short-circuit mounted on the electric circuit of the electric engine operating the compressor, which results also from the integration schemes of the INDA equipments in the electric installation LE 5100 kw.

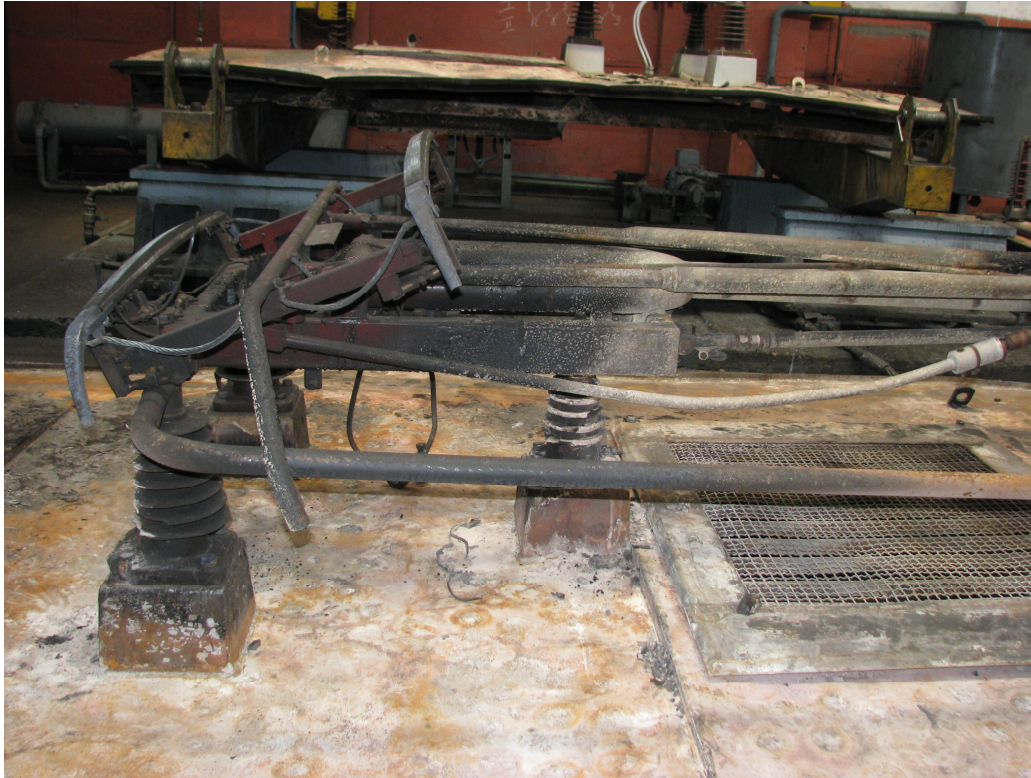
- pantograph no.1 is thermally affected, useless; (Photo 2)
- pantograph no.2 and the support insulators are in proper condition;
- the circuit breaker thermally affected at the control part;
- the discharger, by appearance, corresponds;
- the rods are appropriate;
- the overload measuring transformer 25 KV with the housing melted, useless;
- the bushing broken;
- the roof separators are appropriate;
- the support insulators of pantograph no. 1 damaged;
- the bar support insulators damaged;
- the sheet on the roof and on the side walls thermally affected and deformed.

Photo 2 - Pantograph no. 1

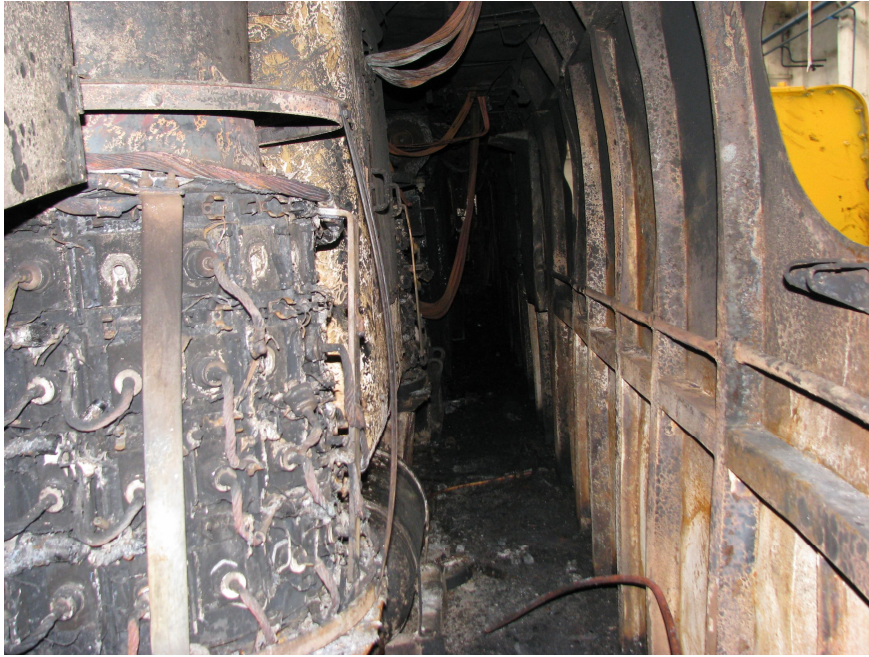
Photo 5 - Blocks S1- S10 burnt

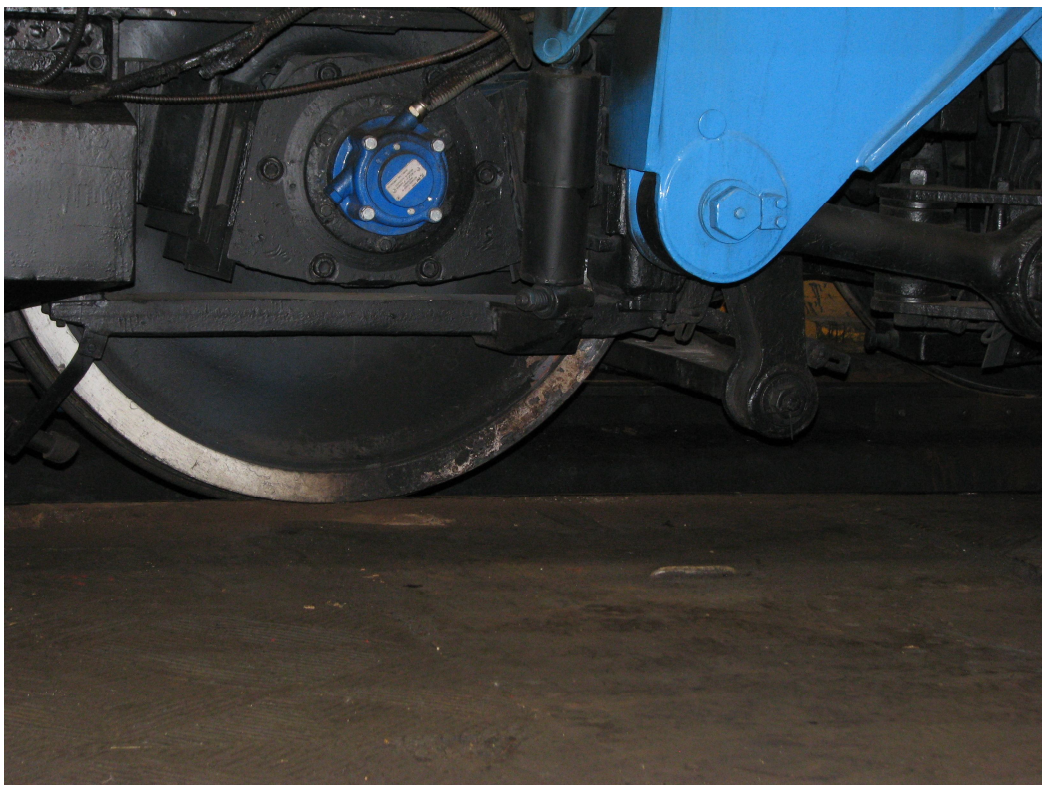
- the brake wheelhouse and the rolling part do not show signs of abnormal heating;
- the frame of the bogie II has signs of burning on the upper side in the area MET 4 (Photo 11);
- the bandages from the wheels of the axles 3 and 4 have signs of smoke (Photo 12);

Photo 12 – the bandages from the wheels of the axles 3 and 4 have signs of smoke
