INVESTIGATING REPORT

of the railway accident occurred on the 12th of November 2012,
in the activity of Infrastructure Manager **SC RC – CF Trans SRL Braşov**,
on the open line, at **km 94 + 910 – 95 +118**, from the line no. 117 Livezeni – Lupeni, after
derailment first bogie in the running direction of the wagon no. 81536654856-9, (the 5th from the
rear of the train) from the train 23815

Final edition
12th February 2013

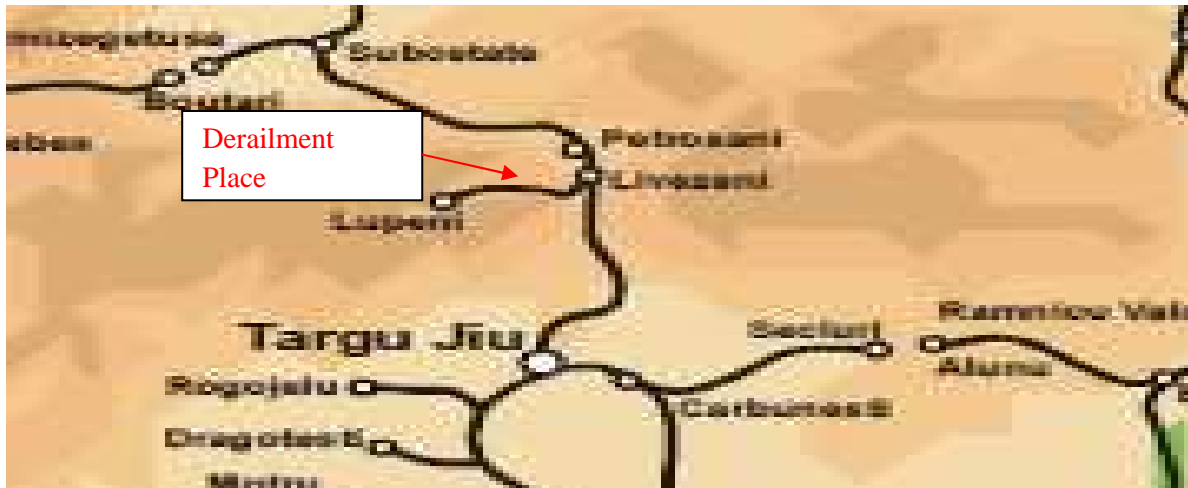
Photo 1

The place where the accident occurred is presented in photo 1.

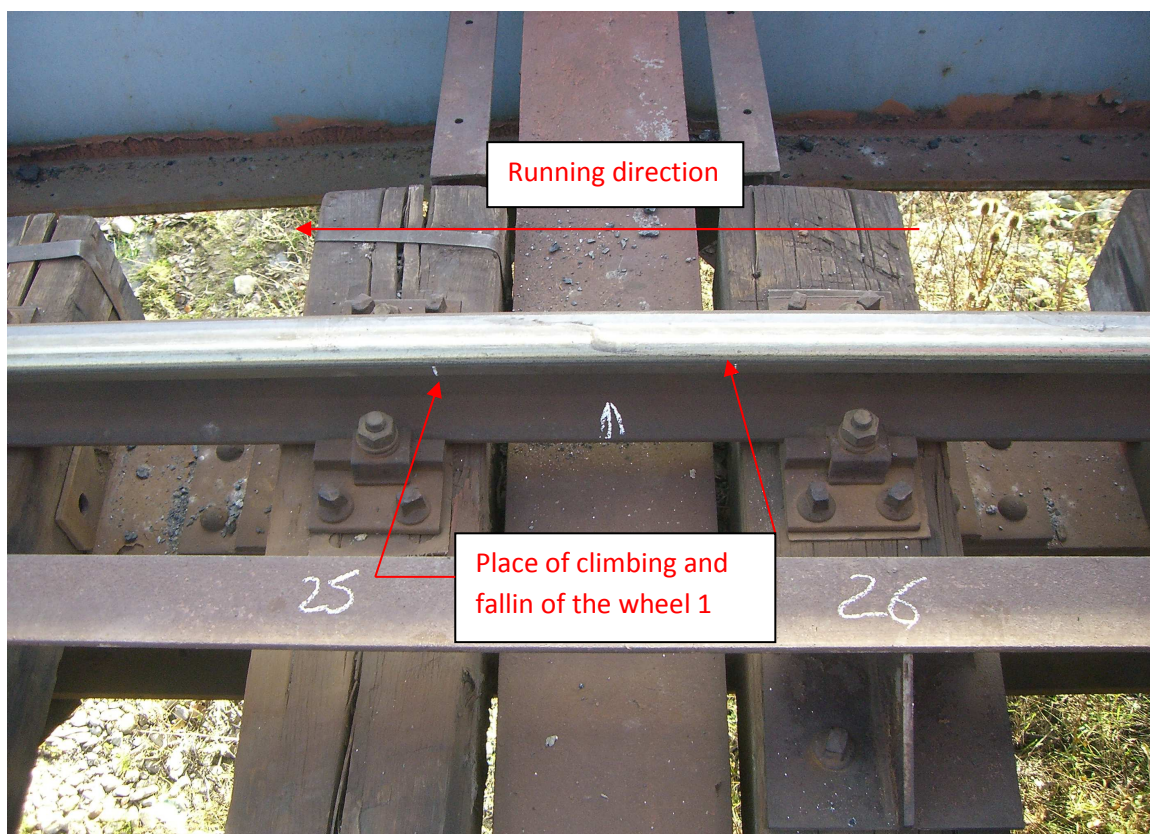
Photo 2

2. In the left curve (in the running direction of the train) from the km. 95 + 310 – 94 + 955, on the circular curve, in the point of the km 95+118,80, in the interior curve rail (left rail in the running direction) happened the loose of contact between wheel/rail through the fall of the first wheel (2), of the first bogie of the wagon no. 81536654856-9 between the sleepers 19 and 18 in the interior of the track, according to the below photo 1. It's stated that the distance of 10,80 is measured from the joint at the km 95 + 108. The wheel no. 1 of the axle 1- 2, situated on the right side in the running direction, run on the rail up to the point from km 95 + 075 (track on metallic floor, up track), where happened the rail climbing and the falling in the exterior of the track from the exterior curve rail, between the sleepers 26 and 25 of the bridge, moment in which is derailed also the axle corresponding to the wheels 3 - 4 (numbered sleepers from abutment 1 to the abutment 2), according to photo 2 from below.

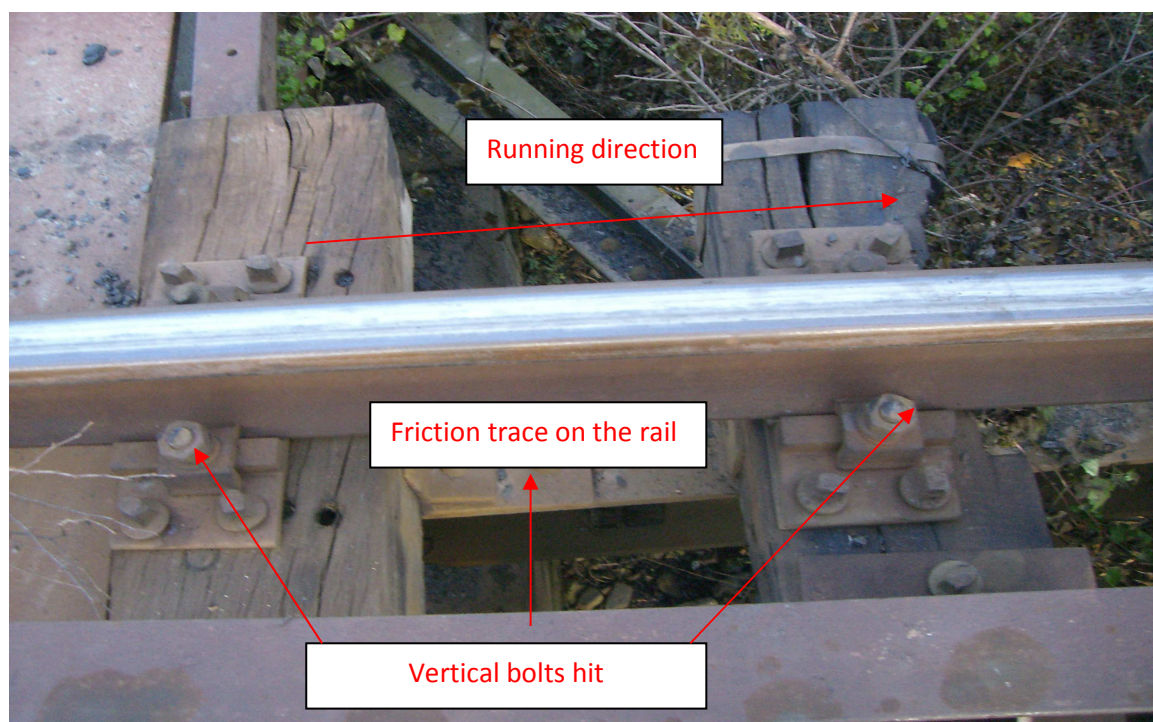
3. Starting his point (km 95 + 118,80 to km 94 + 910) on the vertical bolts from the track interior, on the interior curve rail, running traces from the tyre of the wheel no. 2 can be seen on a distance of 208 m and the friction on the interior lateral surface of the head of the rail by the exterior side of the tyre. Photo 3, taken on the track from the bridge, at km 95 + 075, is obvious.

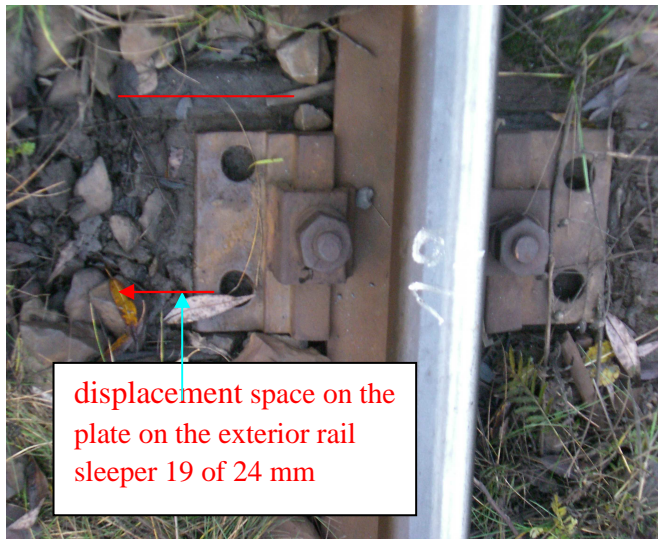
photo 5

- width of the displacement image – 12 mm;
 - resulting a real displacement of 24 mm;
 - interior line:
 - real width of the metal plate for wooden sleepers – 150 mm;

- width of the plate image – 81 mm;
 - width of the displacement image – 4,5 mm;
 - resulting a real displacement of 8 mm;

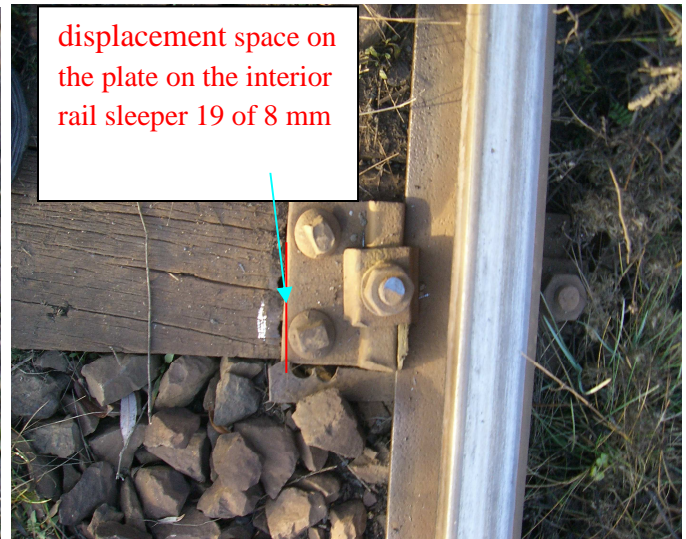
photo 4

- a. the train run in the sense of decreasing the numbering of the sleepers;
 - b. at the sleepers no. 20, 19 and 17 is missing completely the fastening of the rail plate/sleeper corresponding to the exterior line; (eg. Photo 4 - sleeper 19);

- f. on the sleeper 19 the gauge value was:
 - nominal gauge value: 1435 mm
 - measured value: 35 mm
 - displacement value under traffic of the metal plate of the exterior line: 24 mm
 - displacement value under traffic of the metal plate of the interior line: 8 mm
 - total value gauge: $1435 + 35 + 24 + 8 = 1502\text{mm}$
 - exceeding maximum admitted gauge: $1502 - 1470 = 32\text{ mm}$

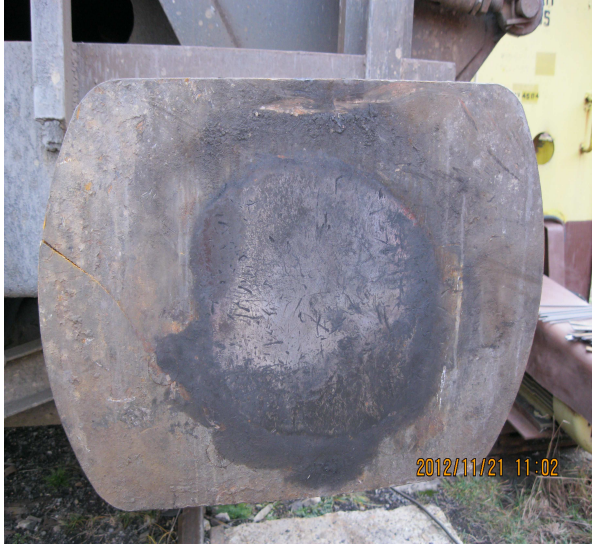
Photo 6

- first bogie, in the running direction, derailed from both axles;
- the buffer from the left, at the end of the wagon with derailed bogie, fallen between the track rails, with the rectangular plate cracked on a 70 mm length and with traces of fractioning on the buffer box, the image from photo 6 was realized in the Repairs Shop;

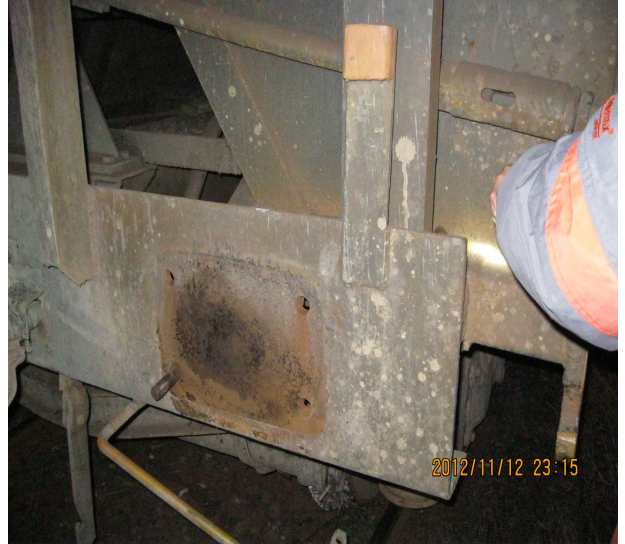
Photo 7

- there were 3 fastening screws found, from which one was in the corresponding hole and 2 screws in the wagon's beam, according to the photo 7;
- the safety stirrup-piece afferent wheel no. 2 was broken (new breakage).

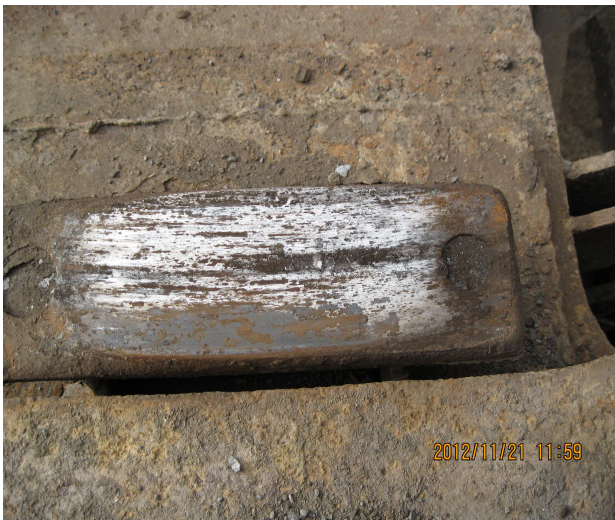
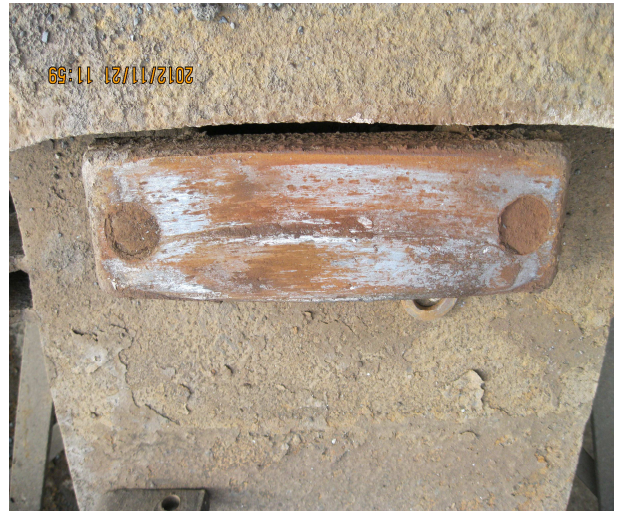
- he couldn't identify the lack of cumulative clearance (zero) afferent to the side bearers from the bogie no. 1 of the wagon no. 81536654856-9 because „this is a cumulative failure on the both sides of the bogie and without a colleague I had none to communicate the findings ”;

- clearance of the side bearers at the wheels no. 1 - 3 = 0, clearance of the side bearers at the wheels no. 2 - 4 = 0; **total clearance = 0**, the inferior side bearers of the both sides of the bogie was presenting traces of material snatching (Photo 8 – right side bearer; Photo 9 – left side bearer);

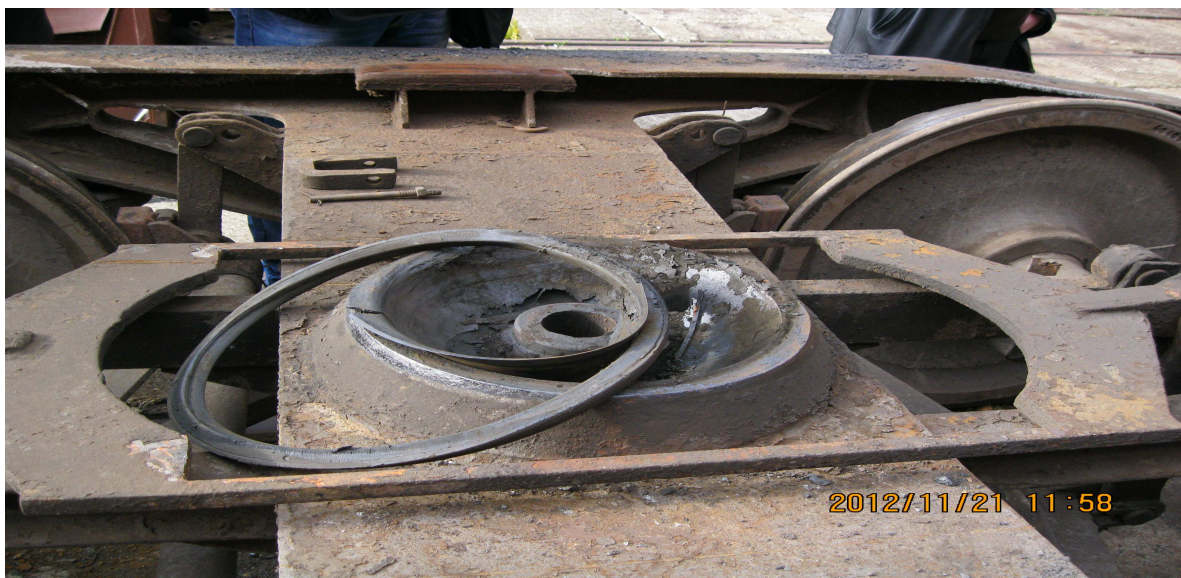
- the polyamide liners, at both centre pivot castings, complete wear with the material fragmentation;
- at the derailed bogie, on an area of about 30-40% from the contact surface between the two centre castings wasn't covered by the polyamide liner, existing traces of friction metal/metal between the two surfaces (upper centre casting/ lower centre pivot casting) (image from Photo 10 / derailed bogie, inferior centre pivot casting);

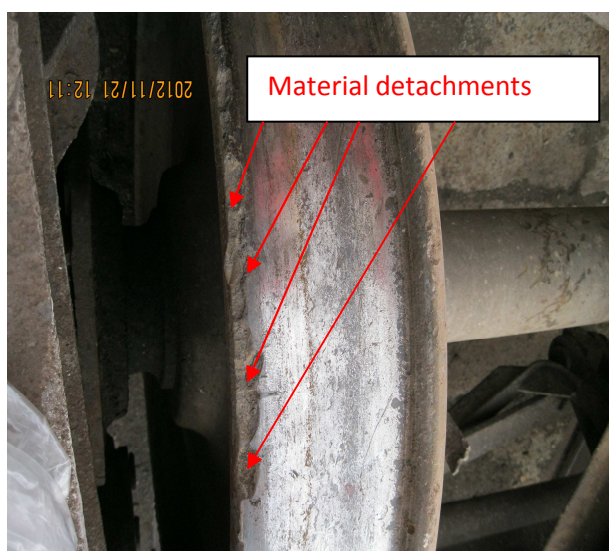
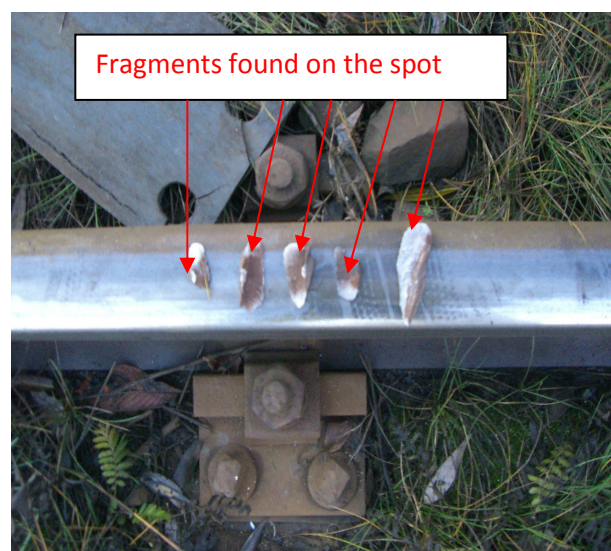
- material detachment from the wheel no. 2 (cast wheel) of dimensions with length from 10 mm up to 50 mm and width between 5 mm and 15 mm, according to the image from Photo 11; it is specified that a part of those fragments with old crack traces were found also on the open line (at the place of the wheel no. 1 fall), according to image from Photo 12.

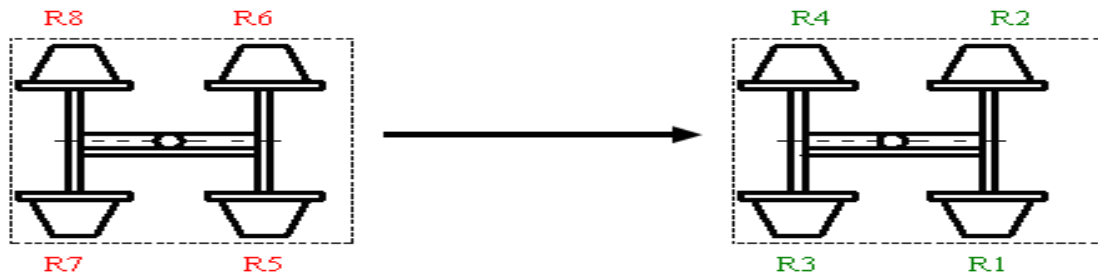
- the wheels of the two bogies were positioned with the odd axle journals on the right side and the even ones on the left sides, in the running direction of the train (as shown below);
