INVESTIGATING REPORT

of the fire occurred on the 2nd of August 2012, in the Branch of the Regional center for railway operation, maintenance and repairs Craiova, between the railway stations Costesti and Parvu, at the ballast cleaner type MCB 450-064, running as train no. 98930

*Final edition
The 25th of September 2012*

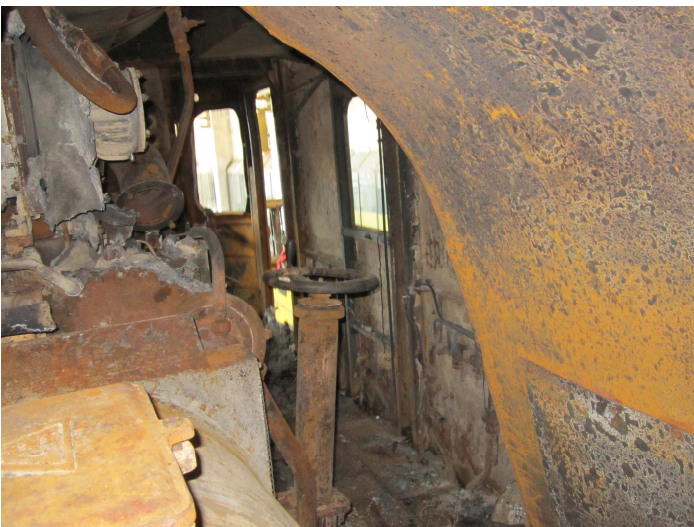
Effect of burning inside the engine room

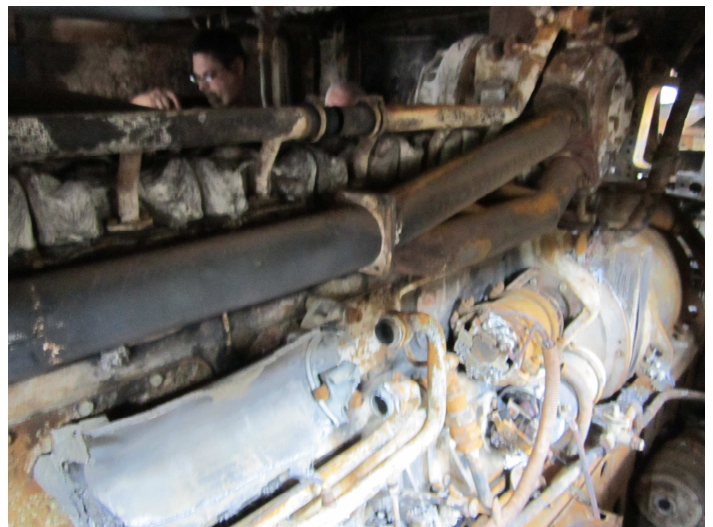
Effect of burning inside the engine room

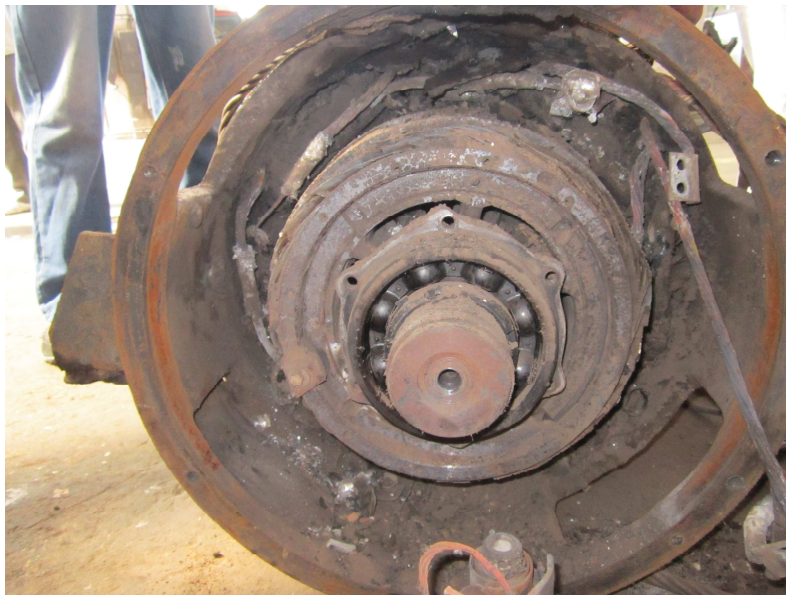
- electric connection between those 2 poles from the stator circuit, with the mica insulation broken and the electric cable cut about 90%, The cut section had traces of flame (melted copper wire), the same traces being also on the brush collar (at the spring of a brush collar);

Following the appearance of some mechanic wears at the electric insulation of the conductor between two poles of the stator circuit of the traction engine M3, respectively because the vibrations and the rolling stock ageing, the dielectric capacities of the insulation were reduced, followed by a short-circuit between this conductor and the electric connection of a collecting brush (charbon), it leading to the partial cut of the conductor and the connection cut.

Photo – the junction wire between the main pole and the reversing pole cut

Short-circuit between the conductor, situated between the a main pole and a reversing pole, of the engine no. 3 and the brush collar support

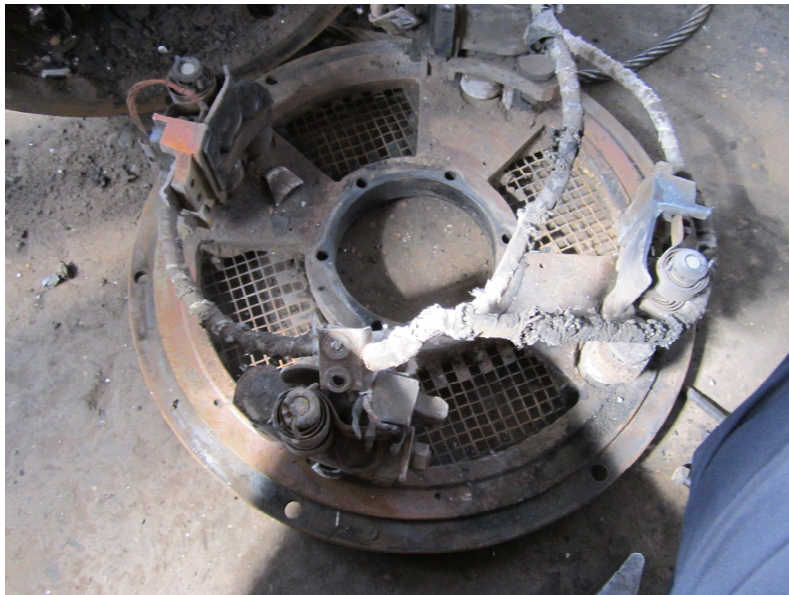
- the electric connection from the same charbon brush, above mentioned, cut, with traces of flame between those two parts (melted copper wires);
- in the box D4, the fusibles and the relays, that ensure the protection of the engine circuit, were in suitable condition.

Photo - support of the brush collar with the flexible connection of the collecting brush cut and melting traces

The railway vehicle continued to run on a straight line in these conditions and another short-circuit between the partial cut conductor and the brush collar appeared, it leading to the local melting about 90% and the brush collar melting (on the part for the transmission of the force from the spring to the brush)

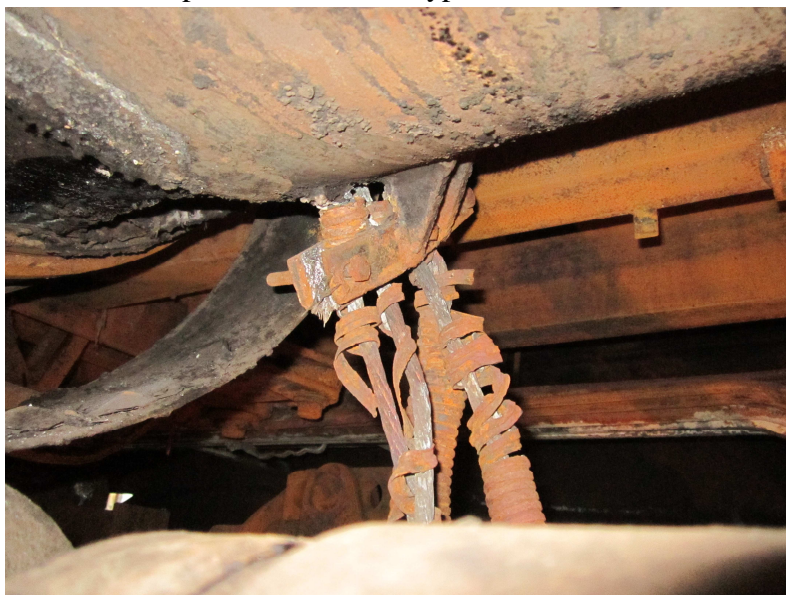
- at the traction engine M3, driving cab 1, cable A3 cut and with the insulation carbonized, and the cables A34, A33 and B30 with the insulation carbonized, being protected with metallic tubes type COPEX;

In these conditions, the insulation of the cables from the traction engine M3 (A33, A34, A38 and B30), by influence, leading to the burn of the terminal connections plate, of the insulation of whole force cables up to the alternator type GSA TH 62-4.

Photo – cable insulation at the exit from the electric engine, burn

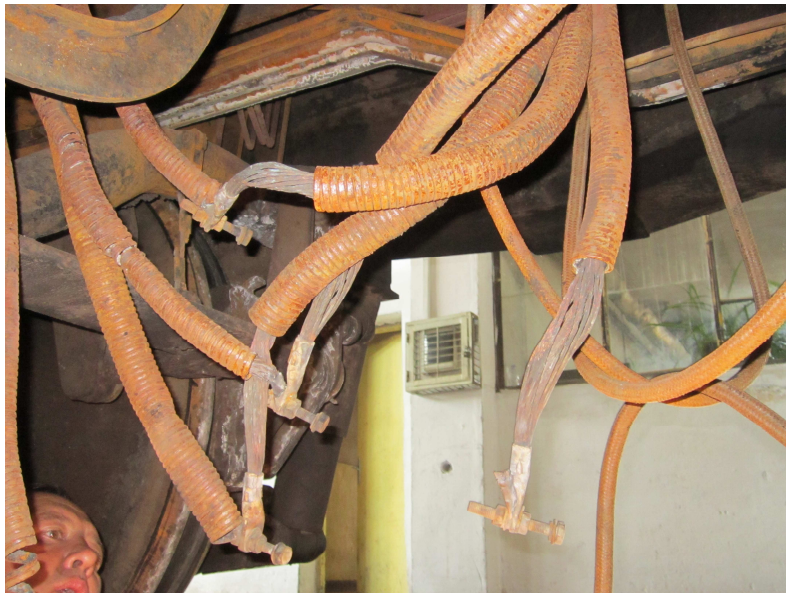
- the plate of connections, for the power supply of the traction motor M3, destroyed by the fire, was missed;
- the collector brushes of the traction motor M3 had corresponding sizes and sufficient pressure in the collector;

Photo – the insulation of the electric engine cables burn, and the terminal connection plate missing because the burning
