**Report into the Fatality at Level Crossing XX 032 between
Ballina and Manulla Junction on the 28th of February 2008**

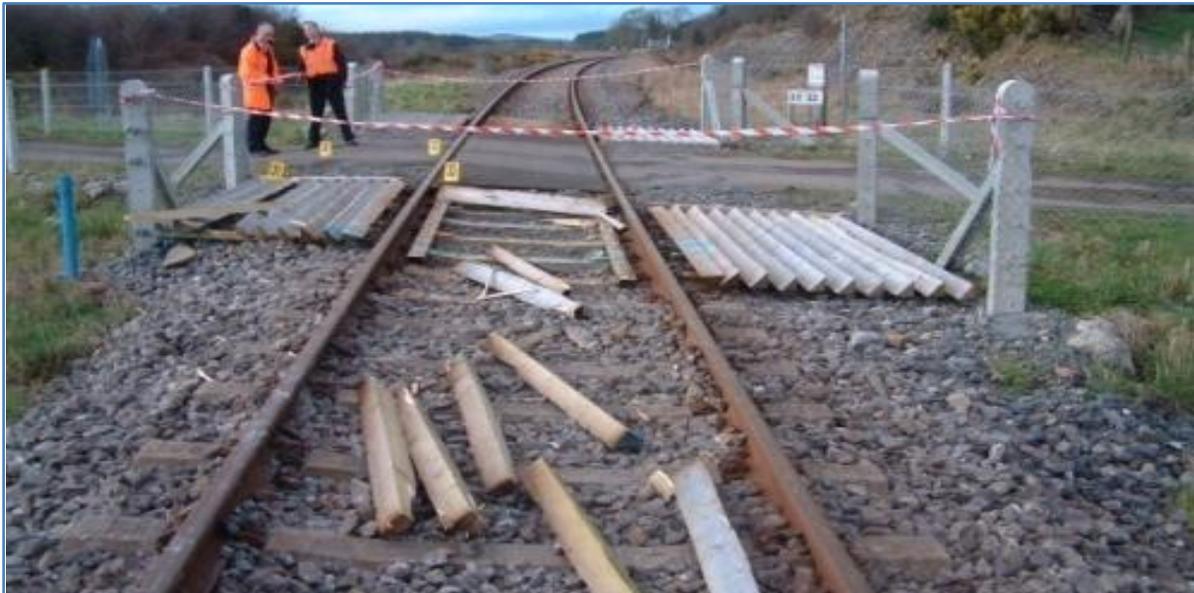
Photo 1 - Damage to infrastructure

There was only minor damage to the infrastructure, damage was caused to the cattle grids at the crossing and a railing on the railway bridge was dislodged when struck by the car (Photo 1 – Damage to infrastructure).

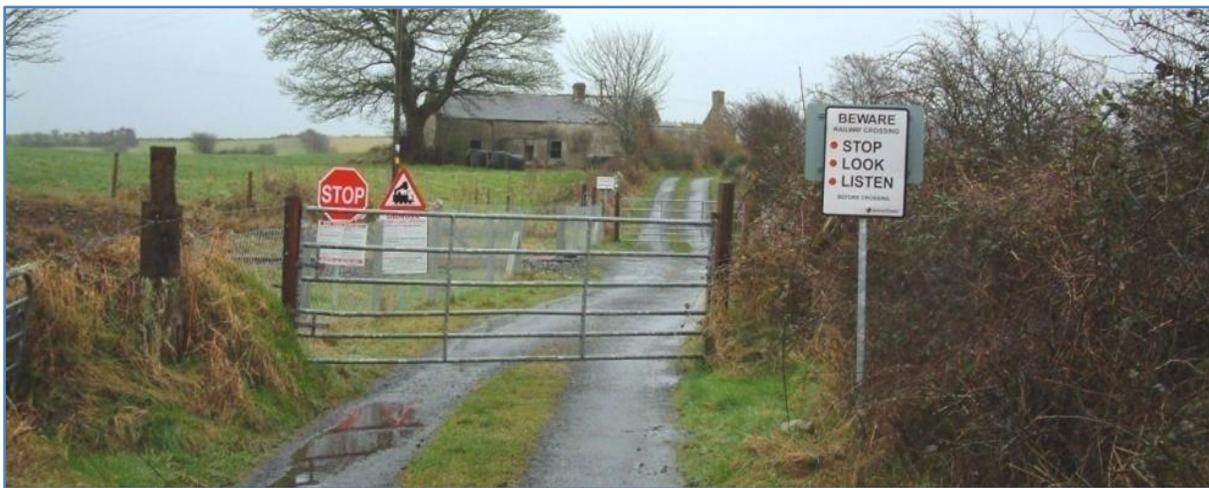
Photo 3 – Signage at crossing XX 032

Approaching the crossing from the T junction, approximately 55.6m from the railway line on the left hand side, there is a warning sign “BEWARE Railway Crossing Ahead Stop before You Cross the Railway”. On the right hand side approximately 23.8m from the railway line there is a warning sign “BEWARE Railway Crossing STOP LOOK LISTEN before crossing”. There is also a “Have you shut the gates” sign on the back of this sign. The gate is positioned approximately 19m before the railway line. On the left hand side approximately 8.4m from the railway line there is a warning sign “DANGER RAILWAY LEVEL CROSSING” beside this sign is a “STOP” sign with a “Keep These Gates Shut” sign below it (Photo 3 – Signage at crossing XX 032).

Currently IÉ do not have a standard that clearly identifies the specification and signage required at crossings. A list of signage for user worked crossings was provided to the RAIU by IÉ (see appendix 1). In addition, the Maintenance of Way Technical Information Sheet MW50, dated 01/01/1983 (MW50) (Iarnród Éireann, 1983) identifies a list of signage to be fitted as does the Report of Committee of Inquiry into Accommodation Level Crossing Safety, dated 13/07/1990 (Iarnród Éireann, 1990). The signage at the crossing was consistent with all three lists of required signage for this type of crossing. The KEEP THESE GATES SHUT sign contains a considerable amount of information which may not be easily read by vehicle users (Photo 4 – ‘Keep these gates’ shut sign).

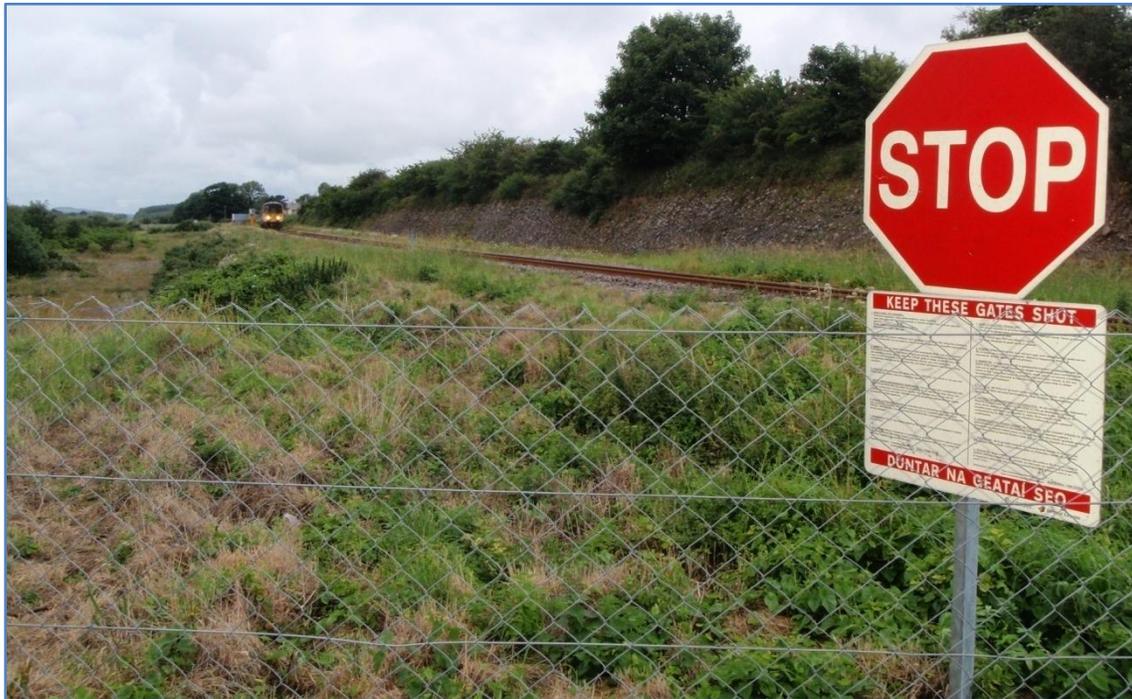
Photo 5 – View from crossing

A viewing distance from the crossing (Photo 5) in excess of 1600 m was recorded on the side that the car approached from, facing the direction from which the train approached the crossing.

This viewing distance (Photo 5) was also in excess of this.
