SEKTOR ZA PREISKOVANJE ŽELEZNIŠKIH NESREČ IN INCIDENTOV

Number: 375-8/2009/12

FINAL REPORT ON THE INVESTIGATION INTO A RAILWAY ACCIDENT – THE COLLISION OF PASSENGER TRAIN NO. 3508 WITH A ROAD FREIGHT VEHICLE

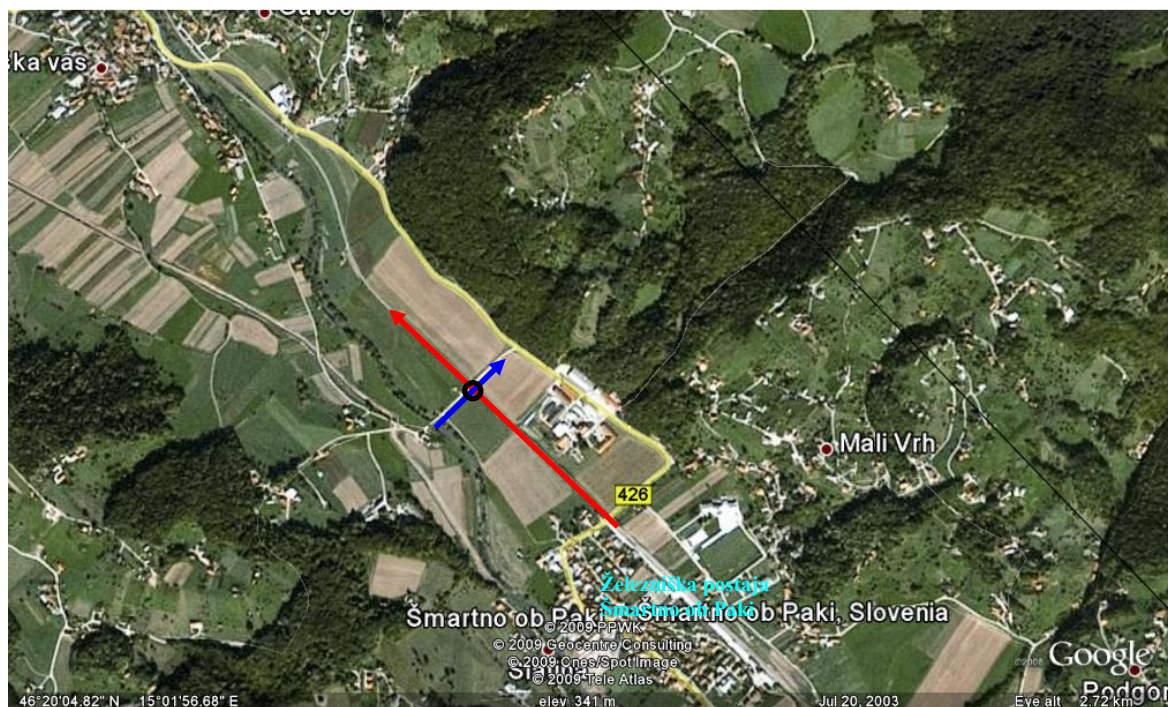
Figure no. 1: Travelling directions of the train and the road freight vehicle and the collision site

The red arrow shows the railway line and the travelling direction of the local passenger train, while the blue arrow shows the local road and the travelling direction of the road freight vehicle; the black circle marks the point of collision at the level crossing.

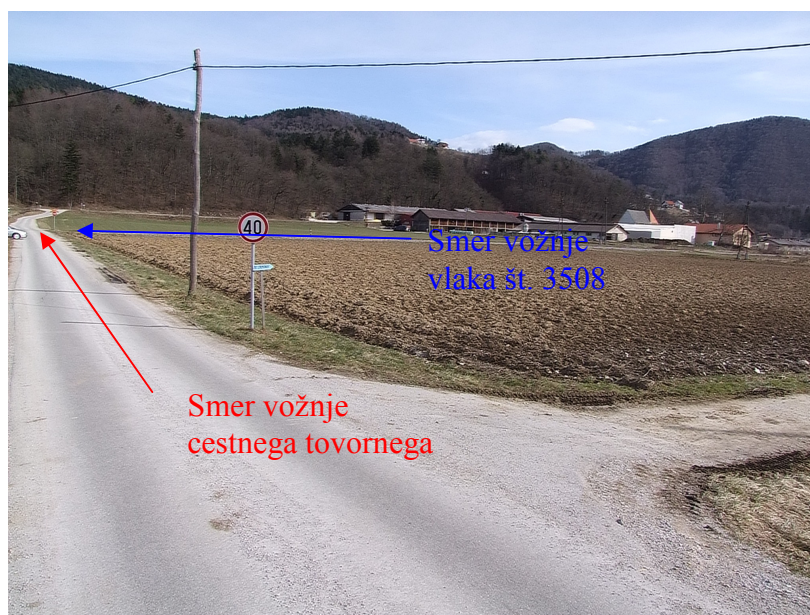
Road users are alerted to the level crossing at km 24+267 between the stations Šmarje ob Paki and Šoštanj by two road signs: a I-38 St Andrew's Cross and a no. II-2 stop sign, fixed one beneath the other on poles on the right-hand side of the road surface from both directions. From the direction of Slatina, from which the road freight vehicle involved in the accident was driving, the speed for road users is limited to a maximum 40 km/h by a II-30 road sign. Road signs are clearly visible at a sufficient distance. There are no obstacles obstructing the visibility of road signs.

In the section approaching the level crossing, the road is straight without any bends. Road users who concentrate and pay attention to safe driving can notice an approaching train in good time without any obstacles. This is particularly true of circumstances prevailing at the time of the accident, when the sun was shining onto the back of the road vehicle driver; this made the train even more noticeable, excluding the possibility of oversight had the driver closely looked at the railway line.

Figure no. 2: View of the travelling direction of the road vehicle and visibility of the level crossing

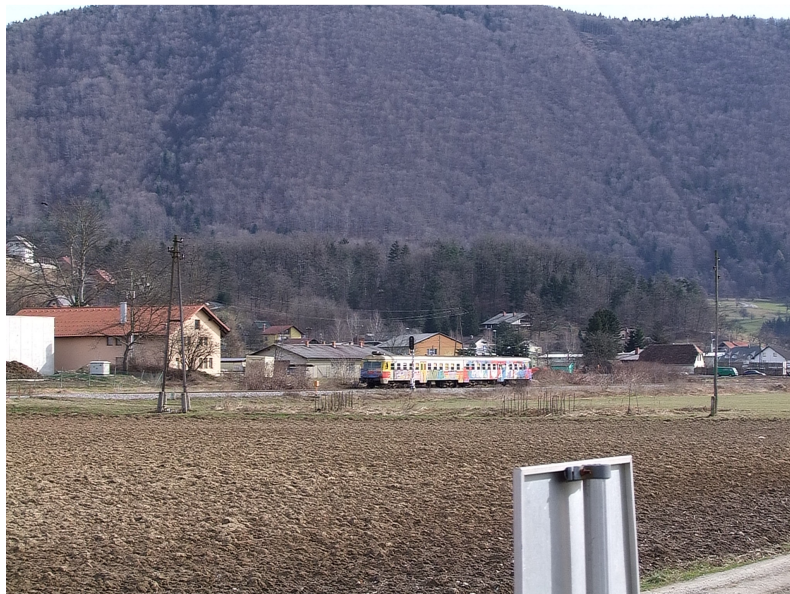
It is also probable that the driver of the road freight vehicle failed to notice the train because at that moment he was scanning the track to his right to see if it was clear. The figure below shows how well the train blends in with the surrounding buildings.

Figure no. 3: Train blending in with the surrounding buildings

Since in many cases trains blend in extremely well with the surrounding buildings, drivers of road vehicles should be additionally alerted to the approaching crossing of the road with the railway line and, possibly, an approaching train, at an organised level crossing fitted with traffic signs. In this way, additional safety would be guaranteed at this level crossing.

- additional marking of the level crossing for the benefit of road users by means of I-37 road signs (approaching the level crossing of the road with a railway line without barriers or half-barriers);
- installation of road humps immediately preceding the level crossing, signalling to drivers that they must proceed with caution.
