Number: 375-12/2009/9

Date: 4 December 2009

**FINAL REPORT ON THE INVESTIGATION INTO THE RAILWAY
ACCIDENT – COLLISION OF REGIONAL PASSENGER TRAIN NO 600
WITH PASSENGER VEHICLE AT LEVEL CROSSING LC-87.4, SOLKAN
1, BETWEEN RAILWAY STATIONS NOVA GORICA AND ANHOVO**

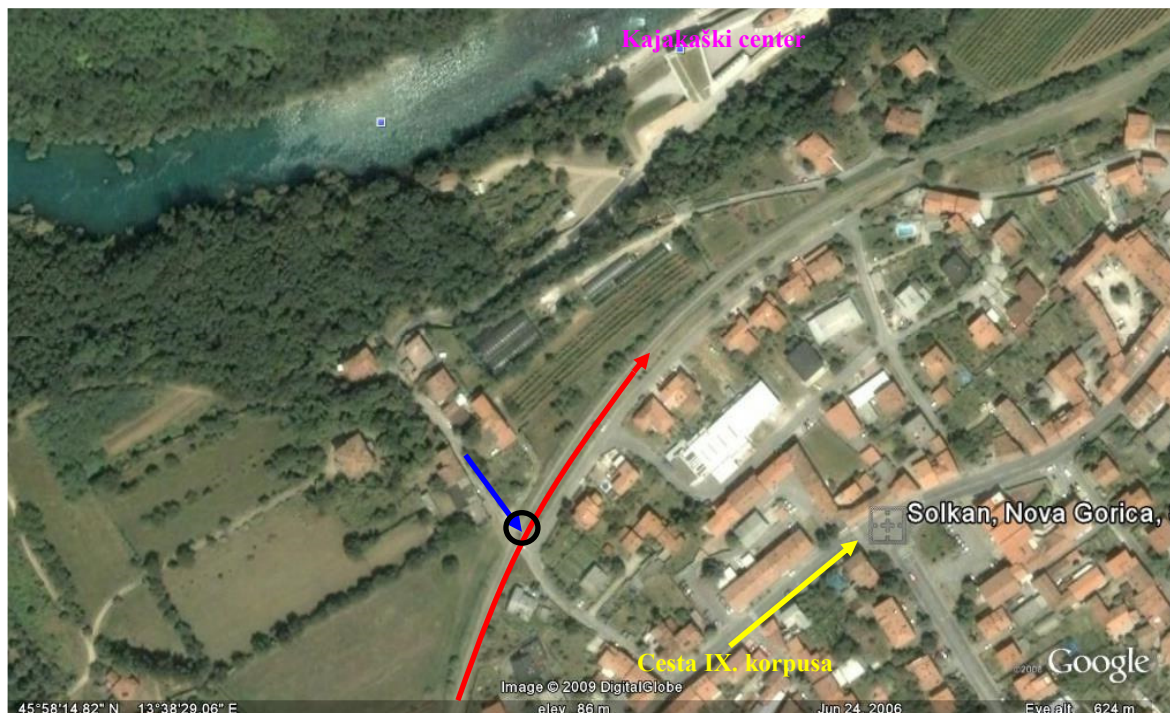
Figure 1: The red arrow marks the railway line and the direction of the travelling regional passenger train, while the blue arrow marks the public road and the travelling direction of the passenger vehicle; the black circle marks the site of the collision at the level crossing; the Kayak Centre and Cesta IX. korpusa are also marked.

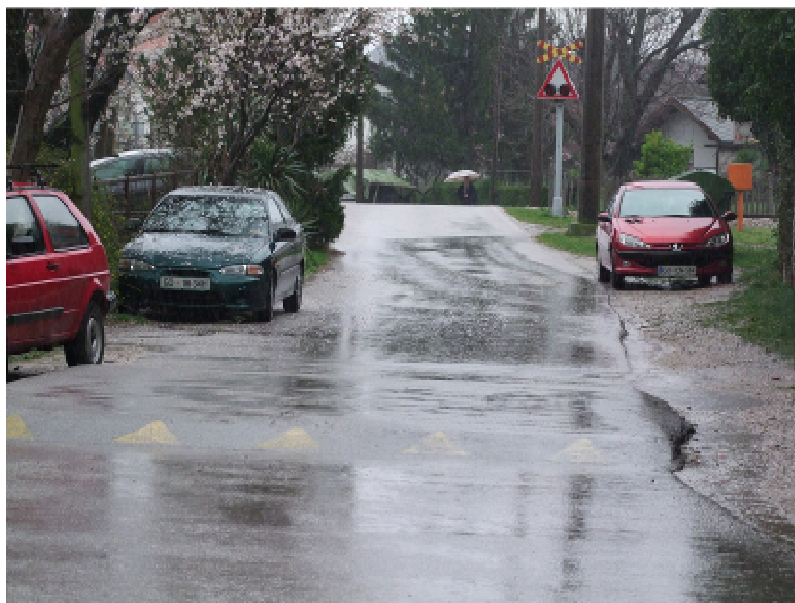
Road users approaching the level crossing from the direction of the Kayak Centre have a limited view of the railway line on account of a stone wall to the right, and trees to the left.

The level-crossing roadway is covered with special rubber elements, laid both in the space between the tracks and on each outer side of the tracks to a width of approximately 60 cm. These rubber elements are laid on top of the asphalt concrete coat. Road users are warned of the approaching train by two illuminated road signs: “Triangle with a yellow background and with a black border and two parallel red lights in a yellow background” and a bell signal emitted by a special bell installed on a pole behind the sign. A St Andrew’s Cross road sign is fastened above this sign.

Some 50 m ahead of the level crossing, a road hump – marked with yellow triangles on both sides of the approach – is built across the whole width of the roadway. The road hump is intended to warn road users of the level crossing and of the speed limit on this part of the road.

Figure 2: View of the Solkan 1 level crossing – equipment and visibility

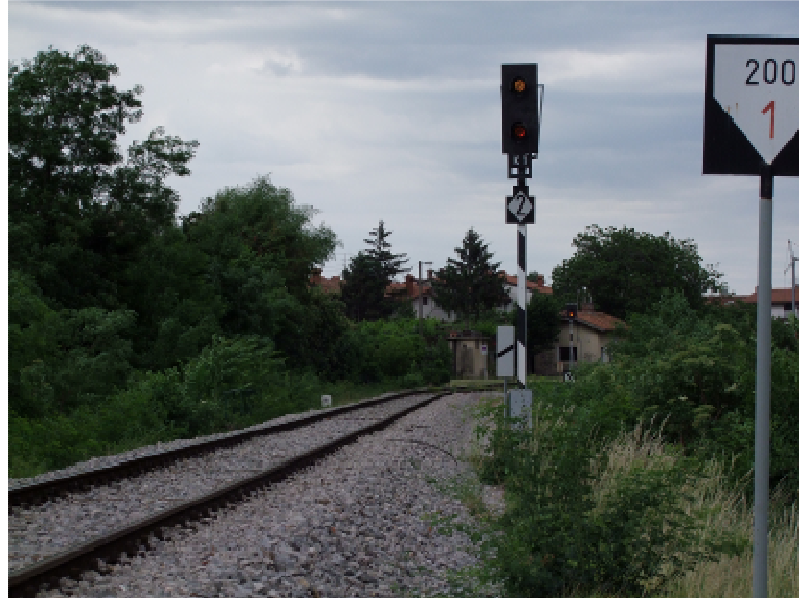
If the device is switched on in its entirety and is operating properly, a white flashing light is also activated on control signals, thereby signalling to the locomotive driver that the road crossing device is activated.

Figure 3: View of the control signal operation at level crossing Solkan 1 and 2 for rail vehicles travelling from the Anhovo direction

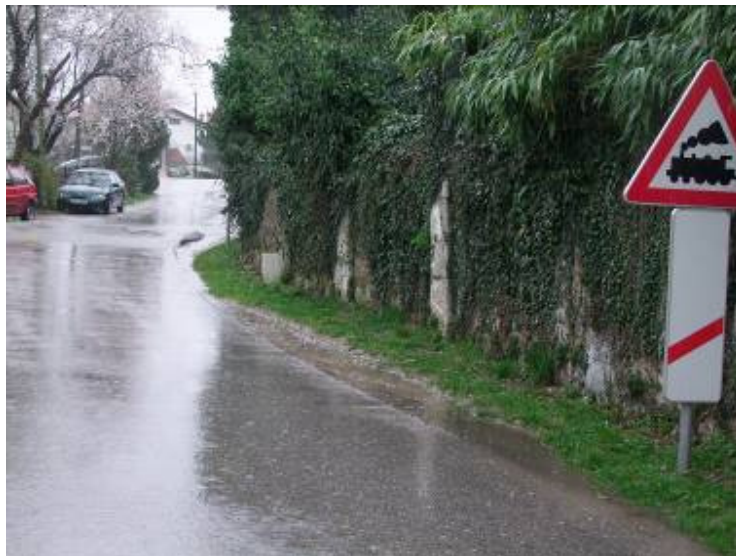
At this level crossing, the railway line becomes visible to road users arriving from the direction of the Kayak Centre towards Nova Gorica station as close as 13.9 m ahead of the level crossing danger zone, which begins 3 m ahead of the nearest railway track.

An analysis of the visibility of the LC-Solkan 1 level crossing was performed; the results obtained show that visibility at the time of the accident was reduced both for the passenger vehicle driver and for the locomotive driver, due to the weather conditions and night. The flashing road-traffic sign and the acoustic warning by means of a bell, both operating flawlessly at the time of the accident, were warning road users clearly enough of the approaching train. The impaired decision-making of the road vehicle driver, due to the influence of alcohol, and the reduced visibility due to heavy rainfall at the time of the accident are undoubtedly two reasons for the conduct of the passenger vehicle driver, which resulted in the accident.

Figure 4: View of the section directly ahead of the Solkan 1 level crossing from the direction of the Kayak Centre
