REPUBLIKA SLOVENIJA
MINISTRSTVO ZA INFRASTRUKTURO IN PROSTOR

SLUŽBA ZA PREISKOVANJE NESREČ

Number: 375-30/2010/2
Ref. No.: 00031020

**FINAL REPORT ON THE INVESTIGATION OF A RAILWAY ACCIDENT – COLLISION OF
REGIONAL PASSENGER TRAIN NO. 2615 WITH A LIGHT GOODS ROAD VEHICLE AT
HALF-BARRIER PROTECTED LEVEL CROSSING
"LEVEL CROSSING – VNANJE GORICE", AT KM 575+460, BETWEEN VNANJE GORICE
AND PRESERJE STATIONS**

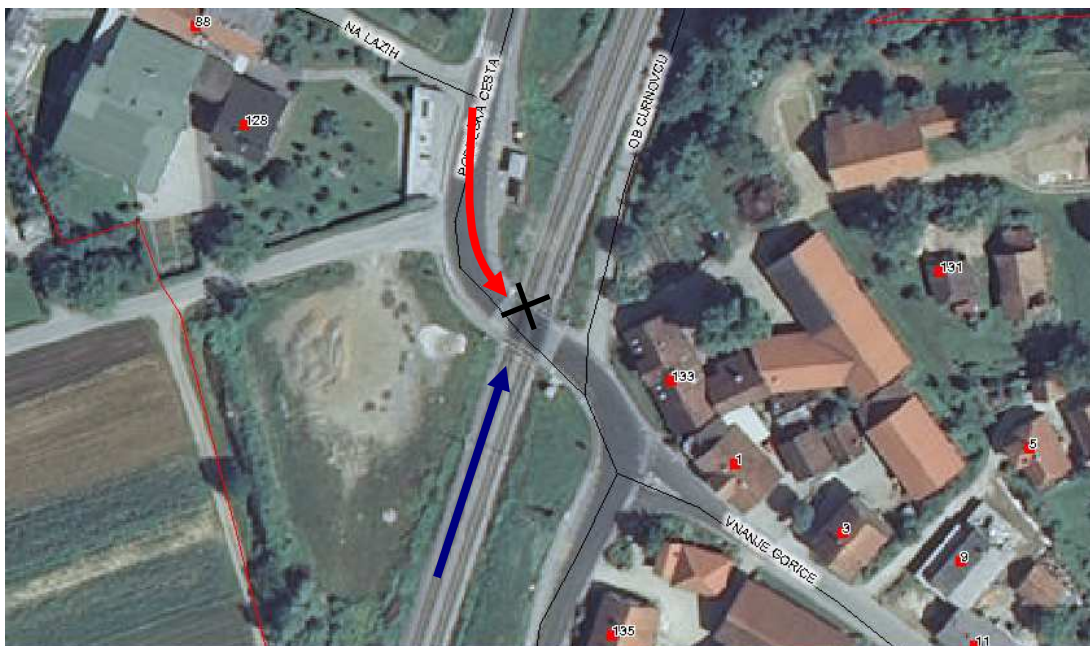
Figure 1: The travelling direction of the train is indicated by a blue arrow, the travelling direction of the road goods vehicle by a red arrow and the site of the collision by a black cross

The direct cause of the accident was the driver of the light goods vehicle tempting fate by circumventing the lowered half barrier and driving onto the right-hand track at the moment when regional passenger train no. 2615 entered the level crossing along this track.

Since road vehicles frequently circumvent lowered half barriers at level crossings where the lowered half barriers protect only one half of the road, i.e. the lane in the travelling direction and not the opposite lane, a gradual modification of protection at this type of level crossing, with half barriers for both lanes from both directions or barriers extending over the entire width of the road, is recommended.

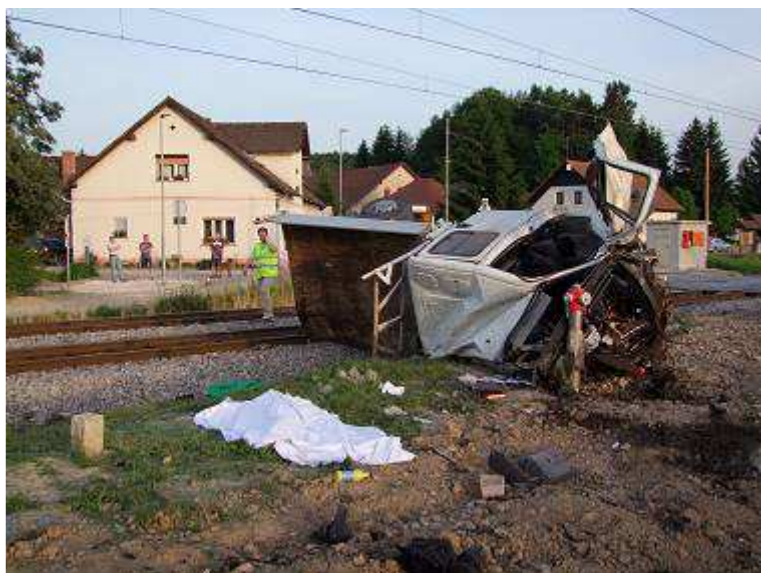
Figure 2: Consequences of collision of regional passenger train no. 2615 with road motor vehicle at Vnanje Gorice level crossing

In the accident, the electric multiple unit of train no. 2615 was badly damaged (damage to the front side of the unit and parts of the left-hand side of the unit in the driving direction). The damage as estimated by the *Sekcija za vleko Ljubljana* (Ljubljana Traction Section) amounted to EUR 30 000.00.

The road goods vehicle was completely written off in the accident. The material damage to the vehicle, according to a non-expert assessment, amounted to approximately EUR 5 000.00.

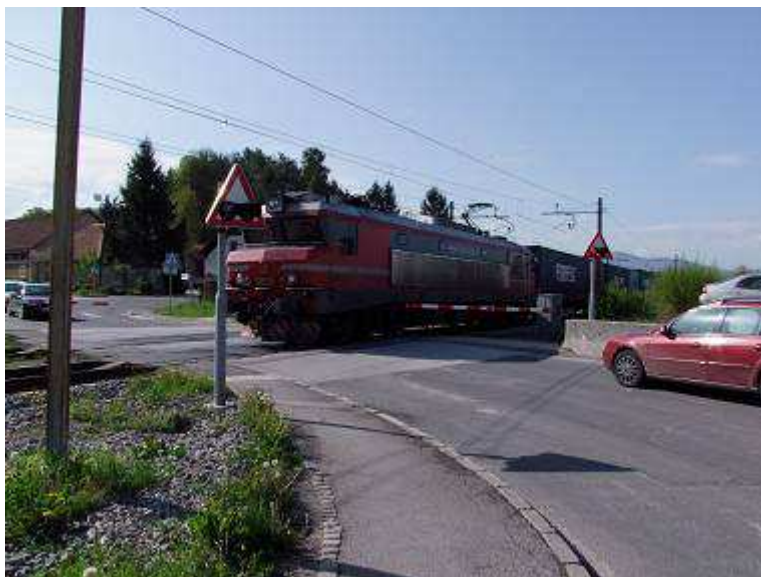
The indirect cause of the accident can be attributed to the type of level crossing protection in use, which enables road users to simply circumvent the lowered half barriers and drive onto the part of the road intersecting the railway line. Special consideration should be given to level crossings in urban settlements.

Figure 3: Display of level-crossing protection during the passage of trains

Since road vehicles frequently circumvent lowered half barriers at level crossings where the lowered half barriers protect only one half of the road, i.e. the lane in the travelling direction and not the opposite lane, a gradual modification of protection at this type of level crossing, with half barriers for both lanes from both directions or barriers extending over the entire width of the road, is recommended.

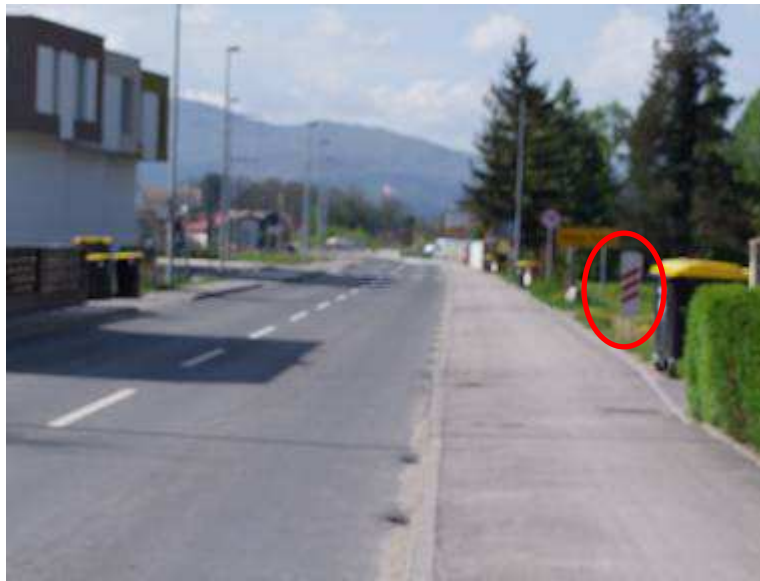
Figure 4: Presentation of visibility of road signs I-39: owing to the buildings and facilities located along the road, these signs are completely absorbed into their surroundings

The road signs indicating the distance from the level crossing protected by half barriers are also inadequate, since on traffic sign I-39 (three-line countdown marker), located at a distance of 240 m from the level crossing, the I-36 sign is missing.

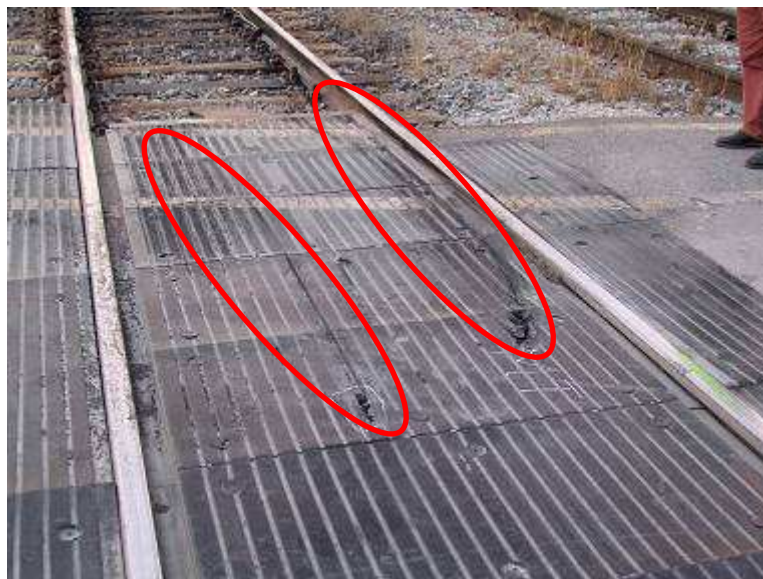
Figure 5: Traces of the road vehicle on the rubber elements of the level crossing after the collision
