MINISTRY OF TRANSPORTS AND INFRASTRUCTURE
ROMANIAN RAILWAY AUTHORITY - AFER

INVESTIGATION REPORT

**of the serious railway accident that occurred on May 10, 2008 to Valea
Călugărească**

Final edition
May 08 2009

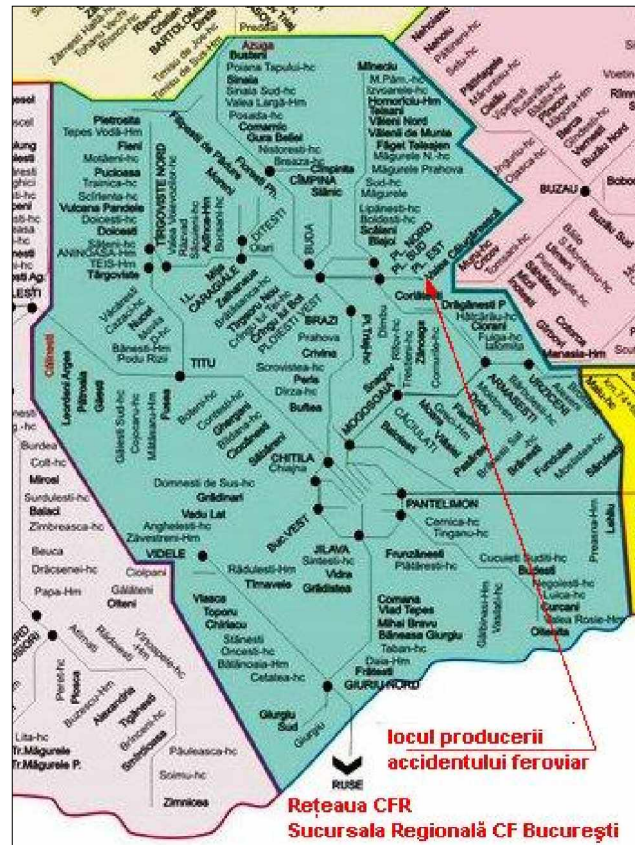
photo 1

On May 10, 2008 the train no.1661 that was put into service on the route Bucuresti Nord –Iasi, left from CFR Ploiesti Sud railway station and passed without stopping, according to the schedule on the track no.6B from CFR Ploiesti Est railway station. When passing through all railway stations, the train was surveyed by the movement's inspector (IDM). According to the schedule after leaving CFR Ploiesti Sud railway station the next stop was supposed to be Mizil railway station (photo no.1).

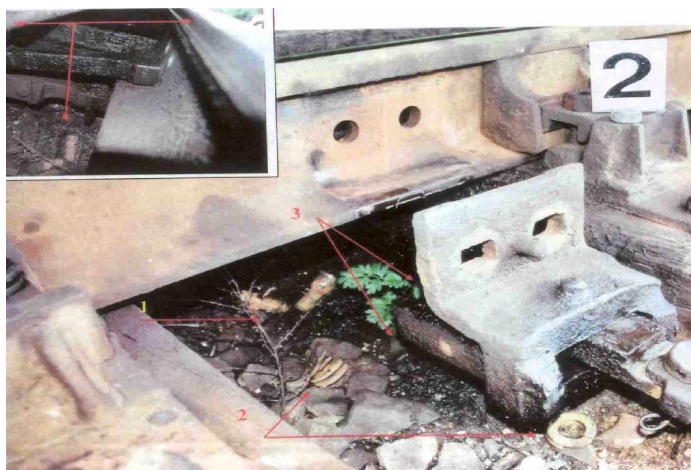
photo 3

The statements of the personnel of the tracks maintainance that was examined on the position of the horizontal screws of fastening the box fallen on the coupling bar are not corresponding to the first photos made by the penal investigating bodies (photo no.3).

The position of the elements of fastening the box corresponding to the right stock of rail of the switch no.9.

I- Screws; II - helical springs; III - nuts;

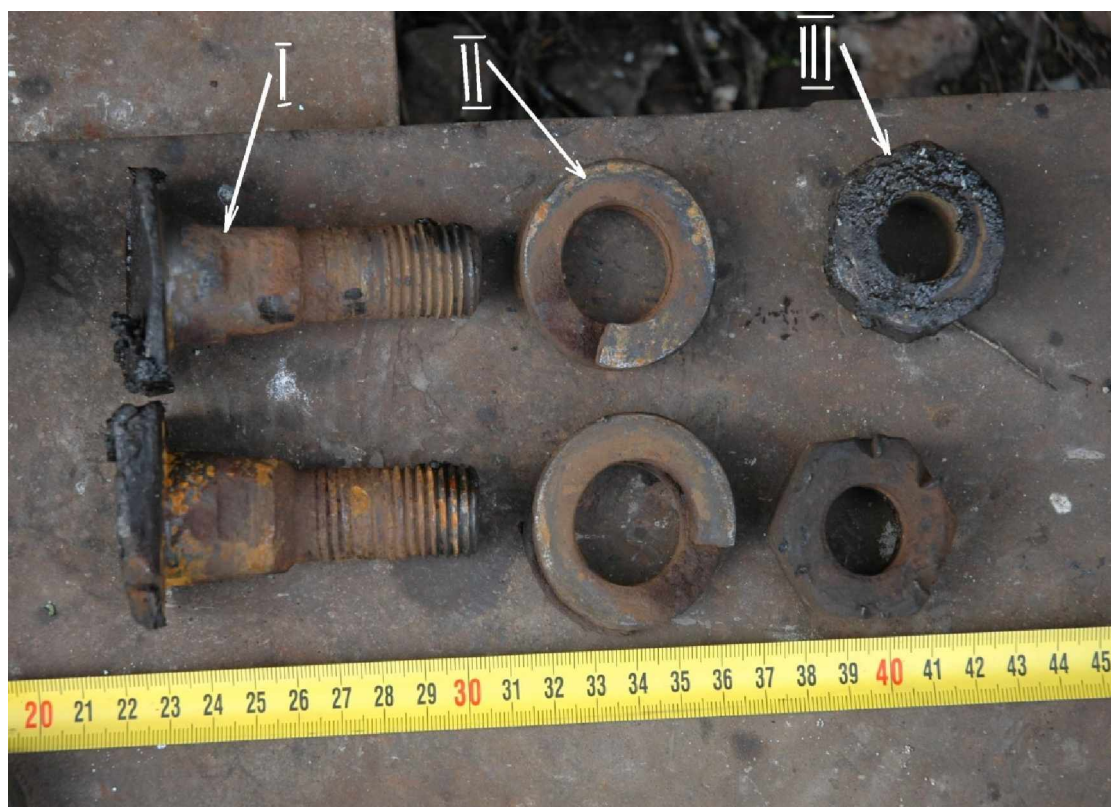
The statements of the personnel examined on the existence of some marks of strokes on the exterior surface of the nuts of fastening the box are not corresponding to the photo made by the penal investigating bodies (photo no.4).

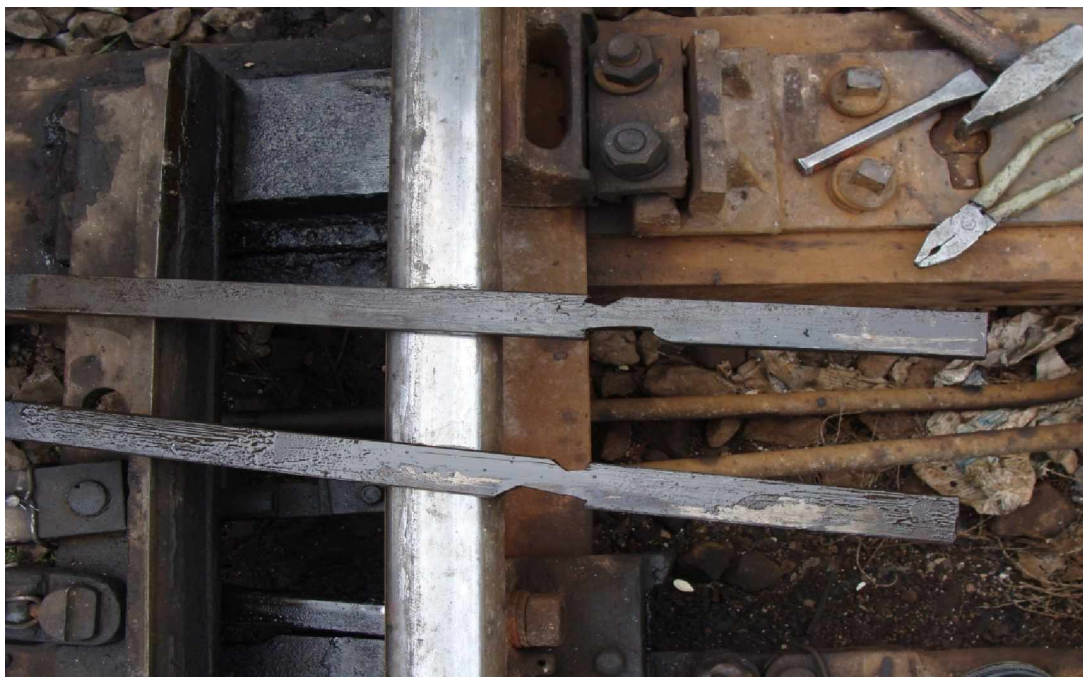
photo 5

In the presence of the investigating commission it was found that the detector slides had the nicks widened in which is entering the beak of the contacts lever that is verifying the mechanical control of the correct displacement of the points in the position attached to the stocks of rail. This nicks were made with the chisel. (photo 5).

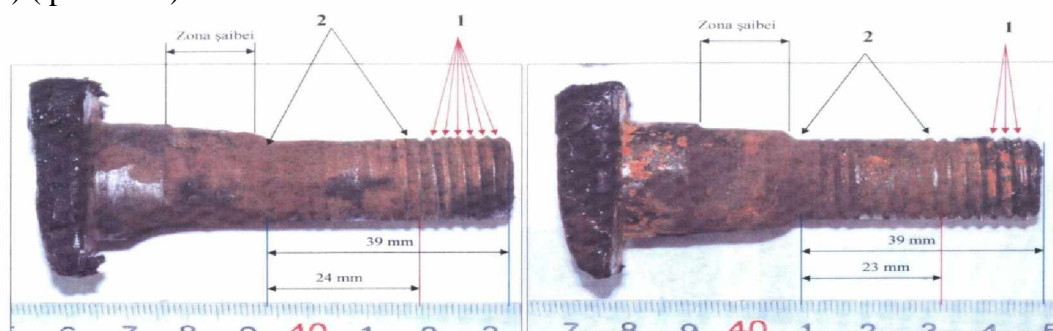
The nuts type B M 22x22 that ensure the fastening of the locking box on the respective stock rail ensured the maximum fastening without their whole inside tapped surface be on the suitable screw tapped rod, according to the specification ($\frac{1}{4}$ of their thread being on the outside of the tapped rod of the screw) (picture 6).

1. Zona filetată activă
2. Zona filetată uzată

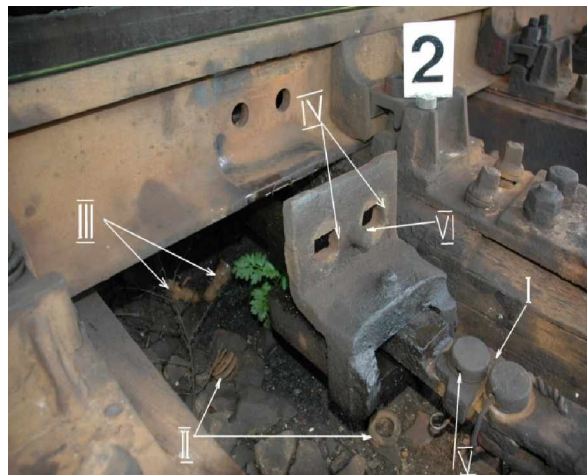
picture 7

The stroke-arresting device was unsuitable assembled on the upper side of the operation bar and the screw 5 was reversely fastened without the crenellated nut A M 22 (I and V in picture 7).

The locking box from the right side was dislocated against the curved stock rail and was fallen on the operation bar (picture 7).

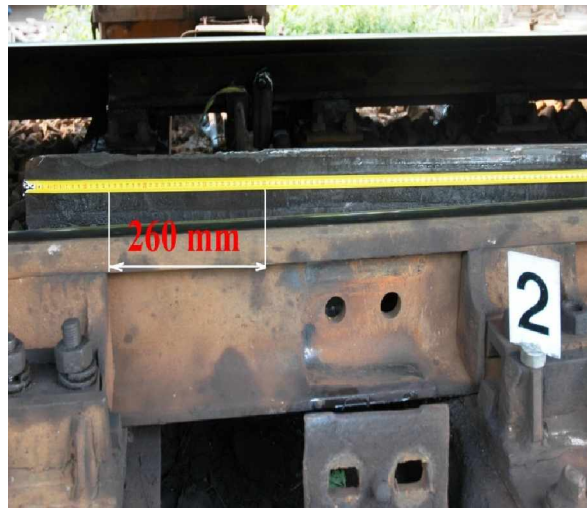
picture 8

The right points had indentures on the upper edge on about 260 mm (picture 8)

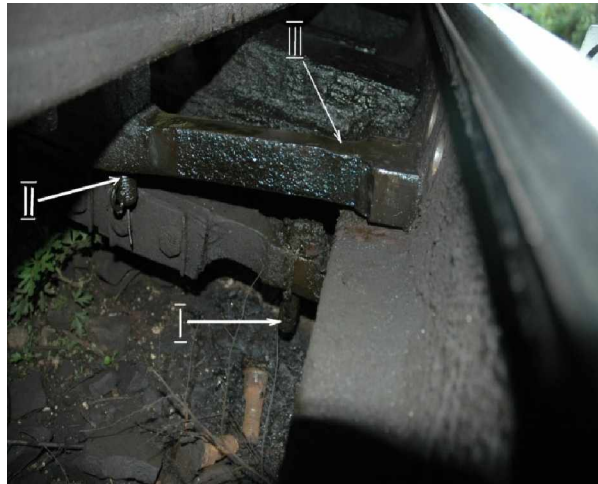
picture 9

The screws type C2 and C4 were not ensured for fastening with crenellated nuts (I and II from picture 9).

The lock clip of the point lock of the right points was removed from the locking box and was on the base of the curve stock rail (III from picture 9)

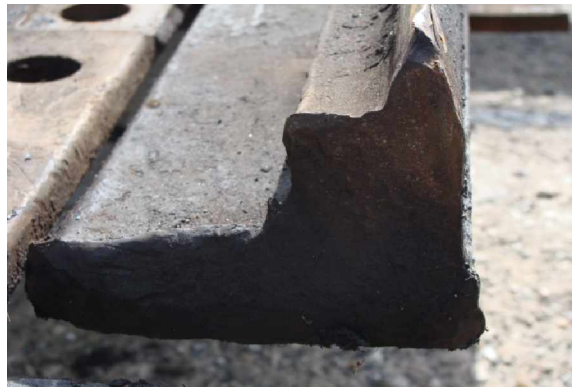
picture 10

The lock clip of the middle lock of the right points was out of shape, but locked in the locking box. The right points had in the tip new hitting traces at the upper side and old traces at the lower side, in the cross section (picture 10)

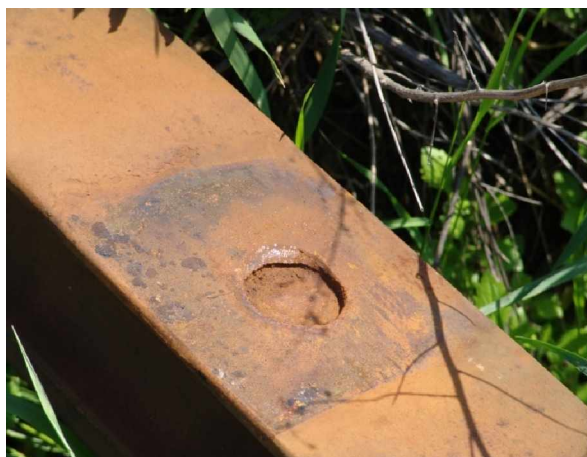
picture 11

- The special places in the points base where had to come the bungs, were oval (picture 11);

- lack of the bungs that had to prevent the move longways the points - bungs that ensure the connection between the base of the points and the metallic plate of the special sleeper from the points heel (picture 11);

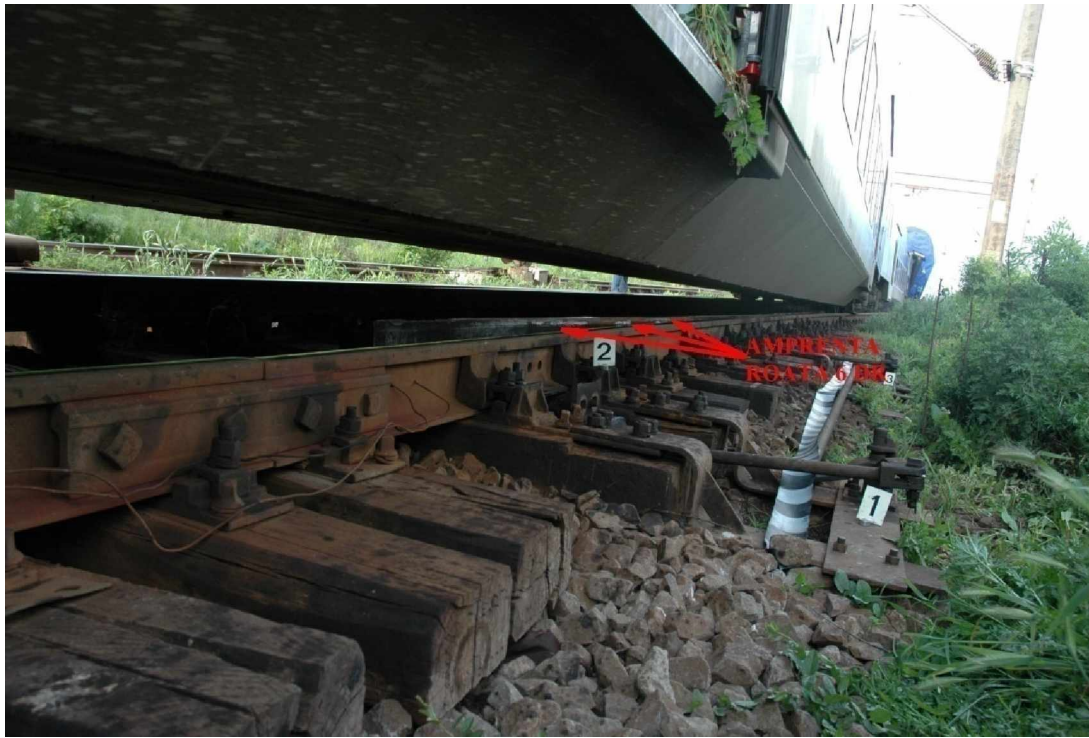
picture 13

The axle no. 6 of the locomotive was the first in the running direction of the train 1661. The wheel from the right side of the running direction of the axle no. 6 hit the tip of the right points of the switch no. 9 half-opened, and the lip of the tire of this wheel passed between the right points and the curve stock rail, operating the right points to the centre of the track III, with a force lateral horizontal. (picture 13)

Running of the maximum distance between the outside surfaces of the tires is seen also on the outside surface of the tire of the right wheel no. 6 which rubbed on the lateral surface of the right points from the curve stock rail (pictures 13 and 17)

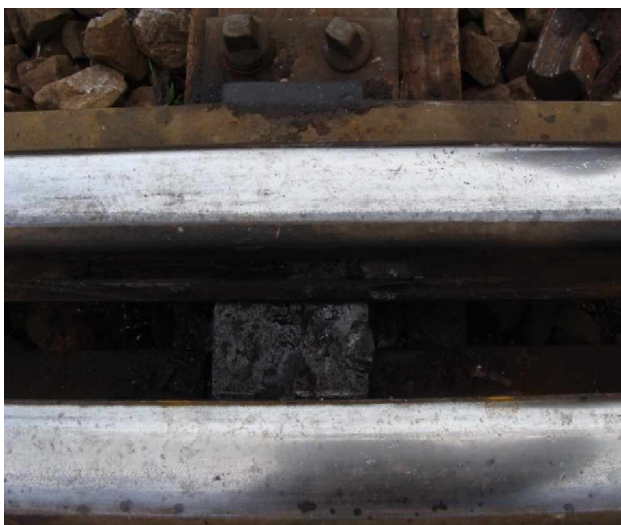
Picture 14

The first trace of derailment is seen on the 12th curve points slide chair, in the place between the curve points and the right stock rail (picture 14) and on the right side of the running direction, at the 18th right points slide chair, on the head of a vertical screw and of its nut being between the right points and the curve stock rail (picture 15).

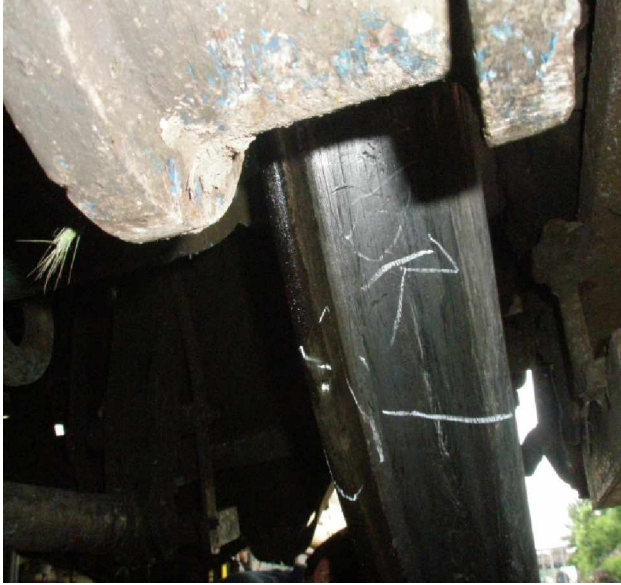
Picture 16

The traces of the derailment are seen both on the tire and on the lip of the tire of the right wheel of the axle no. 6 (picture 16).

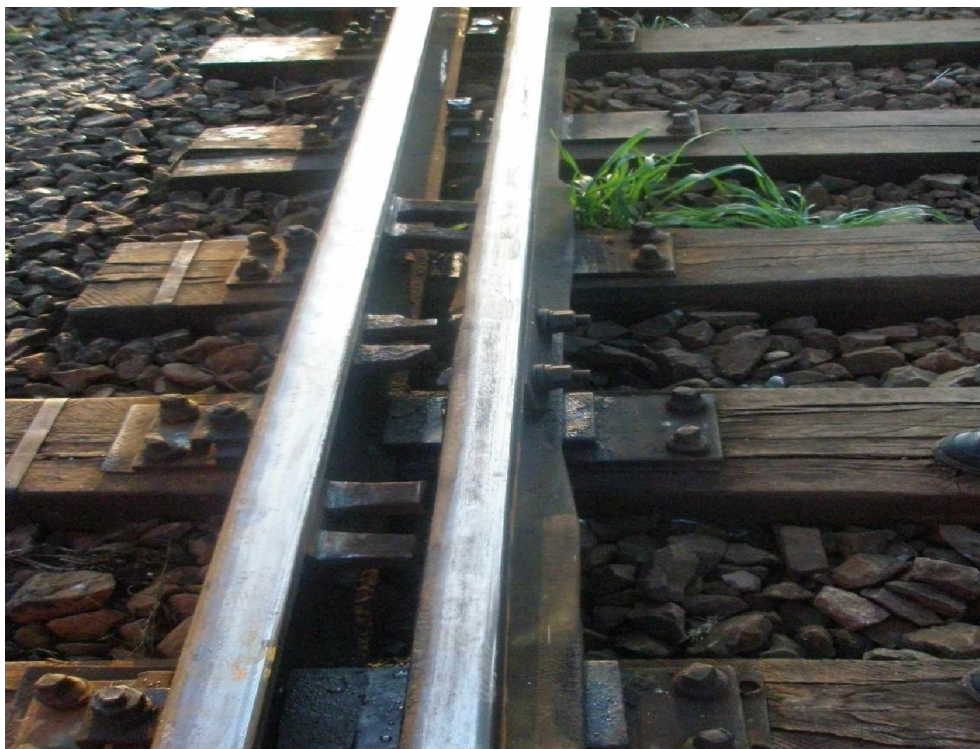
picture 18

On the length of the switch no. 9, the wheels of the bogie axles no. 2 and 1 of the locomotive run on the slide chairs, beams, vertical screws and metallic plates (picture 18).

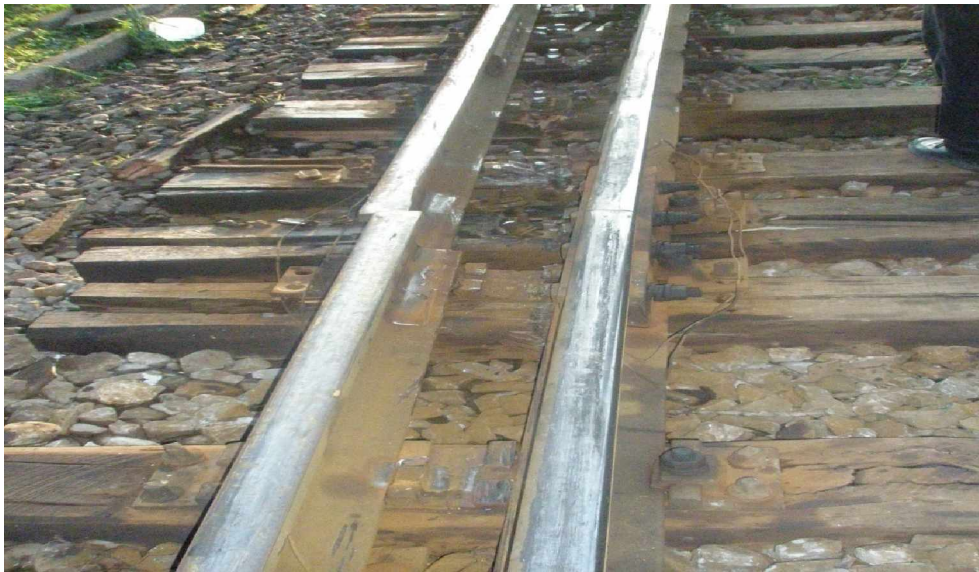
picture 19

The left wheel of the axle 6 cut the horizontal bolts of the glued insulated joint and of the normal joint from the right stock rail heel (picture 19).

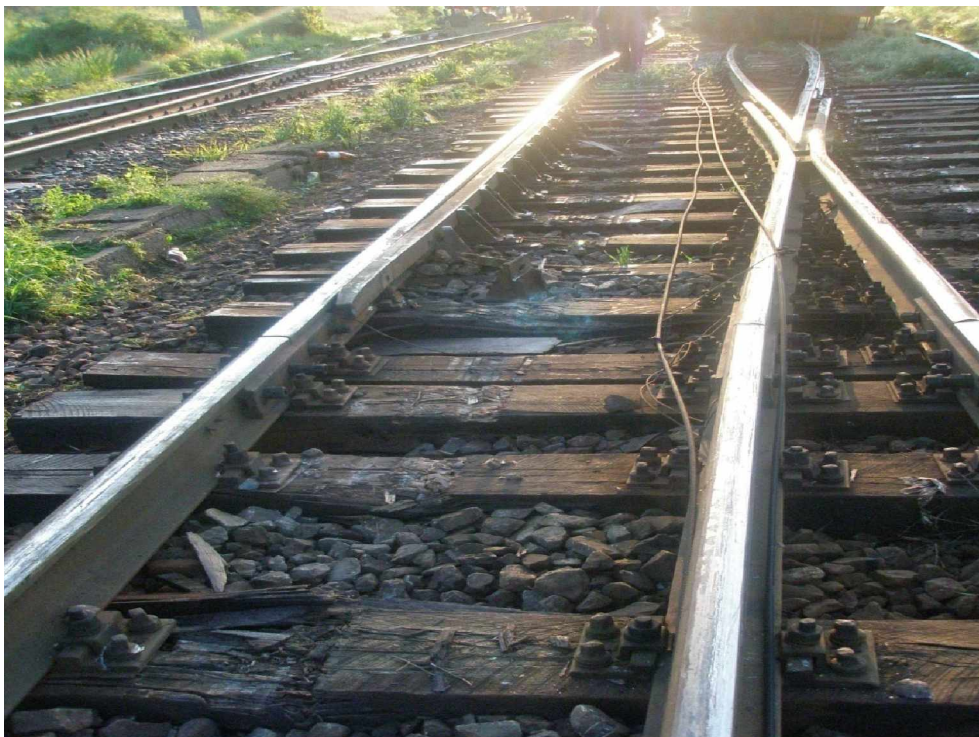
picture 20

Then this run on sleepers on the direction of the centre of the direct line of the switch no. 9, and the right wheel of the axle 6 on the sleepers of the deflecting section to the switch heel (picture 20).

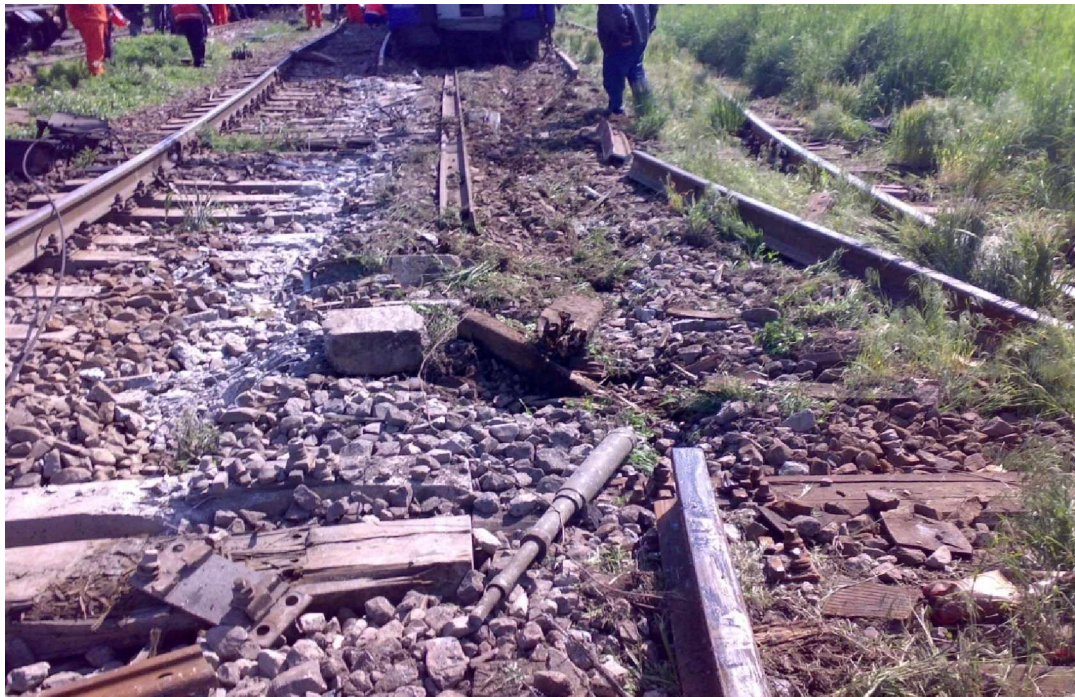
picture 21

This distortion happened on a distance of 14 m from the heel of the switch no. 9, when the horizontal lateral forces transmitted by the wheels exceeded the resistance of the fish-plates and of the first rail section type 65 from the glued insulated joint of the line 4, left stretch of rails. Because of it in this area were cut the connections to the normal joints of the glued insulated joints type 65 from the line III, as well as a rail from the right side was broken and from the line 4 was broken a rail from the left side. The first rail section type 65 from the glued insulated joint of the line 4 left stretch rails was broken at 2,5 m from the gap of the glued insulated joint and also were cut the connections of the special fish plates from the glued insulated joint type 65 from the line 4, the left side (picture 21).

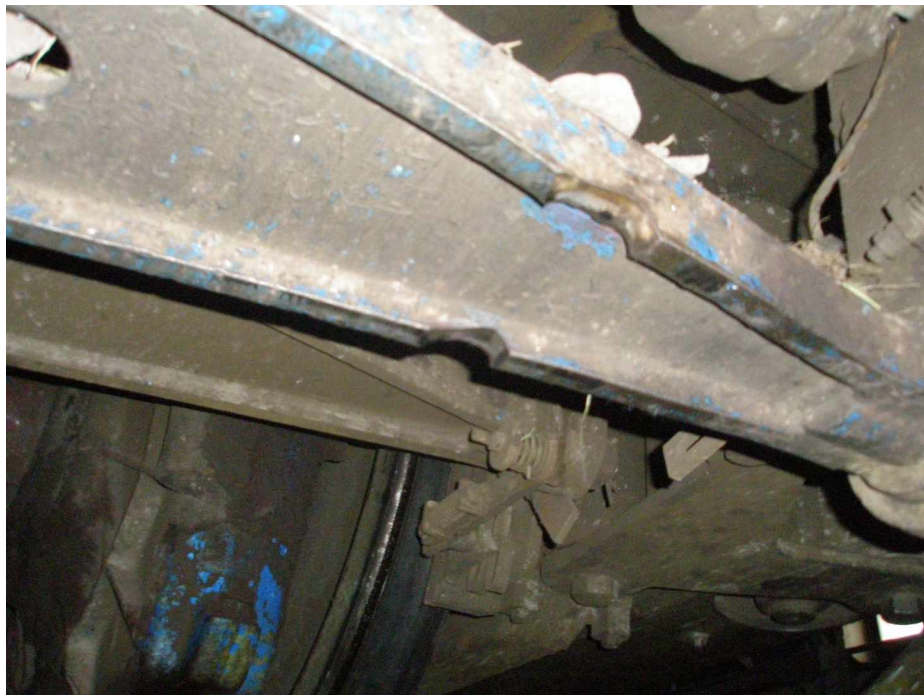
picture 22

The locomotive ran derailed on about 97 m. During this running the locomotive hung also the rail section that in its relative move against it hit with the end from the railway station the track sleepers, and with the other end hit and deteriorated the subassemblies under the locomotive (the triangle axles, drum of gears, pair of wheels) – picture no. 22

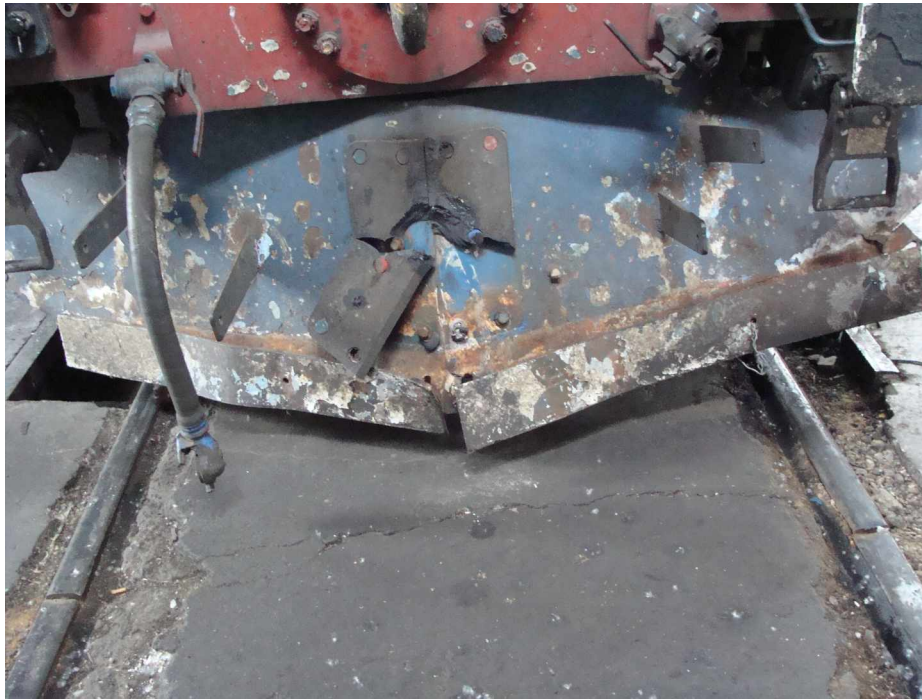
picture 23

The rail section exited under the locomotive hitting and deteriorating the locomotive plough at the end from the first wagon of the train. (picture no. 23).

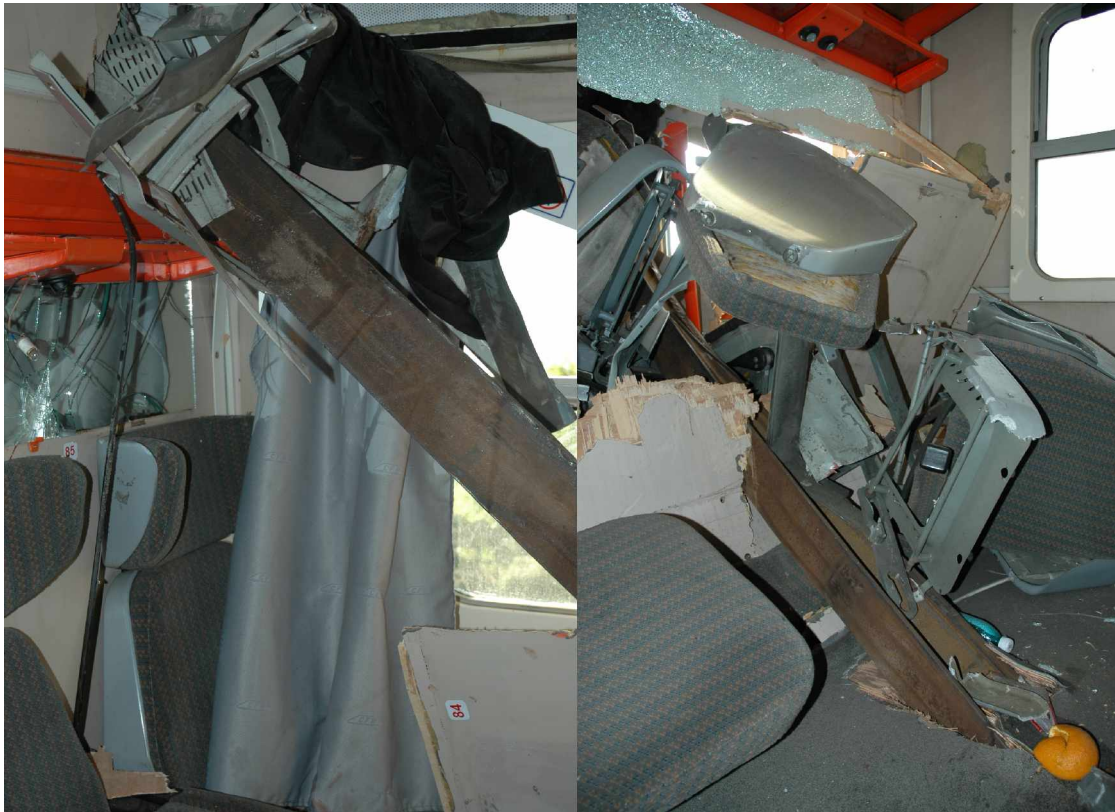
picture 24

After holing the wagon deck, the rail section penetrated under an angle of 45° in the fixed wall between the compartments no. 8 and no. 9 (first compartments in the wagon running direction), devastating the seats 91, 93 and 95 from the compartment no. 9 and the seats 82, 84 and 86, stopping at the moment of train stop in the upper part above the seat 85 of the fixed wall between the compartments no. 7 and no. 8 (picture 24).

This rail section in its movement, injuring the master train who was in the compartment no. 9, as well as killed a traveler and injured slightly 3 travelers.

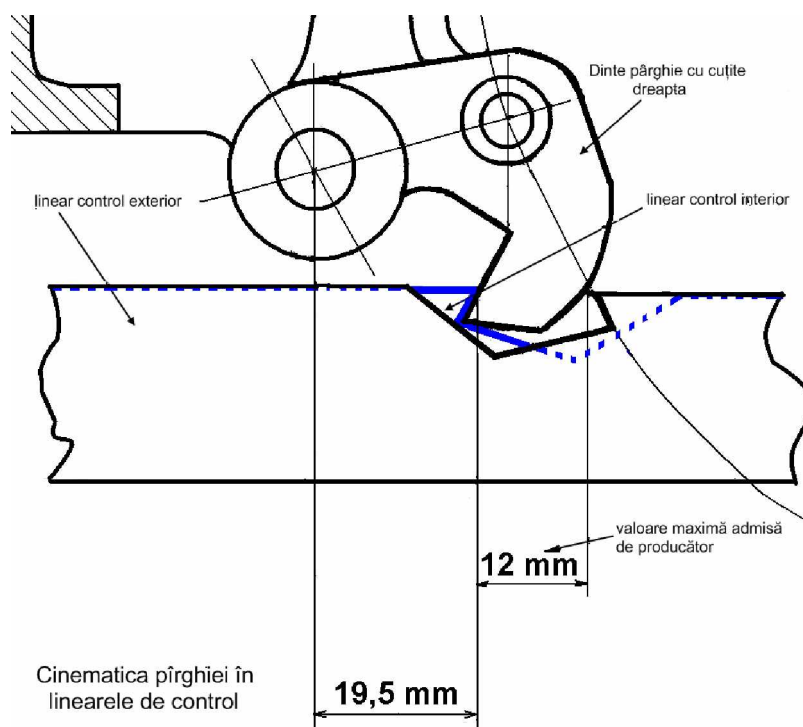
picture 25

The profile of the levers of the automatic switch during the notmal operation of the assemble (or the automatic circuit-breaker of the point motor) is based on the in and out detector slides movement by the control bars, at their turn, they are moved by the switch points. The control of each of these two positions of the switch points is gotten when the claw of the lever with knives can move along in the same time in the grooves of the two detector slides, which maximum accepted value is 12 mm (picture 25).

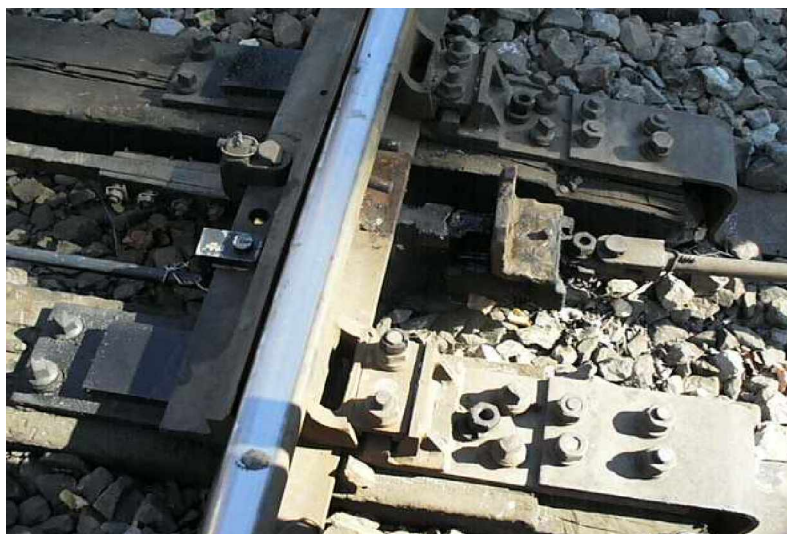
picture 26

- At the third check that was performed with the locking box detached from the switch (the both nuts disassembled), at the second operation, the switch was operated with control in the conditions of half-opening of 7 mm between the points and the stock rail, because the exit of the locking clip from the box following its movement and exit from the assembled place (picture 26)

Following the simulations in the railway station Chiajna, the investigation commission *concluded that in the conditions given by a detector slide to which was changed the groove on a length 3 times higher than this accepted by the manufacturer (38mm), the profile of the automatic switch rods in this operation of the assembly (or the automatic circuit-breaker of the point machine), can lead to a controlled operation of the switch, in the conditions of remaining a half-opening conditioned on the points positioning against the stock rail.*

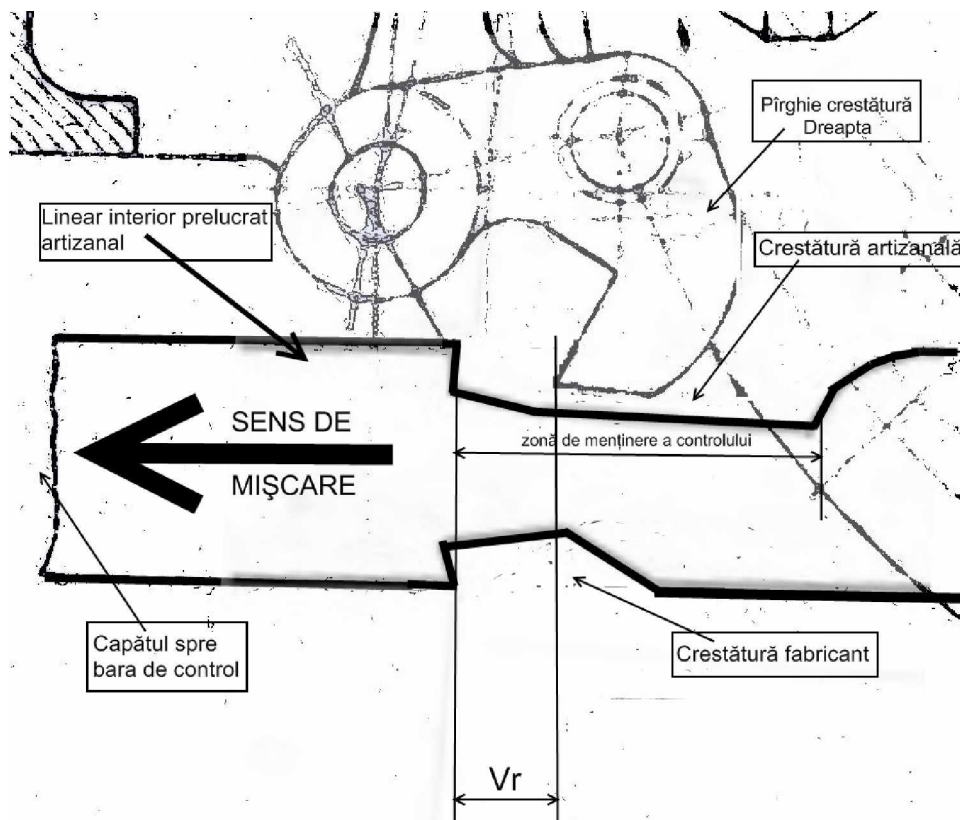
picture 27

- By an unsuitable adjustment imposed by the forging at the control log rod adjustment, issue for which the execution staff is not responsible because the lack of the visibility of the claw in the grooves of the inner detector slider;
- by applying a force on the middle of the control long bar because of a adult person weight, distortion that could be increased also by the rolling stock ageing in time, in the conditions of a proper adjustment of the lever claw in the detector slide groove
- combination of the above cases, the most probable situation, taking into account the mixture of the malefactors present in the area

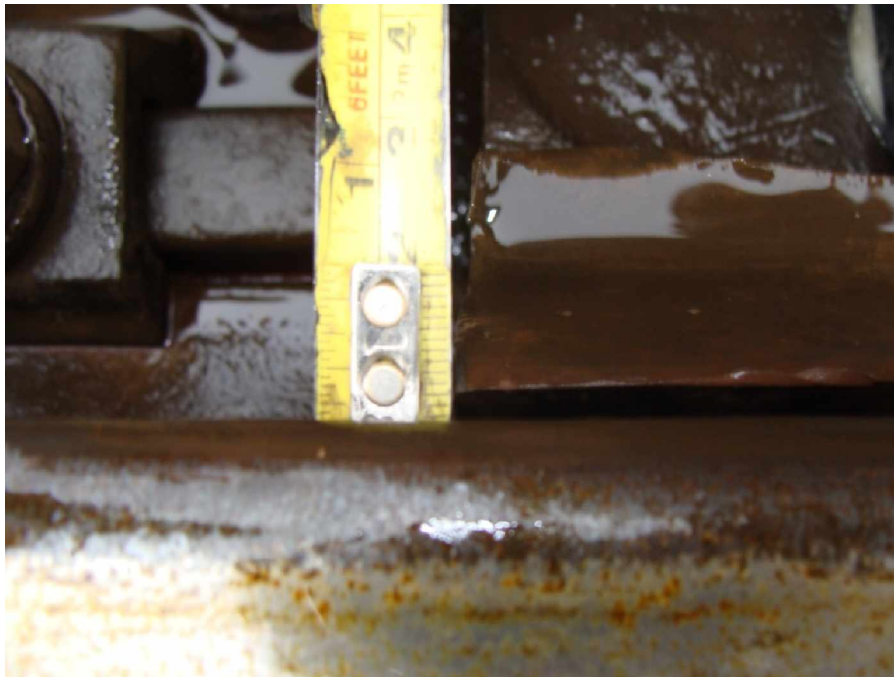
picture 28

screwing off the nuts of the fastening screws of the locking box from the points on the position “plus” with a half-opening of the points of 2mm, the switch did not receive control (picture 28)

Following the simulations in the railway station Giurgiu Nord, the investigation commission concluded that, at a linear with a groove that complies with the designing quotas, colligated with a assembly and an accuracy adjustment of the adjusting rods (a complete turning round of the screw correspond to variation of 0,5 mm), if the assemble locking box-clip could damaged (by detaching or breaking from its fastening), the point motor does not received electric control at the moment of the locking box detachment from the stock rail if there is a half –opening accepted be the instructions in force (the obtained half –opening of 2 mm complies with the accepted instruction values).
