SEKTOR ZA PREISKOVANJE ŽELEZNIŠKIH NESREČ IN INCIDENTOV

Number: 375-21/2009/9

Date: 14 May 2010

## **FINAL REPORT ON INVESTIGATION INTO A RAILWAY ACCIDENT – COLLISION OF FREIGHT TRAIN NO. 42772 WITH PASSENGER VEHICLE**

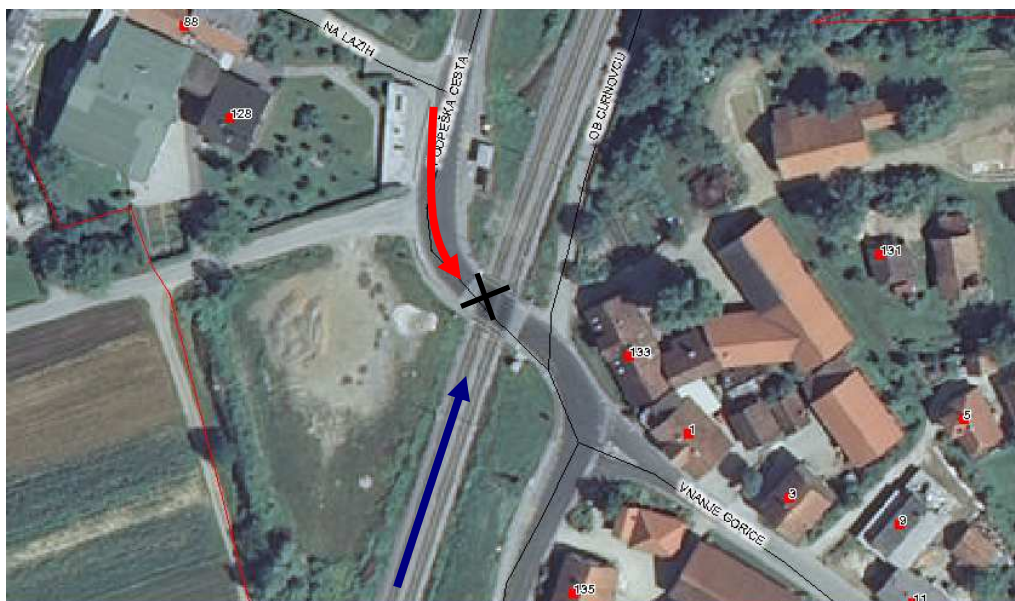
Figure 1: View of travelling direction of train and passenger vehicle, and site of the collision

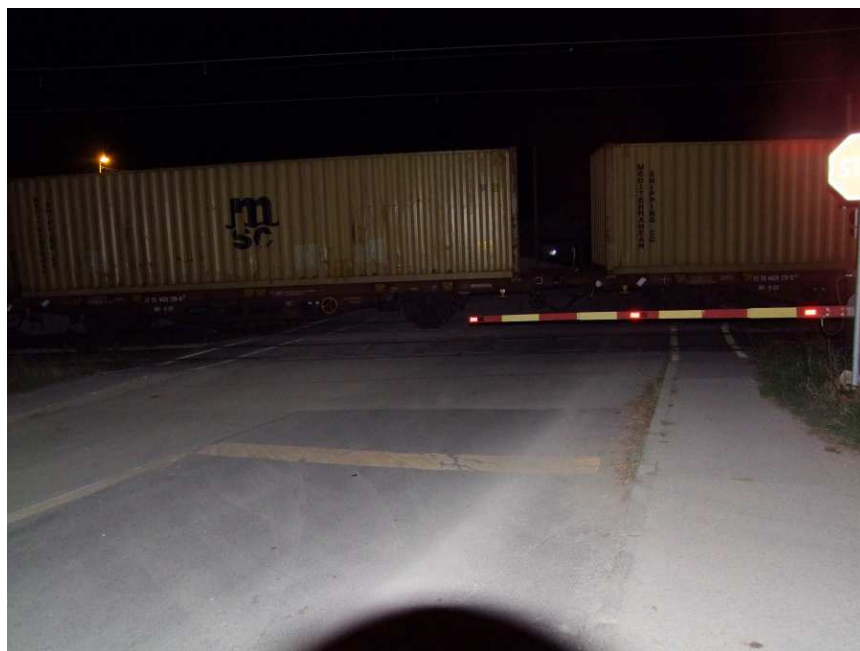
The level crossing is protected by half-barriers with the Iskra CPr-DK signalling and safety device. The remote control of the device is connected to Brezovica station. At the time of the accident, the device was in perfect working order and the half-barriers were lowered horizontally across the road. All the lights of the signalling and safety device at the level crossing (lights on half-barriers and lights on the road sign) were in perfect working order at the time of the accident.

Figure 2: Functioning of the device for protection of the level crossing immediately after the accident when the train involved in the accident was still standing on the level crossing and the consequences of the accident were being removed.

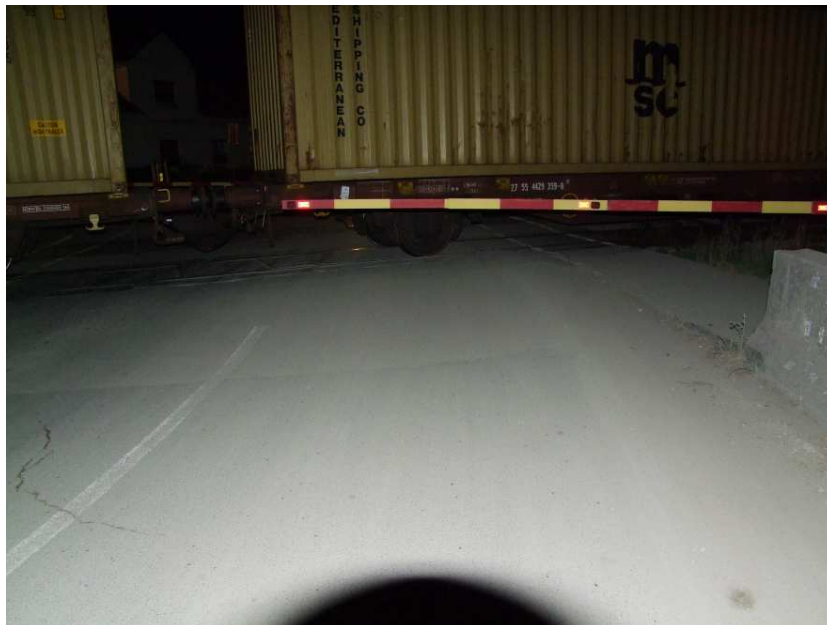
Figure 3: Half-barrier at Vnanje Gorice level crossing reaches as far as the illustrated point

It was established during the investigation that the direct cause of collision between train no. 42772 and the passenger vehicle at the level crossing with half-barriers between Brezovica and Preserje stations at km 575+460 was the driver of the passenger vehicle, who failed to give way and thus tempted fate, and who, despite the fact that the signalling and safety devices at the level crossing were in perfect working order and the half-barriers were lowered, thus unmistakably warning road users of the approaching train, drove his vehicle onto the opposite lane, circumvented the lowered half-barrier and drove in front of the locomotive.

Since lowered half-barriers are often circumvented at level crossings where the lowered half-barrier protects only half of the road, i.e. the lane in the travelling direction and not the opposite lane, a gradual modification of protection at this type of level crossings with half-barriers for both lanes from both directions or barriers extending over the entire width of the road is recommended.
