1. **PERFORMER:** Romanian Railway Notified Body – Laboratories Department
2. **CLIENT:** Romanian Railway Investigating Body – OIFR
3. **TESTING OBJECT:** broken axle journal, end B, in the connection point of stress relief with the obstructing area, with the order number 14, charge 311561, series CFR 3836632, belonging to the wagon no. 31535494306-2, involved in the railway incident from Zavideni, occurred on the 13th of March 2008.

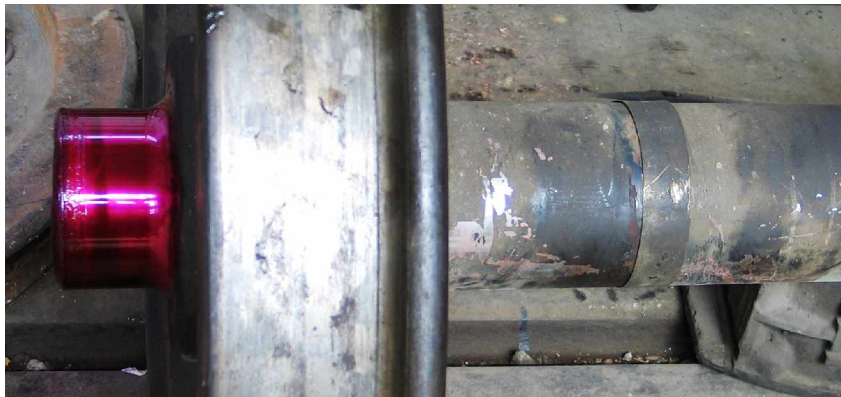
Picture 1

Axle breaking happend in normal plane on its logitudinal axis, by stress relief, under the roller bearing WJ, in the connection point with the cobstructing area – picture 1.

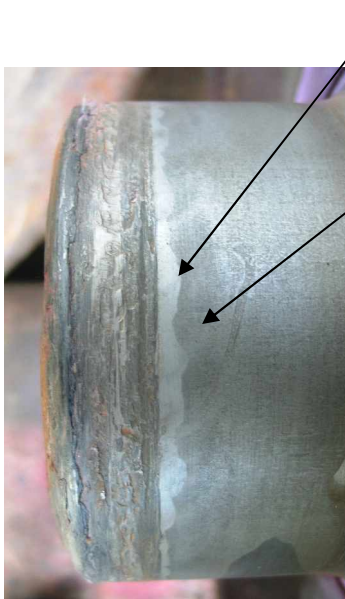
Picture 2

In the picture 2 one can notice a detail of the breaking area, where can be noticed an area with material deposited circular of silver colour, of irregular shape (I), with a breadth between 2 and 6 mm and an adjoining dark grey band (II), of thermo influence (II), with the breadth between 8 and 10 mm.

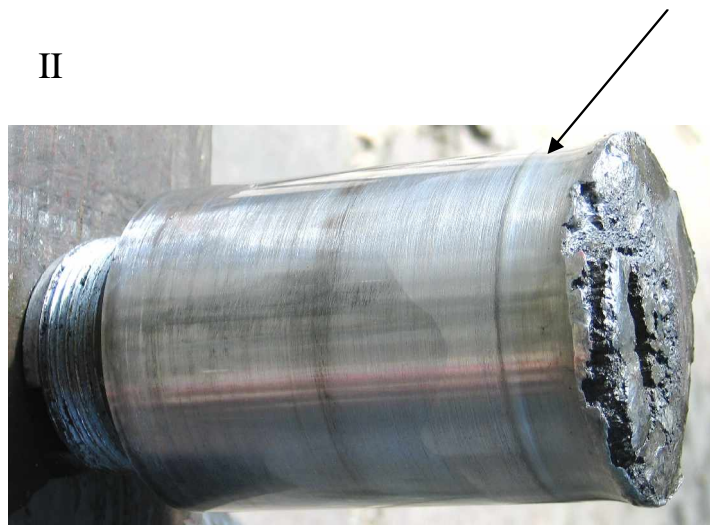
Picture 3

The broken axle journal of 220 mm length has the end threaded, and at about 35 mm from the breaking point is emphasized a circular area, with an increased height of about 0,15 mm, picture 3. The visible marks on the end of the broken axle journal are: IOB SNTFM 07 04 M90 070453 CFR 38366 32 – picture 4.

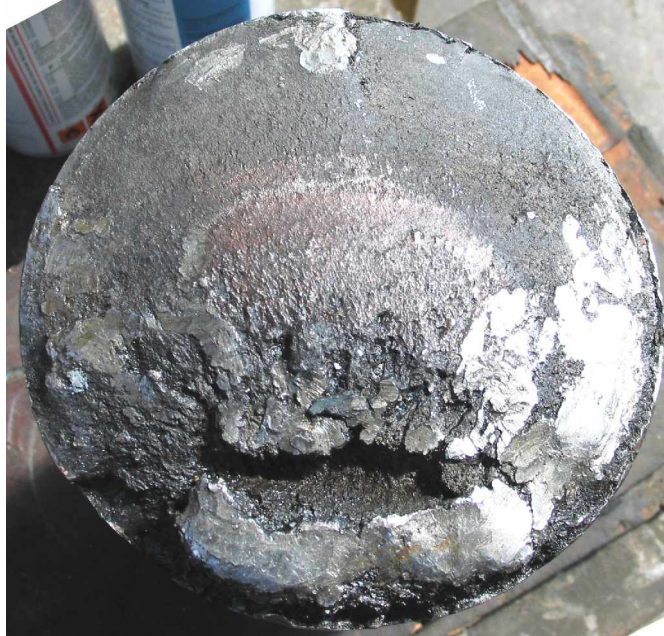
Foto 6

The aspect of one of these two breaking surfaces (breaking) is presented in the picture 6, where can be noticed on about 60% fatigue breaking area (gradual) and on over 40% sudden breaking (with material plucking).

On the section edge can be noticed gradual tendency to break, areas with material deformed and printed form, following the repeated hits of the opened breaking surfaces until the axle journal breaking.

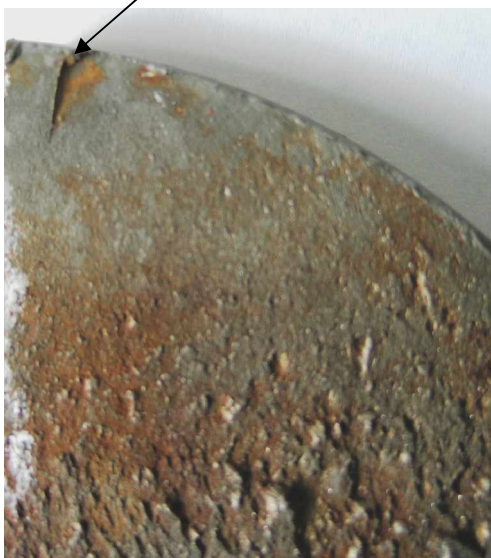
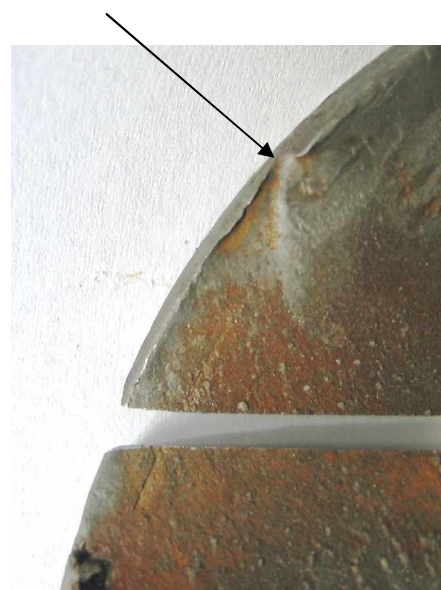
Two details of the edge tendencies to brake of the breaking section (marked with arrows are presented in the pictures 7 and 8).

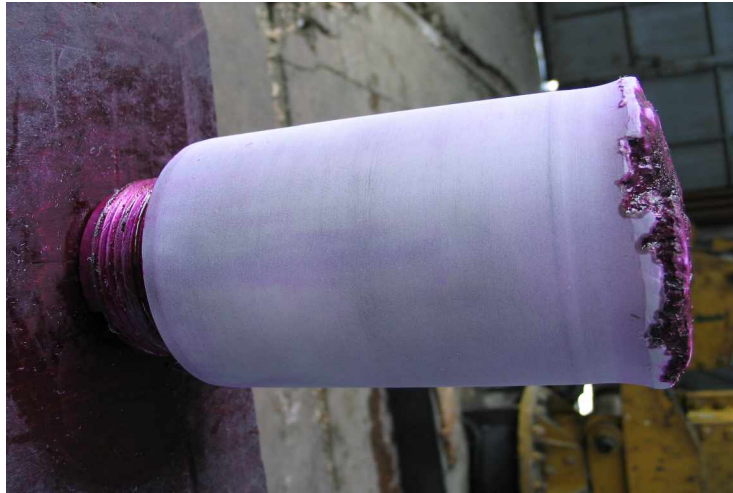
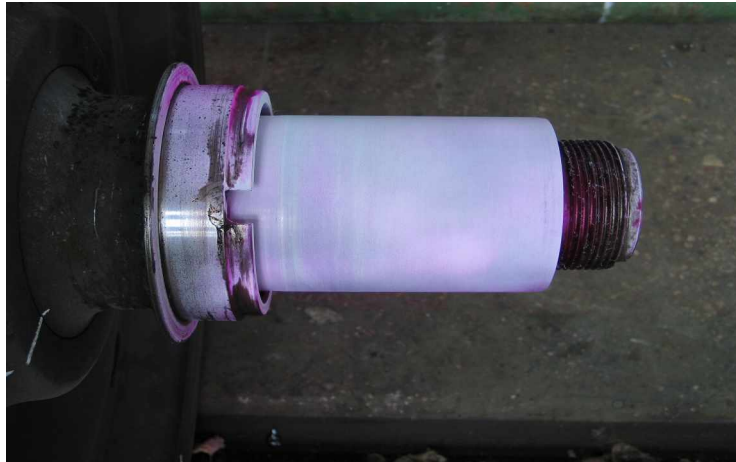
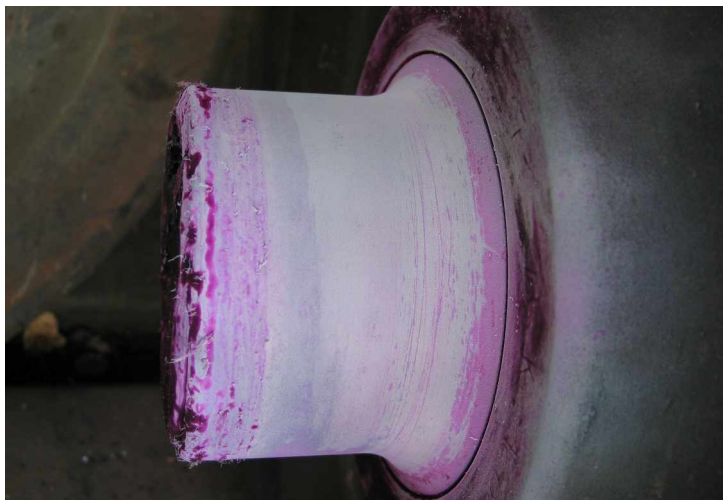
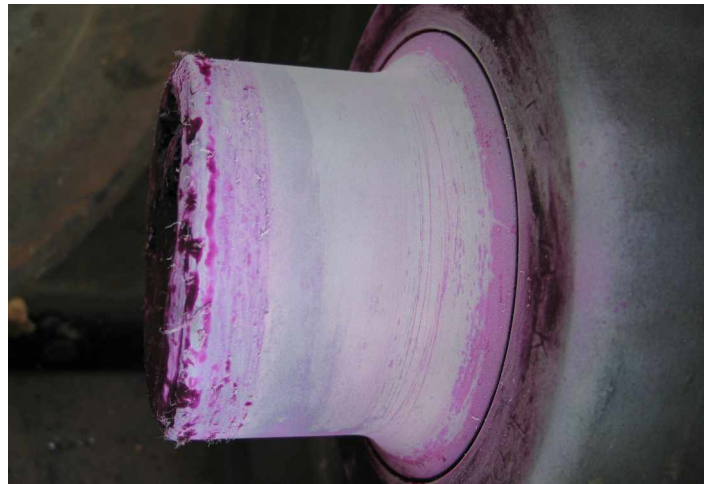
Following the control performance, there were no failures found out, but was noticed the unaccountable presence of a circular ring, as an increased height at the begining of the stress relief, both on the broken axle journal and on the non-broken one.

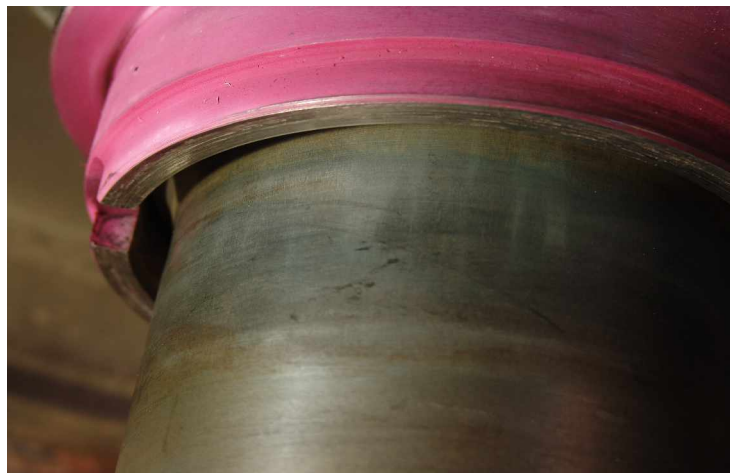
Picture 13

Following the increased height finding out, one proceeds to a wash with solvent, followed by an attack with a Nital substance 5%, at the visual examination were found out dark areas in the stress relief point, as can be seen in the next picture:

The same situation on the broken side.

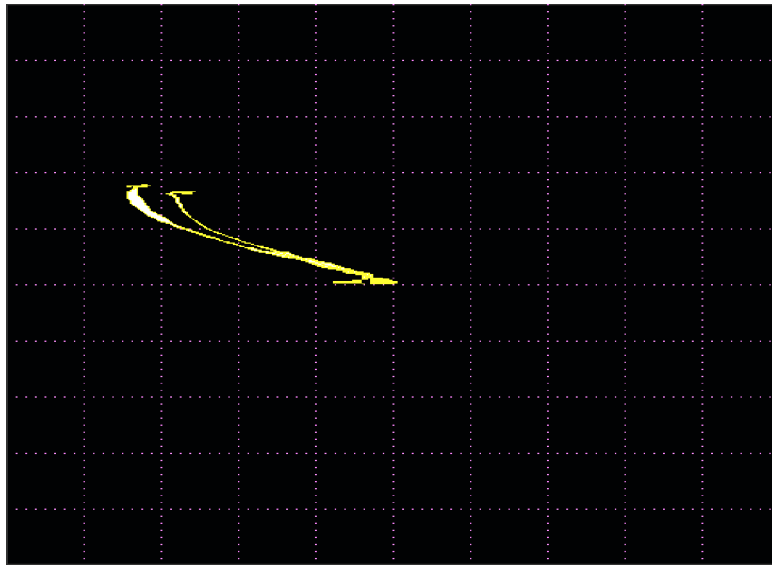
Following the control with the equipments above presented, was found out that there was an electrical conductivity difference between the rest of the axle and the stress relief area at the both ends of the wheel set, as results from the next diagram.

Aspect with conductivity difference on the stress relief area against the rest of the axle on the broken part.

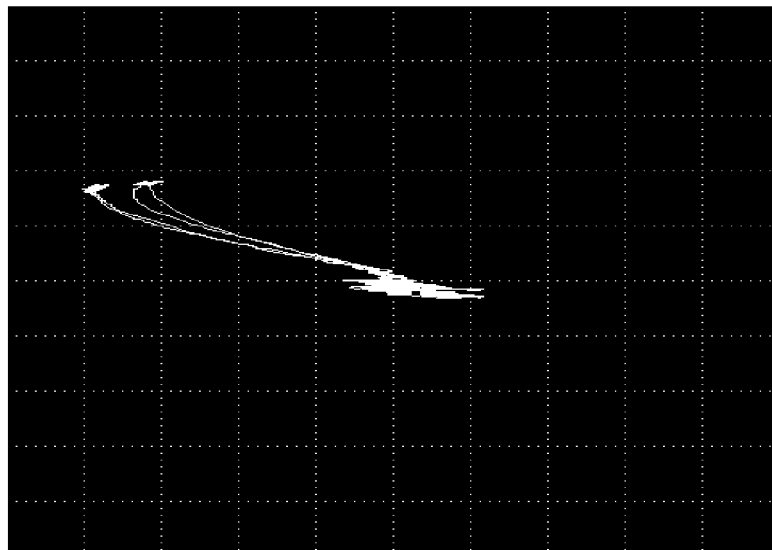
Aspect with conductivity difference on the stress relief against the rest of the axle on the non-broken part

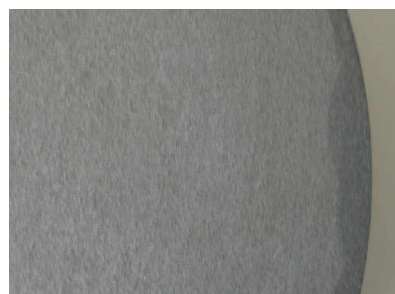
Picture 17

Characteristic type	Conclusions on the analysed characteristic	Picture	Conditions established by the UIC Leaflet 811/1-87 for the analysed characteristic
Macrographic and macroscopic analysis			
Baumann stamp	h Sulphur uniform ditribution on the cross section, without segregations. The image ranges among the limit images included in the enclosed album at the leaflet.	14	Point 6.2.2.4 – The image obtained has not to present failures more visible than those presented in the limit images included in the enclosed album at the leaflet
Macro aspect of the cross section after the heat attack in substance of 50% HCL	h Without macro-failures type flakes, material overlaps, segregations, macro-inclusions, cracks	15	Point 6.2.2.3 – After polishing, the examined surface has not to present any continuity solution
	One can notice a central porosity with points= 1	16	
	On the section outline one can see, detailed, a thermic influence area, without interruptions, of dark colour, on a breadth of about 4 mm	17

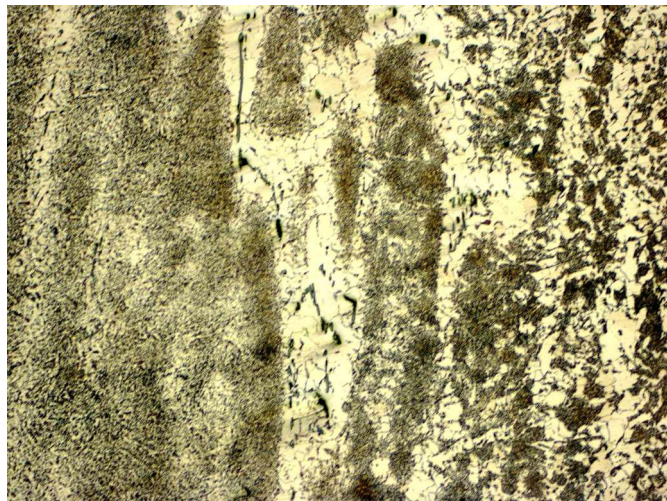
Picture 19 – (100:1), atac

Microscopic analysis			
Characteristic type	Conclusions on the analysed characteristic	Picture	Conditions established by the UIC Leaflet 811/1-87 for the analysed characteristic
The structure at the outside cylindrical surface	h On the outline of the section was found out , at micro level, column pearlite- ferrite constituents, structure specific to a melted material (A). On the edge deposited material (A) – basis material (B), one found out a contraction micro-crack of about 1,22 mm length.	18	Point 7.8.2.2 – Any welding, cutting/burning, heating, any re-building up by metallization, chemical or electrodepositions also any correction to hide a failures are strictly forbidden and lead to the whole lot refuse.
	h In the thermic influenced area, in the conditions of a ferrite structure, one pointed out the presence of some non-metallic inclusions series. Area (B) from the axle material has grain structure pearlite-ferrite fine recrystallised, being typical to a total recrystallization due to a thermo action.	19

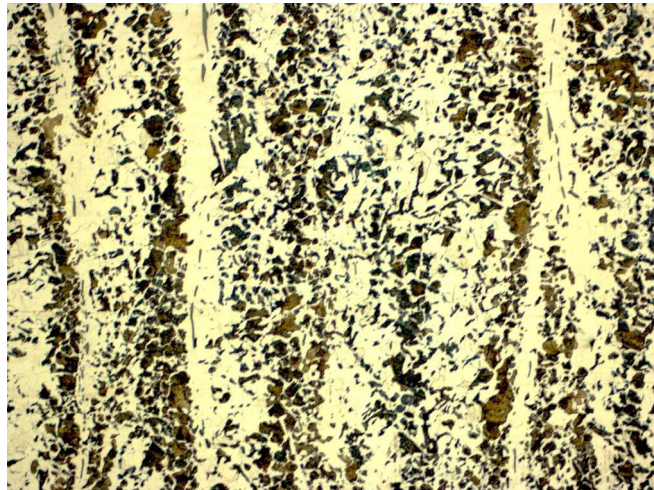
Picture 20 – (100:1), atac

The structure of the axle material in the central section	h The pearlite-ferrite structure as rows, specific to a heat plastic deformed steel and submitted to a normalizing thermo treatment. The size of the structural composition corresponds to the grain value 7-8, so under the stipulated value 5.	19C 20	Point 6.2.2.2 – The normalized, axles structure has to be uniform and specific to the ordered thermo treatment. The size of the pearlite grain determined according to the SR ISO 643 has not to be over the value 5.
