TECHNICAL REPORT

Extension of the investigations on the breaking surface and on the adjoining area of the breaking surface of the broken axle at the wheel 5 of the wagon no. 315354943062, from the freight train nr. 41651, belonging to Romanian Railway Freight Company "CFR Marfa " SA, involved in the railway incident from the 13th of March, 2008 in the Railway County Craiova area

BENEFICIARY: Romanian Railway Authority – AFER
AFER order no. 1080/870/14.04.2009

MAY 2009

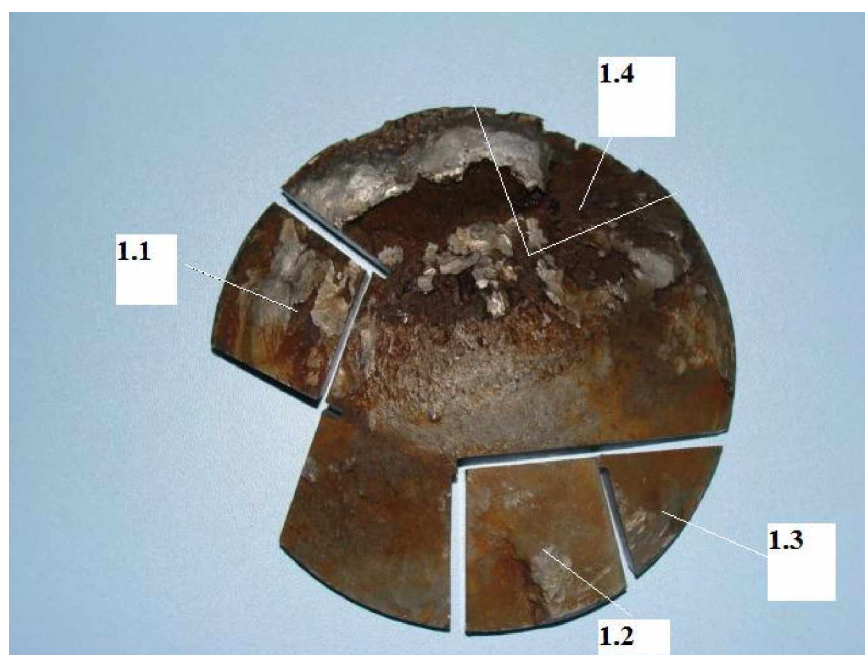
Fig. 1

In the picture no. 1 is presented the breaking surface of the axle journal, consisting in parts (samples), cuts from the axle journal section as disc, containing the breaking surface. At the performer (ECOMED) was cut only the sample 1.4 from the picture 1, the other sections from this disc was being cut by the customer before starting this investigation.

The aspect of the breaking surface is characteristic to a fatigue breaking process with multiple cracks. Deterioration both of the breaking surface and of the edge of the breaking surface (axle journal exterior) that happened either during the railway event or in the process of drawing and keeping of the samples does not allow to identifying clearly the breaking cracks.

The surface aspect suggests the beginning of the breaking process (and so at least 2 cracks) first from the area A (very deteriorated) and then from the area B.

The two breaking processes met in the threshold C that limits them, by the level differences. To the area D, the breaking surface becomes more undulated, this suggesting an increase of the breaking spreading speed up to the area D, where happened the final breaking, with material plucking.

The sample 1.2 contains a part of the initial breaking (area B). The radial spreading (as lens) of the breaking in the area B looks central on the point E of the sample 1.2.

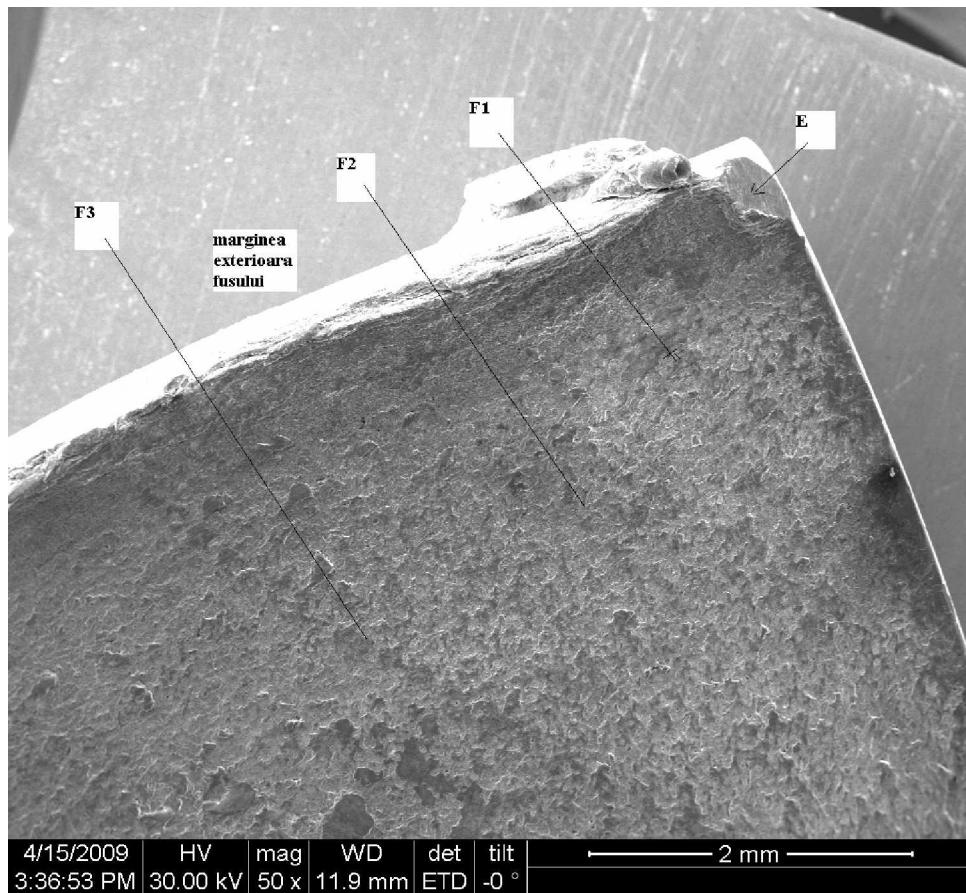
Fig. 2

The image of the electronic scan microscopy (picture 2) has a part of the area B of the breaking starting. In the point E (maybe one of the cracks) the visible mechanical deterioration does not permit to identify the crack. One can see the existence of the fronts F1, F2, F3 of the breaking spreading speed change, specific to a fatigue breaking. In the picture no. 2, the edge corresponding to the axle journal outer surface is distorted from the mechanical point of view, in a deep of about 0,3 – 0,4 mm (maybe after the axle journal breaking), having cracks and also material detachments to the inside of the breaking surface.

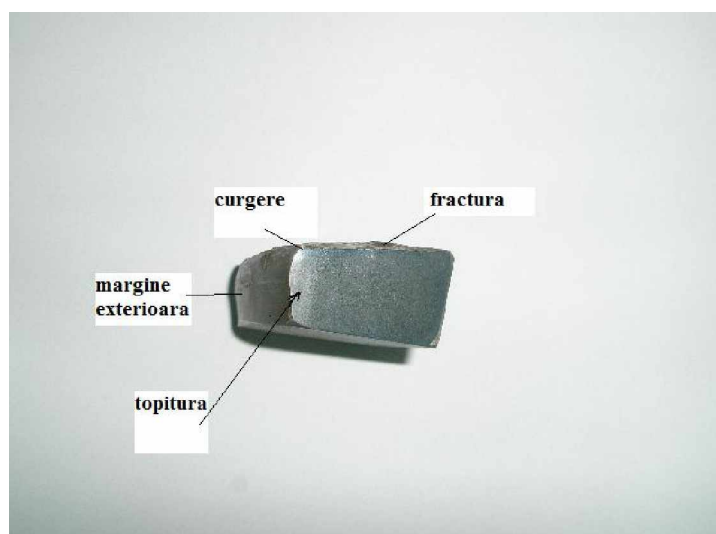
Picture 3 Sample 1.1

During the visual inspection of the disc outer surface (cut from the axle journal) that contains the breaking surface was identified a change of its thickness. This is observed (picture 3) in the cross section of the sample 1.1 (see picture 1) from the final breaking area, section made at the performer in order to watch the micro-structure in the breaking surface area and to characterize the micro-area that contains this dimensional change of the axle journal diameter.

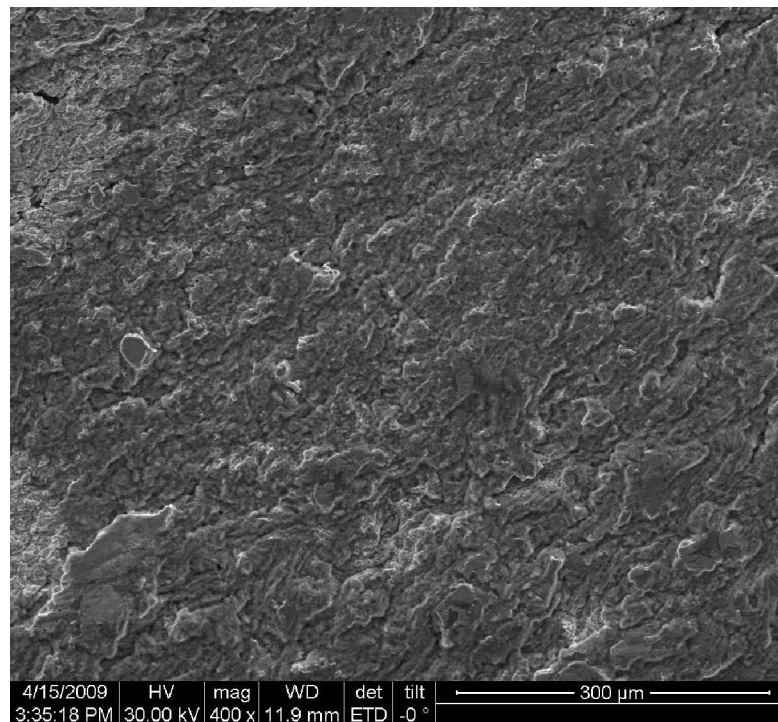
4.2.1 One also tried to characterize from the microscopic point of view the breaking surface. So, in the picture 4, at an increased zoom (x400) is shown that the breaking surface (images from the crack area) is covered by a continuous thick bed of oxides with micro-cracks in the bed. This bed is clearly resulted following the corrosion of the breaking surface after the event.

Picture.4 The beginning of breaking area – oxide bed (x 400)

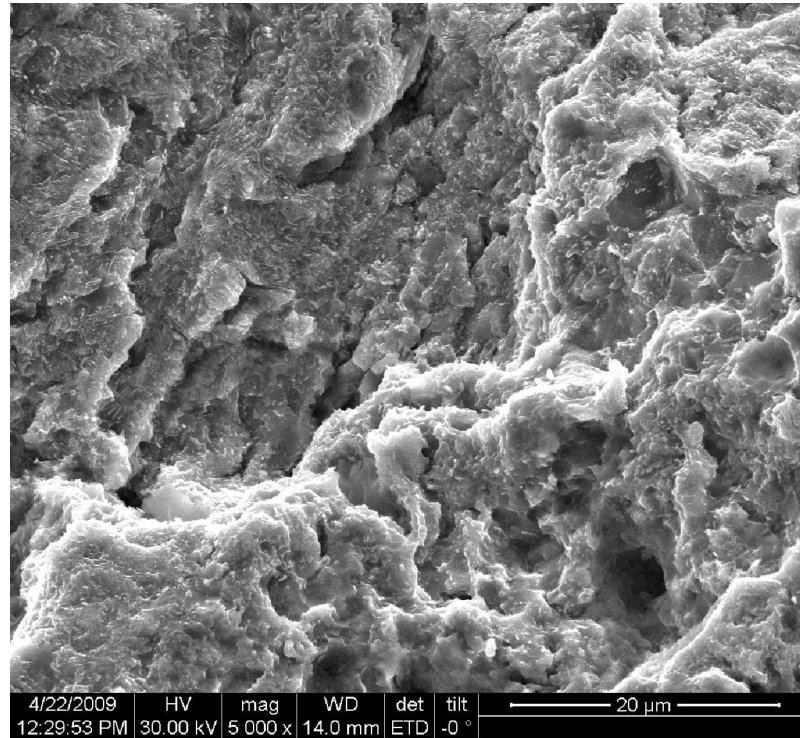
In order to observe the micro-structural details of the breaking surface one try to remove carefully the oxide bed by replies method. One noticed (picture 5) at a higher zoom (x5000) that, practical, the breaking surface is very corroded (existence of the corrosion pitting (small holes) and even the continuous corrosion of the limits of ferrite-pearlite grains). It is the reason for which one could not obtain micro-structural details of the breaking surface.

Picture.5 Microstructure of the breaking surface after replies pull up – surface very corroded (x 5000)

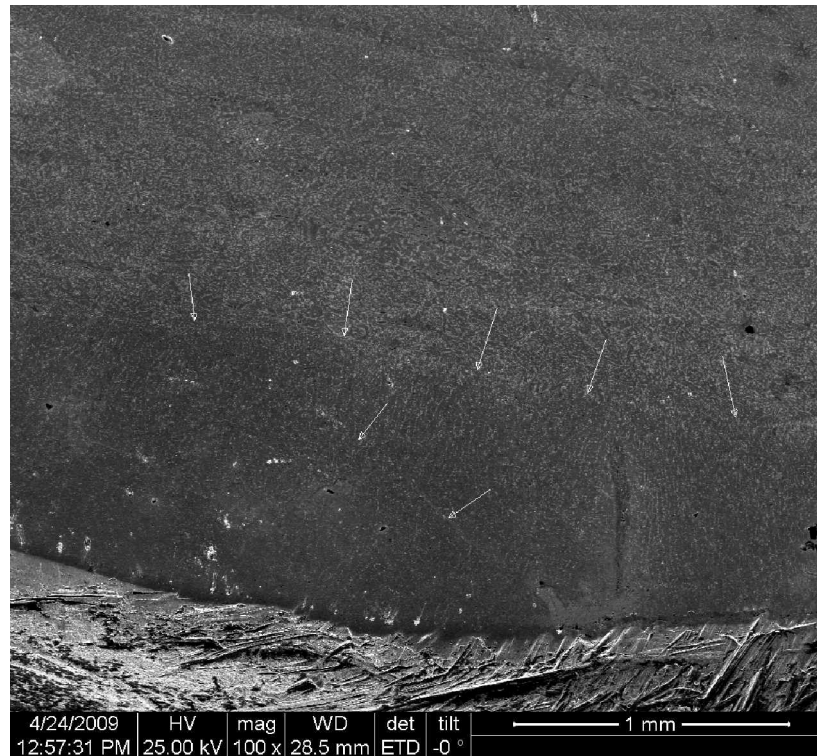
In the picture 3 is observed this micro zone (sample 1.1). In the next images (picture 6) is observed micro-structural details of this micro zone. The edge zone (corresponding to the narrower zone of this section) has micro structural aspects characteristic to an area of local molten material, with the increase direction of the pearlite-ferrite grains perpendicular on the longitudinal axis of the axle. One observes solidification fronts, existence of micro-cracks in the material of this zone.

Picture 6a Edge zone putting in evidence the molten material. The arrows show the starting lines of the solidification fronts (x100)

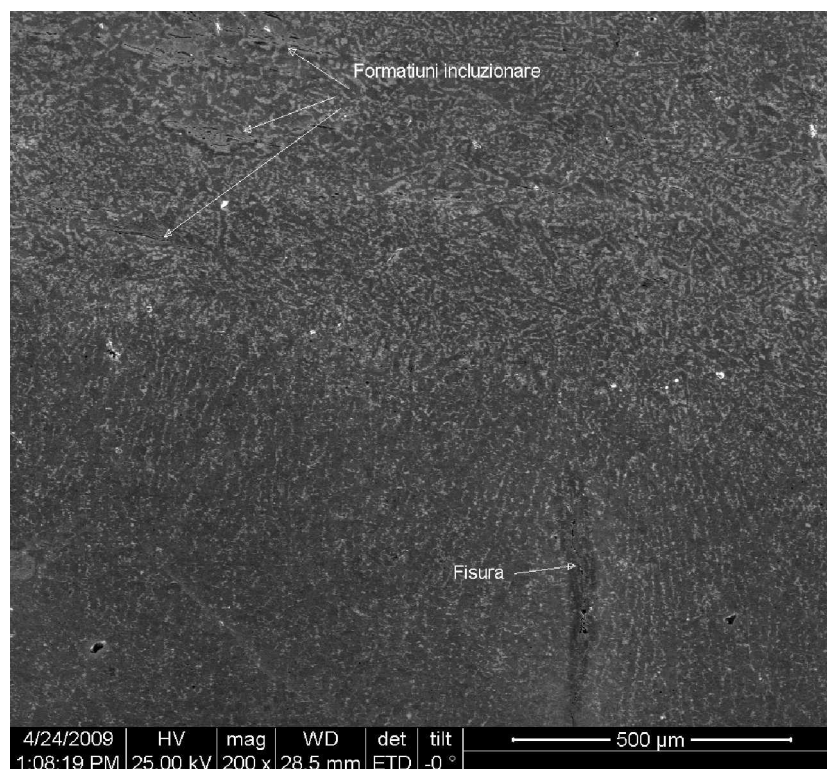
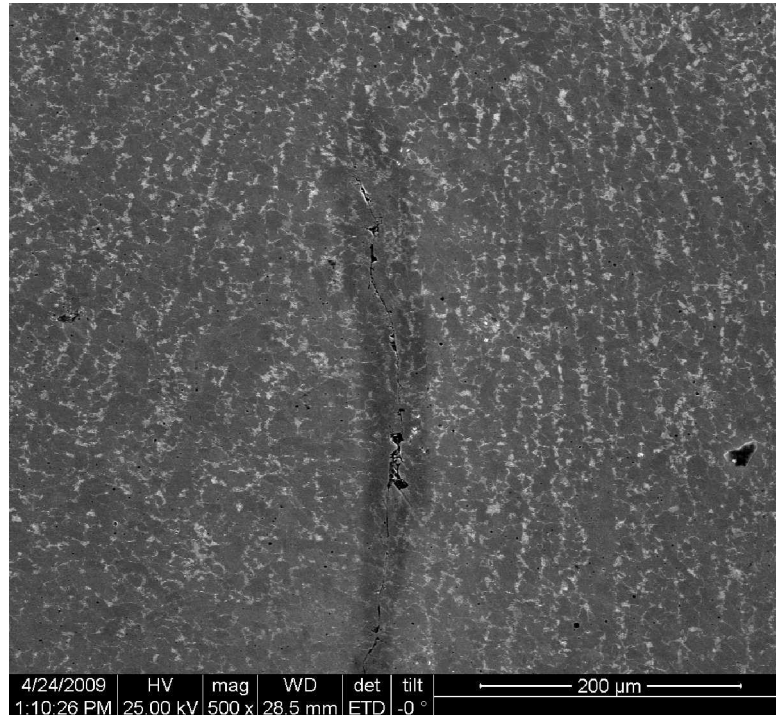
Picture 6 b, c Details from the picture 1. The parallel crack with the temperature gradient at the solidification (x200). One can notice the oriented character of the solidified material structure.

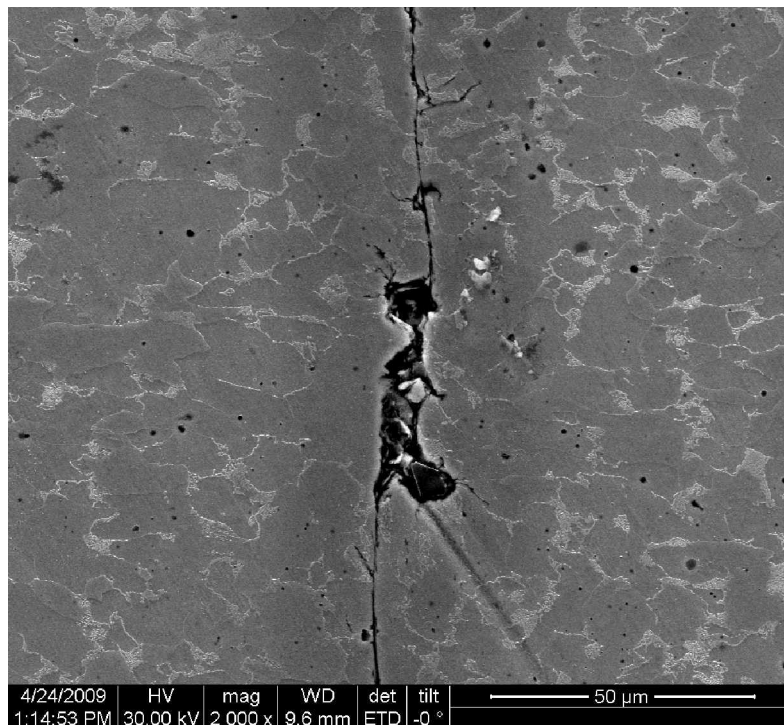
Picture 6d Higher order of zoom putting in evidence the crack intra-granular spreading(x2000).

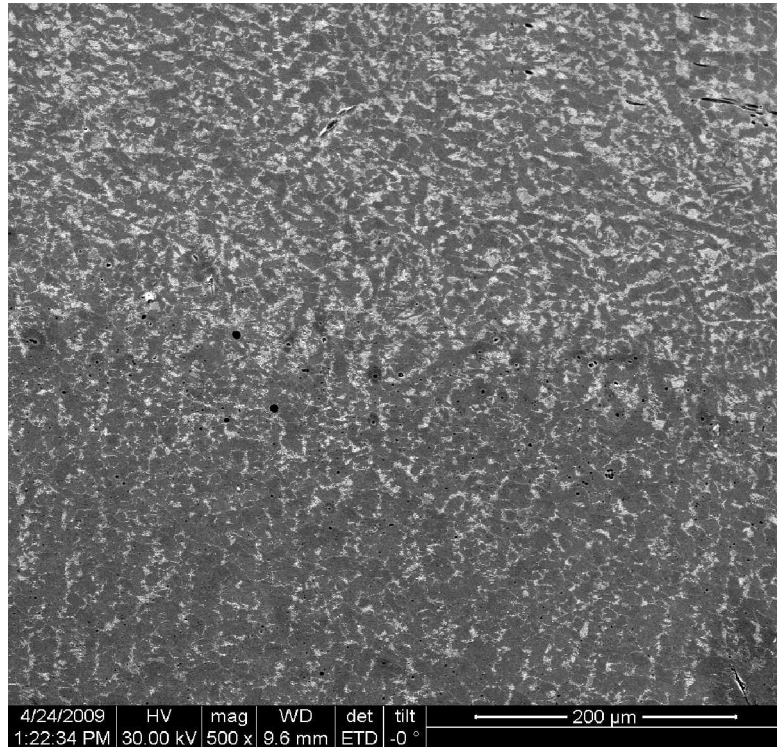
Picture 6e The picture got on the passing point from the basis material to that molten (x500). One can notice the direction difference of the structural formations and more reduce pearlite part in the molten zone (due to the carbon loss). One can also notice pores and micro-inclusions at the interface between these two material volumes.

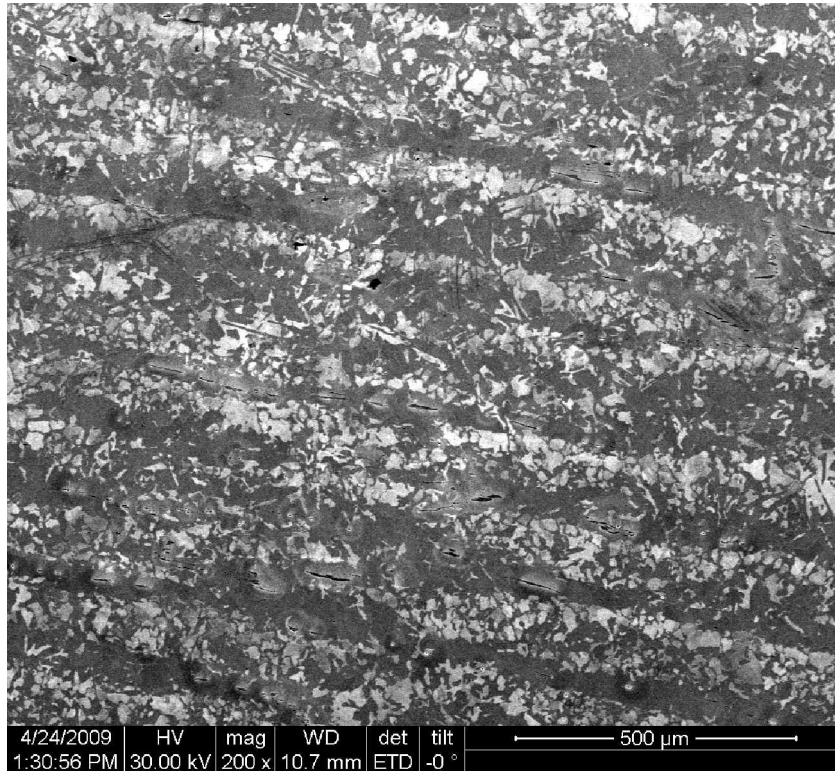
In the images 7a and b is presented the micro-structure of the basis material of the axle journal – micro-structure disposed on tapes, areas with a lot of pearlite that alternate with those ferrite. One also can notice plastic inclusions of long MnS on the distortion direction.

Picture 7a The micro-structure of the axle journal basis material (x200). Oriented structure, in tapes, with areas with a lot of pearlite alternating with that ferrite. One can notice the presence of plastic inclusions especially in the areas with ferrite.

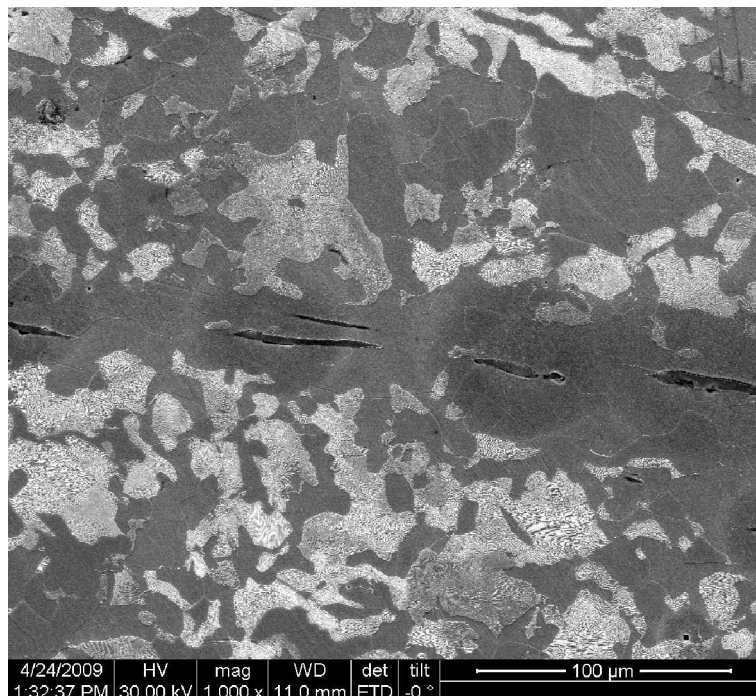
Picture 7b. Detail from the image of the picture 7a. Plastic inclusions placed on the distortion direction (x1000)

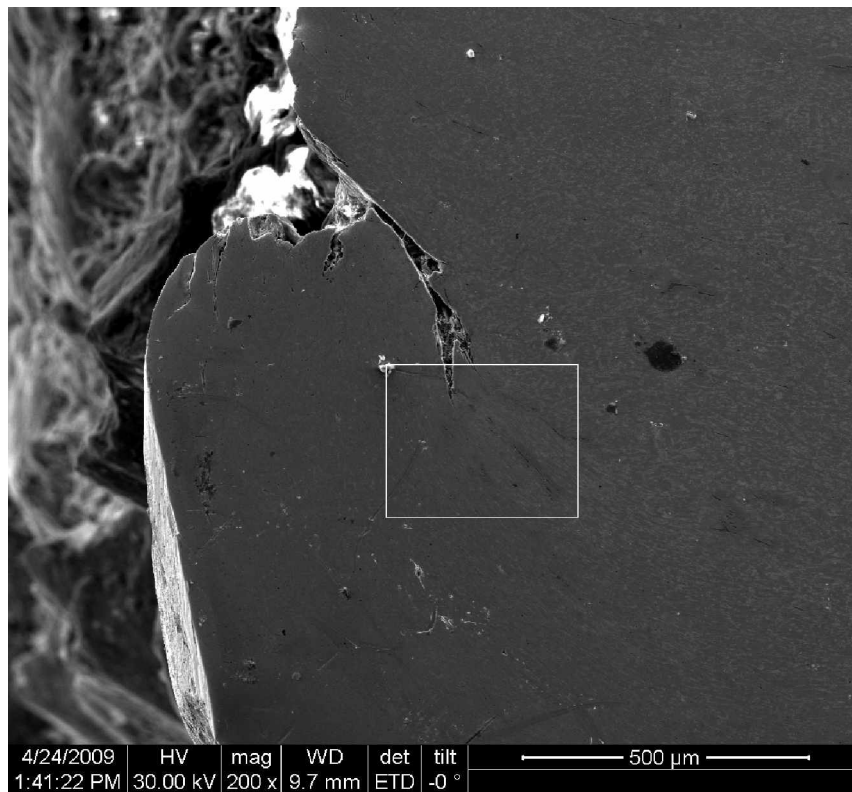
In the thicker zone, one notices a material folding (on the outer surface of the axle journal) to the breaking surface (picture 8a). The images of electronic scan microscopy from the pictures 8b and c put clearly in evidence, long micro-structure (flow) to the breaking surface.

Picture 8a Material „folding”, observed near the breaking surface (x200)

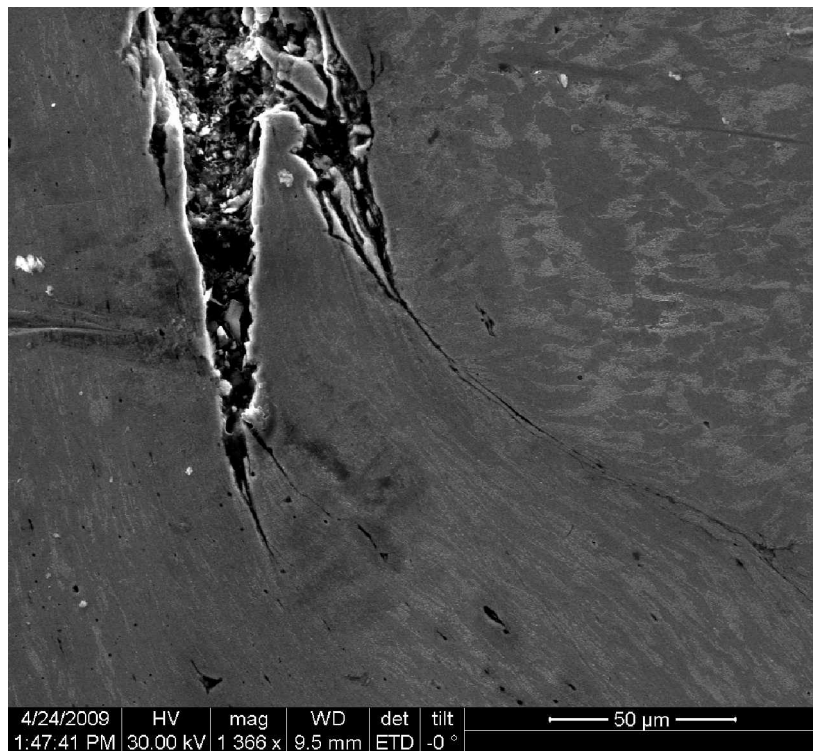
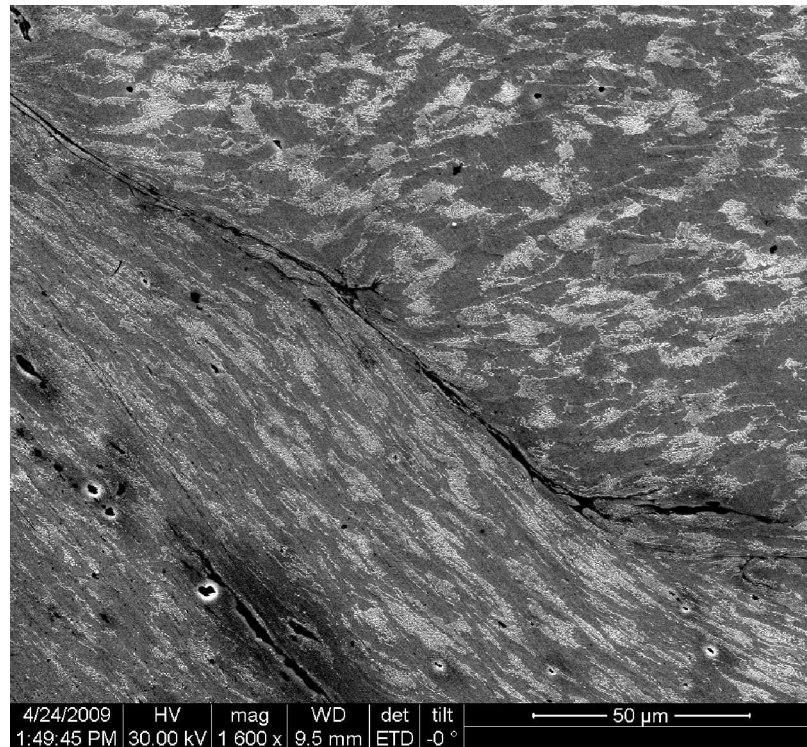
Picture 8 b and c. Details from the picture 8a. The material volumes, with different flow directions (x1366; x1600)

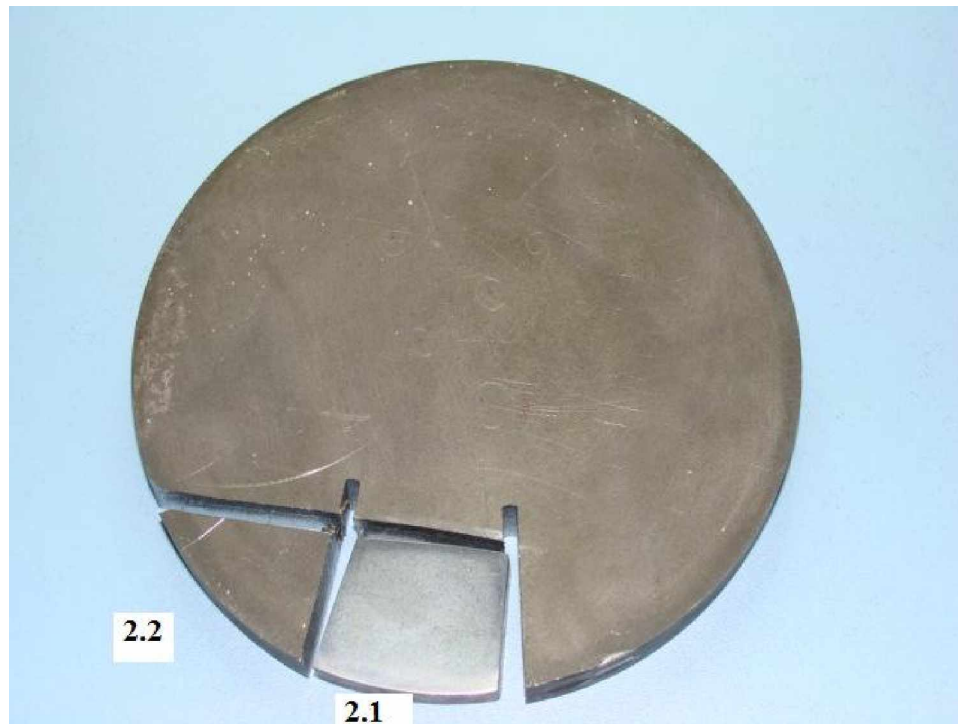
The picture 9 presents a disc cut (by the customer) cross from the axle journal close to the breaking surface.

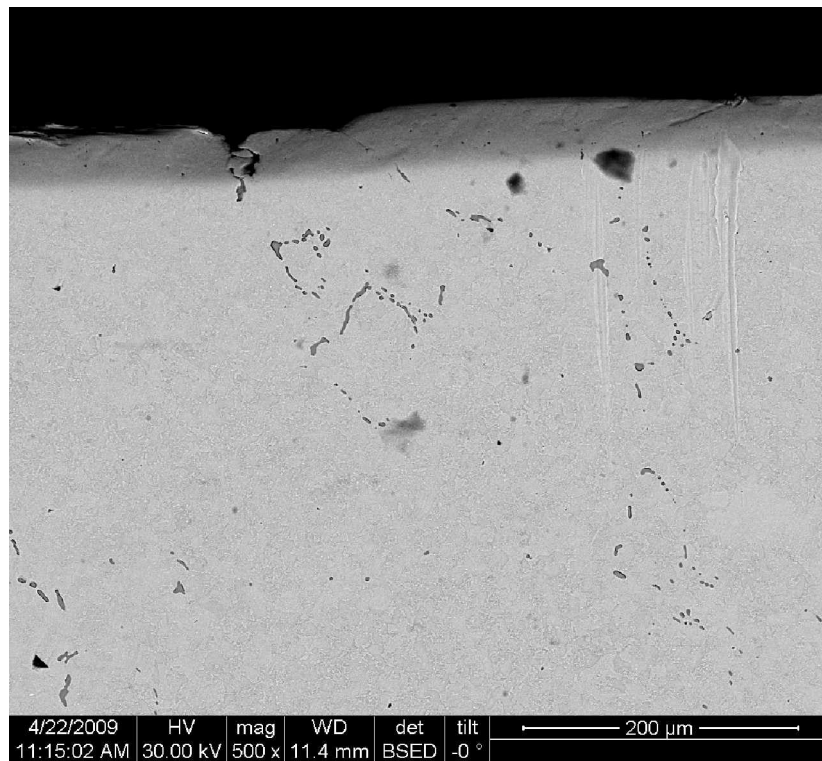
The images from the picture 10 (from a to d), images with secondary electrons retro-scattered, present the micro-structure of the material got on the sample 2.1. One can notice, against the pearlite / ferrite micro-structure, existence of inclusions MnS, irregularly distributed in the material. Unfavourable for its mechanical characteristics, these inclusions are generally grouped in discontinuous networks. One can also notice the existence of MnS inclusions rows that appear on the axle journal surface. Such edge inclusions can be tendencies to fracture of the respective marks in force, the inclusions rows that are come out from the surface are preferential areas for the spreading and development of the micro/cracks.

Picture 10a The axle journal micro-structure (image with retro-spread electrons) – cross-sections on the axle journal (x500). MnS inclusions both insulated and in discontinuous networks; MnS inclusions rows that are coming out in the exterior edge of the axle journal.

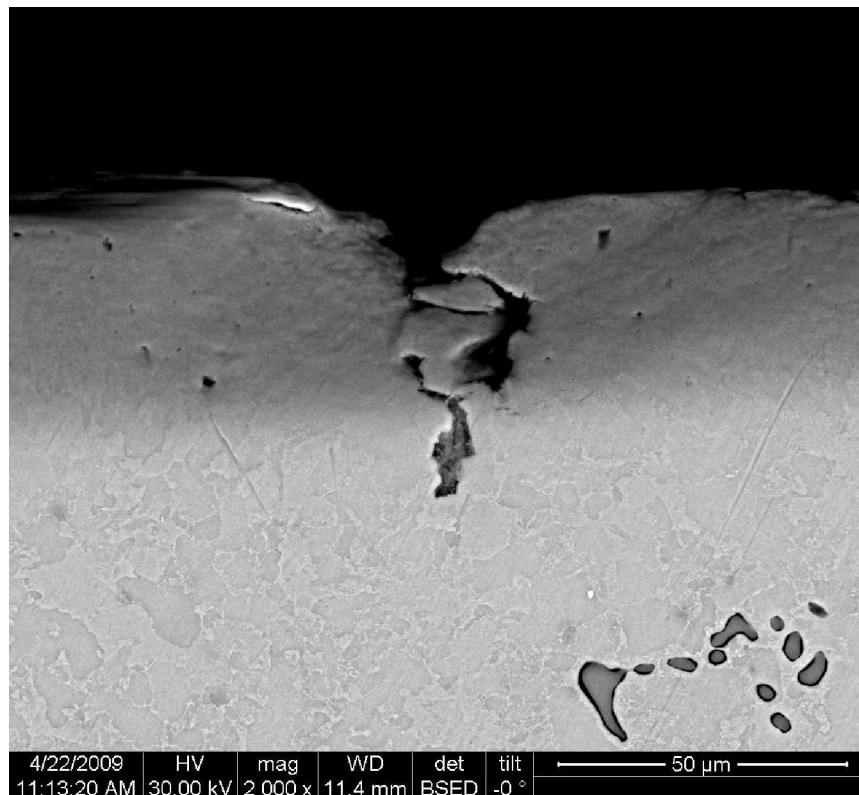
Picture 10b Detail in the picture 10a (x2000) – corrosion at the cracked edge on inclusions row

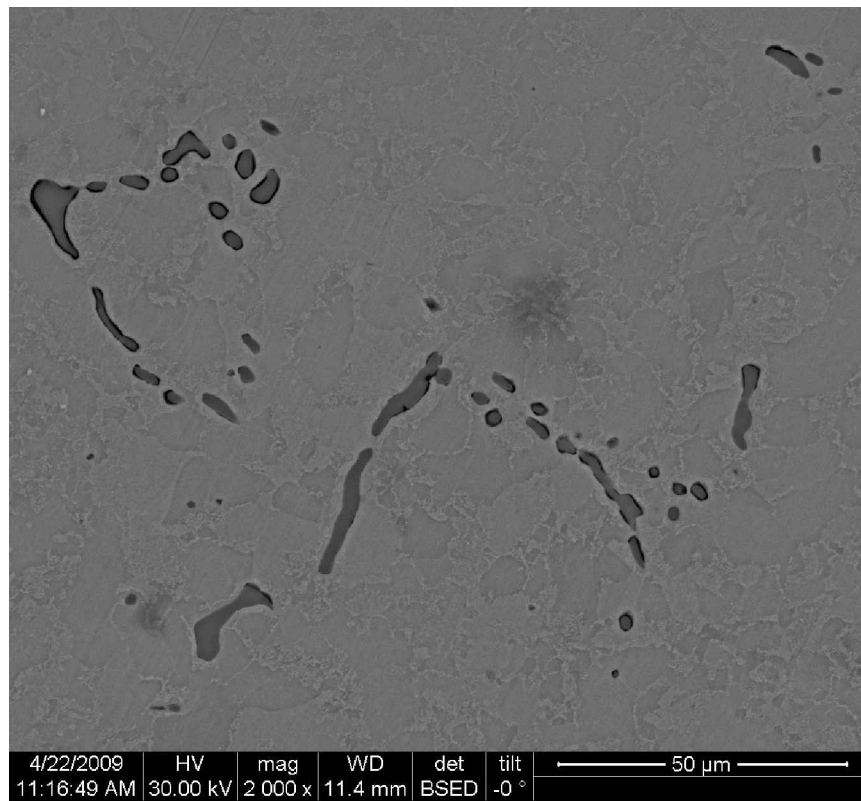
Picture 10c Detail in the picture 10a – discontinuous network of MnS inclusions (x2000)

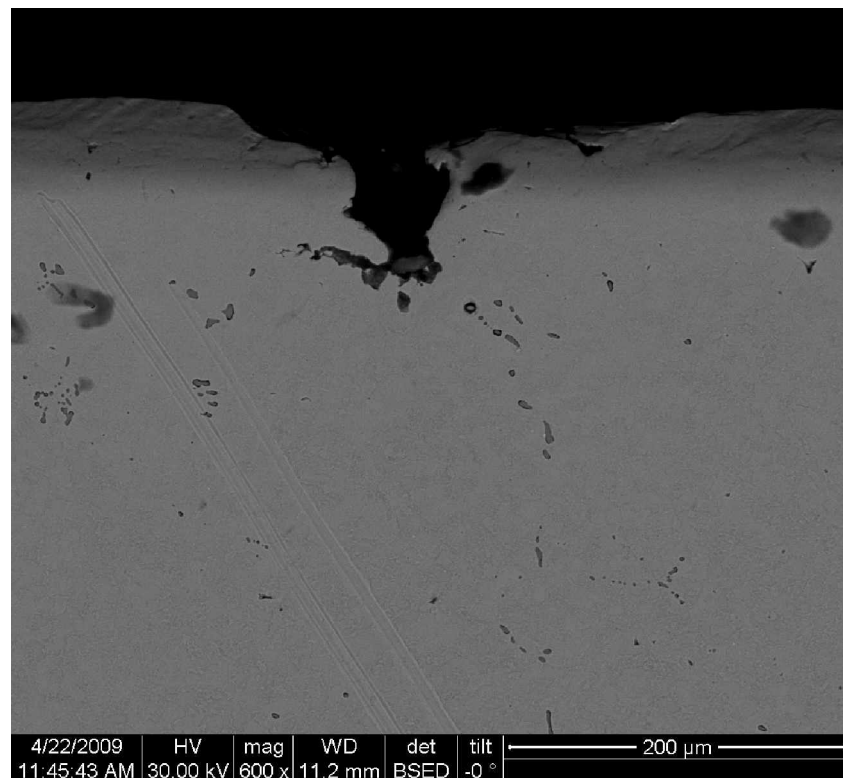
Picture 10d Aspect of other edge micro-zone with the initial corrosion on inclusions row (x600)

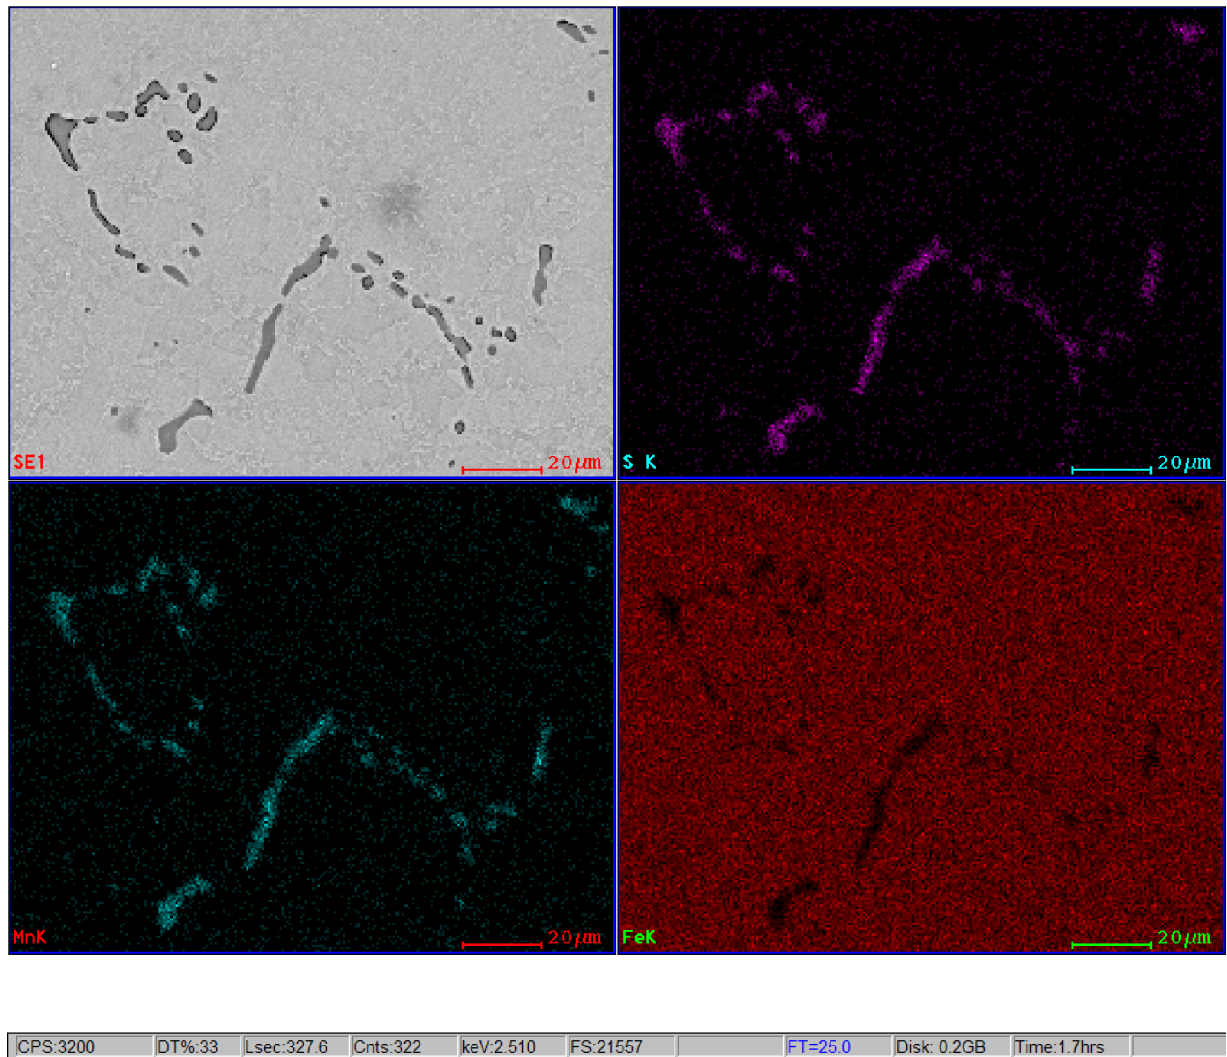
So in the picture 11 is presented the distribution of the elements Mn, S and Fe in the micro-zone put in evidence in the up right corner of the picture. One can notice the main presence of the elements Mn and S in the long inclusions (manganese sulphide).

Picture 11 – Distribution of the elements Mn, S and Fe in the zone put in evidence in the up left corner

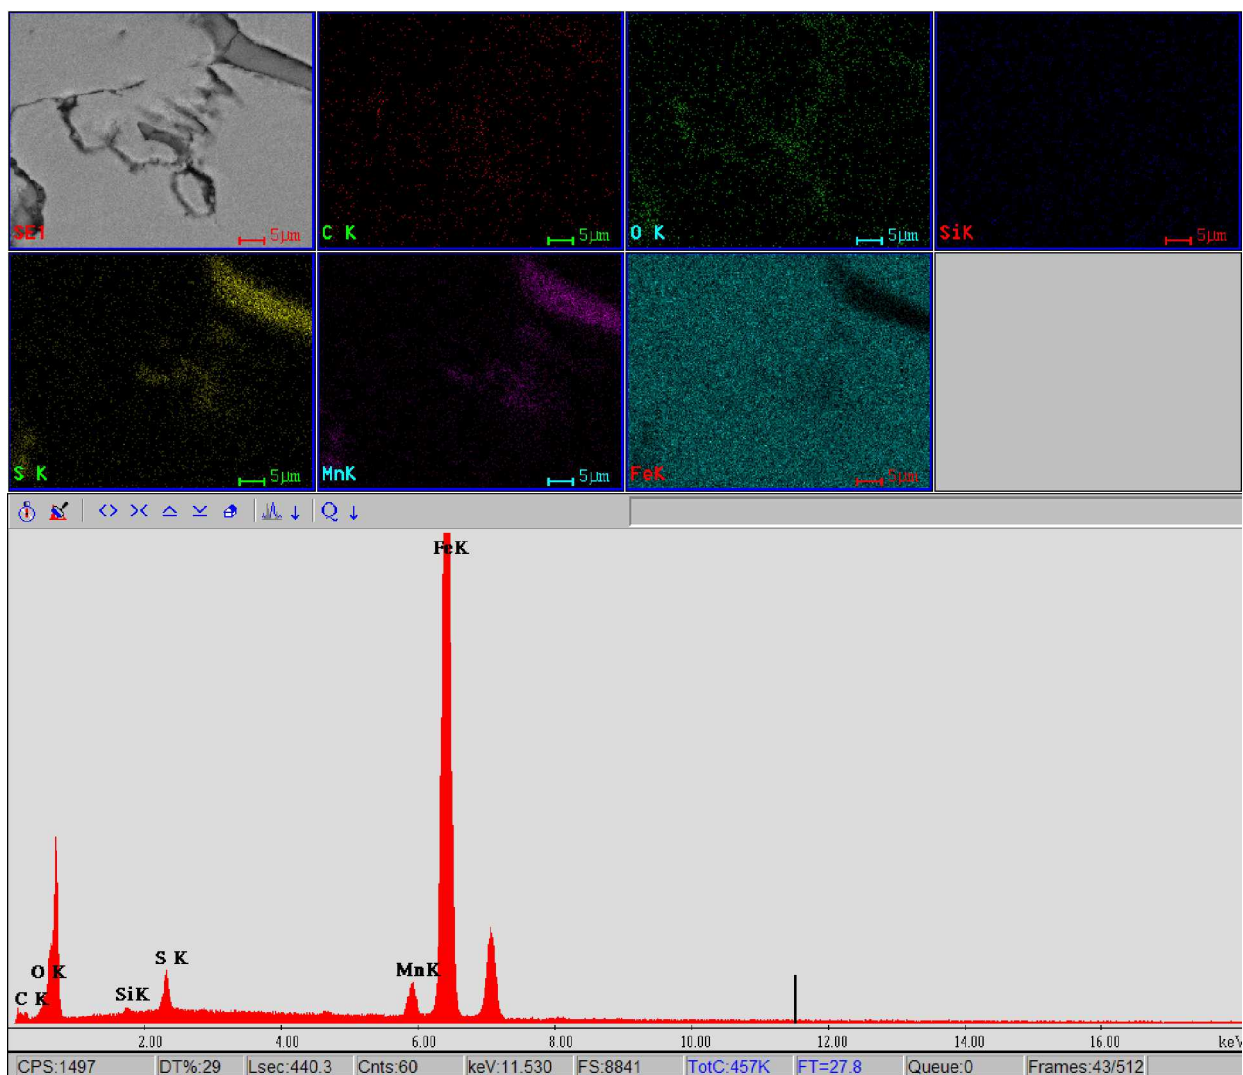
Favouring of the micro-cracks development by the MnS inclusions networks rows is proved by the images from the picture 12.

Picture 12 Distribution of the elements put in evidence by the dispersive X-ray spectrum in energy in the micro-area of the up left corner. The micro-area is adjoining the breaking surface and corresponds to the sample 1.4
