**MINISTRY OF TRANSPORTS AND  
INFRASTRUCTURE  
ROMANIAN RAILWAY AUTHORITY – AFER  
ROMANIAN RAILWAY INVESTIGATING BODY**

## **INVESTIGATING REPORT**

**Of the railway incident occurred on March 13, 2008**

**Final edition  
May 18, 2009**

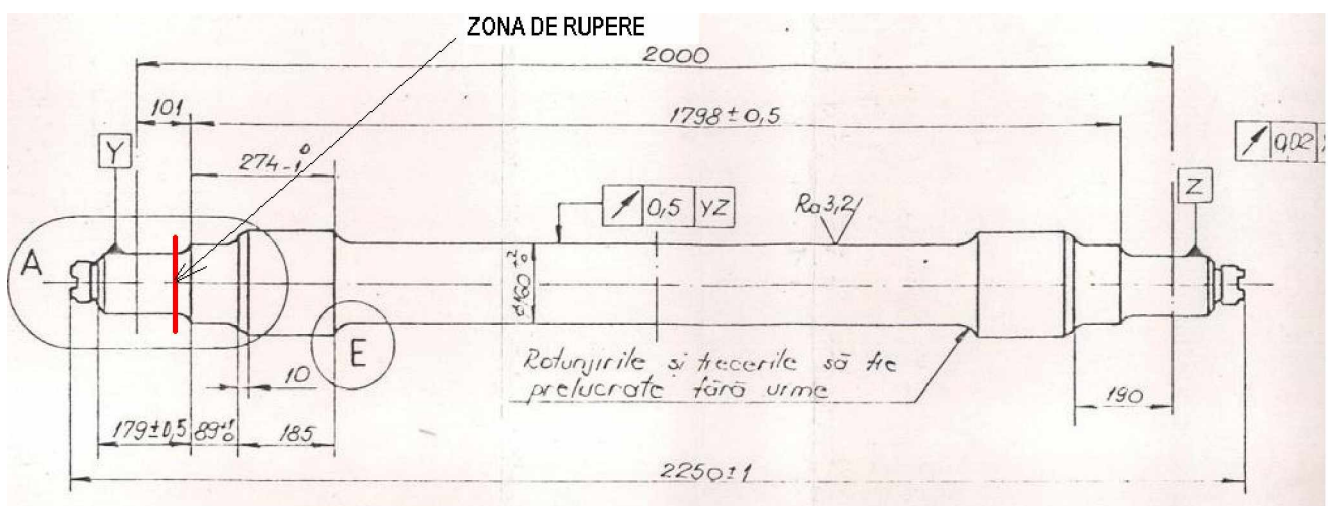
The axle having the registration number in the engine stock of CFR 3836632 (no.14) is a part of the charge 311561 manufactured by SC SMR SA Bals, axle type AI. The axle breaking occurred into an area located at a distance of 217-219 mm from the axle extremity, perpendicular on its longitudinal bar , on connecting the assembling part of the bearing WJ and the shutter.

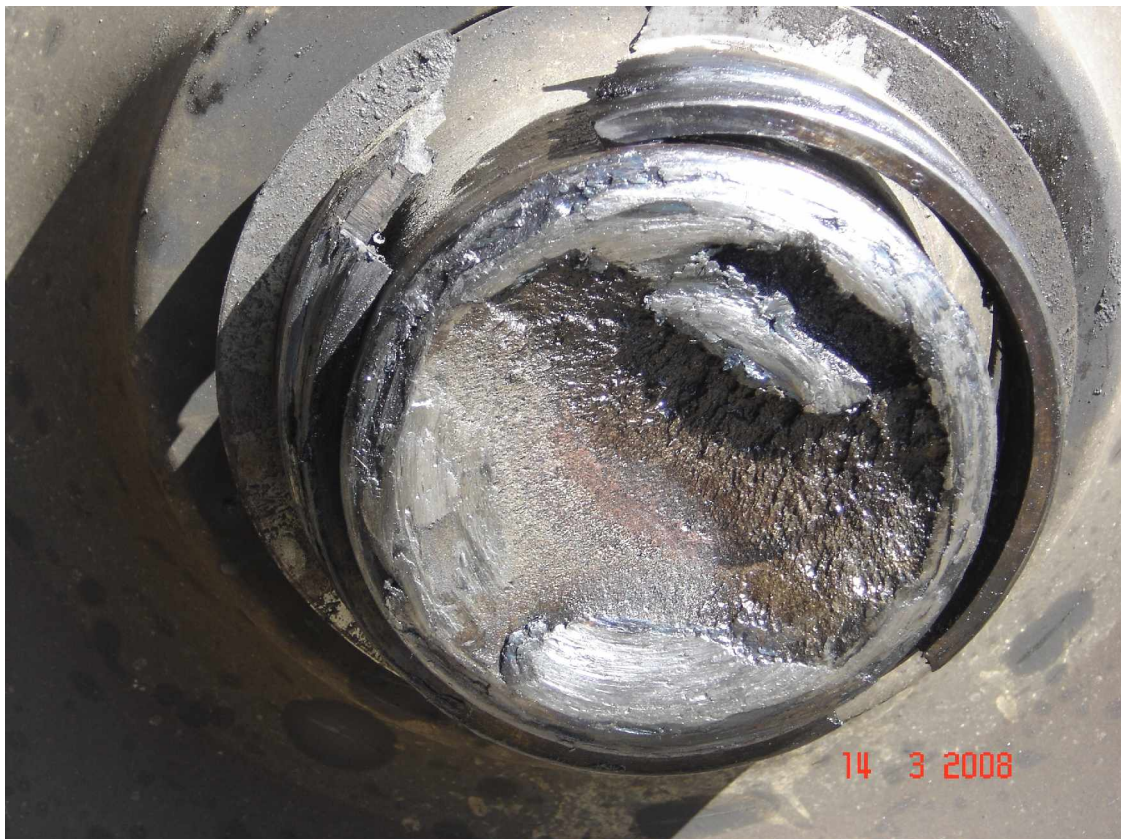
The axle breaking occurred in an area located at a distance of 217-219 mm from the axle extremity, perpendicular on its longitudinal bar, on connecting the assembling part of the bearing WJ and the shutter.

The direct cause of the railway event occurrence is the breaking of the wheel set no. 3836632 from the wagon no. 31535494306-2 in the area of the stress relief clearing between the axle journal and shutter as result of the decrease of the material fatigue strength against the development of micro cracks in the areas with high density of the networks with manganese sulphide (MnS).

1. Withdrawal from circulation of all axles from the charge no.311561 produced by SC SMR SA Bals, from which the axle no.3836632 was a part, for the non-compliance of the conditions established by the UIC leaflet 811-1/87 - Chemical composition, mechanical tests, Axles axis and the rejection of the respective charge.  
SNTFM „CFR Marfa” SA, other railway undertakings and also owners of wagons equipped with axles from the charge no.311561 will perform investigating actions and will comply with the present recommendation.
