## Safety Investigation Report

Collision of an SNCB/NMBS passenger train with a railway crane  
Melsele - 15 October 2016

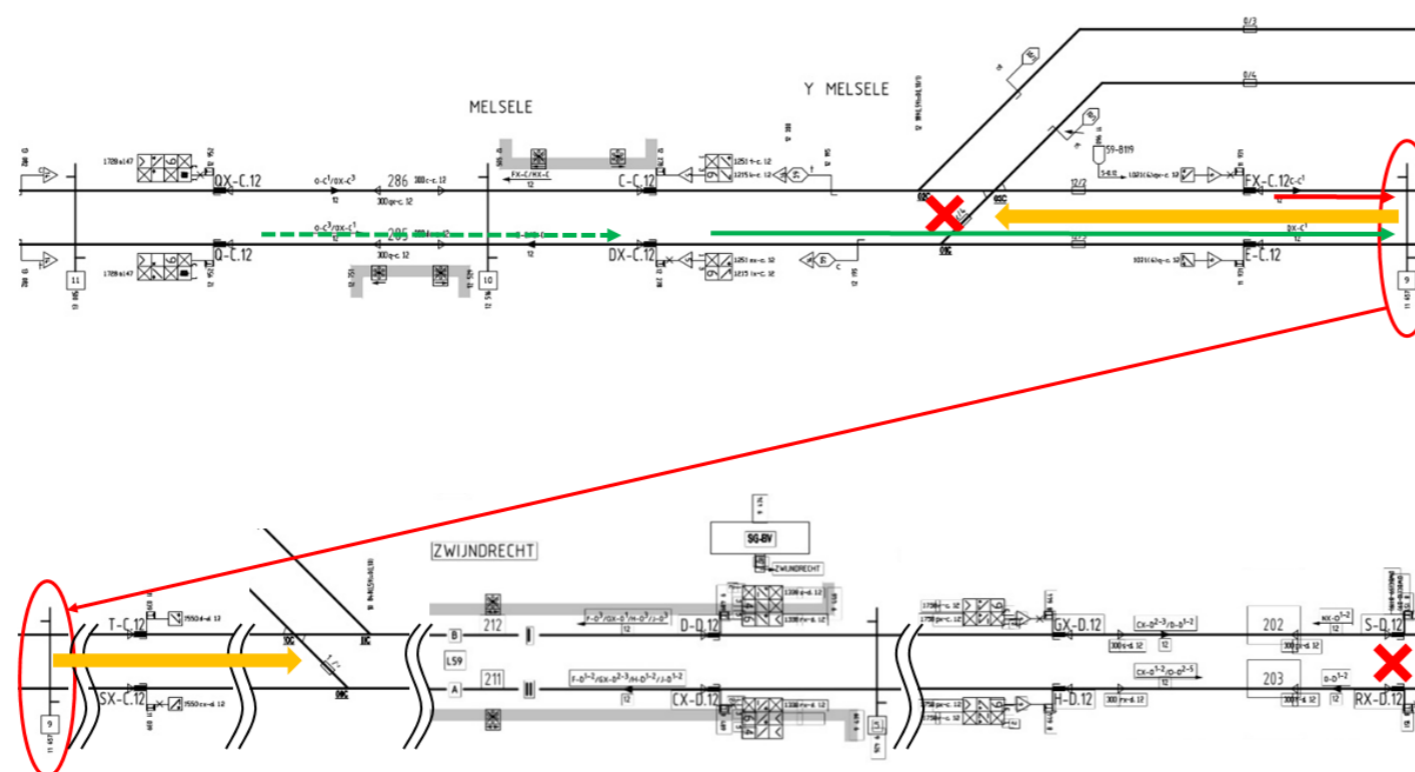
Diagram: Schematic signalling plan – SSP

Around 07:20, while the team was finishing the works, train E727 was approaching the work zone and stopped at the foot of the closed signal DX-C.12 (see diagram below). The train was held up there until 07:24.

- zone of the works;
- X demarcations "total line interruption";
- route taken by the train (solid line from the opening of signal DX-C.12);
- route taken by the railway crane just before the accident.

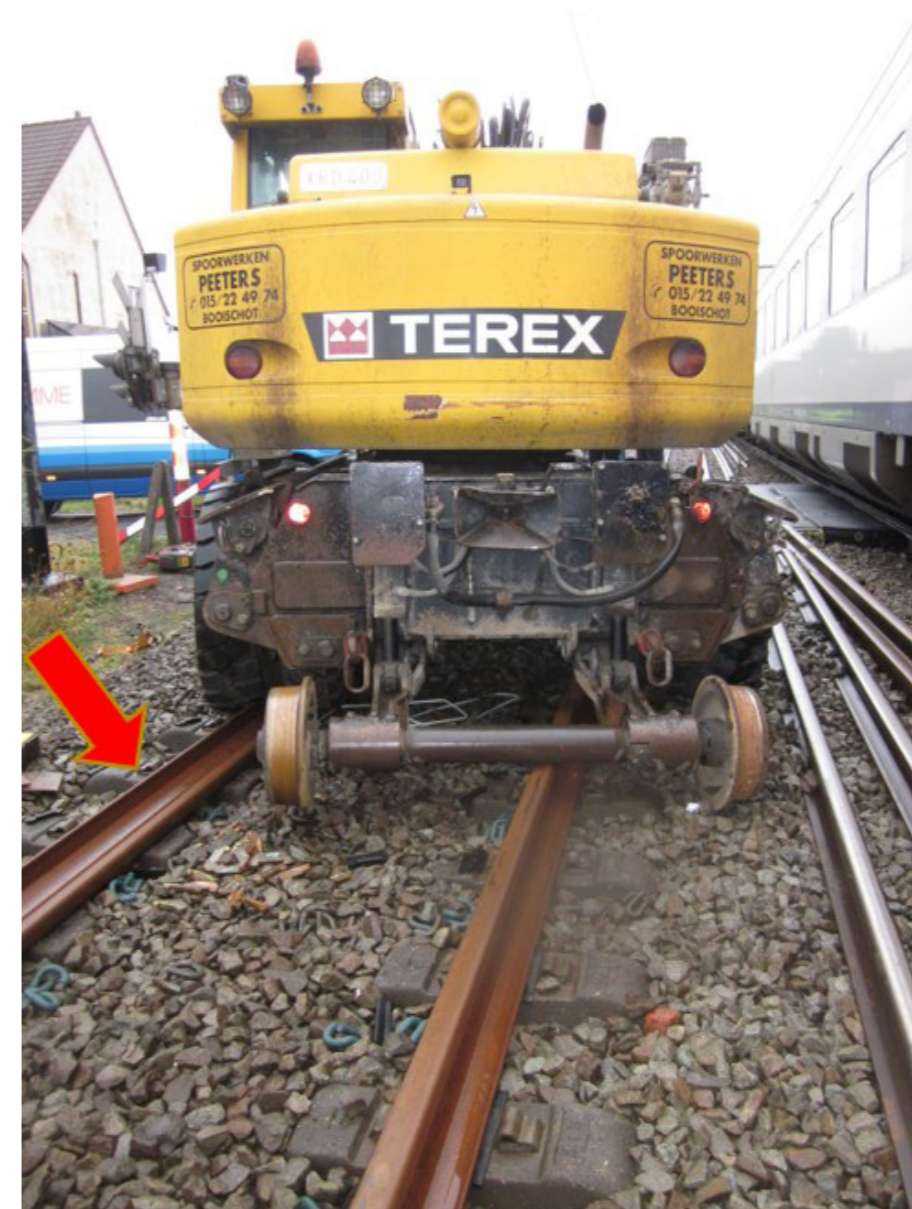
The shock from the train pushed the railway crane forward and derailed it. This caused a rail that had not yet been secured to topple. The foot of the labourer standing just in front of the railway crane became trapped and the labourer suffered serious wounds, with lasting injury. The work equipment in the grapple was flung away and damaged the private car of a local resident.

The **direct cause** of the accident was the intrusion of the crane jib into the adjacent track's loading gauge and the train's ability to enter this zone without an effective safety method being activated.

Position of the railway crane after the accident.

**The infrastructure manager should ensure that there is an active safety method in place at all times when works are being carried out.**
