# Summary of Security Investigation Report

## DERAILMENT OF A FREIGHT TRAIN WETTEREN - 4 MAY 2013

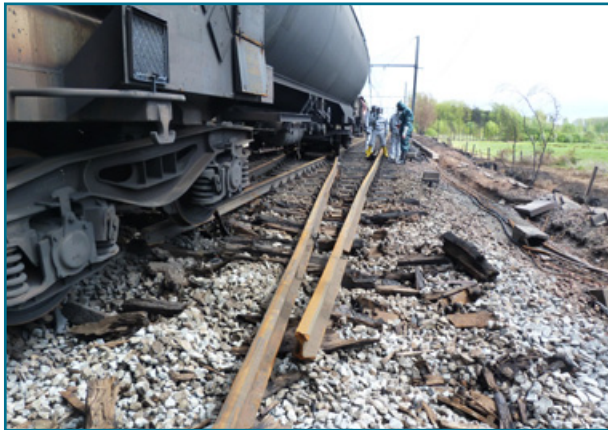
According to our scenario, the direct cause of derailment is the toppling of the first three wagons when they passed over the switches. The toppling of the wagons was made possible by the combination of the following factors:

- a non-adapted speed;
- two successive small curves of switches, radius  $\pm 215\text{m}$ , in a S-shape and designed for a maximum speed of 40km/h when placed in deviating position;
- the high centre of gravity of the fully (correctly) loaded wagons;
- the initiated emergency brake.

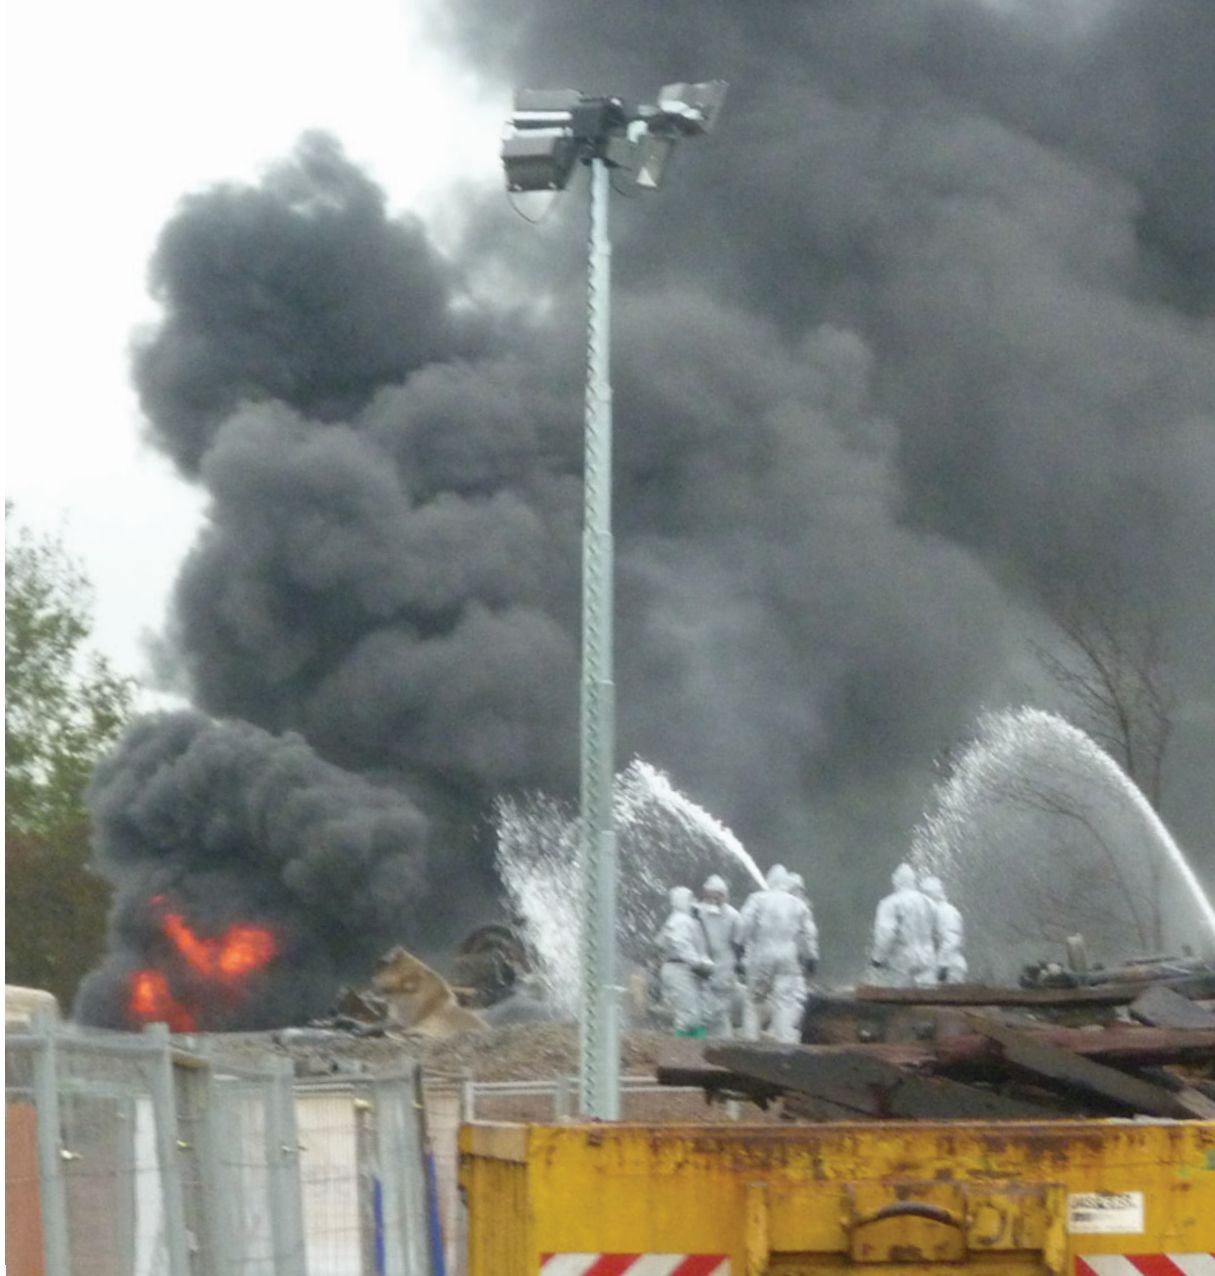
They decided to let the substances burn themselves out in a controlled way and to spray the tank wagons with water to cool them down in order to avoid explosions. The generous use of extinguishing and cooling water fills the ditch with a mixture of water and toxic products. Very quickly the ditch threatens to flood, and the decision is taken to pump the content of the ditch into the pumping station. According to our information, the submersible pump from the pumping station switches automatically on when the liquid level reaches a certain level and pumps the contaminated liquid via the separated rainwater drainage system into the river Schelde. The sewers are filled with toxic gases, that come up through the manholes. It became clear that the initial safety perimeter did not take in account the release of toxic gases via the sewers. It was then decided to enlarge the safety perimeter.

One person was found deceased in his home: the judicial enquiry is still ongoing to determine the exact cause of decease.
