Rail Accident Investigation Branch

Rail Accident Report

Report on the runaway manually propelled trolley between Larkhall and Barncluith Tunnel 2 November 2005

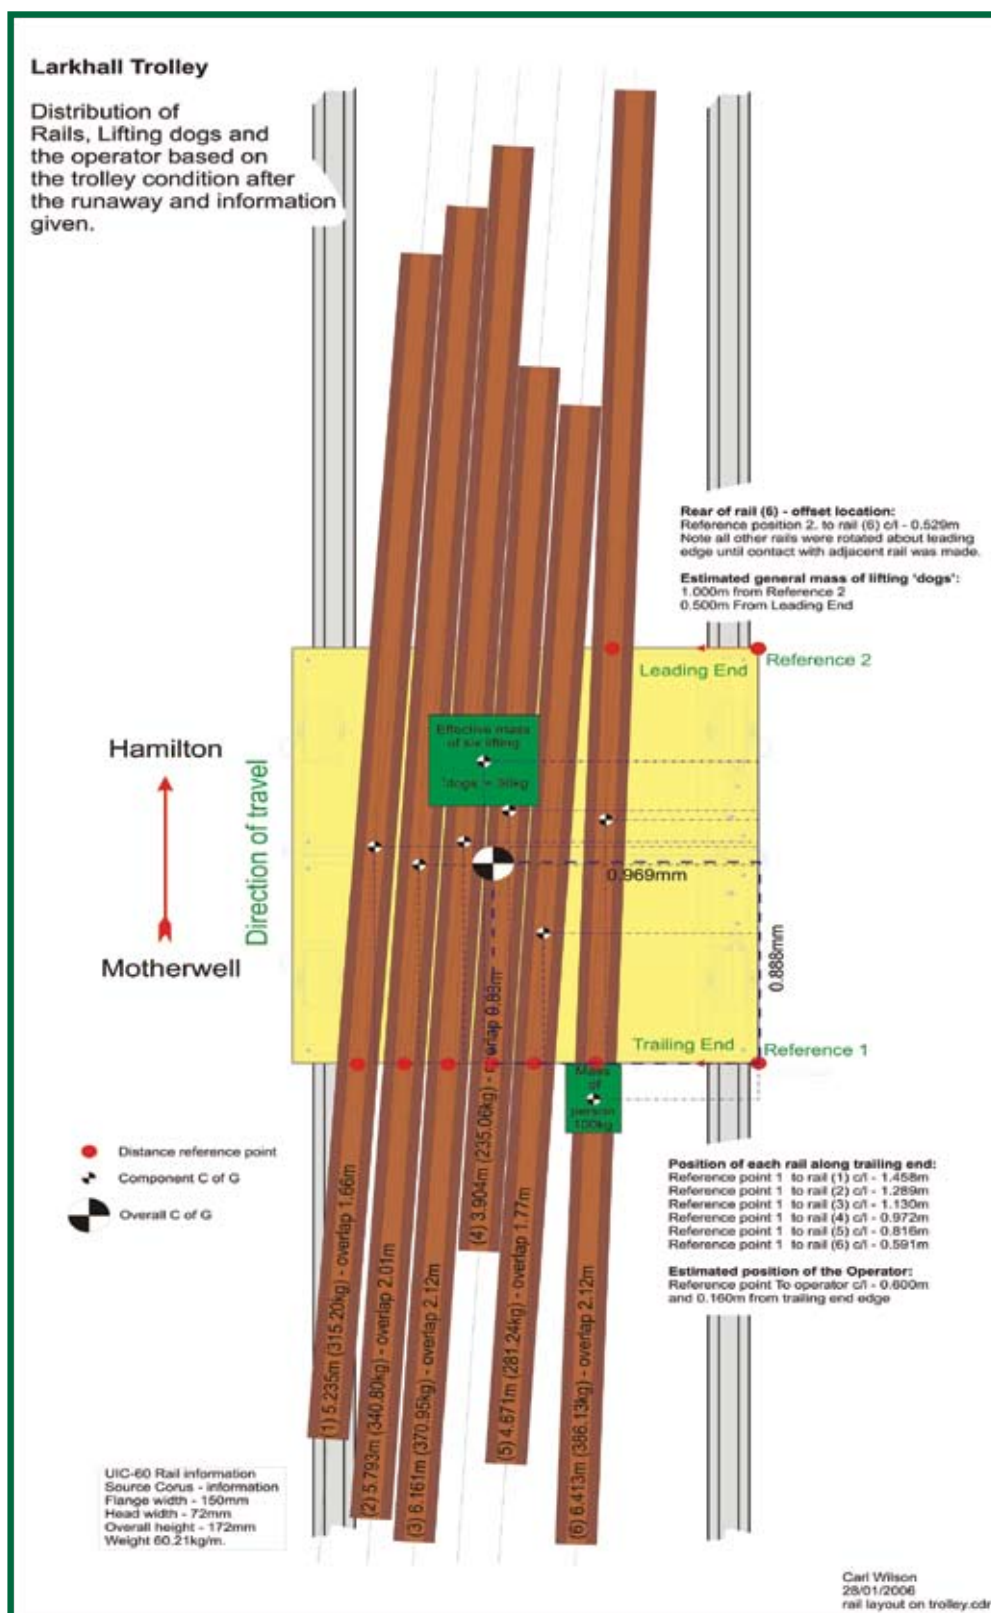
- 66 At the Merryton site (see Figure 9) old rails were removed from the track, and new rails installed and welded into longer lengths. The scrap rails were cut into smaller sections in order that they could be lifted onto the trolley for onward transportation. Two sections of rails loaded onto the incident trolley were 0.413 m and 0.161 m above the 6 m requirement for movement by a single trolley; the remaining four were within the specified limit. Appendix C contains full details of the rail lengths, weights and overhangs.

Figure 9: Load distribution diagram derived from photographic evidence

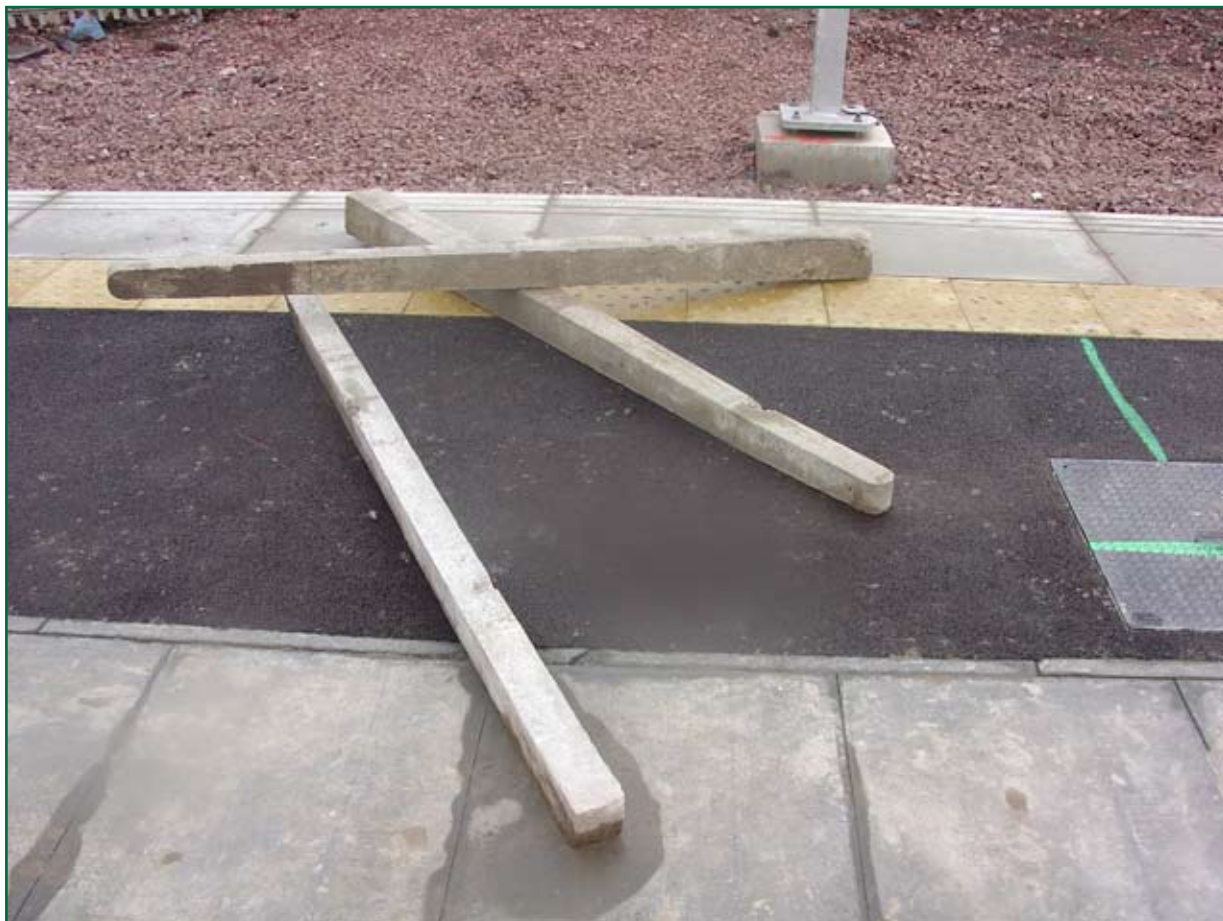
- 87 Skyblue and Carillion staff had by this time made their way to Chatelherault station. Three fence posts were thrown onto the track onto in an attempt to derail the trolley and prevent it from proceeding down the line. Unknown to these members of staff, the trolley had already passed this location. The fence posts were later removed and placed on the station platform.

Figure 11: Image of fence posts thrown onto the running line in an attempt to prevent the trolley passing through Chatelherault station
