Rail Accident Report

Derailment at Oubeck North near Lancaster 4 November 2005

This report is published by the Rail Accident Investigation Branch, Department for Transport.

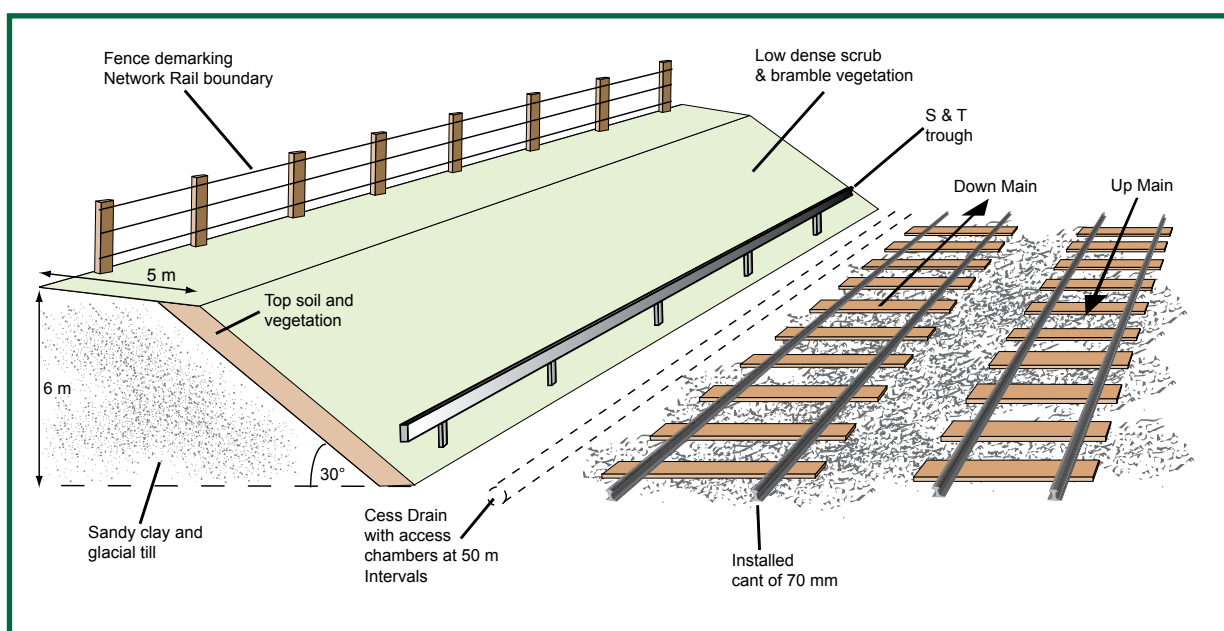
Figure 2: Diagrammatic presentation of the cutting slope prior to failure

- 29 There is a *cess drain*, but no *crest drain* or surface drainage on the cutting. At this location and to the south of the failure site the cess drain is a piped system, containing several chambers at approximately 50 m intervals.

- 30 There is a *signalling and telecommunication* (S&T) trough route supported on stub concrete posts at 1.5 m centres set into the *slope toe*.

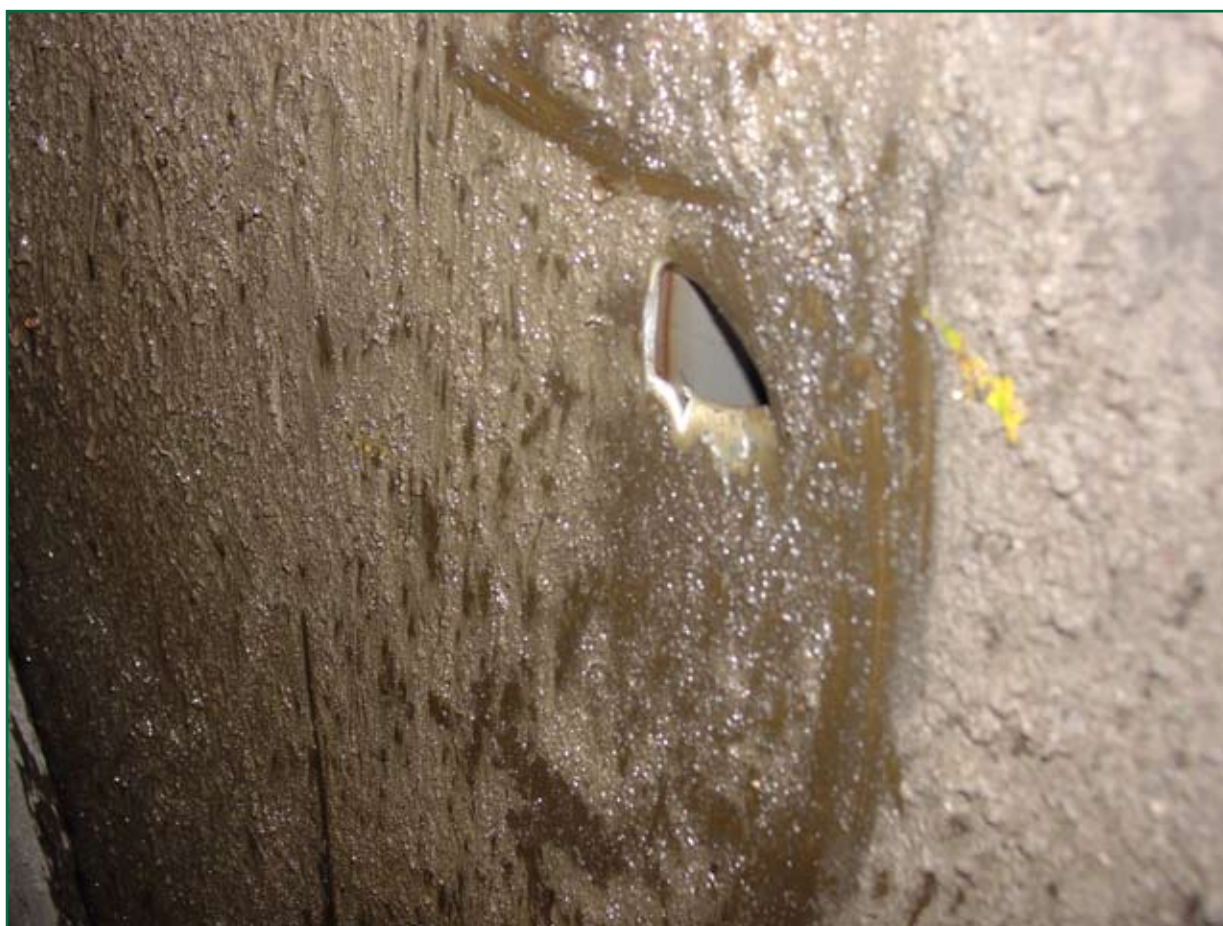
Figure 3: Hole in fuel tank

- 35 At approximately 13:56 hrs the train ran into a landslip at Oubeck North. The trailing wheelset on the leading bogie on the leading car derailed to the six foot. No other wheels were derailed. The train came to rest in an upright position after travelling a further 1430 m.
- 36 There were no injuries, although one passenger was airlifted to hospital with a suspected angina attack.
- 37 There was no collision with structures or other trains. A freight train on the up main line was stopped by emergency hand signals given by the driver of train 1C62. This prompt action by the driver prevented the consequences being more serious.
- 38 Two coupler lateral bump stops were dislodged from the leading vehicle and came to rest 200 m after the landslip. They caused damage to the underframe including holing the fuel tank on the leading vehicle as shown in Figure 3.

125 The most significant damage caused by the coupler lateral bump stops was the puncturing of the air suspension surge reservoir, the tearing of the TCA bracket, the holing of the fuel tank and the damage to the final drives. There was nothing significant about the design of these features that made them more susceptible to the effect of impact than those used on other trains and therefore there are no recommendations relating to their design.

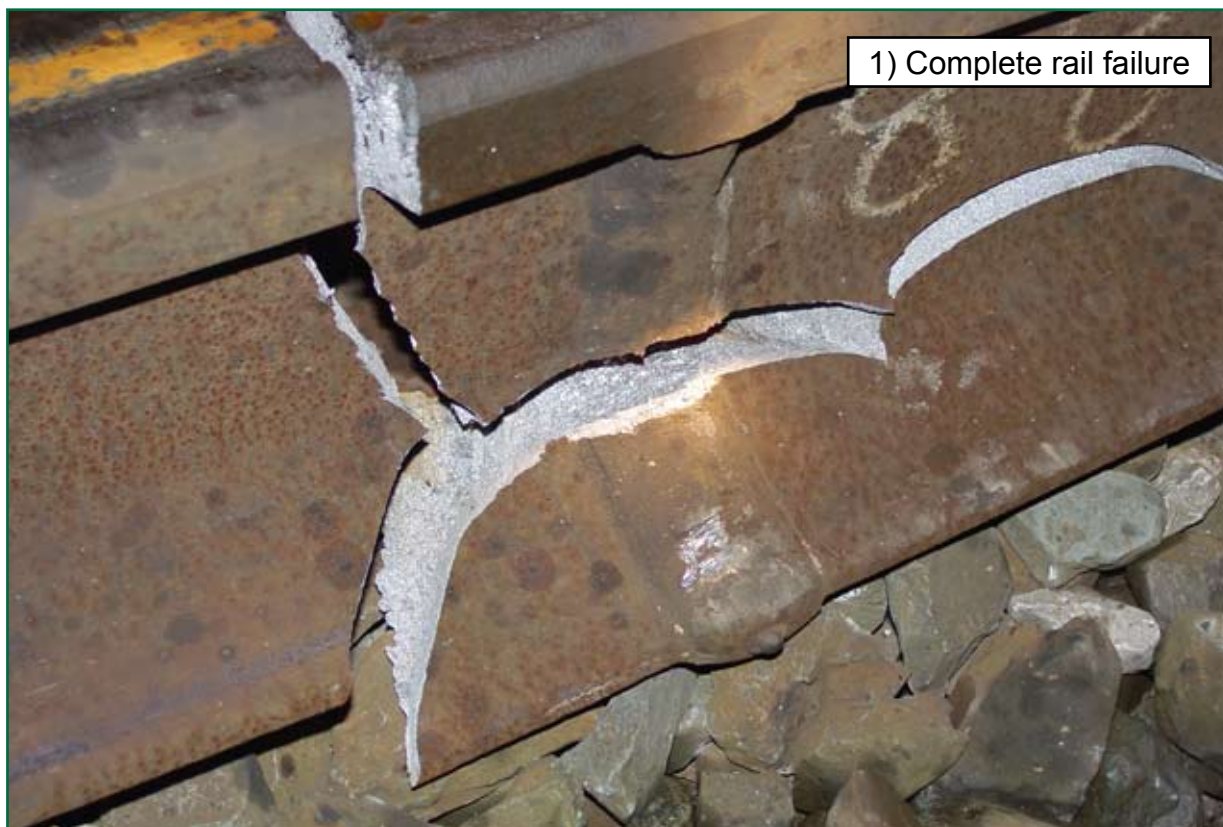
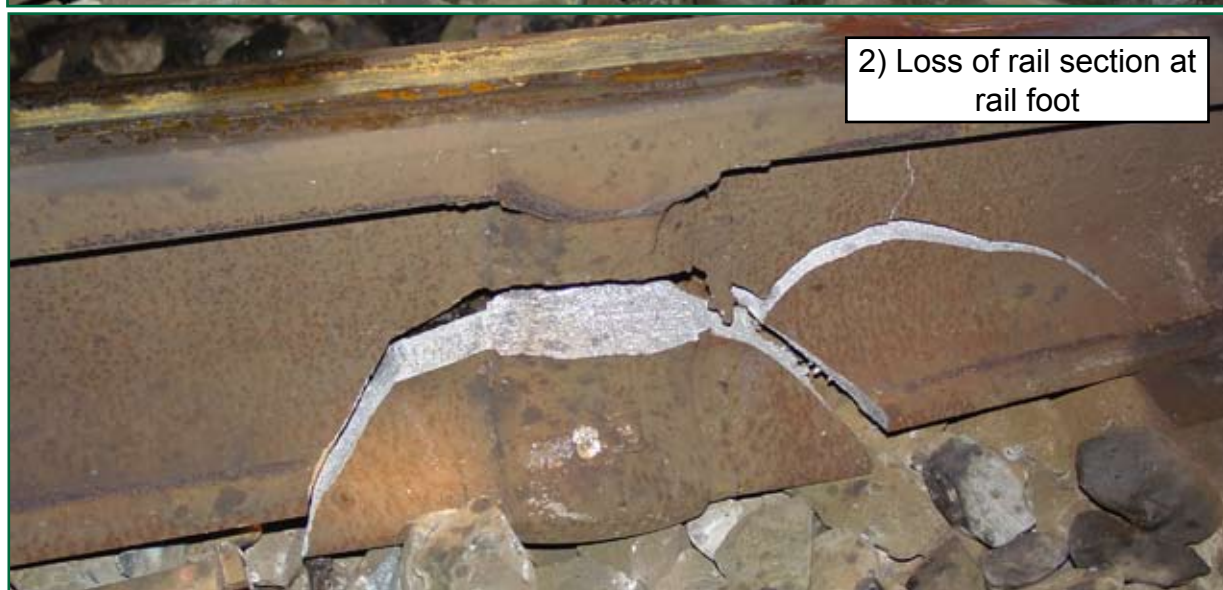
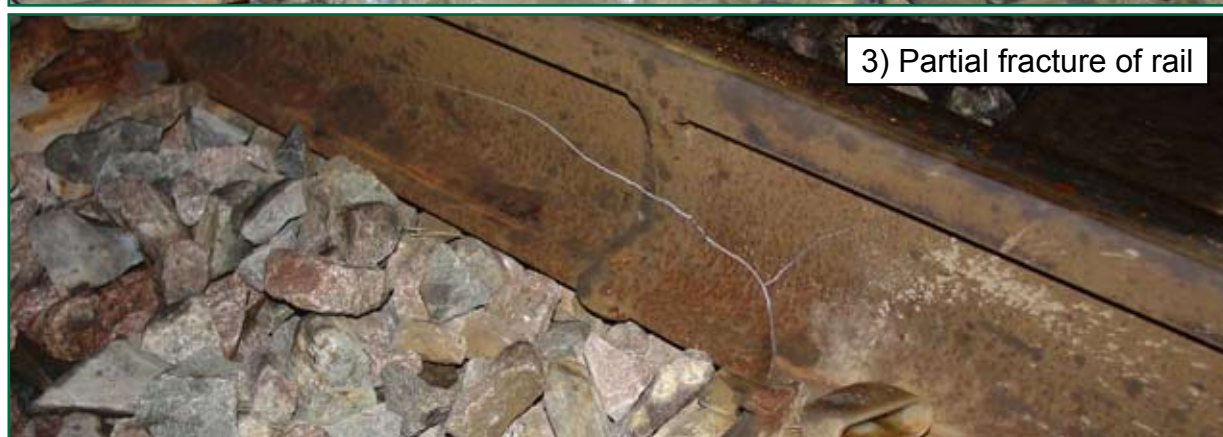
Figure 4: Examples of three different types of rail fractures observed

- 16 The immediate cause of the rail fractures was the impacting of the *raised collars* of the *Thermit* welds by the derailed wheel *flange tip*.
- 17 Six recommendations are made in the following areas, to improve safety (paragraph 170):

- 39 The derailed wheelset caused extensive damage to the rail fastenings, *sleepers* and rails over a distance of 1430 m. Additionally, eighteen rail fractures of the six foot rail were identified, comprising nine complete failures, seven with loss of rail section at the rail foot and two partial cracks. Examples of the three different types of fractures are shown in Figure 4.

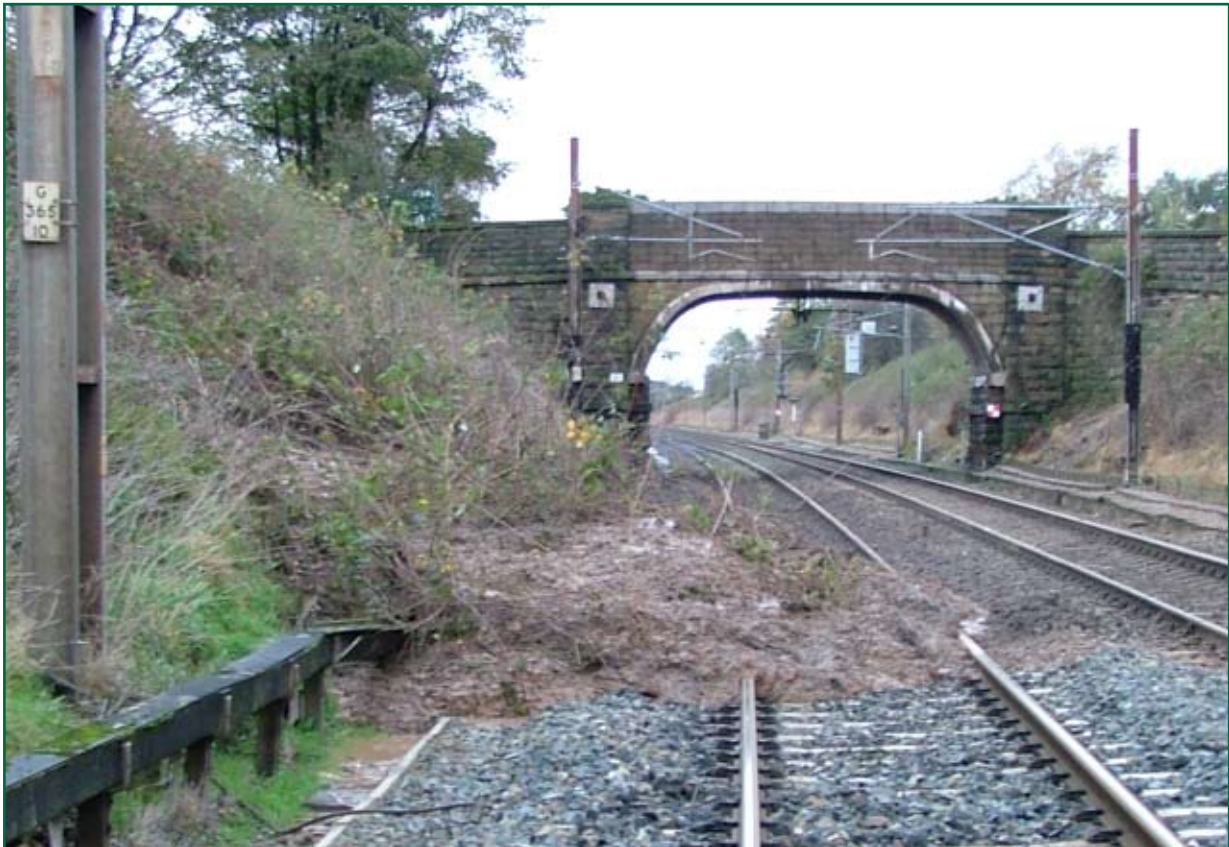
Figure 5: Landslip at Oubeck North looking in the direction of traffic

- 49 Post incident site investigations revealed that the landslip left a *scar face* approximately 10 m long and 2.5 m high on the cutting slope.

- 50 The length of the debris deposited on the track was about 10 m. It was between about 0.5 m and 1 m high at the cess rail falling sharply to a few centimetres on the six foot rail. The material on the track did not show any disturbance as a result of a train running through it. Figure 5 is a photograph of the landslip taken on the day following the incident looking in the direction of travel.

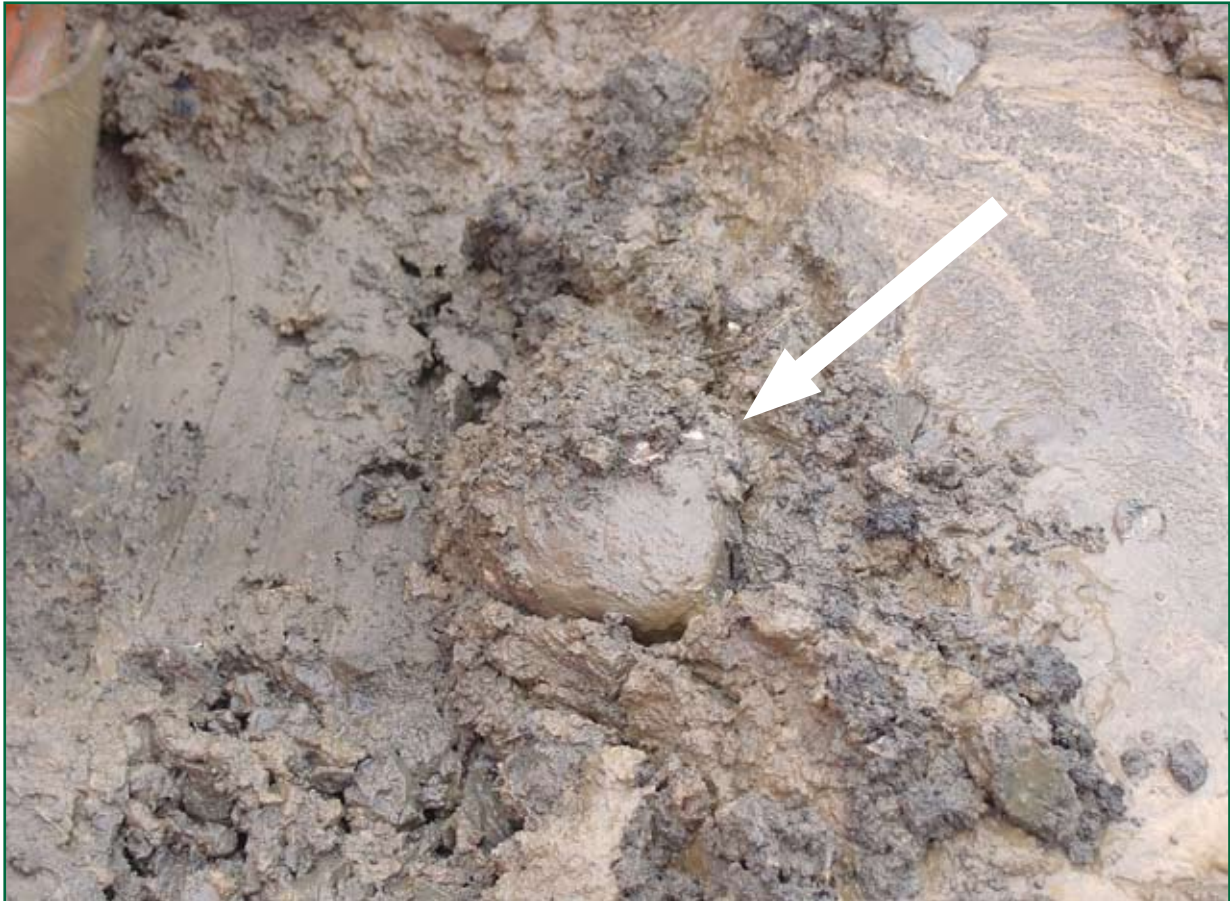
Figure 6: Indication of consistency and boulders in the landslide material

- 51 The landslip material comprised slabs of turf with saturated flow deposits behind. The material on the track was supersaturated and mainly consisted of soil and clay material, but also contained a number of large boulders, several of which were reported as being in excess of 500 mm in diameter. Figure 6 gives an indication of the consistency and shows a boulder of the order of 200 mm diameter in the landslip, indicated by the arrow. This photograph was taken during the digging out process on the day following the derailment.

- 52 During the remedial work three distinct streams were noticed flowing from the slope crest. Excavation of the slope exposed a 100 mm diameter historic earthenware field drain approximately 0.5 m below ground level issuing water onto the scar face at approximately 1 litre/s.

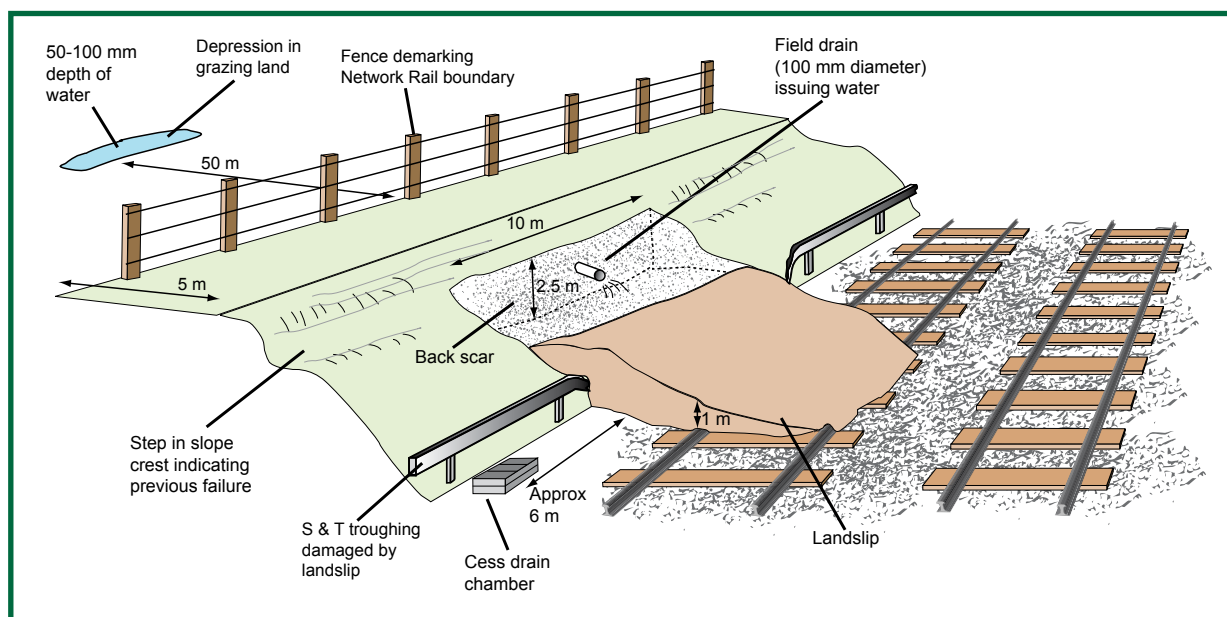
Figure 7: Cutting slope after landslide

- 54 During the remedial work the vegetation was cleared from the top of the cutting for a distance of approximately 25 m north and south of the landslide location. This revealed an obvious step in the slope crest. This may have been an indication that there had been a previous failure at this location. The step was very rounded and buried by deep vegetation. Additionally, a site of possible previous *toe heave* was identified.

- 55 The cess drain at this location and to the south of the failure site was a piped system, containing several chambers at approximately 50 m intervals. The cover of the nearest chamber to the derailment site was removed to reveal that the drain was free flowing. Each of the chambers contained inlet pipes of about 100 mm diameter coming from the direction of the slope. One of these chambers was roughly in line with the outflow from the field drain. It is uncertain whether the pipes in the chambers are connected to *carrier drains* connecting the field drains to the cess drain. No records were made of any discovery of the remains of any pipes connecting the exposed field drain to the cess drain during the excavation and repair of the slope. The site findings are shown in Figure 7.

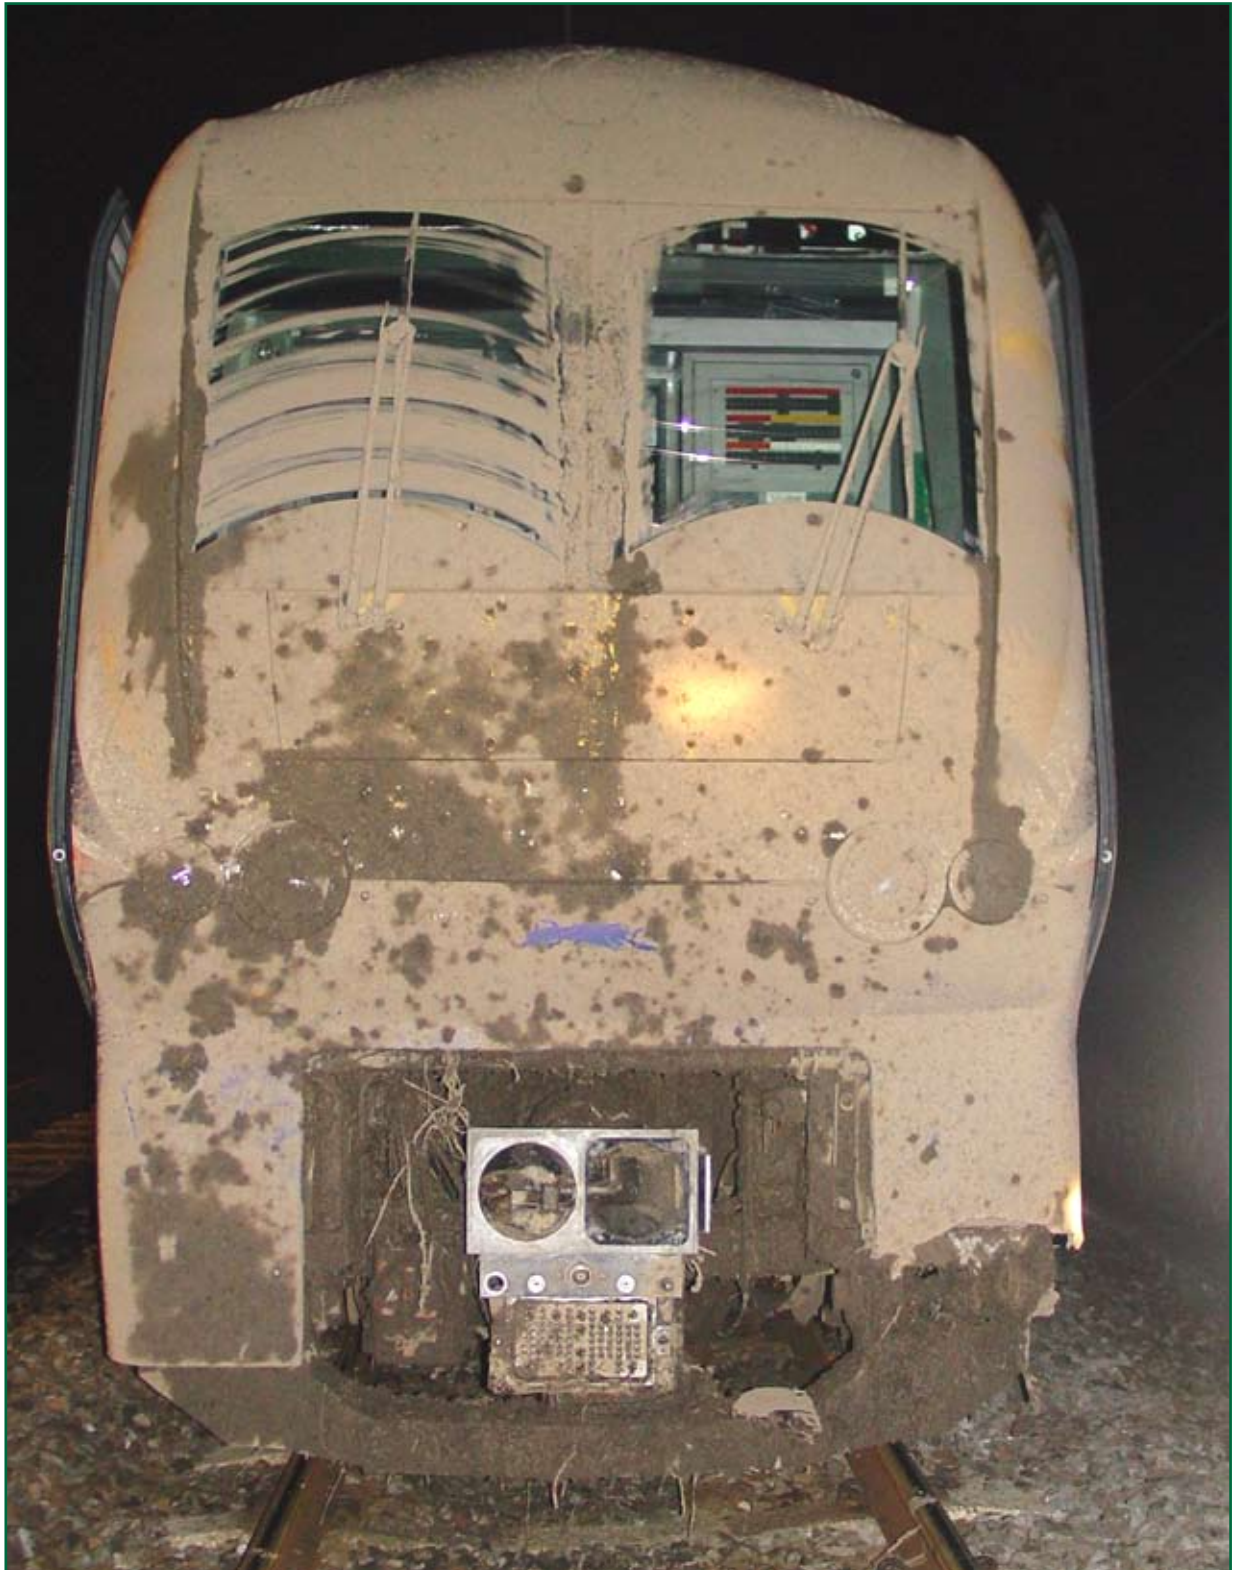
Figure 8: Exterior of the vehicle following derailment

- 65 The train was examined at the site of the derailment prior to re-railing (see Figure 8), at Carnforth on 16 November 2005 and at Alstom Trainline Services, Wolverton on 30 November 2005 (before cleaning) and 9 December 2005 (after cleaning). The key findings are summarised in the following paragraphs (left and right hand sides are relative to the direction of travel when the train hit the landslip).

- 91 NR/SP/TRK/001 does not require any inspections of drains, other than those serving the track.
- 92 Permanent way staff focussing on formation, sleepers and track are unlikely to notice anything other than significant cutting failures under the present regime.

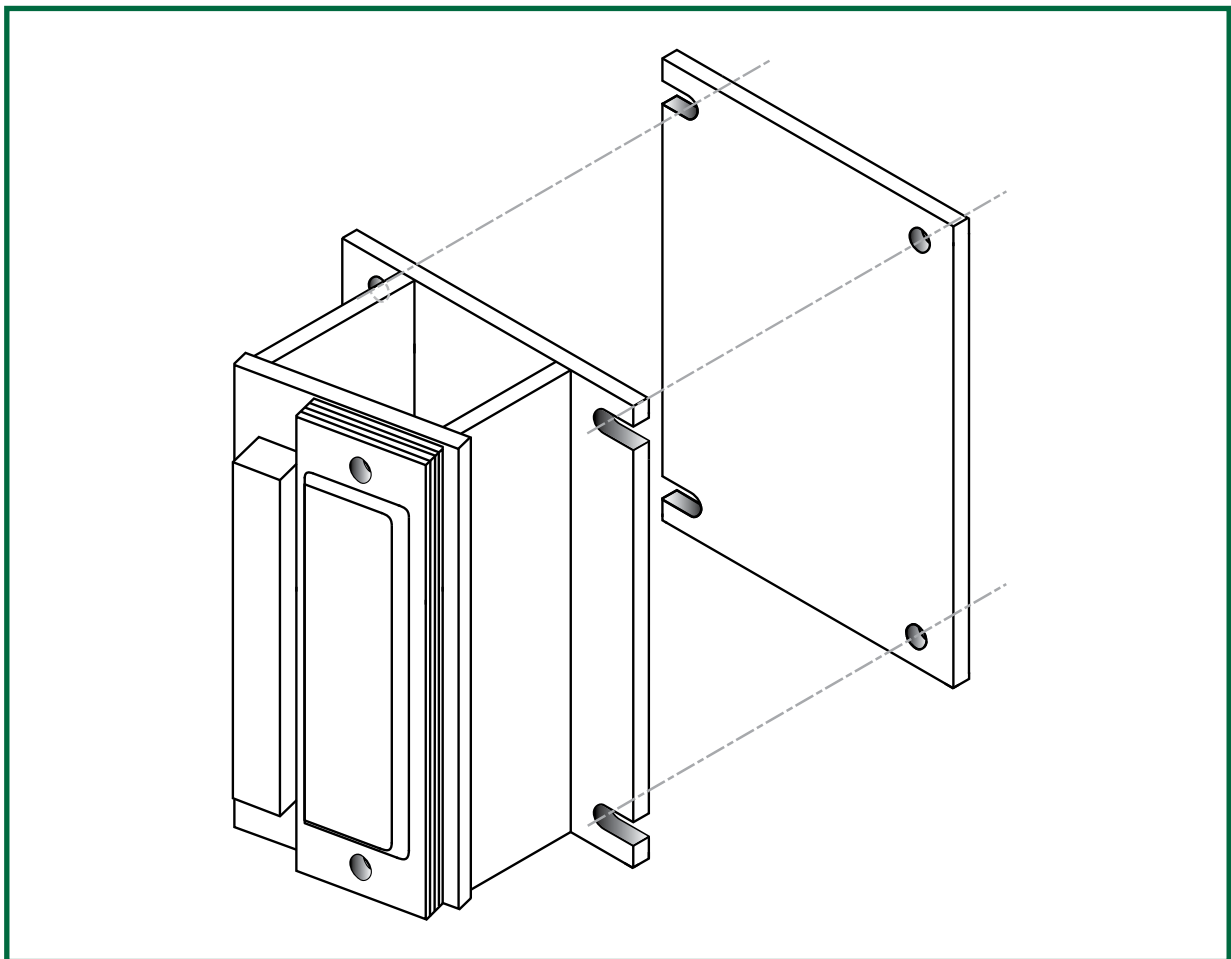
Figure 9: Class 175 coupler lateral bump stops

- 77 The coupler lateral bump stops are bolted onto plates mounted onto the *cab structure*, as shown in Figure 9. The lower edge of the coupler lateral bump stops is 787.5 mm above rail height.

- 78 The holes are slotted on the leading edge of the coupler lateral bump stop plate and on the trailing edge of the headstock, all other holes are drilled. Alstom, the train manufacturer, has advised that this arrangement is to ensure that the coupler lateral bump stops do not prevent the coupler retracting in a significant collision, thereby avoiding 'bridging out' the crashworthiness performance of the train structure.

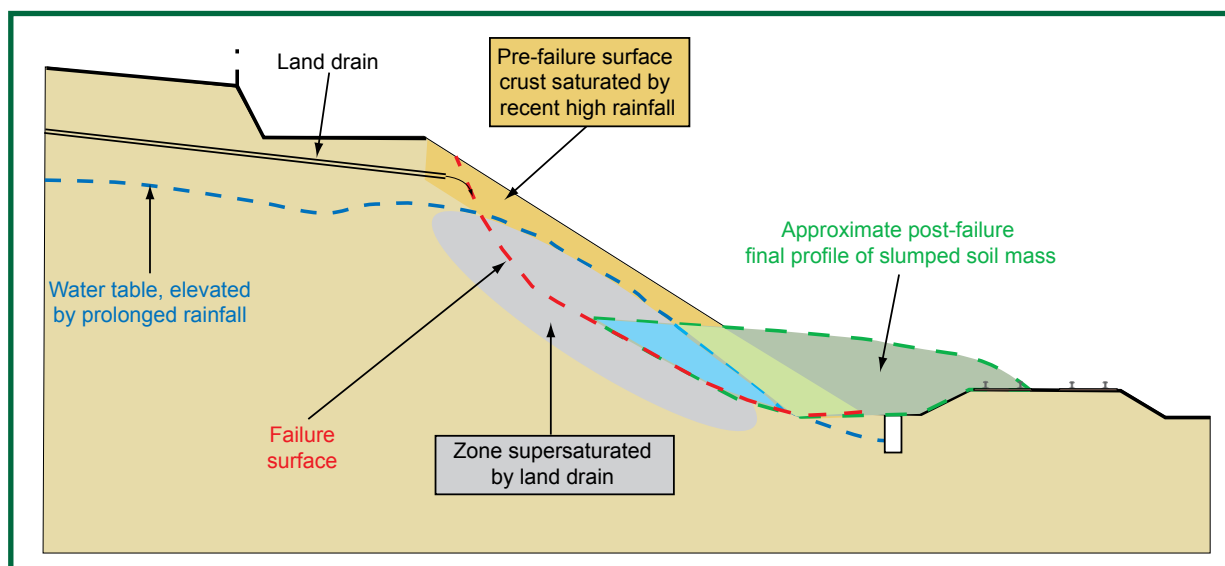
Figure 10: Sketch section through the failed cutting slope

114 The heavy rainfall immediately prior to the incident saturated the topsoil and vegetation layer on the cutting slope surface. The resulting weight increase caused the upper 300 to 500 mm soil layer to slide down the bank (a *translational failure*).

115 The loss of the constraint on the underlying glacial till allowed it to flow. The liquefied soils flowed down to the south covering both rails and pushed the top soil to the north and further onto the track.

116 This earthwork failure is described as earthflow and is shown diagrammatically in Figure 10.

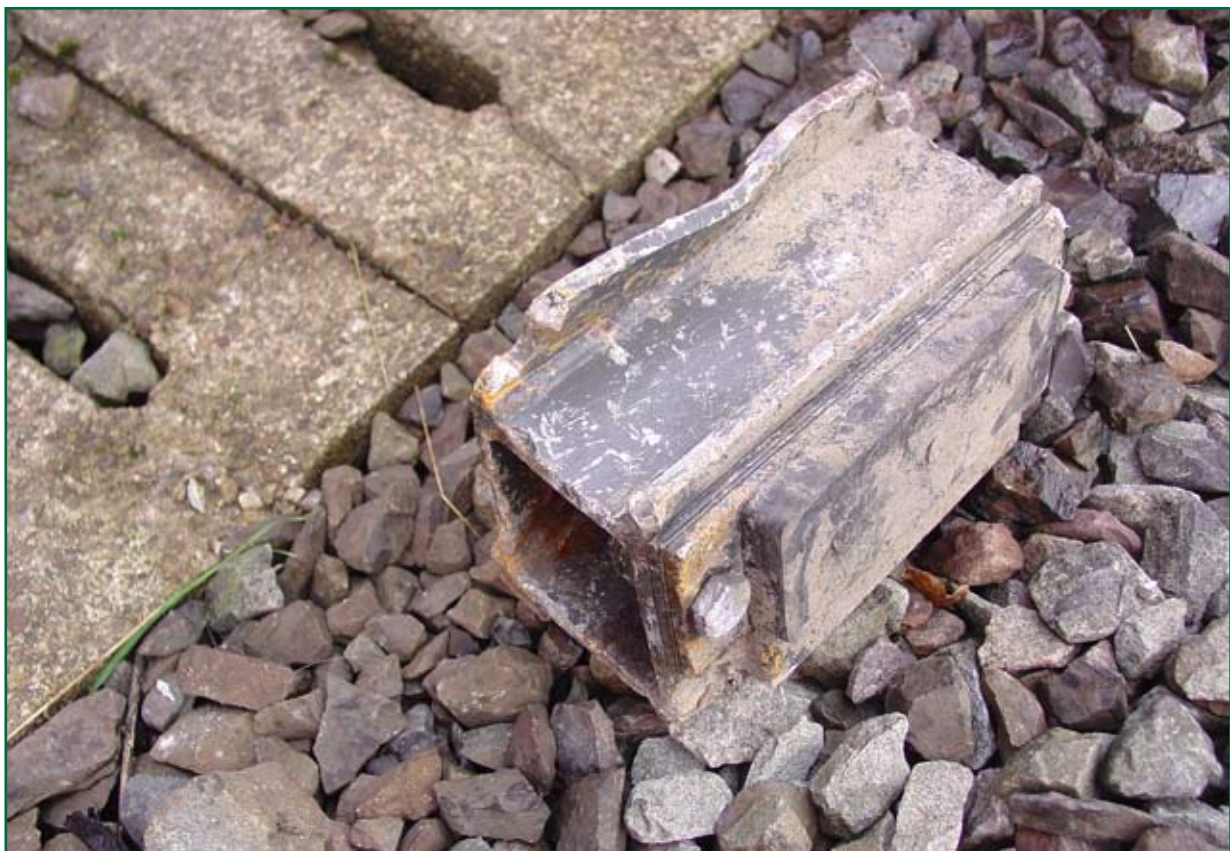
Figure 11: Coupler lateral bump stop in the 'as found' condition

- 133 The coupler lateral bump stops were found in a relatively clean condition (see Figure 11) when compared with the rest of the front of the vehicle (see Figure 8) and especially considering the state of the equipment and surfaces within the coupler pocket (see Figure 12). This suggests that the coupler lateral bump stops were dislodged early in the incident, before the train ploughed through the debris, however it is not conclusive.

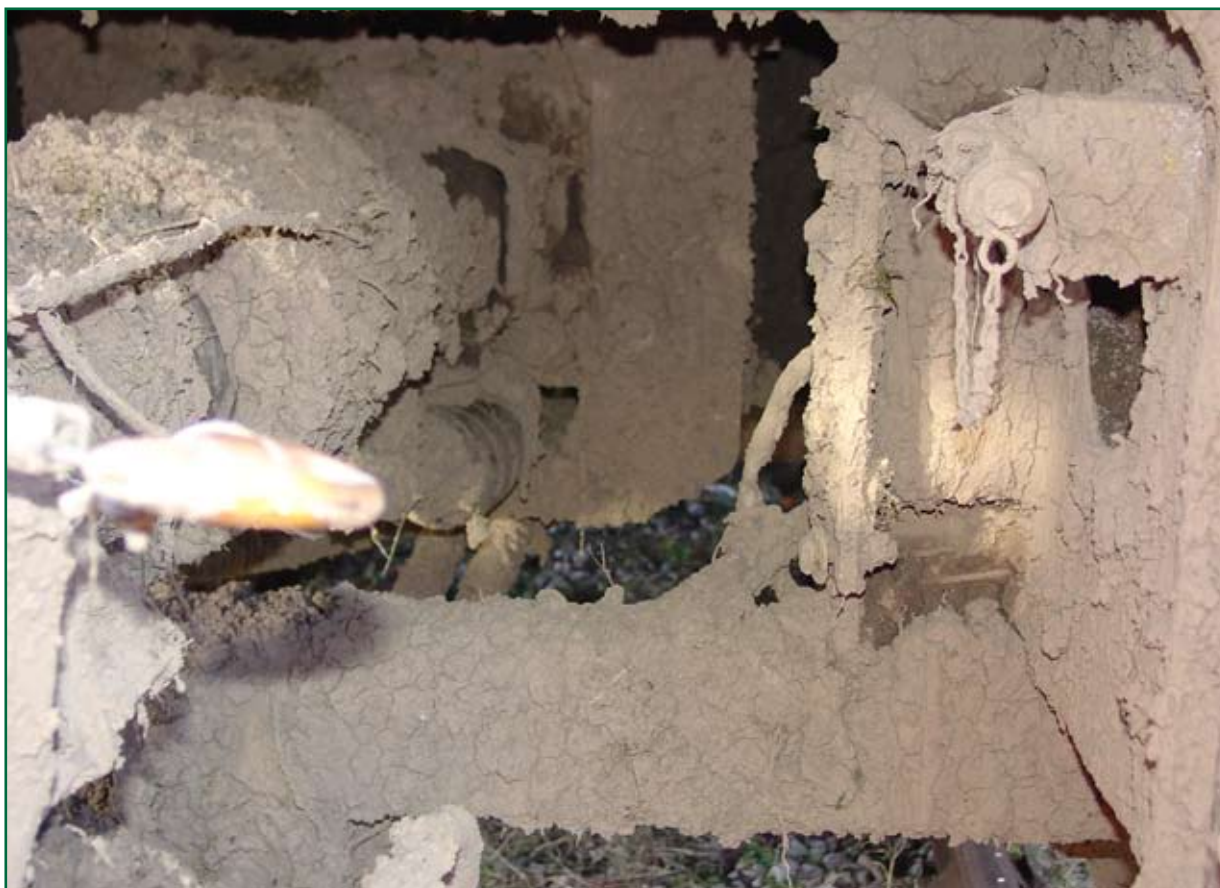
Figure 12: Coupler pocket following passage through landslide

- 134 **Coupler impacting the coupler lateral bump stops** either as a result of the train body receiving a lateral acceleration due to the asymmetric impact with the landslip and in turn exciting the coupler to accelerate in the lateral direction or as a result of an input force causing the coupler to swing from side to side.
- 135 The body would have been deflected laterally by the obstacle deflector and the GRP valance hitting the landslip debris mound. The dynamics of this situation made it possible that the coupler oscillated from side to side in the coupler pocket at least once.
