Rail Accident Investigation Branch

# Rail Accident Report

**The collision of a locomotive with carriages at  
Great Central Railway's Loughborough Central  
station,  
4 February 2006.**

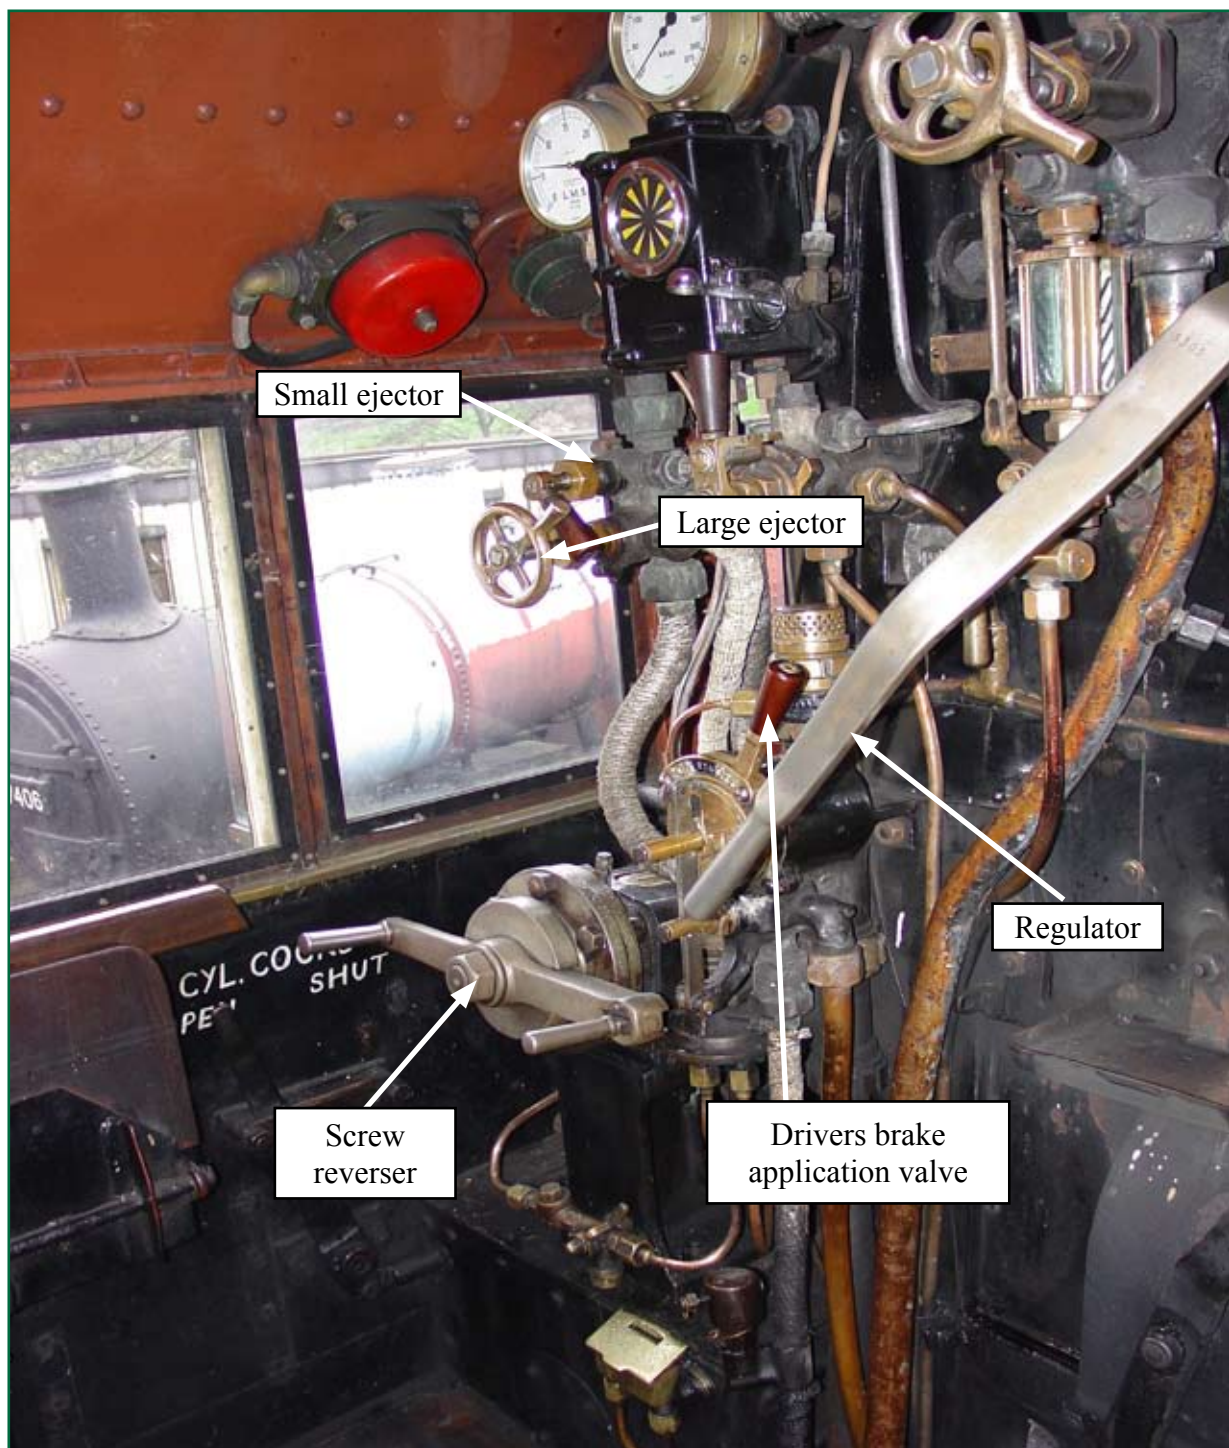
Figure 3: Locomotive 45305 cab controls

- 29 The fireman remained standing, coming to rest against the boiler. The fireman was not injured and applied the locomotive brake when instructed to do so by the driver. See Figure 3 for the location of the locomotive brake and cab controls.

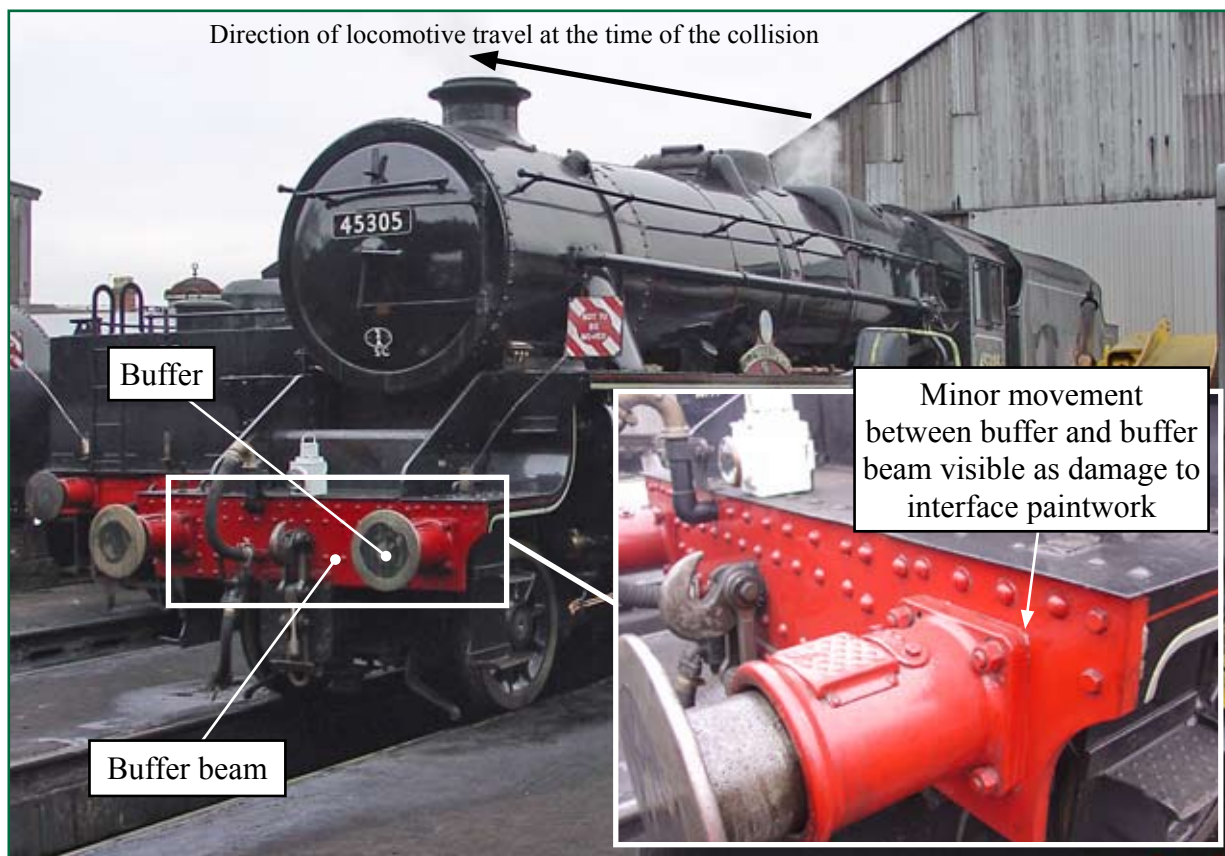
- 33 Only the locomotive and carriage 9124 sustained minor damage. There was minor movement of the locomotive *buffers* relative to the *buffer beam* as evidenced by cracked paint at the interface (Figure 4). The buffer beam was slightly deformed. Carriage 9124 sustained damage to its buffers and the coupler casting at its coupling to carriage 4662. The buffers had moved relative to the buffer beam, evidenced by cracked paint at the interface. The coupler casting was cracked (Figures 5, 6 & 7).

Figure 4: Locomotive 45305 with damaged buffer and buffer beam

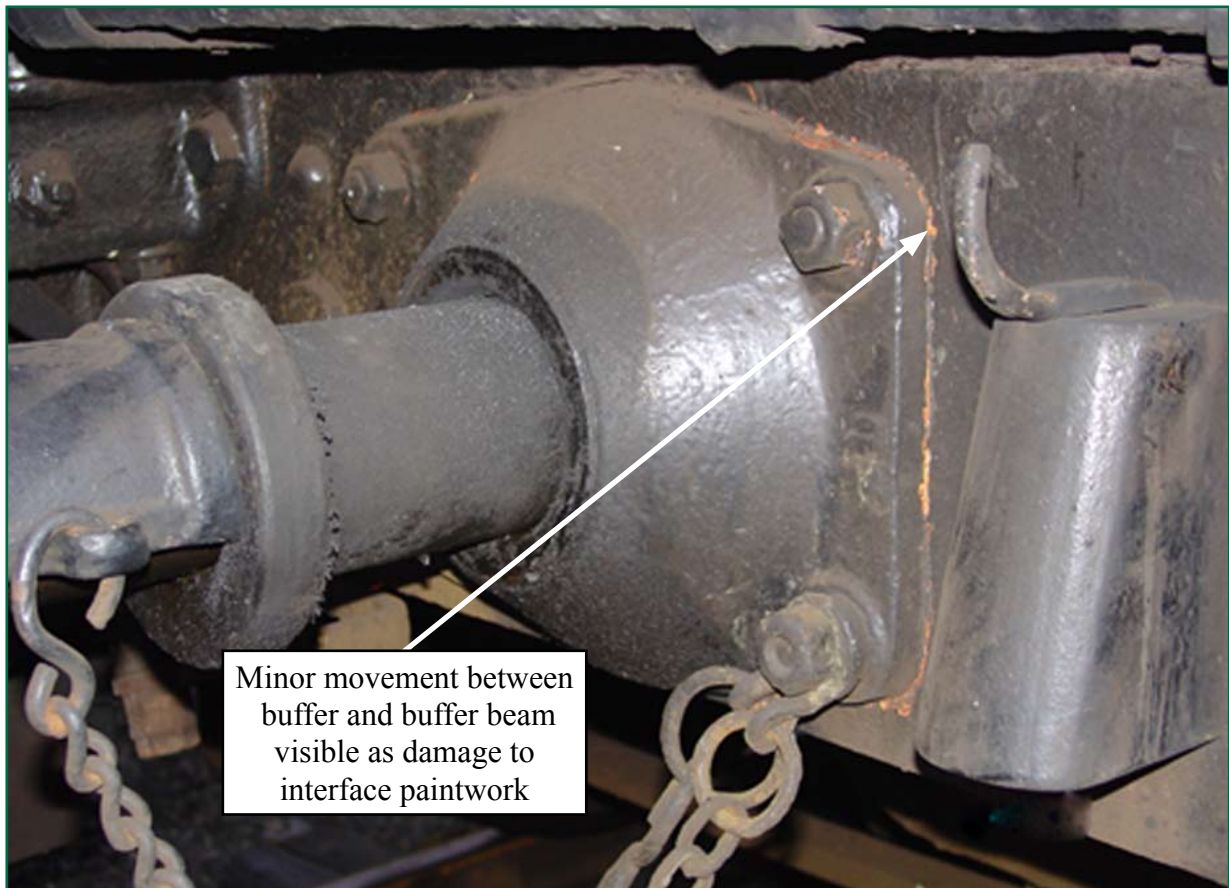
Figure 6: Carriage 9124 buffer struck by locomotive

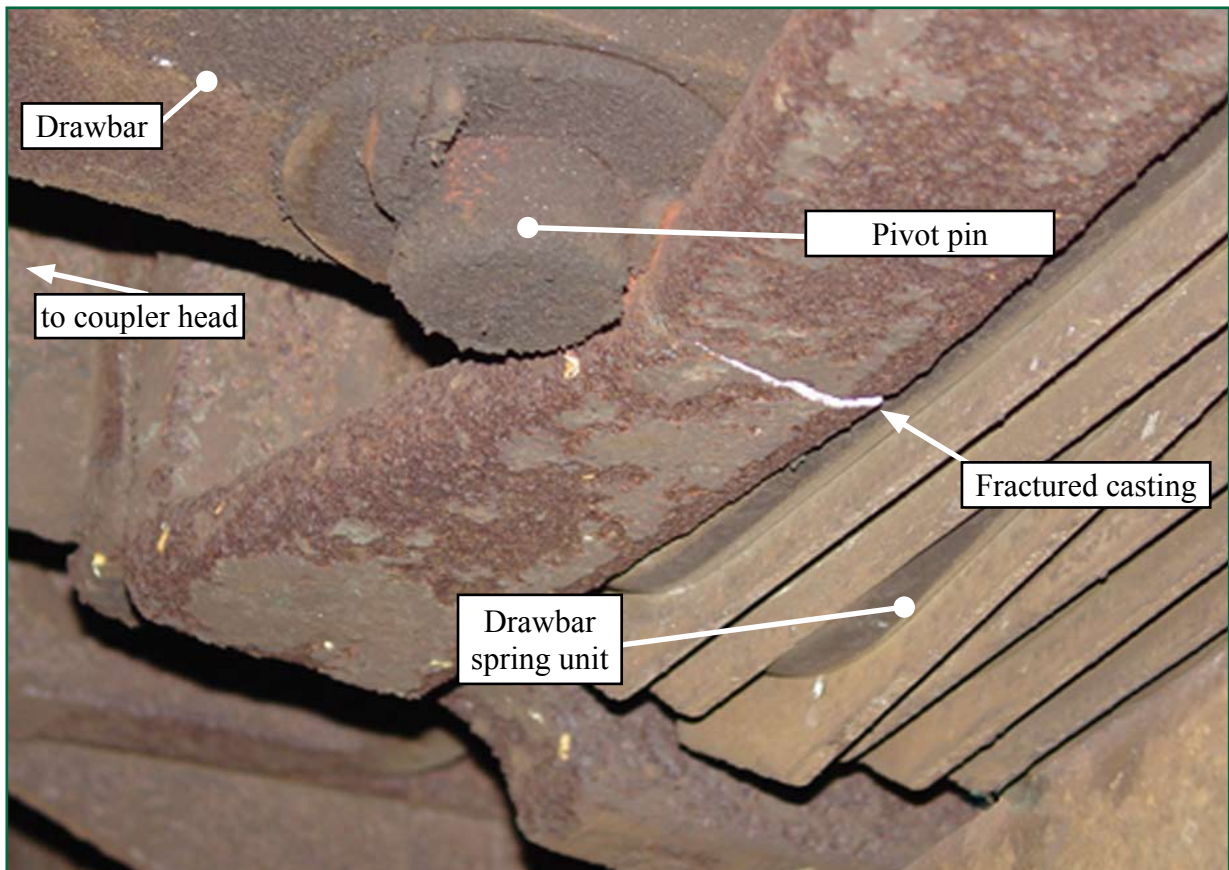
Figure 7: Carriage 9124 coupler connected to Mark 1 carriage 4662

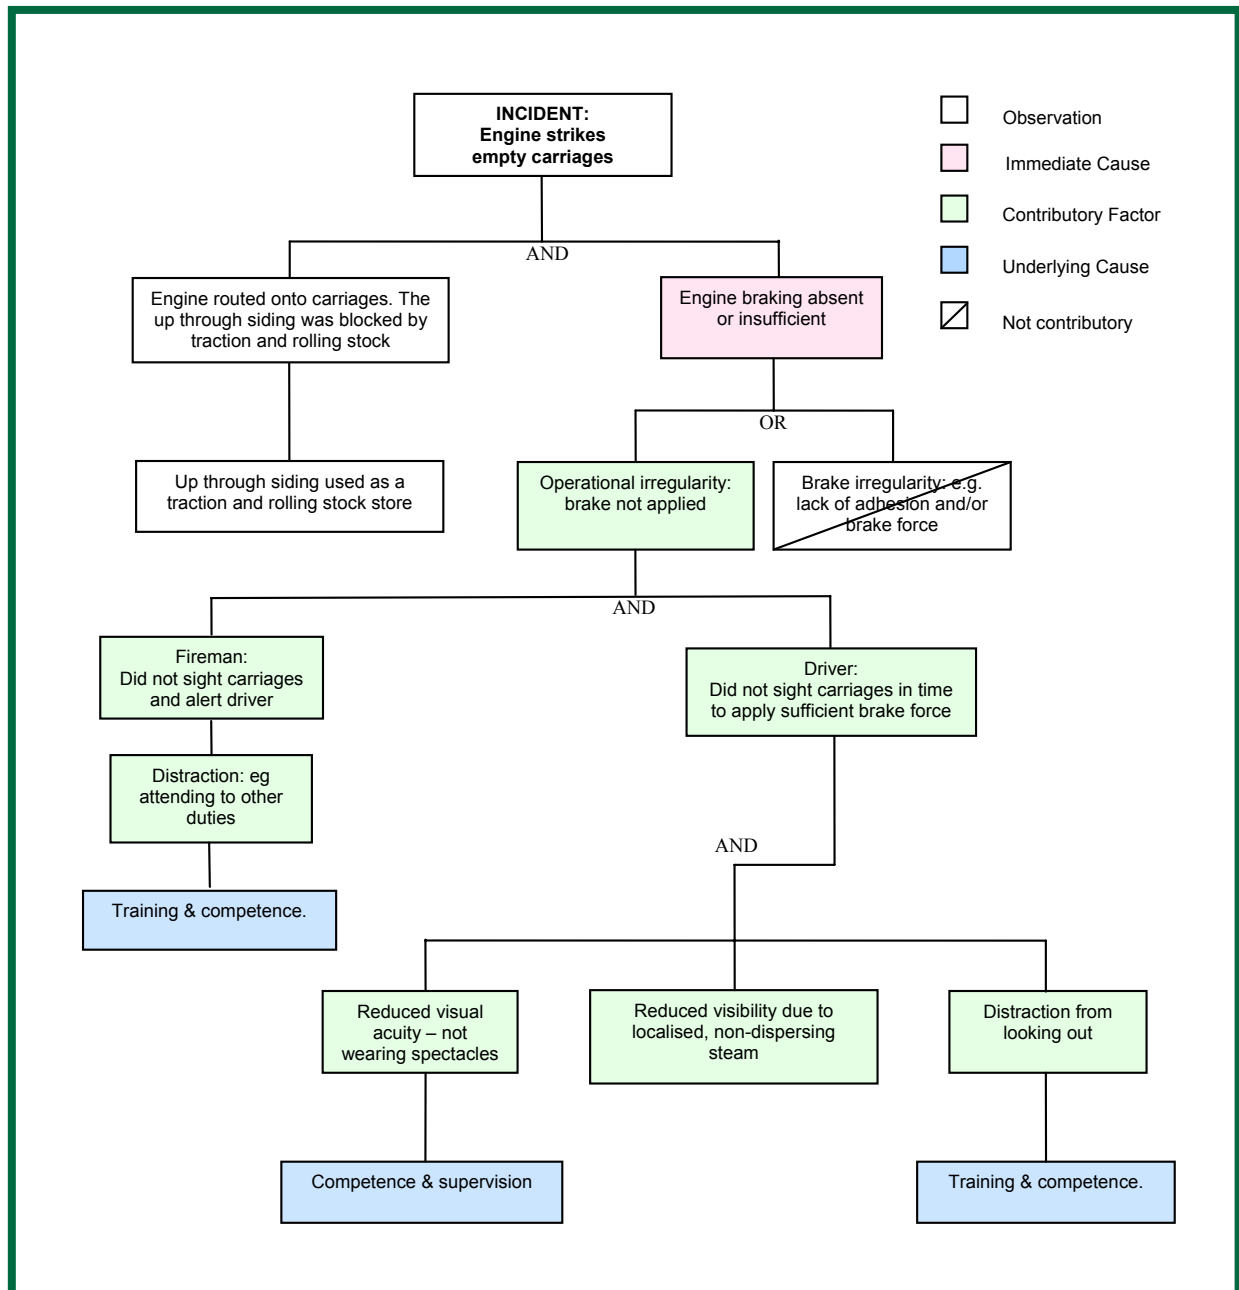
Figure 8: Causal Analysis

- 34 The causal analysis into the incident is given in Figure 8. The locomotive passed braking tests during daily exam, during the driver's brake test and in a post incident test. Neither the wheels nor the railhead were contaminated, therefore adhesion conditions were normal. Thus a brake irregularity was not contributory to the incident.
