# Rail Accident Report

## **Derailment at Phipps Bridge, Croydon Tramlink 21 October 2005**

# **Derailment at Phipps Bridge, Croydon Tramlink**

## **21 October 2005**

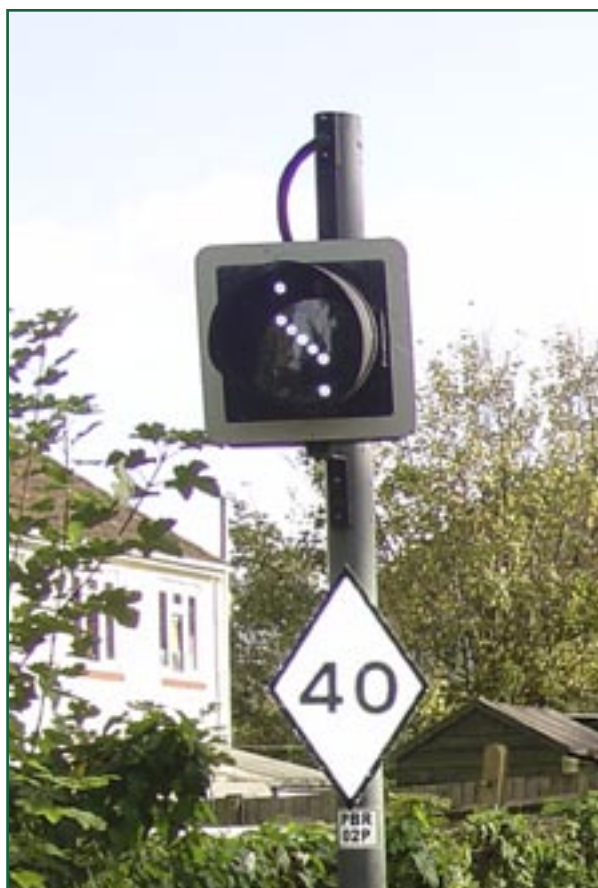
Figure 2 : Points position indicator - points correctly set

- 13 The track on the *single line* section consists of flat-bottomed rail on concrete sleepers. The points at Phipps Bridge are carried on timber *bearers*, and are fitted with a Hanning & Kahl HW 40 operating mechanism. The mechanism is not power operated, but the points are sprung to lie *normally* towards the eastbound line. There is a points position indicator (PPI) located 4m before reaching the points, at drivers' eye level on a post to the left of the line. When the points are correctly set and detected in this position, the PPI shows a pattern of white lights indicating the left-hand route (see figure 5). If the points are not correctly set, only the central white light of the PPI is lit (see figure 6).

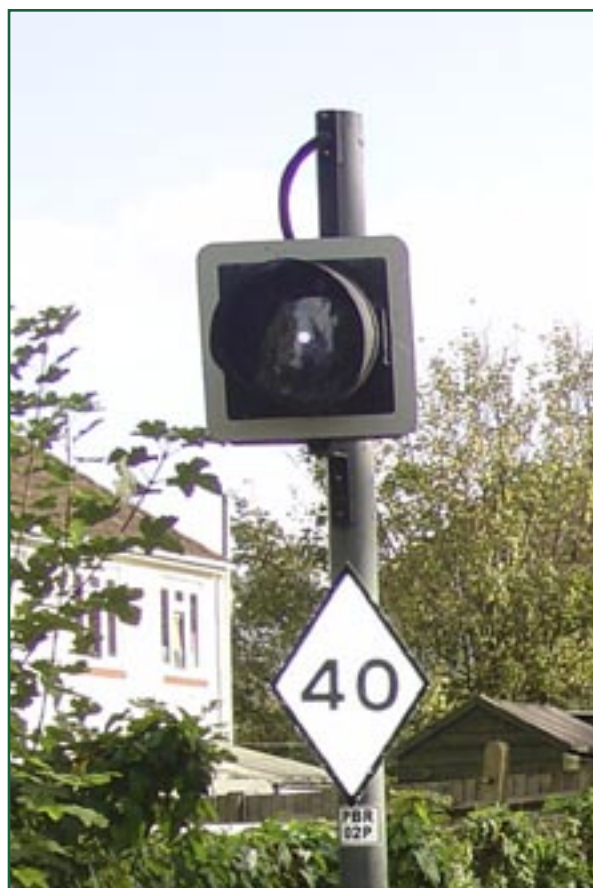
Figure 3: Points position indicator - points not correctly set

- 18 The tram is fitted with CCTV cameras which record the interior, and forward and back facing exterior views. The forward facing camera showed that the PPI was showing a single white light (meaning that the points were not set and detected for the left-hand, eastbound, route) as the tram approached and passed it, and the camera showed that the points appeared to be set, incorrectly, for the right-hand, westbound, route.

- 29 The tram driver had encountered indications of incorrectly set points before but in his experience this was extremely infrequent compared to the number of times the PPI showed that points were correctly set. The driver was concentrating on the tram speedometer while reducing the speed of the tram for the speed restriction over the points. The PPI becomes visible from a distance of about 200 m, and the investigation into this accident confirmed that the pattern of lights forming the “points set” indication (see figure 4) is not easily distinguishable from a single light at this range; only as the tram comes within about 100 m of the PPI does the form of the indication become clear. The single white light shown by the PPI is less conspicuous than the “points set” indication, and does not stand out as an indication requiring a response from the driver in the same way that a horizontal bar or red light would do.

- 31 Human factors research indicates that suggests that an “abnormal” indication should be easily distinguished from a “normal” indication, and be at least as conspicuous. Conspicuity can be improved by increasing the number of lights in the display and arranging them in a distinct pattern (recommendation 1).

- 1 The conspicuity of the PPI ‘abnormal’ indication should be assessed and improved by an appropriate means, such as display of a horizontal white bar when the points are not correctly set (para. 34).

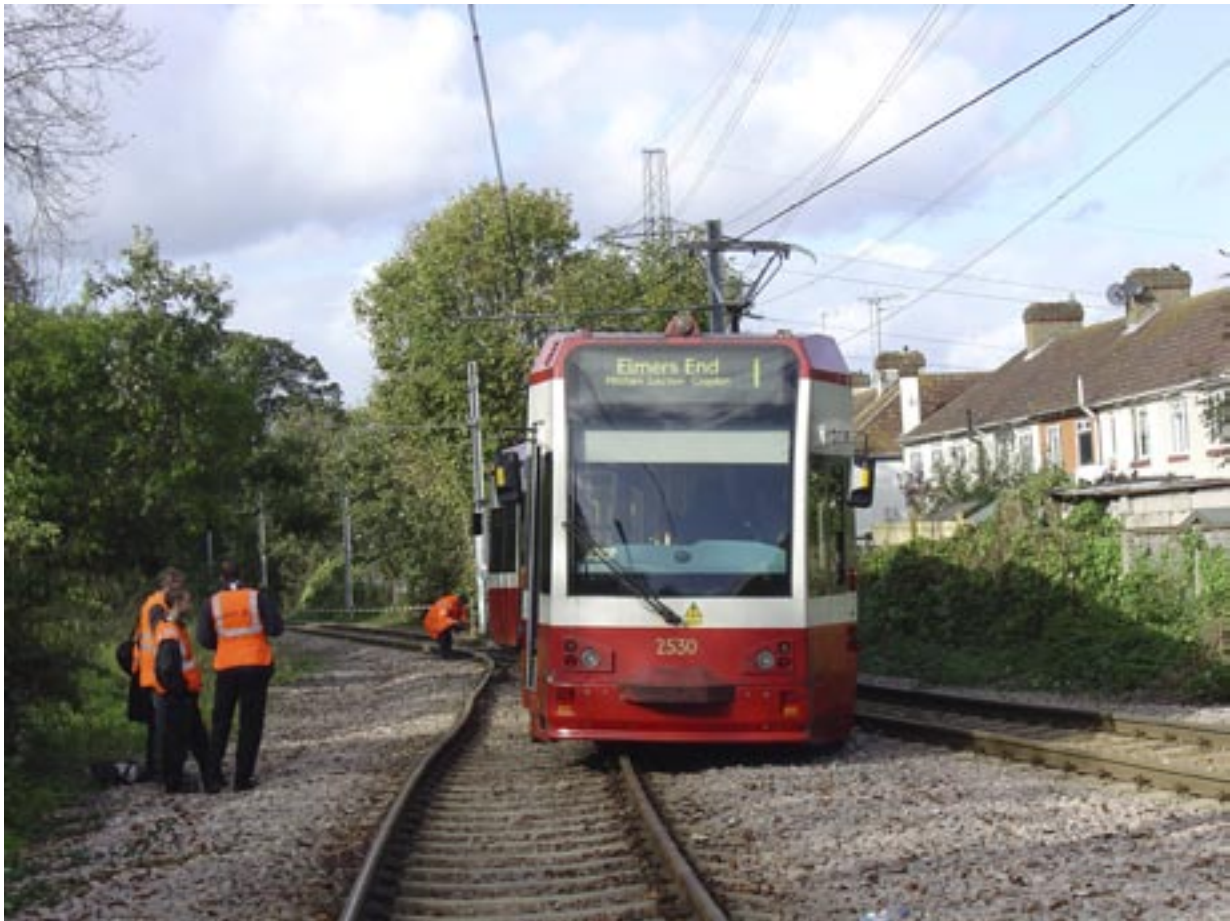
- 19 The leading bogie of the tram became derailed at the points. The left-hand wheels, facing the direction of travel, passed between the *switch blade* and *stock rail*. The right-hand wheels then dropped into the *four foot*. The tram then slid as its traction motors and other underbody equipment rode on the rail head over the crossing of the points until the inside of the right hand leading wheels came into contact with the rail head. The left hand wheels then rode over the right hand running rail and dropped into the *ballast*, and the tram came to a stop. The front of the tram came to rest 25m from the point of derailment, and 37m from the tips of the *switch blades* (see the photographs, figure 4 and 5). Following the accident, the driver made an emergency radio call to the control room and appropriate steps were taken to deal with the situation.

Figure 4: The derailed tram from the front, showing distortion of the track

- 22 The lateral forces involved in the derailment were sufficient to cause minor displacement of both tracks. These required realignment and minor repairs before the line was reopened for normal services at 21.10 hrs the same day. There was no damage to the points mechanism.

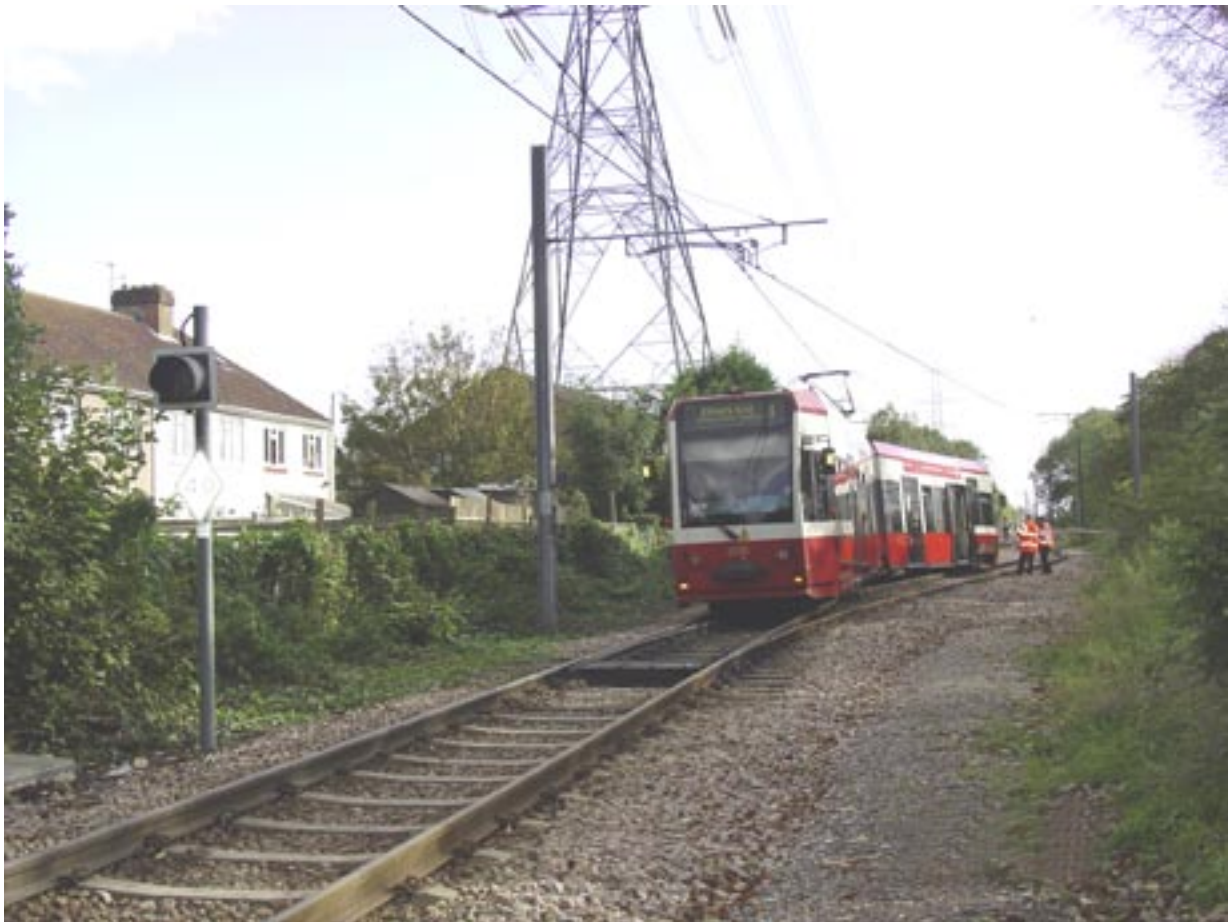
*Figure 5: The derailed tram from the rear, showing the points position indicator and speed restriction sign*

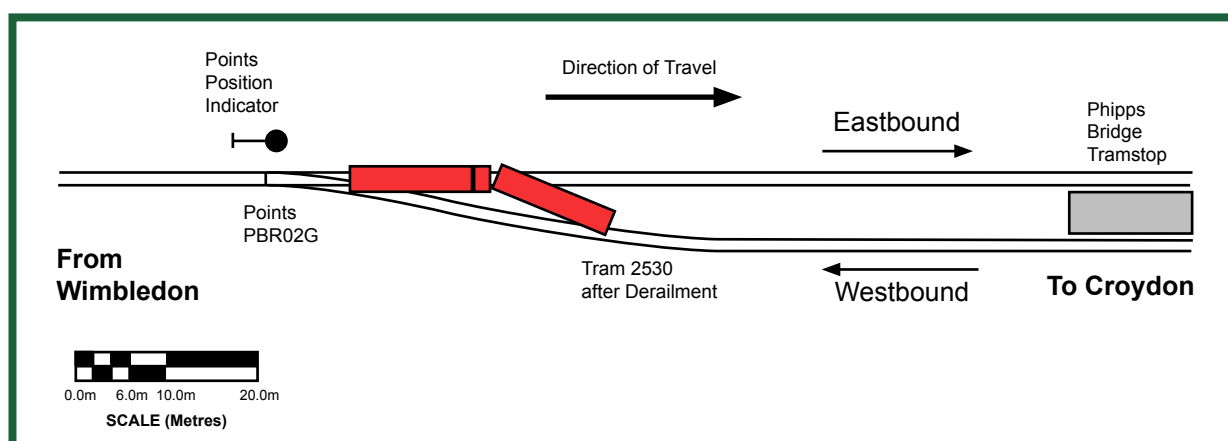
- 28 The evidence of the control room alarms and the CCTV on the tram shows that at about 10:32hrs, when the previous westbound tram passed over them in the *trailing direction*, the points at Phipps Bridge failed to self-restore to *normal* and remained stuck, lying for the right-hand, westbound, route. The PPI therefore showed a single white light to the driver of tram 2530 as it approached eastbound. The driver did not react to this warning until the tram was about to pass the PPI, and by the time he applied the emergency brake the tram was passing over the points. The shock of the tram passing over caused the points to spring back to their *normal* position, lying for the *normal* route, where they were found after the accident. Consequently the leading bogie was derailed, and the centre and trailing bogies of the tram were diverted to the left. The tram stopped 37m after reaching the points. It is notable that although this derailment occurred at almost the maximum speed permitted for trams passing over spring-operated points, there were no injuries to passengers or crew and relatively little damage to the tram and the track.

Figure 6: Site plan of the derailment
