Rail Accident Report

Passenger train collision with a road vehicle at Swainsthorpe level crossing, Norfolk

13 November 2005

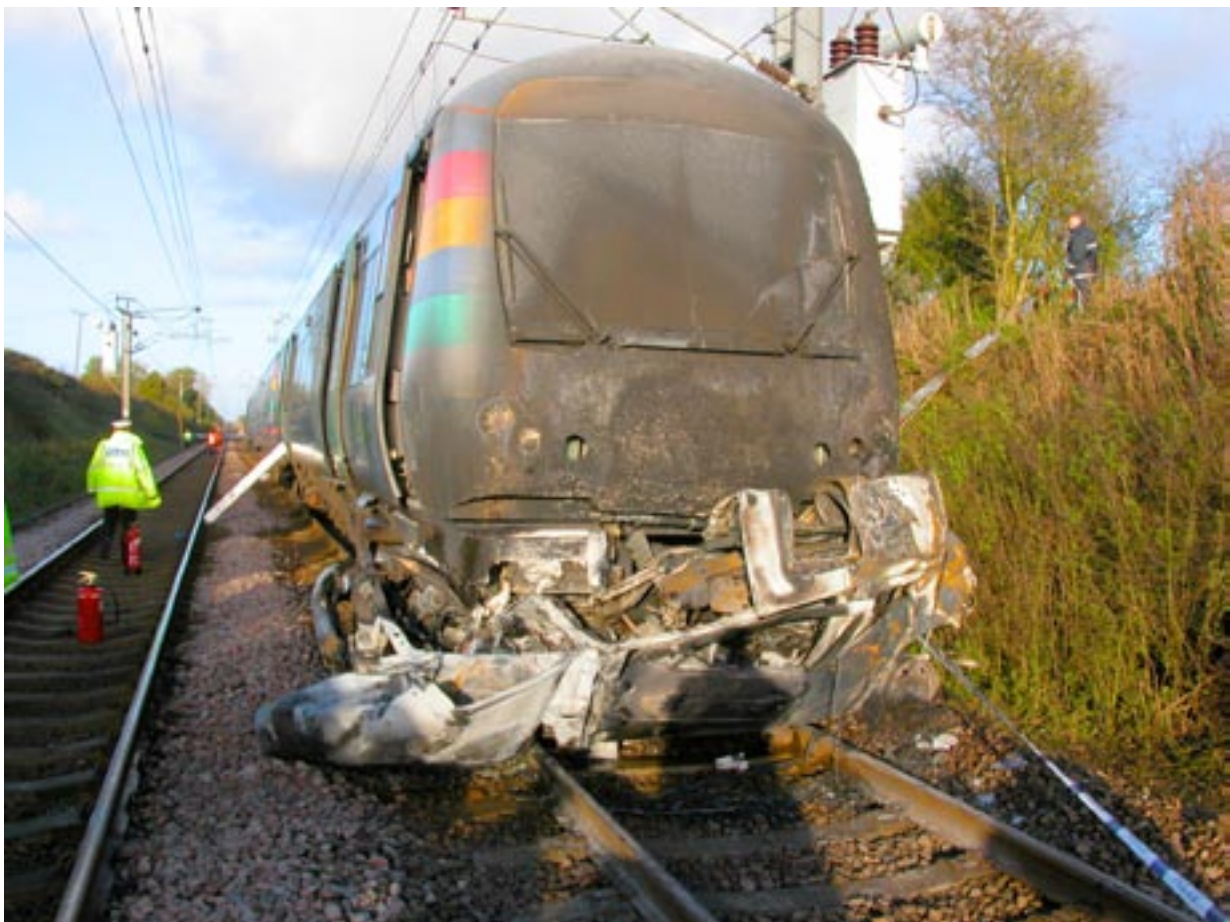
Figure 2: Damage caused to class 170 170207 as a result of the collision (courtesy of Norfolk Police)

train showed that most of the damage occurred to the driver's side cab area of the leading vehicle due to the fire. There was no distortion of the bodyshell structure, and little other mechanical damage – the trailing vehicle suffered some minor bodyside and body structure damage, as well as damage to the power bogie. This is thought to be impact damage from components of the car that became detached as a result of the collision.

27. After the impact, the car caught fire. The fire burnt fiercely as the petrol in the car's petrol tank ignited. As well as the considerable exterior fire damage to the train driving cab and body structure forward of the leading wheelset, the fire penetrated the cab back wall cubicle containing electrical wiring behind the driver's seat, causing significant damage. This issue was examined by AEA Technology on behalf of the vehicle manufacturer, Bombardier, who concluded that the wiring in the cab back wall cubicle probably ignited due to the fact the self-ignition temperature of the insulation was 330 C, whereas temperatures close by had exceeded 660 C – the melting point of aluminium. The performance of wiring insulation is covered by British Standards BS4066 and BS7622, and the fire experienced gave rise to temperatures well in excess of the performance required.

28. The standard used to assess the fire resistance of structural elements of railway rolling stock is BS476: Part 20 'Heating Curve' and specified in BS6853:1999. AEA Technology concluded that the fire seen on the cab front of the train was well in excess of requirements laid down in BS476. Despite this, the extent of the fire was limited due to the fire resistance performance of the vehicle.

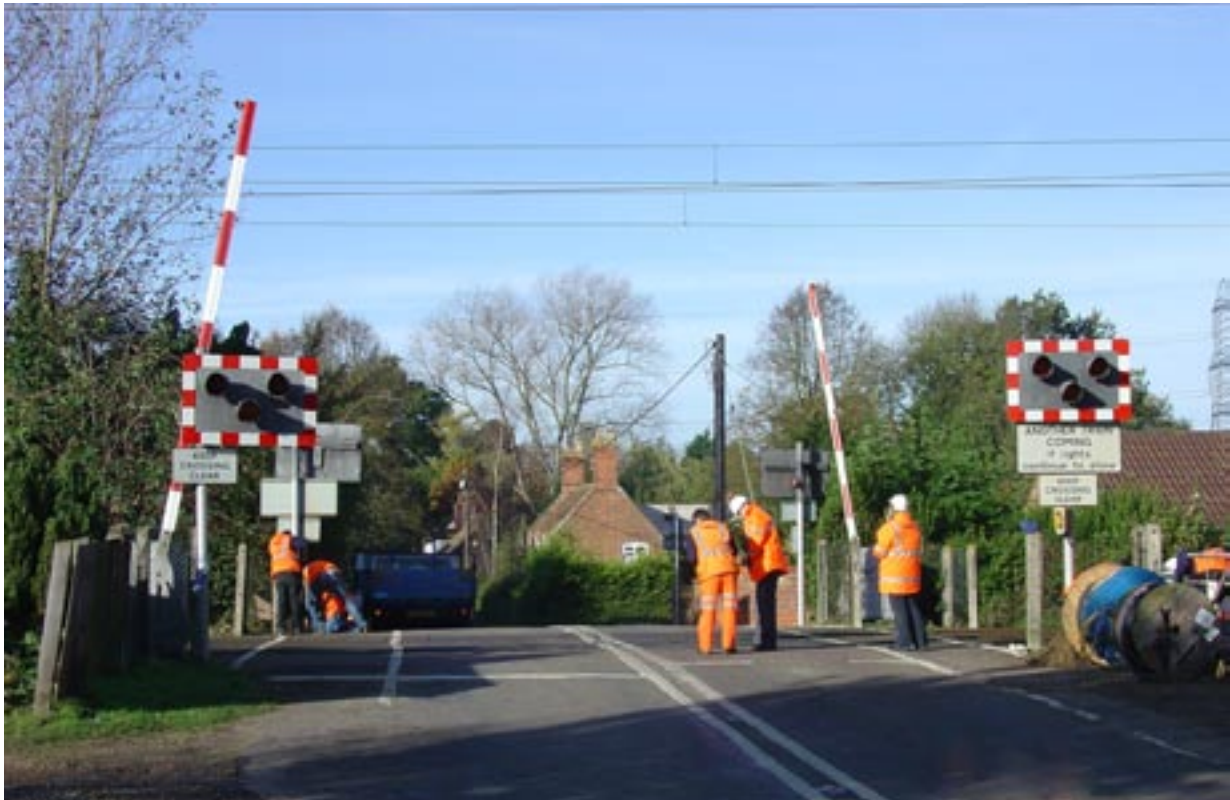
20. The railway between Norwich and Diss consists of double track and is signalled with colour light signals and continuous *track circuiting* controlled from the signal box at Colchester. The AHB level crossing (shown in Figure 3) is located at 109 miles 54 chains from Liverpool Street Station and comprises standard flashing road traffic light signals, audible alarms and lifting booms that close off the nearside half of the carriageway width in each direction. Assuming normal operation, for trains running at the maximum permitted speed of 100 mph (161 km/h), the lights illuminate at least 27 seconds before a train's arrival, and the booms are fully lowered at least eight seconds before a train's arrival. Emergency telephones are fitted on the offside of the crossing on both sides that connect to Colchester signal box. An 'Instead' 64 datalogger is fitted which monitors and records the operation of the level crossing. Located 183 m before the crossing on the *Up* line, there is a *two-aspect colour light signal* which the level crossing datalogger indicates was showing green as the train approached it

Figure 3: General view of the eastern (*Up* side) approach to Swainsthorpe level crossing

25. The level crossing datalogger was downloaded under the control of the RAIB, and this confirmed that the road traffic light signals and *crossing booms* had been working correctly as reported by the witness interviewed by the BTP. The RAIB Lead Inspector considered that full *wrongside failure testing* was not necessary given the clear witness evidence and agreed the scope of more limited *functional testing* of the level crossing equipment, prior to re-opening, with Network Rail. This acted as a further confirmation that the crossing had worked correctly. The testing was carried out during the night following the collision, and the key elements of the test were witnessed by the RAIB. As a result of the testing, Network Rail renewed three cables that were found with resistance values lower than those specified in maintenance documentation. The datalogger records showed that the low resistance values had no effect on the operation of the level crossing before the collision occurred. The operation of the crossing was neither a causal nor a contributory factor in the collision.

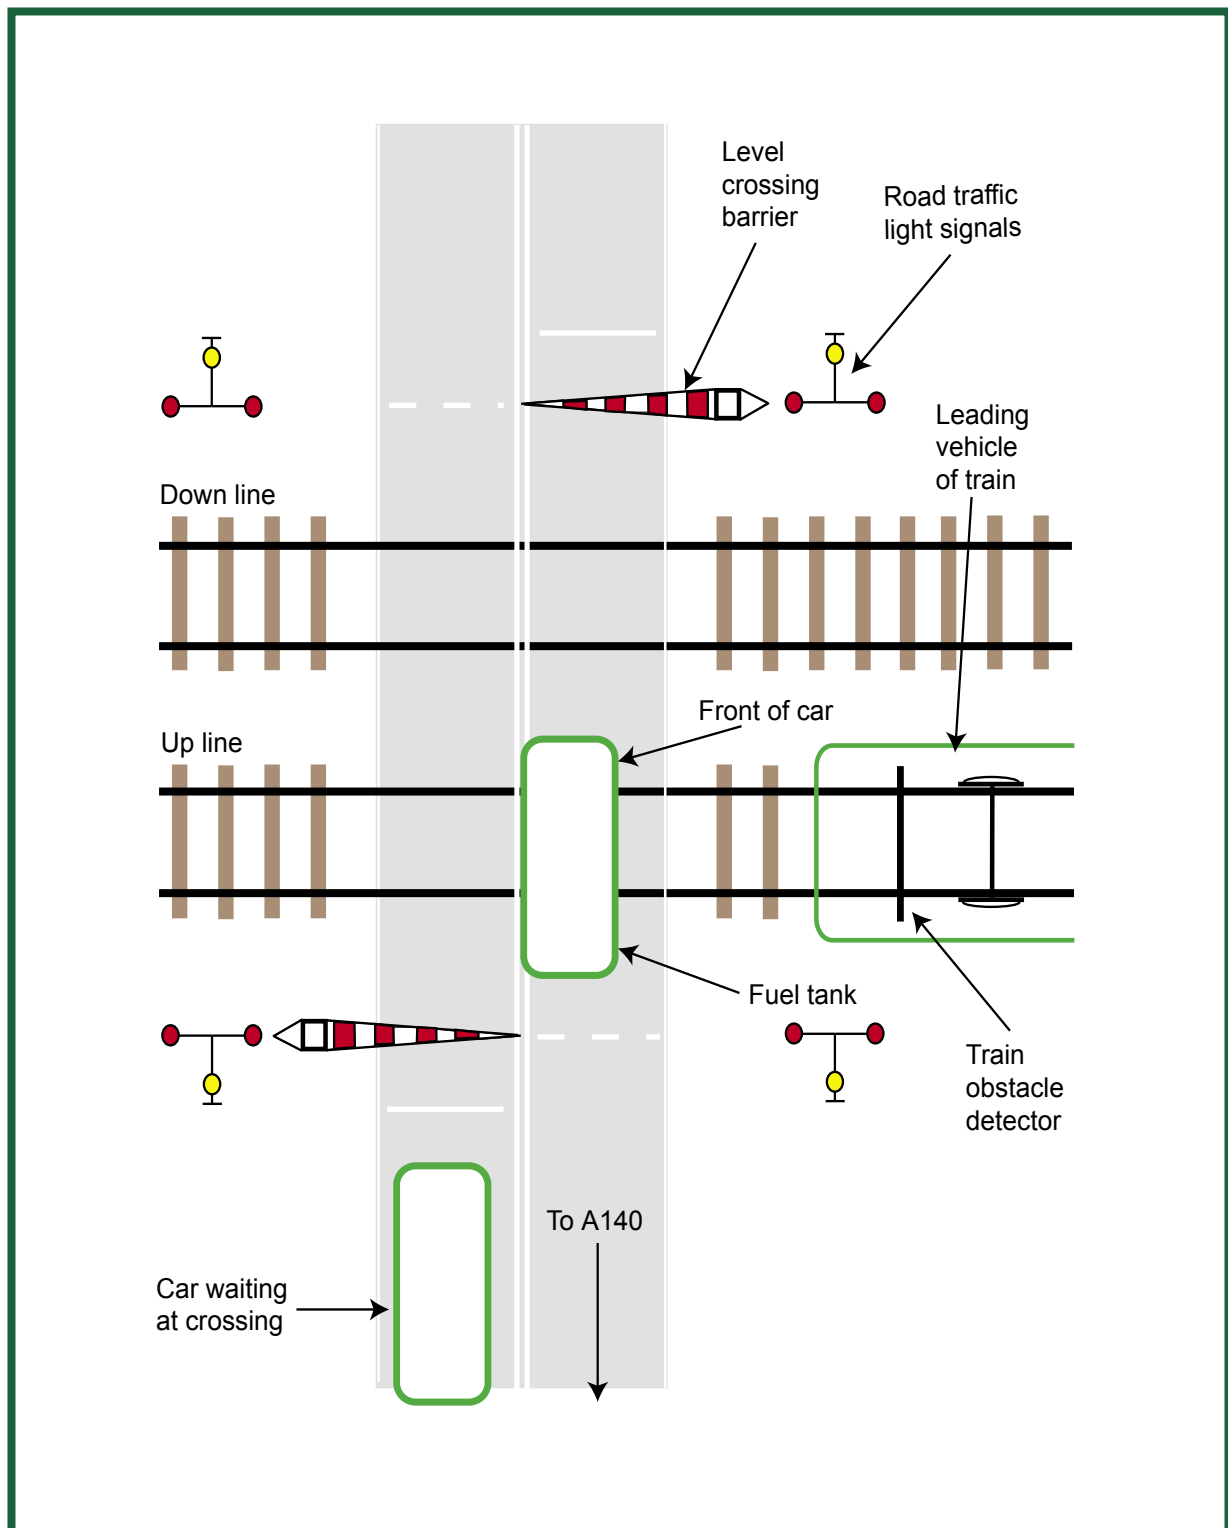
16. Appendix B Figure 4 shows the relative positions of the car that was positioned on the crossing and the car that was correctly waiting before the flashing road lights on the east side of the crossing just before the collision occurred.

Figure 4: Diagrammatic representation of relative positions of train and cars at impact

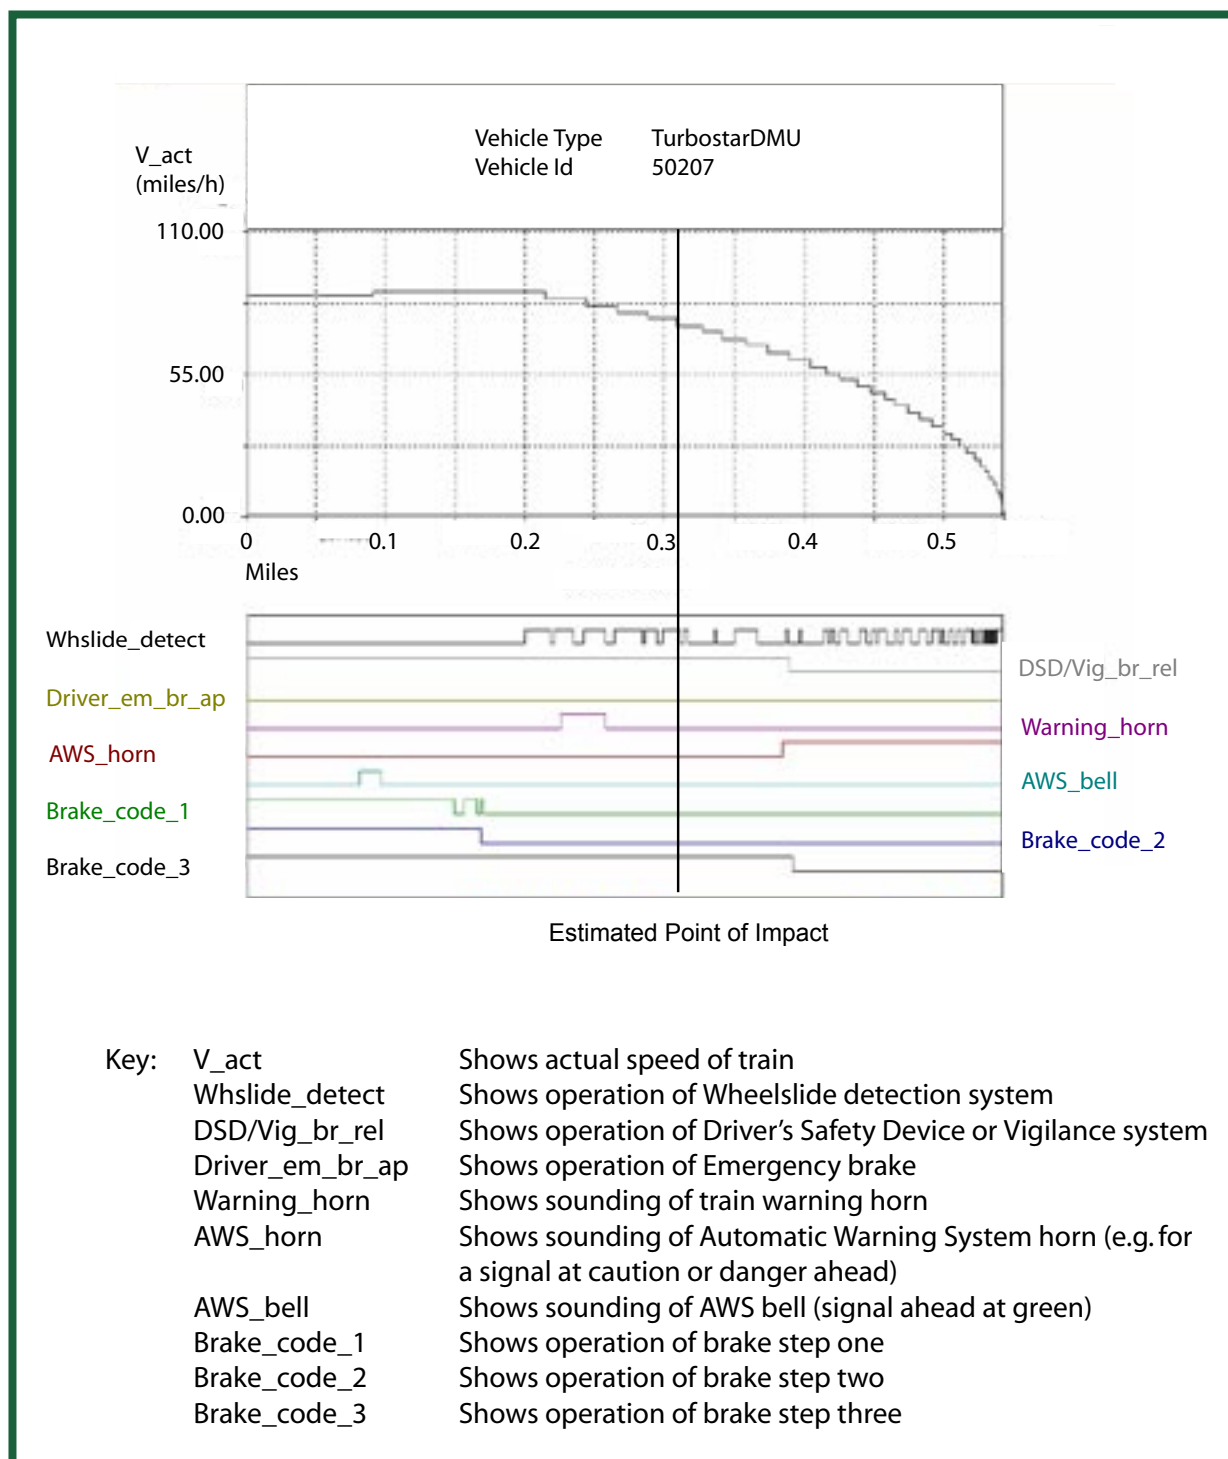
23. The RAIB oversaw the downloading of the train data recorder, and this shows that from the point the driver first made a continuous brake application, the train took 602 m to stop. The data recorder also indicates that the continuous brake application was made 226 m from the crossing following which the horn was sounded 131m from the crossing. From the results of the train data recorder, it is estimated that the train hit the car at a speed of 77 mph (124 km/h).

24. The train driver thought that he had applied the brake into the emergency position, whereas the data recorder indicates that he had applied the brake into the 'Step 2' and 'Step 3' positions instead. The emergency position provides an enhanced braking capability. However, given the time for the brakes to apply following operation of the driver's brake handle, and the distance the train was from the crossing, calculation shows that an emergency brake application would have further reduced the speed of the train by less than 5 mph. It is unlikely therefore that this would have made any difference to the outcome of this collision. A copy of the data recorder download is in Appendix C Figure 5.

Figure 5: Data Recorder download trace from the leading vehicle no. 50207 of train 1G33
