Rail Accident Investigation Branch

Rail Accident Report

**Freight train derailment at Hatherley, near
Cheltenham Spa
18 October 2005**

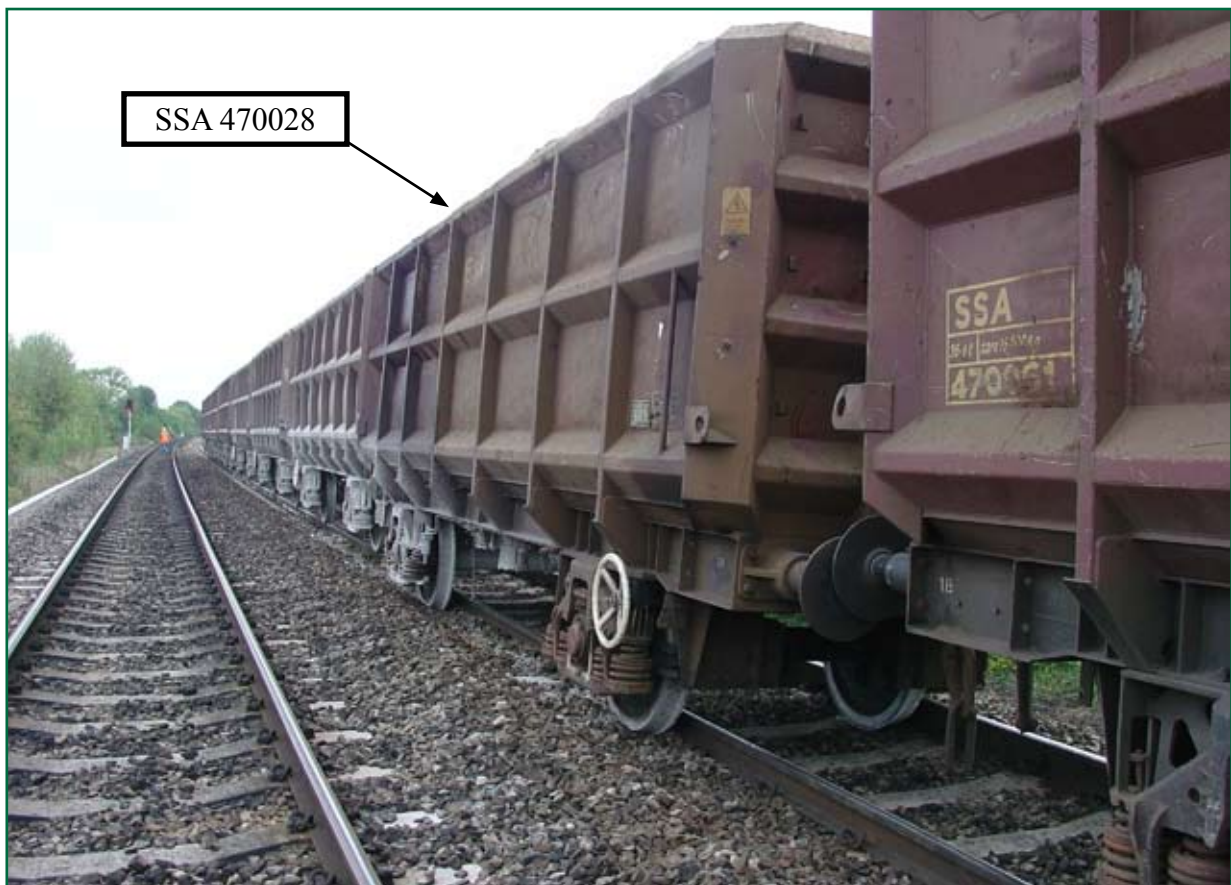
Figure 2: SSA 470028 after derailment

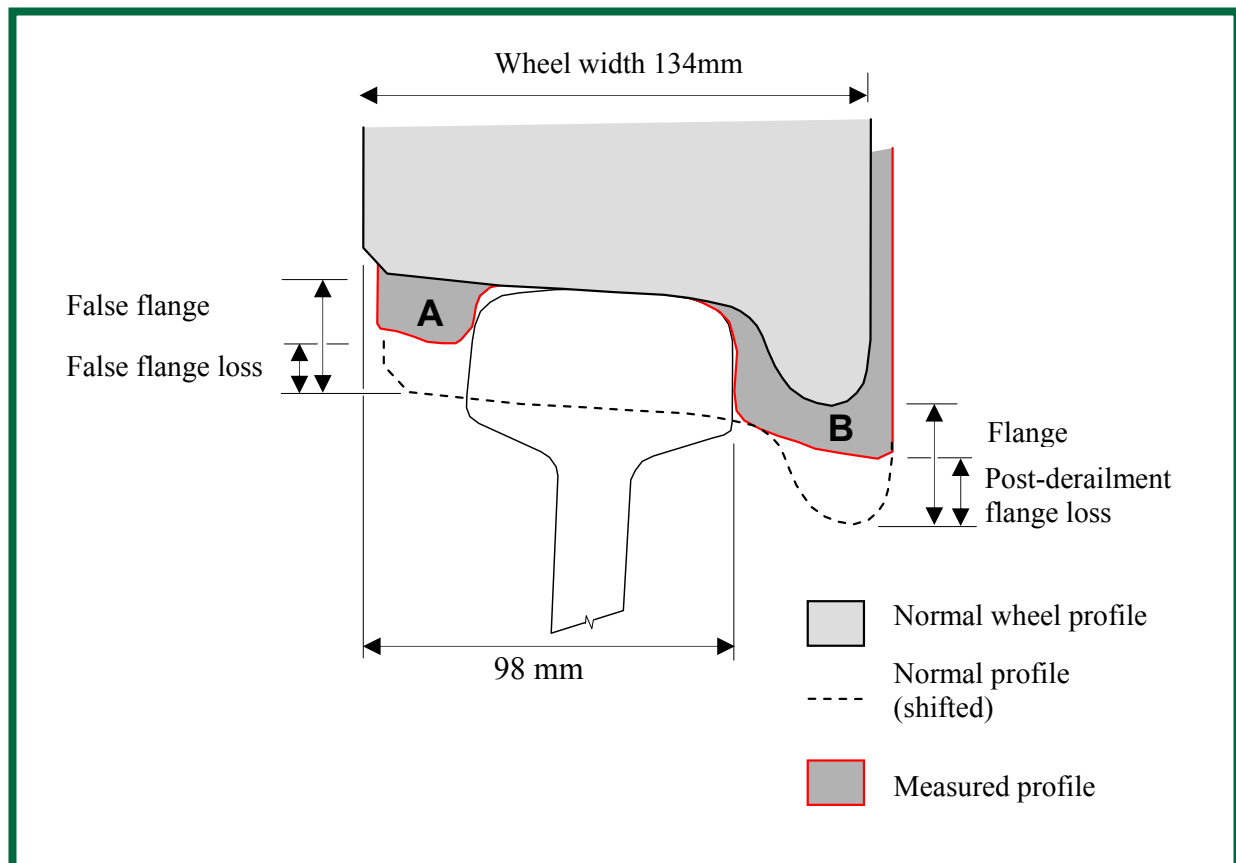
56 Having departed from Bescot Yard with the handbrake on, Wagon SSA 470028 ran with the leading wheelset dragging (ie not properly rotating). This had the effect of gradually wearing down the profile of the wheels, leading to an increased flange depth and allowing a false flange to develop as the centre part of the tread wore away (Figure 4). The normal profile of a rail wheel is such that it allows limited movement across the rail head. With the second (false) flange, the effect was for the wheel to 'clutch' the railhead, impacting with obstacles in its path. The majority of the flange loss indicated in Figure 4 occurred as the wheels ran on their flanges over ballast and sleepers for 4 miles post-derailment.

Figure 4: Profile of SSA 470028 Wheel 2A (leading left wheel) and illustration of flattened wheel profile wrapping around the rail head. The false flange is indicated at **A**, and the increased flange depth is shown on the opposite side at **B**.

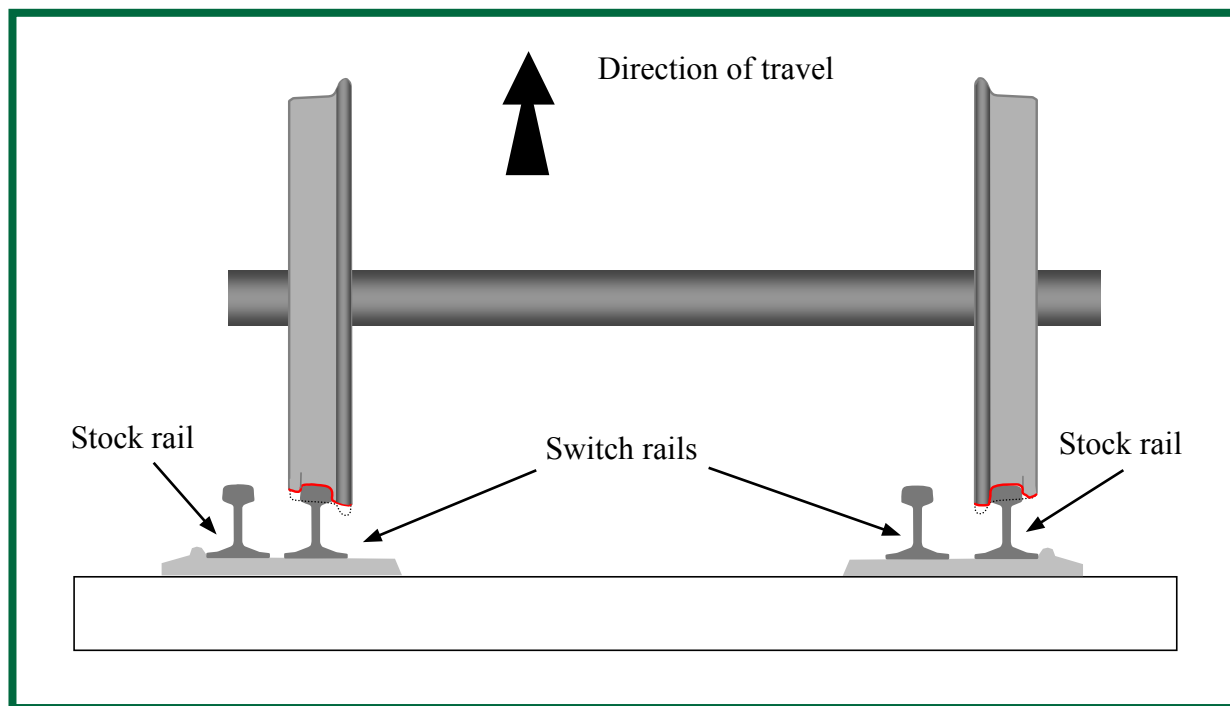
- 60 The derailment commenced as the leading wheelset passed through 673B points (trailing) which form the exit to the Down Goods Loop near Hatherley. The left wheel followed a similar path to that taken at 669A points, in that the false flange dropped between the left hand *stock rail* and *switch rail*, experiencing an increasing lateral force to the right as the rails converged (Figures 5 and 6).
- 61 The derailment sequence has been deduced from the damage and markings on site and is illustrated below. Sleeper 0 is located at the point of derailment (POD), which was identified as being at the toes of 673B points.

Figure 5: False flange on left wheel drops into gap between converging stock and switch rail at 673B points, 12 sleepers before point of derailment.

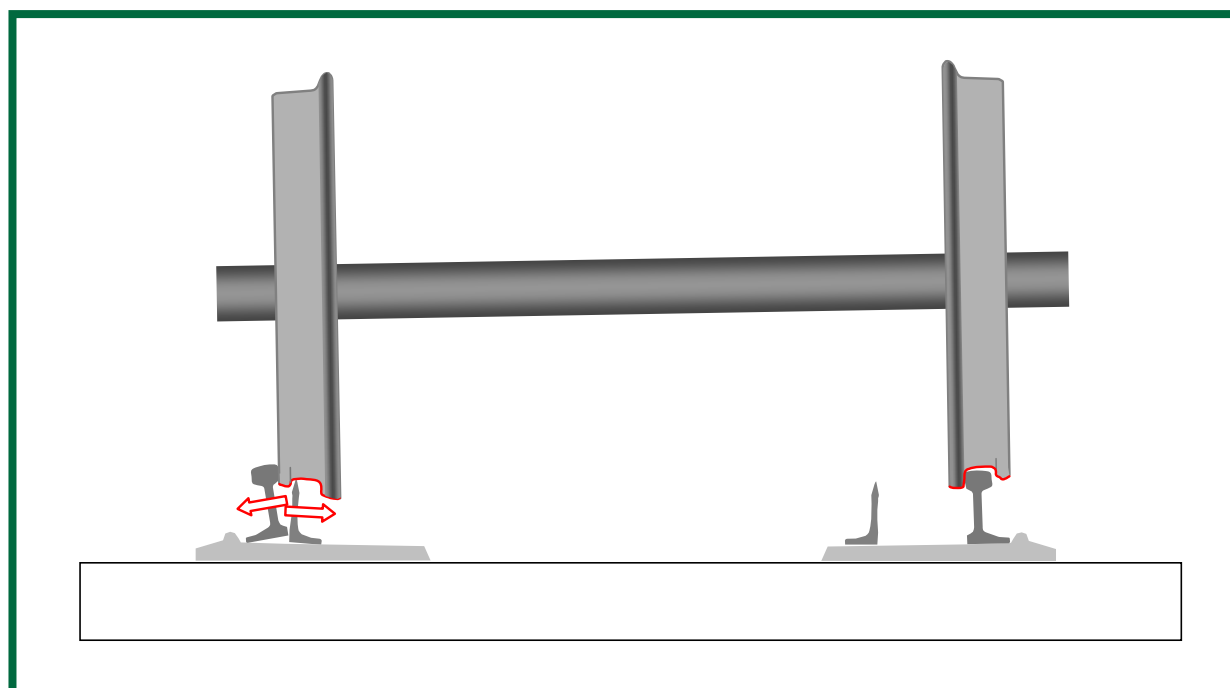
Figure 6: Six sleepers before point of derailment. As left-hand stock and switch rails converge, the stock rail is displaced to accommodate the false flange on this wheel. The left wheel is now running below the rail head.

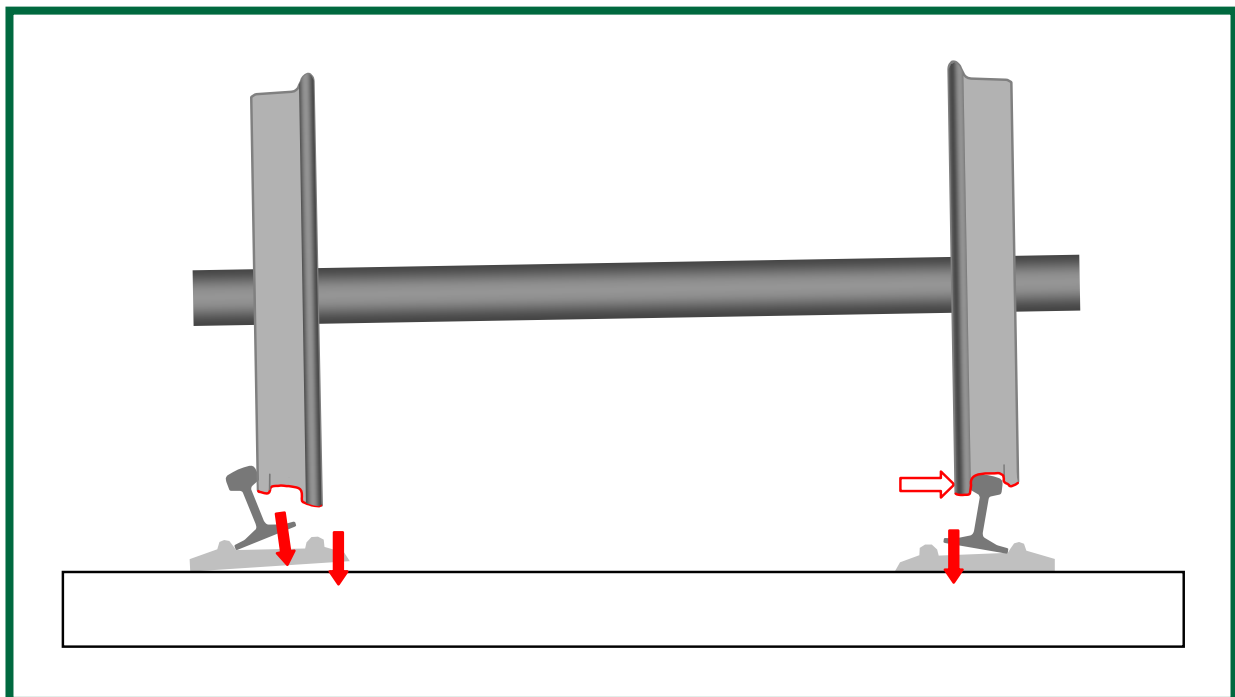
- 63 The leading wheelset continued to skid in this partly derailed configuration (Figure 7), with the tread (outer) face contacting the *gauge face* of the left rail. Gauge widening was accommodated by the partial overturning of the left rail, evidenced by lifted and fractured baseplates and displaced rail clips from the *gauge side* of the left rail (Figure 8). The resistance to gauge spreading forces on the next length of track was sufficient to prevent the left wheel descending onto the ballast, but not high enough to force the wheel back into the normal running position, as was the case beyond 669A points.

Figure 7: One sleeper after point of derailment. High lateral forces are developed by track's resistance to gauge spreading following partial derailment of left wheel. A 98 mm effective gauge increase was accommodated by lifting of baseplates and failure or displacement of 'Pandrol clips' (see Appendix B), resulting in outwards rotation of left rail.

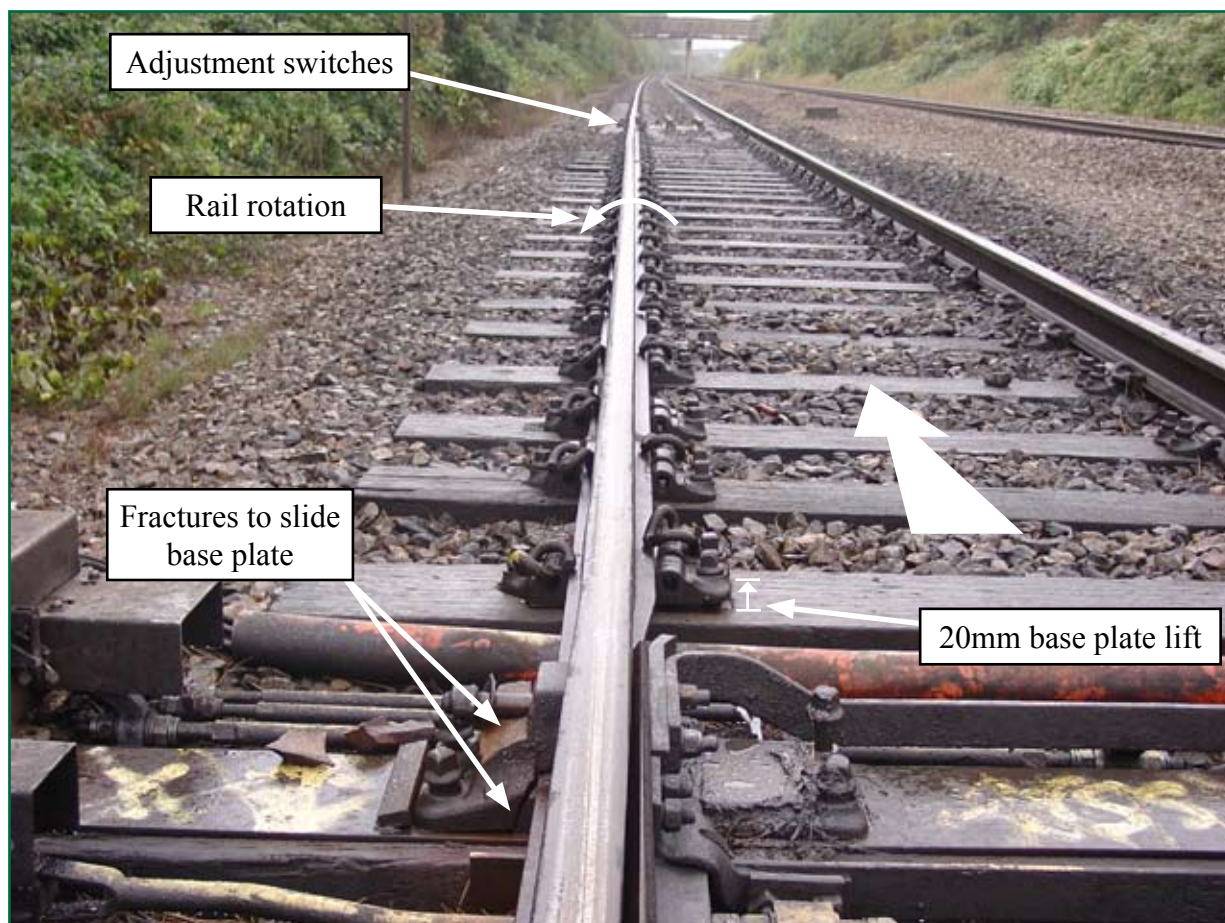
Figure 8: View along left hand rail in direction of travel from toes of 673B points showing rotated rail, lifted baseplates and displaced rail clips. The partially split points are visible in the foreground as a result of the action of the false flange at the point of derailment of the first wheel (sleeper 0). The adjustment switches, where full derailment occurred, are visible in the background.

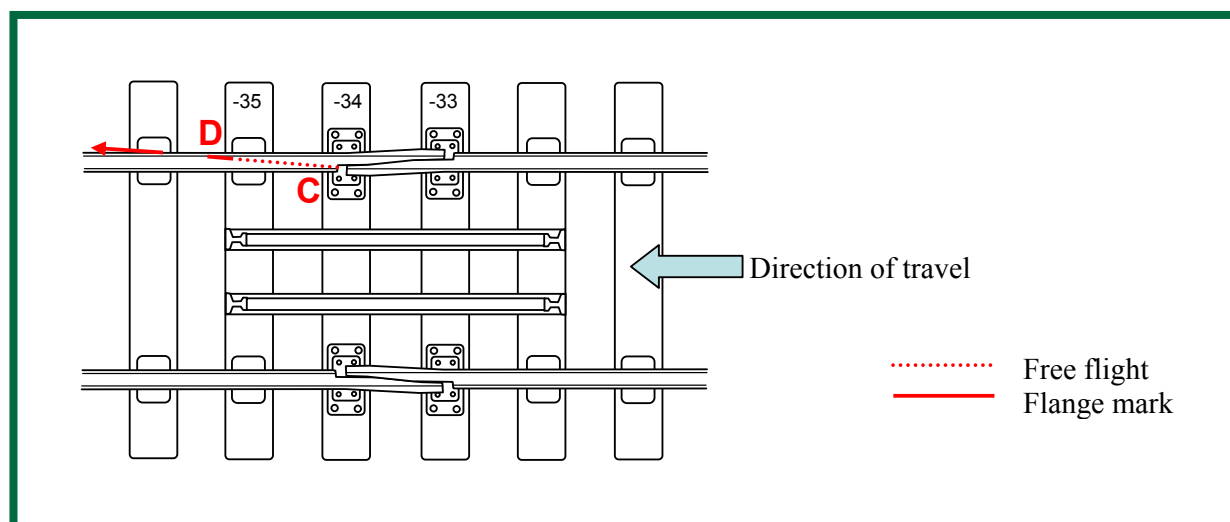
- 66 Rail markings showed that the right wheel flange made contact with the machined notch on the right hand rail (point C, Figure 9) as a result of the high lateral forces imposed on it. The wheel struck the notch and was catapulted into free flight for a distance of 700 mm, releasing the gauge spreading force which resulted in a lateral movement to the right (Figure 10). The flange landed on the rail head and lacking lateral restraint, descended onto the ballast (Figure 11) derailing to the *field side*.

Figure 9: Full derailment triggered by impact of right wheel with machined notch in adjustment switch layout (C). Flange landed on rail head after free flight of approx 700 mm at (D). Sleeper numbers are indicated. Figure 11 uses the same notation.

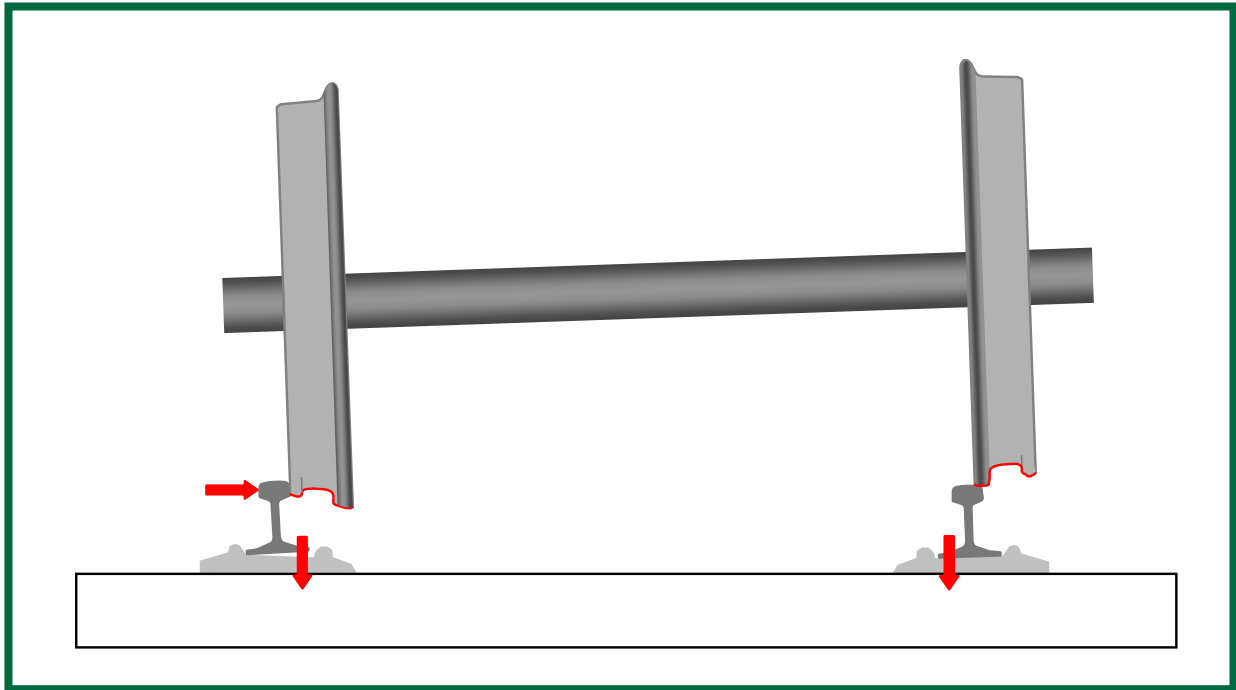
Figure 10: 35 sleepers after the point of derailment. As right wheel passes adjustment switches, it is catapulted into free flight. Resistance to gauge spreading forces exerted by the left rail caused the wheelset to be displaced sideways leading to full derailment to the right.

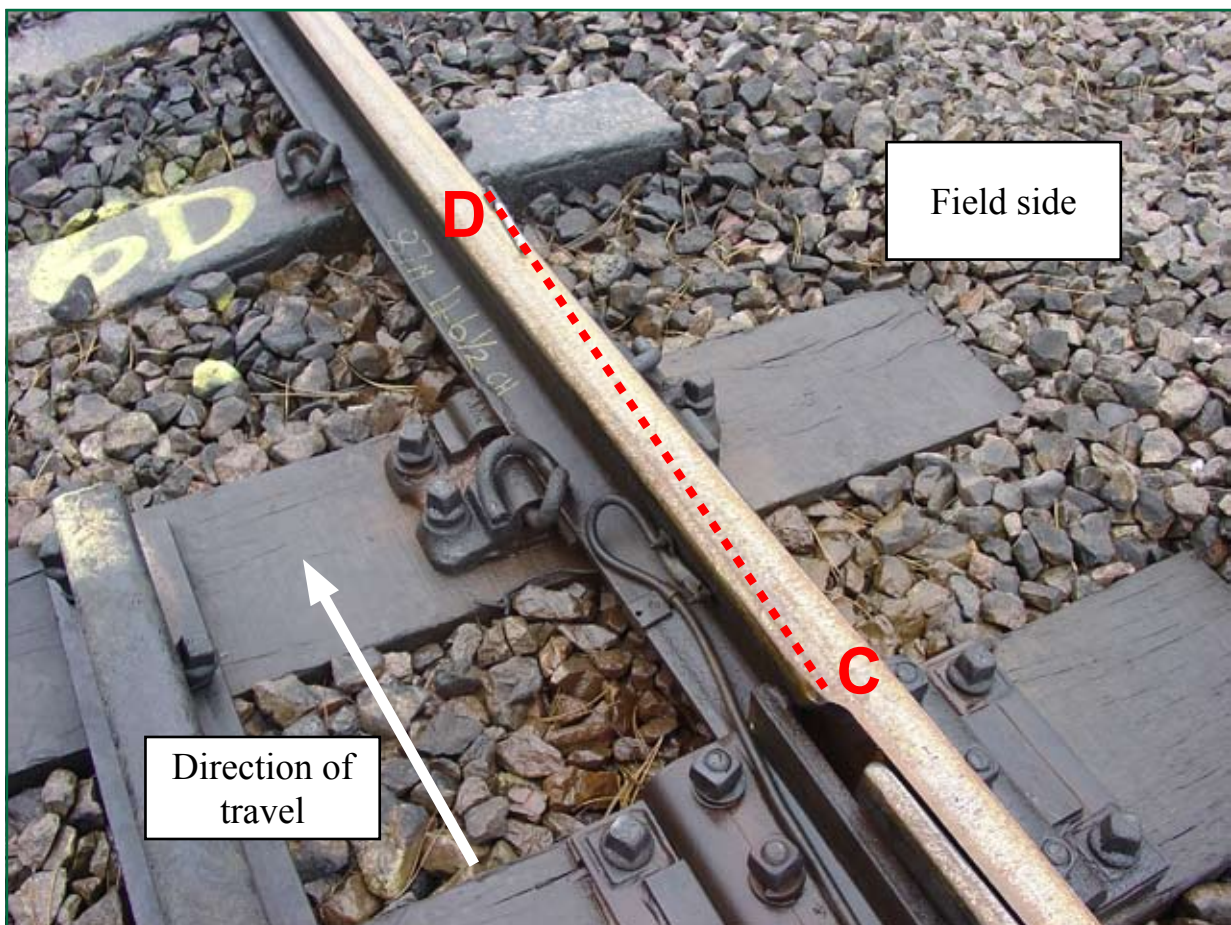
Figure 11: Photograph of adjustment switches showing point of impact with the machined notch (**C**) and derailment mark indicated by the position of the pen on rail head (**D**) where right hand wheel landed after being in free flight for 700 mm (grinding marks are visible on the rail head, showing light corrosion following overnight rain).

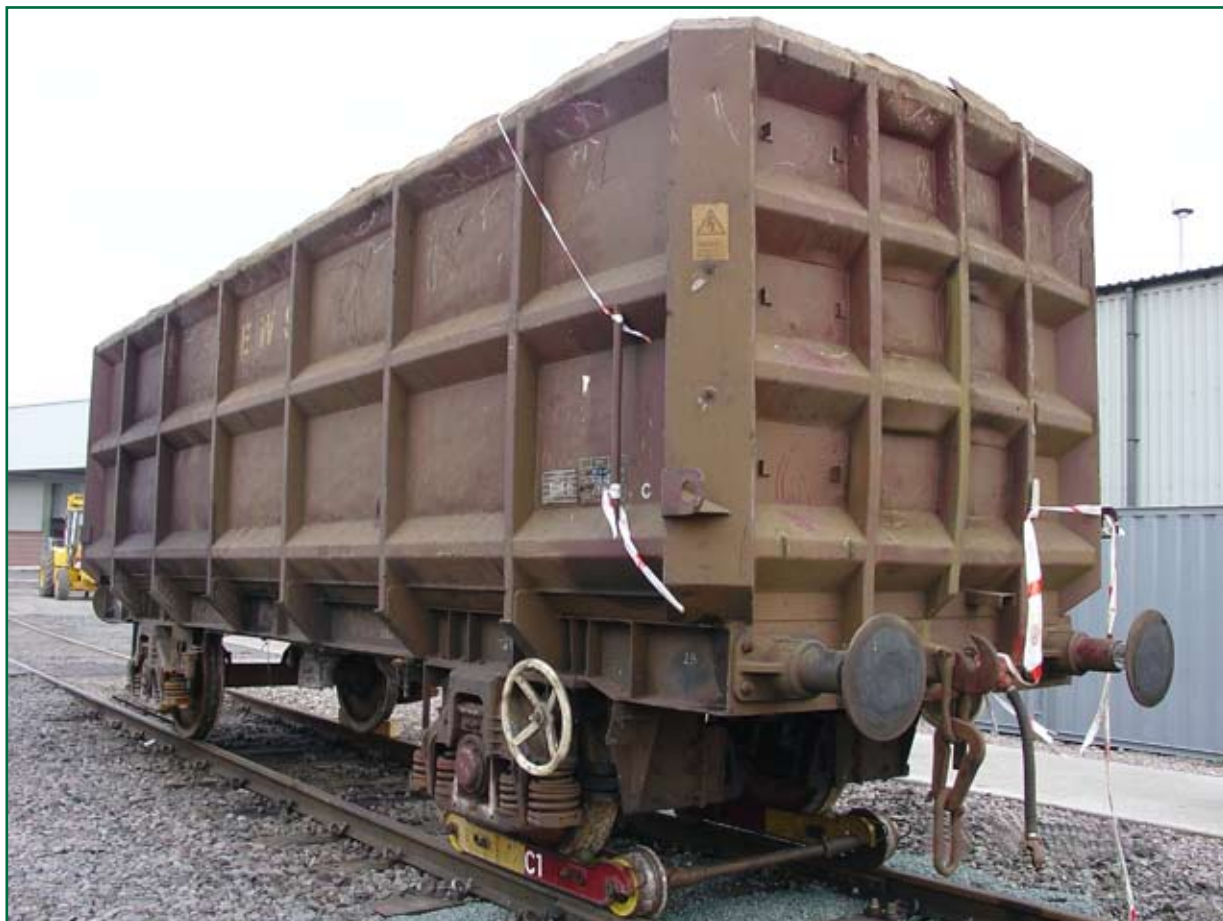
Figure 12: SSA 470028 after recovery to Toton Depot with wheel skate (marked C1) used to move the wagon with its damaged wheelset after the derailment

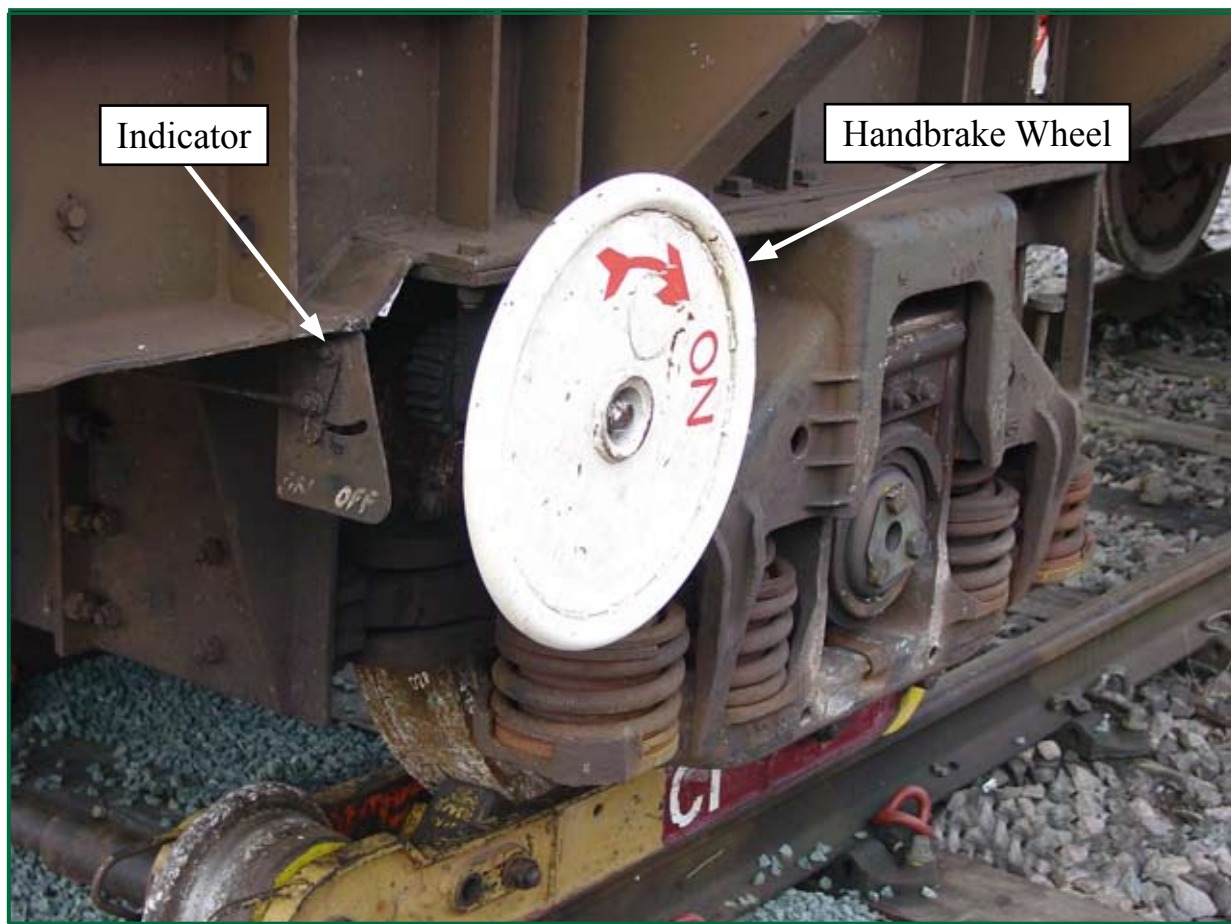
Figure 13: Handbrake wheel and indicator on SSA 470028

- 91 The handbrake indicator on the left side of the vehicle clearly showed the handbrake was 'on'. On the right side the indicator was approximately halfway between 'on' and 'off' and the lettering was not clearly legible. A check of the brake rigging on site confirmed the pads were firmly up against the discs. Tests on the left hand handbrake wheel also confirmed that the handbrake was almost fully on; it was $5\frac{3}{4}$ turns towards 'on', with the maximum possible number of turns on this vehicle being $5\frac{7}{8}$. Additionally, the handbrake wheel was found to be noticeably stiff to turn in both directions.

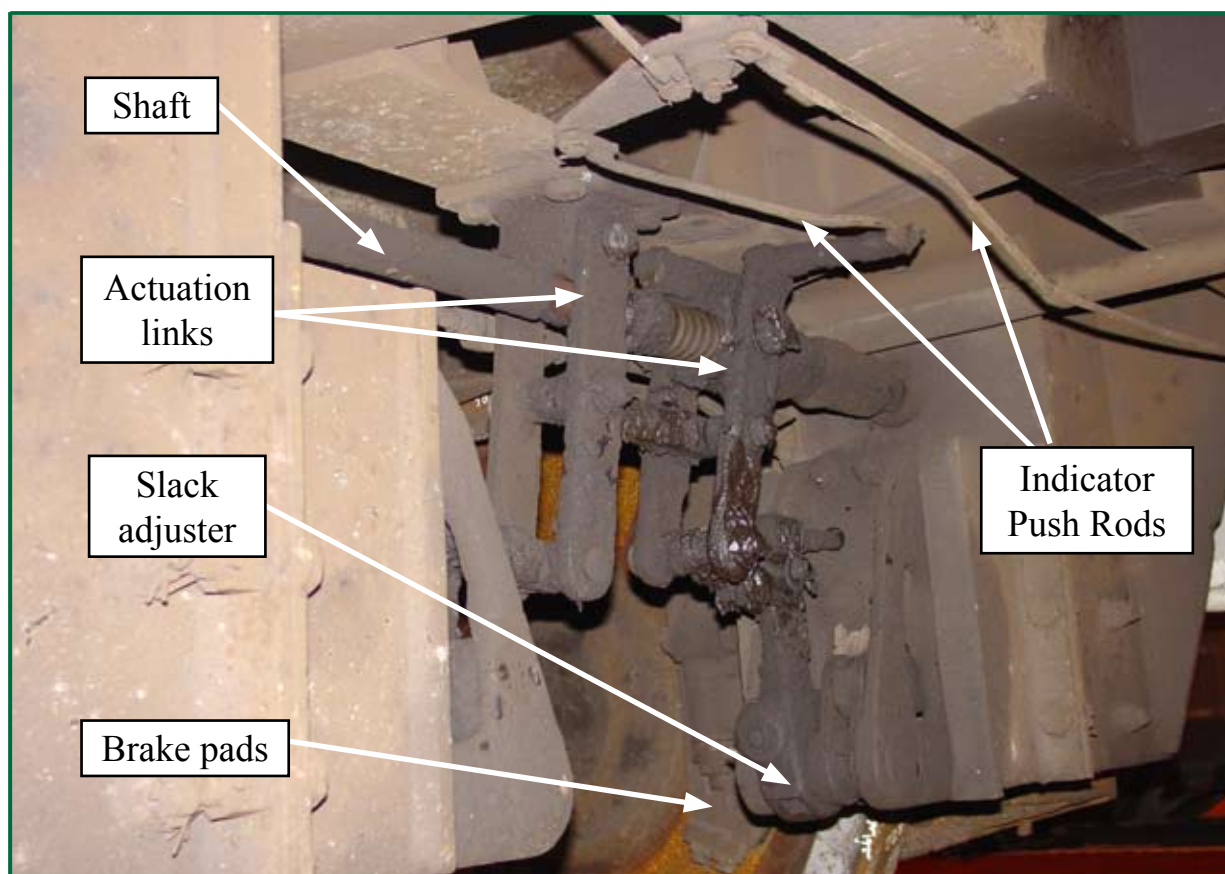
Figure 14: SSA 470028 handbrake components below the underframe.

- 112 The reason for the stiff handbrake (paragraph 110) was traced to the handbrake shaft. This was found to be bent by approximately 10 mm near one end, which caused the shaft to rotate eccentrically when the handbrake wheel was turned. The cause of the deformation is not known but, from the pattern of detritus, it appears to have been in this condition for some time.

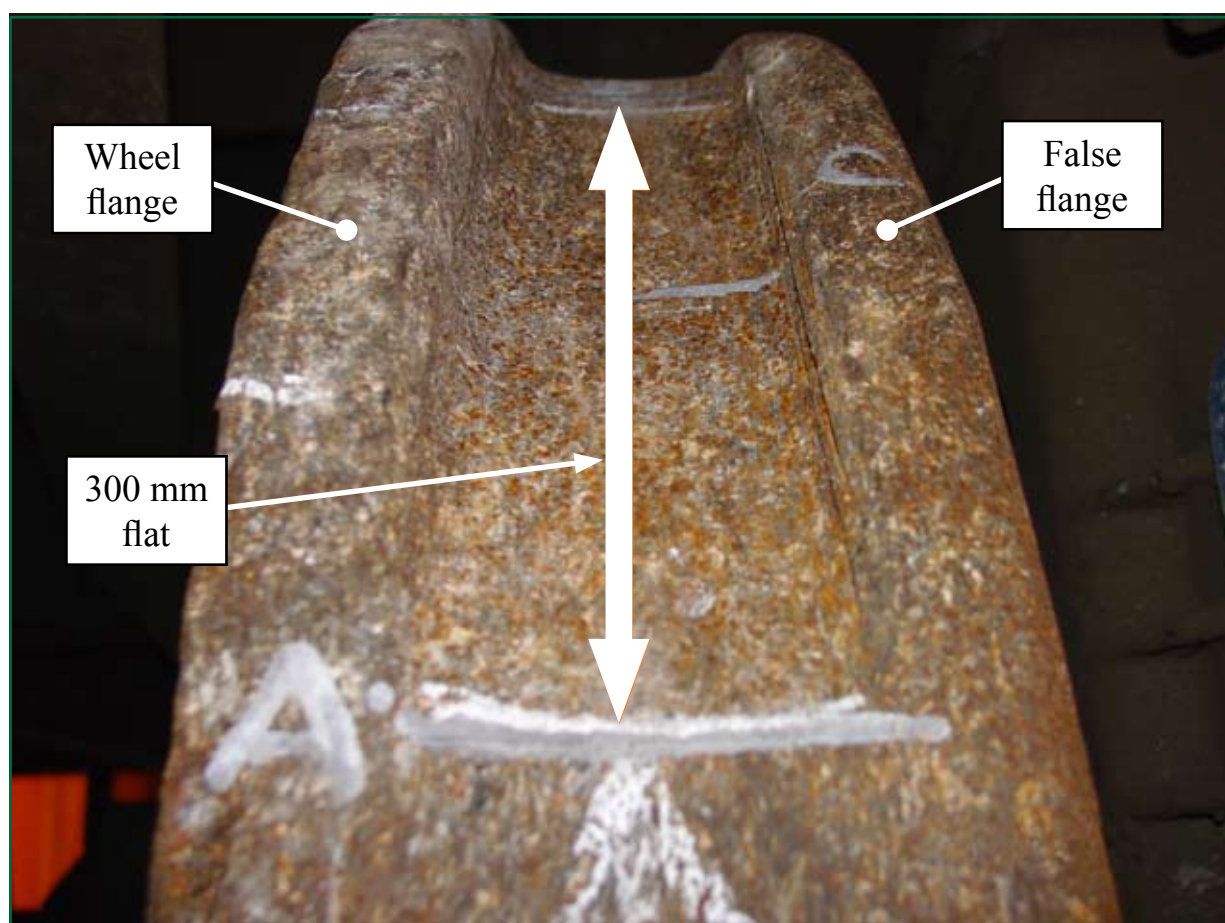
- 8 The immediate cause of the derailment was the interaction between *false flanges* (Figure 15) which had developed on the leading wheelset of SSA 470028 and 673B *trailing points* at Hatherley. This resulted in the wheelset riding up over the railhead and derailling to the right (*six foot*) side, approximately 20 m further down the track.
- 9 The false flanges had developed as a result of the leading wheelset being dragged from its origin at Bescot Yard to the point of derailment with the handbrake applied.

- 48 SSA 470028 suffered extensive damage to the leading (handbraked) wheelset, each wheel of which had developed large flats and deep false flanges (Figure 15). Additionally, there was also some suspension damage.

- 99 The principal features of the leading wheelset were the large flats, approximately 300 mm in length and deep false flanges which had developed on the wheels, as shown in Figure 15.
- 100 The distance required to create such large flats is dependant on many factors and there is no rigorous method for evaluating the distance dragged. However, it has been estimated by Serco Assurance, based on evidence from previous incidents in which wheelsets have run in a seized condition for long distances, that this wheelset had been dragged a distance consistent with an origin at Bescot. It is therefore unlikely that the handbrake had been left on prior to arrival at Bescot Yard. The previous occasion when the handbrake could have been applied was at Washwood Heath on 17 October.

Figure 15: Large wheel flat and false flange on right leading wheel of SSA 470028

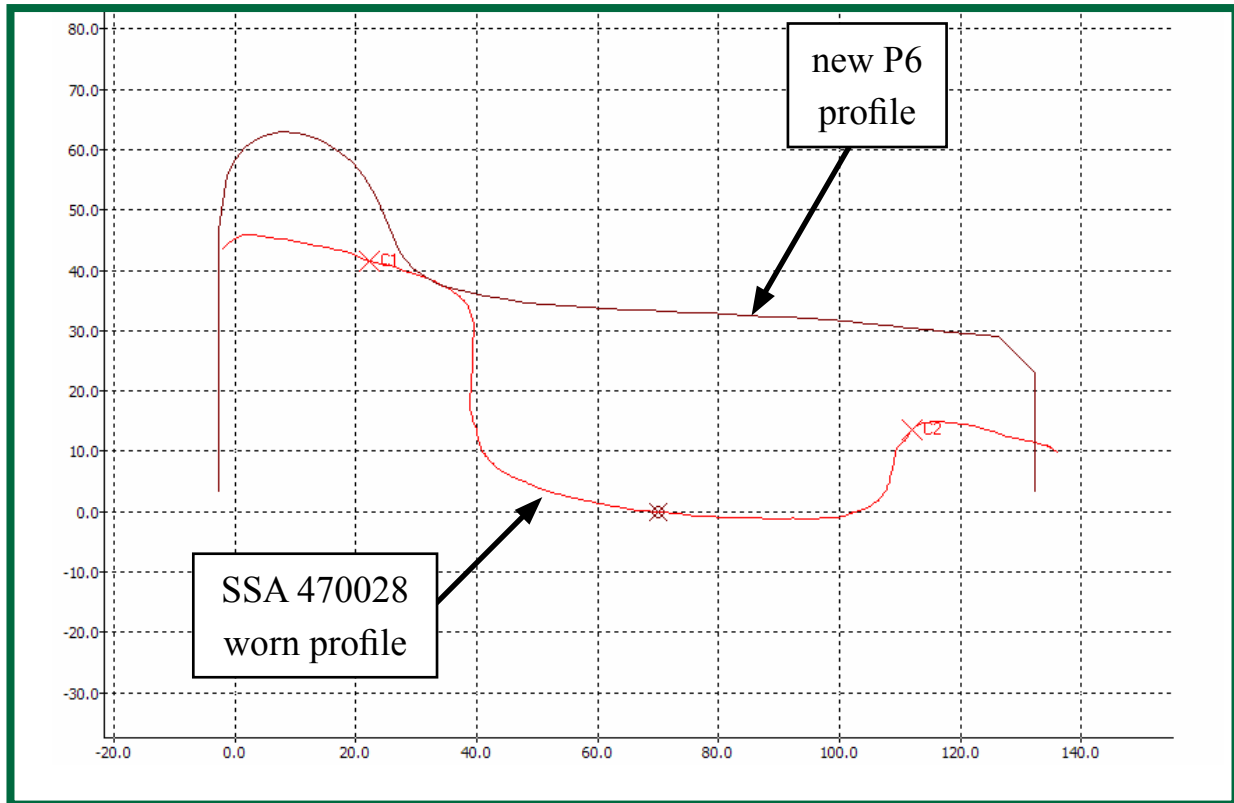
101 The profiles of the two wheels are shown in Figures 16 and 17. The different depths of the two false flanges, measured at the centre of the flats, is attributed to post derailment impact damage; the left wheel suffering more damage than the right. Some of this damage may have resulted from impacts with track components before derailing as explained in paragraph 57.

Figure 16: Profile of left leading wheel near centre of large flat

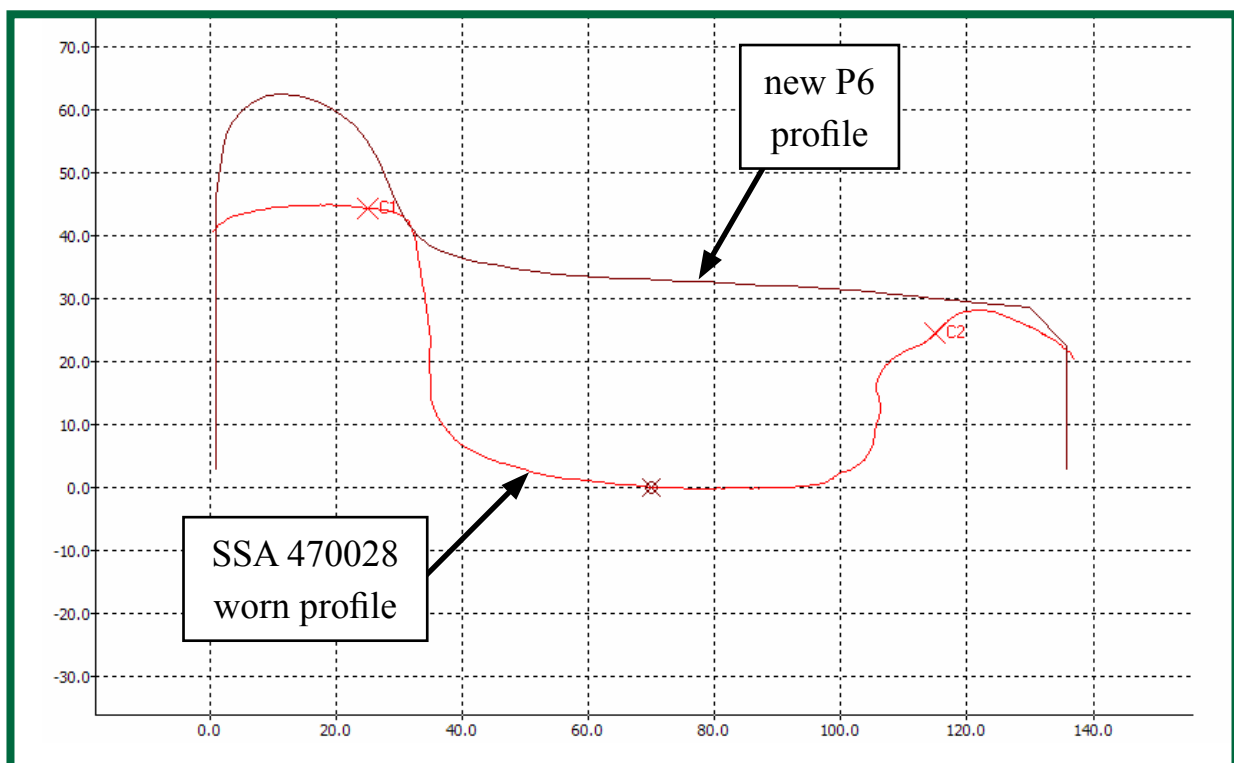
Figure 17: Profile of right leading wheel near centre of large flat

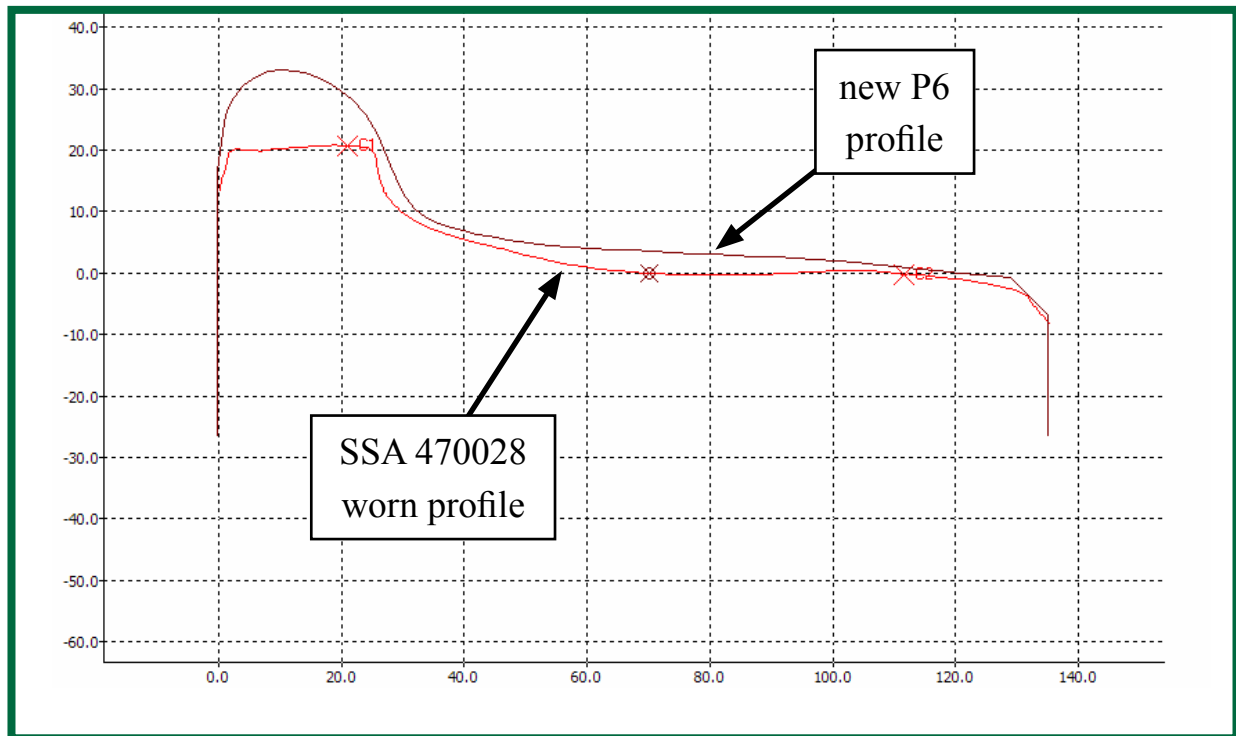
102 Each wheel of the leading wheelset also exhibited a uniform 'groove' similar in appearance to hollow wear, approximately 2-3 mm deep, around three quarters of the circumference (Figure 18). Over the remaining quarter, the depth of this groove increased in depth up to the trailing edge of the large flat.

Figure 18: Profile of right leading wheel showing uniform groove pattern due to slow rotation and wear during early part of journey.

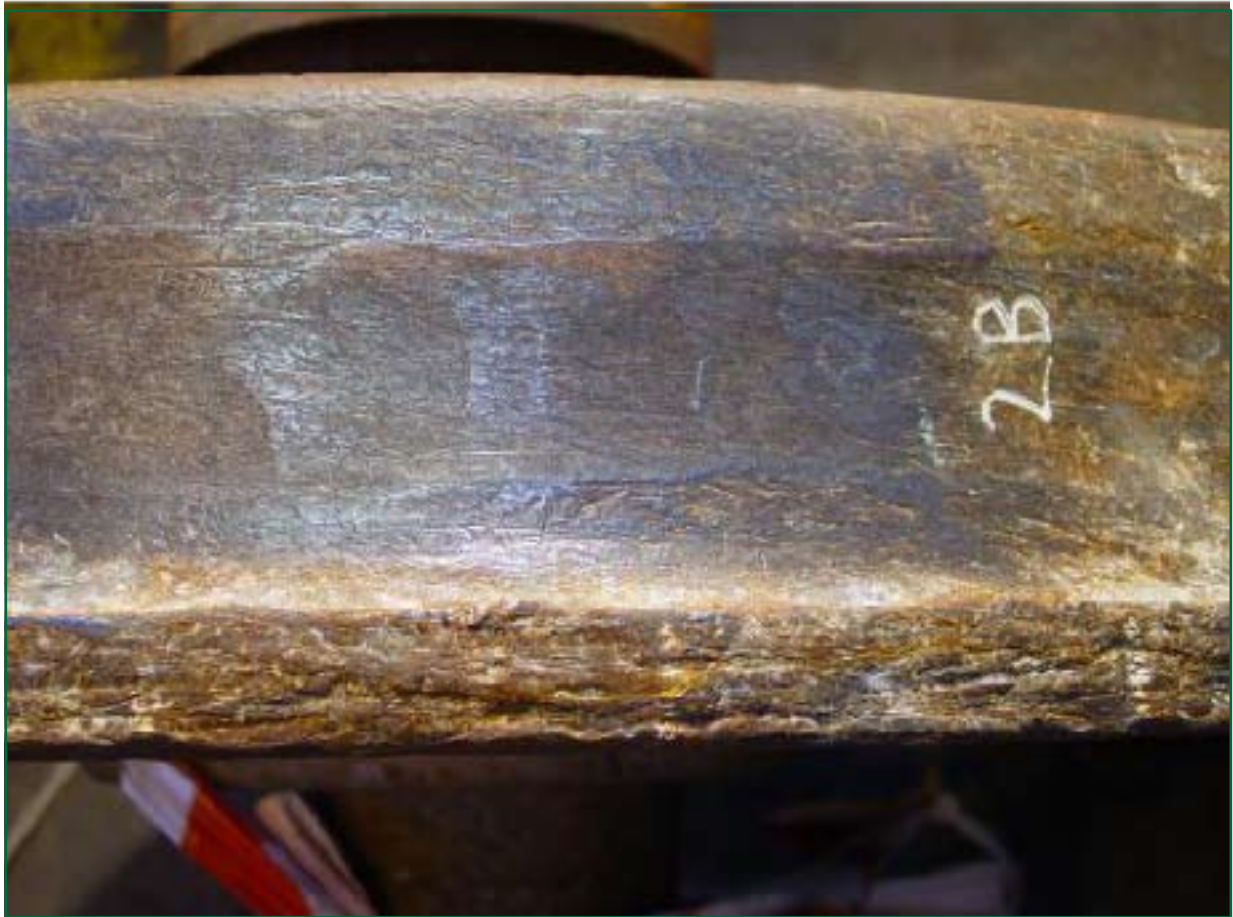
105 It is considered that the leading wheelset was initially locked (due to the handbrake being left on) when it began its journey from Bescot Yard, based on evidence from skid tests as explained later in paragraph 117. However, as the journey progressed the wheels appear to have crept round against the brake pads. This resulted in gross slip and wear at the wheel/rail interface around the whole circumference of the wheels and the formation of the uniform groove. Detailed examination of the surface of the groove (Figure 19) revealed evidence of metal flow consistent with this.

Figure 19: Surface the uniform groove, visible after gentle burnishing.

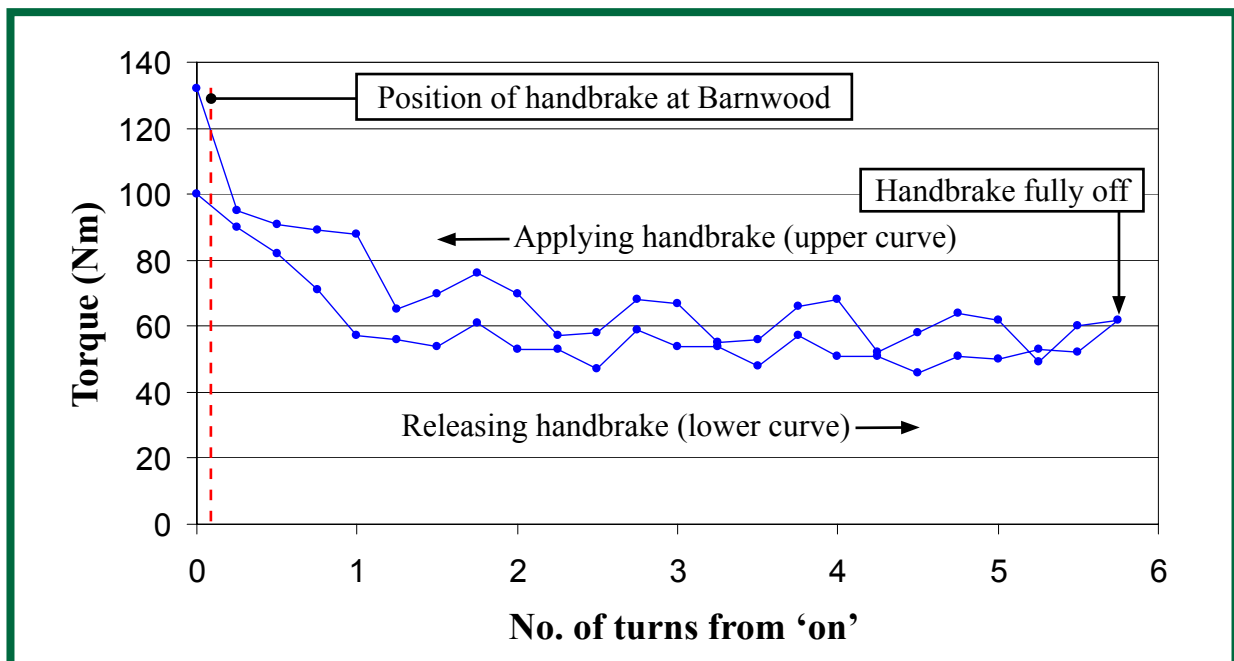
- 110 The handbrake on SSA 470028 was tested three times from each side (six in total), turning the wheel through its full range. On each test, the wheel was found to be stiff to operate, requiring torques of between approximately 50 and 70 Nm to turn it from 'off' to within two turns from 'on'. Thereafter it rose sharply, over the final two revolutions. There is no specification for the allowable maximum torque in the maintenance procedure. Figure 20 shows the variation of torque with number of turns. The position the handbrake was found at Barnwood is also shown.

Figure 20: Observed variation of applied torque with turns of the handbrake wheel on SSA wagon 470028

- 111 The torque was also found to vary cyclically within a revolution of the handbrake wheel, particularly when applying the handbrake (upper curve in Figure 20). The possibility was considered that this cyclic variation could have led ground staff, reliant on the sense of feel alone, to believe that a handbrake was 'off' when it was actually 'on'. However, at the position found post-derailment, the handbrake wheel did not exhibit cyclic variation and the wavelength of the variation elsewhere was too short to cause confusion if the correct handbrake release routine was used. Nevertheless, it is conceivable that if the handbrake wheel was briefly checked by turning to the 'off' position only (ie contrary to standard practice), the stiffness of the handbrake wheel could lead a train preparer to incorrectly believe the handbrake was 'off'. The handbrake indicators were rechecked and found to be the same as noted on site (see paragraph 91)
