Rail Accident Report

**Near miss of two track persons by a tram on
the Manchester Metrolink, Radcliffe
8 November 2005**

Near miss of two track persons by a tram on Manchester Metrolink, Radcliffe 8 November 2005

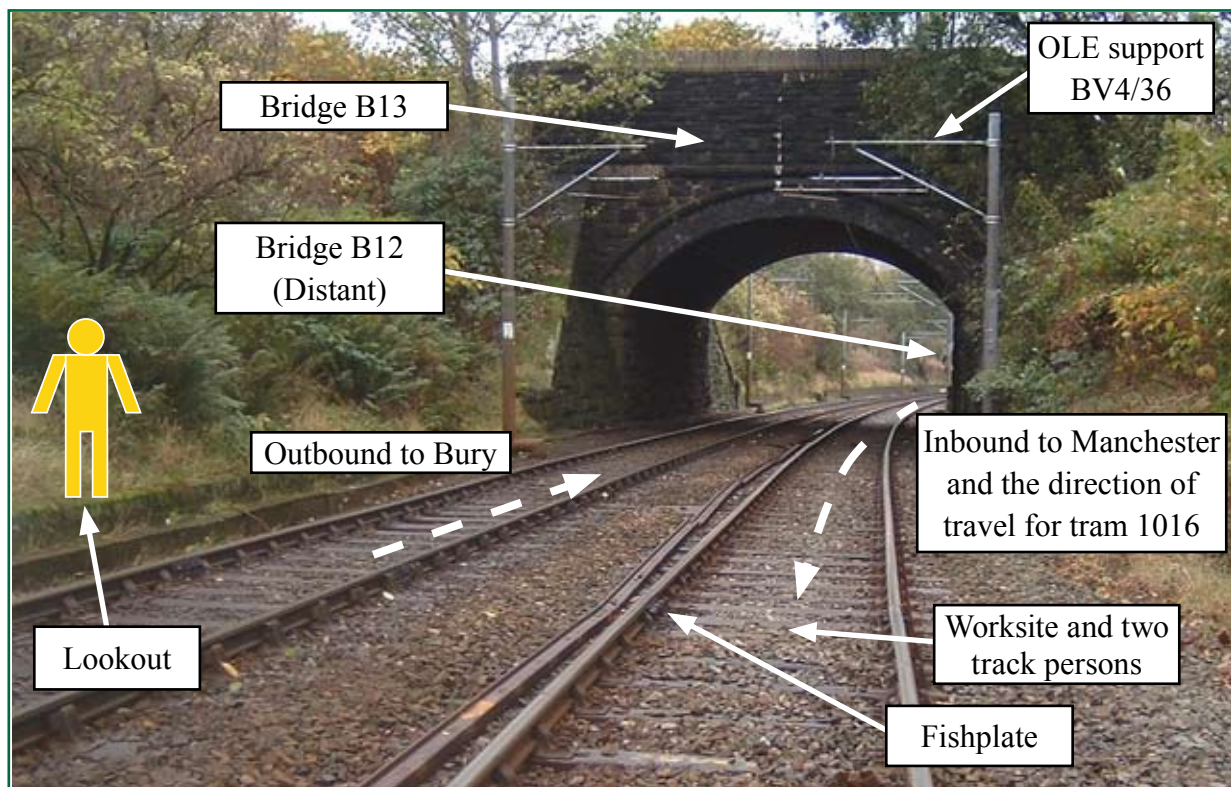
Figure 2: Photograph of the location

- 20 The incident occurred in the segregated section south of Bury, between Radcliffe and Whitefield tram stops. The location was the inbound running line beyond OLE support BV4/36. It is shown in the photograph (Figure 2) and the site plan (Figure 1). Events following the incident extended the incident site to the operational area bounded by Radcliffe and Whitefield stations.

- 29 PIC 1 placed contractor B on the outside of the curve in the *cess* adjacent to the outbound line to act as lookout. Refer to the photograph in Figure 2 and the site plan in Figure 1 for clarification.

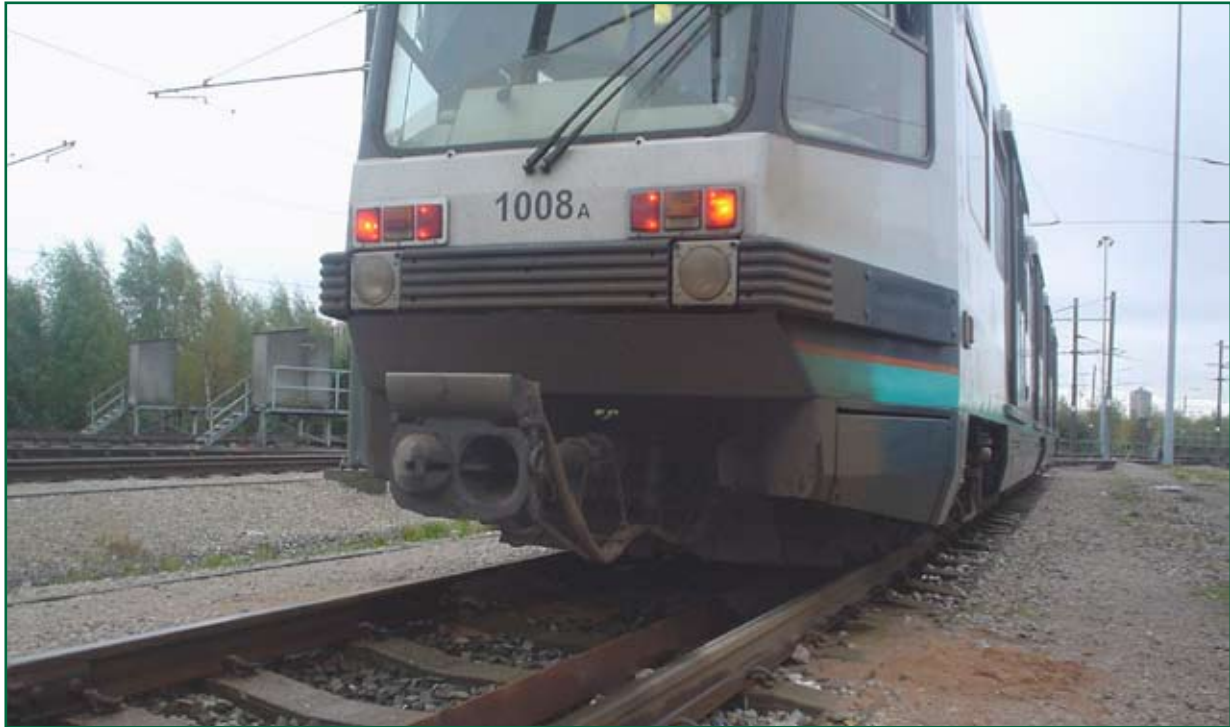
Figure 4: Photograph of the lower aspect of a phase 1 tram

- 35 There were neither fatalities nor injuries among the tram driver, passengers or track persons. The tram sustained minor damage to brake rigging adjacent to the leading axle, the Vehicle Recognition System (VRS) coils and an Automatic Tram Stop (ATS) beacon. Inspection, repairs and functional testing were carried out during the day of the incident and the tram was back in service by early evening. Photographs of the lower aspect of a phase 1 tram and the irreparably damaged Bance are shown in Figures 4 and 5.

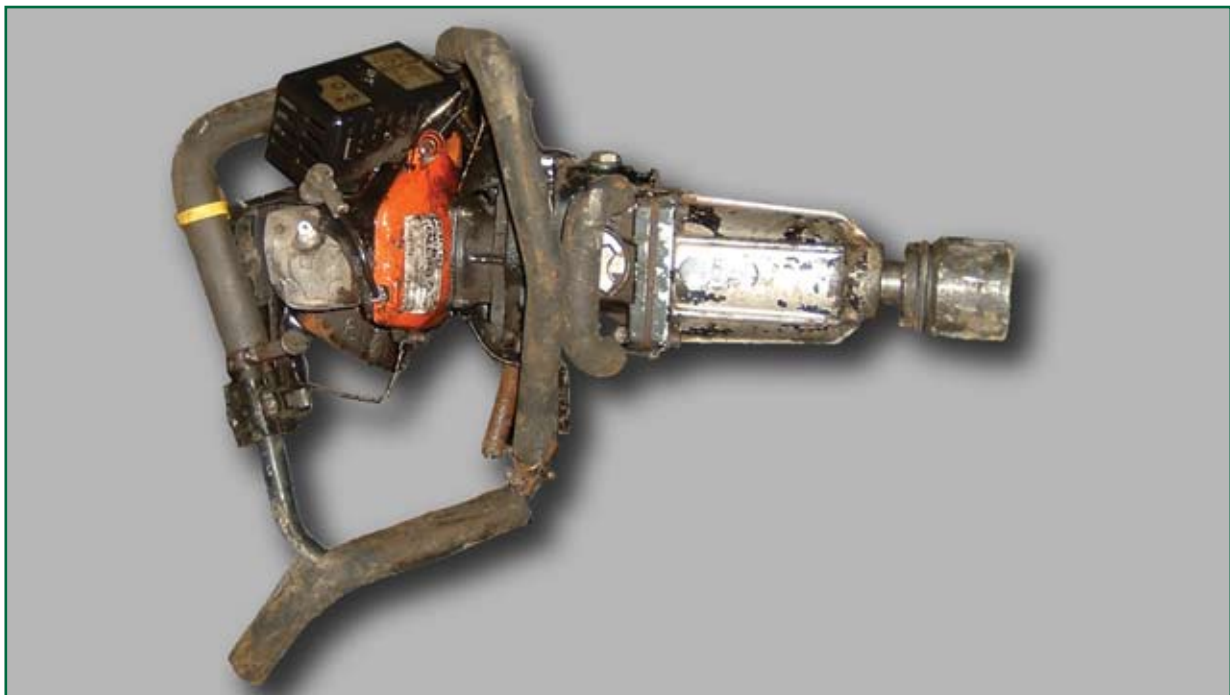
Figure 5: Photograph of the irreparably damaged Bance

- 34 The tram struck the Bance that neither PIC 1 nor contractor A had the opportunity to take to a position of safety. The tram stopped with its rear car 40 metres from the worksite. The actions of the driver and the response of the tram can be seen in the context of time, distance and location in the diagram in Appendix C.

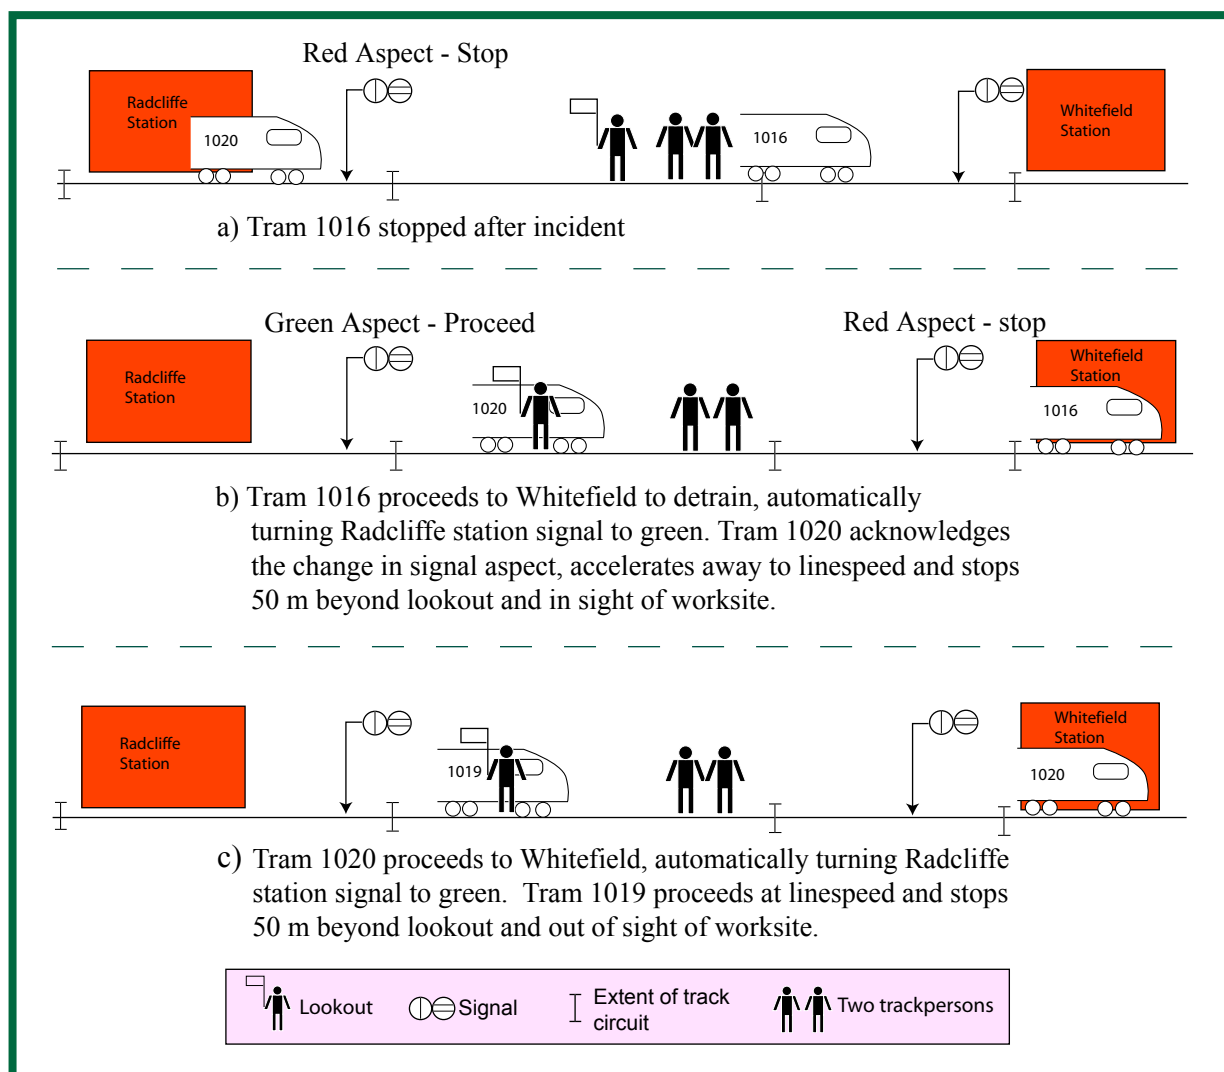
Figure 6: Sequence of events following the incident

36 The sequence of events following the incident are illustrated in Figure 6.

- 37 The driver of tram 1016 contacted control by cab radio and was answered by controller A. He reported that the tram had struck a workers tool.
- 38 Controller A asked the driver to:
- speak with the track persons and have them contact the control room;
 - detrain passengers at Whitefield station;
 - bring the tram back to Queens Road Depot at reduced speed.
- 39 PIC 1 contacted control via mobile telephone after speaking with the tram driver and was answered by controller C. PIC 1 asked for trams to be stopped while work was completed and stated that the lookout was walking outbound to stop trams with the red flag. No clear understanding was reached between PIC 1 and controller C, and trams were not stopped.

- 40 The call between PIC 1 and controller C remained open although PIC 1 believed the call was concluded. At this time the driver of inbound tram 1020 called control and was answered by controller B. The driver questioned being stopped at Radcliffe station by a signal with a red aspect. The signal changed to a green aspect immediately contact was made with controller B who advised the driver that the previous tram had been involved in an incident at a worksite but was now on the move. The driver was advised that normal running had resumed and he accelerated away from Radcliffe as normal.

- 41 The driver of tram 1020 sighted the lookout displaying the red flag and braked to a stop approximately 50 metres beyond the lookout and in sight of the worksite. PIC 1 used hand signals to instruct the tram to move towards him and pass the worksite at slow speed as the replacement fishplates had not yet been secured. Tram 1020 passed the worksite and continued normally.

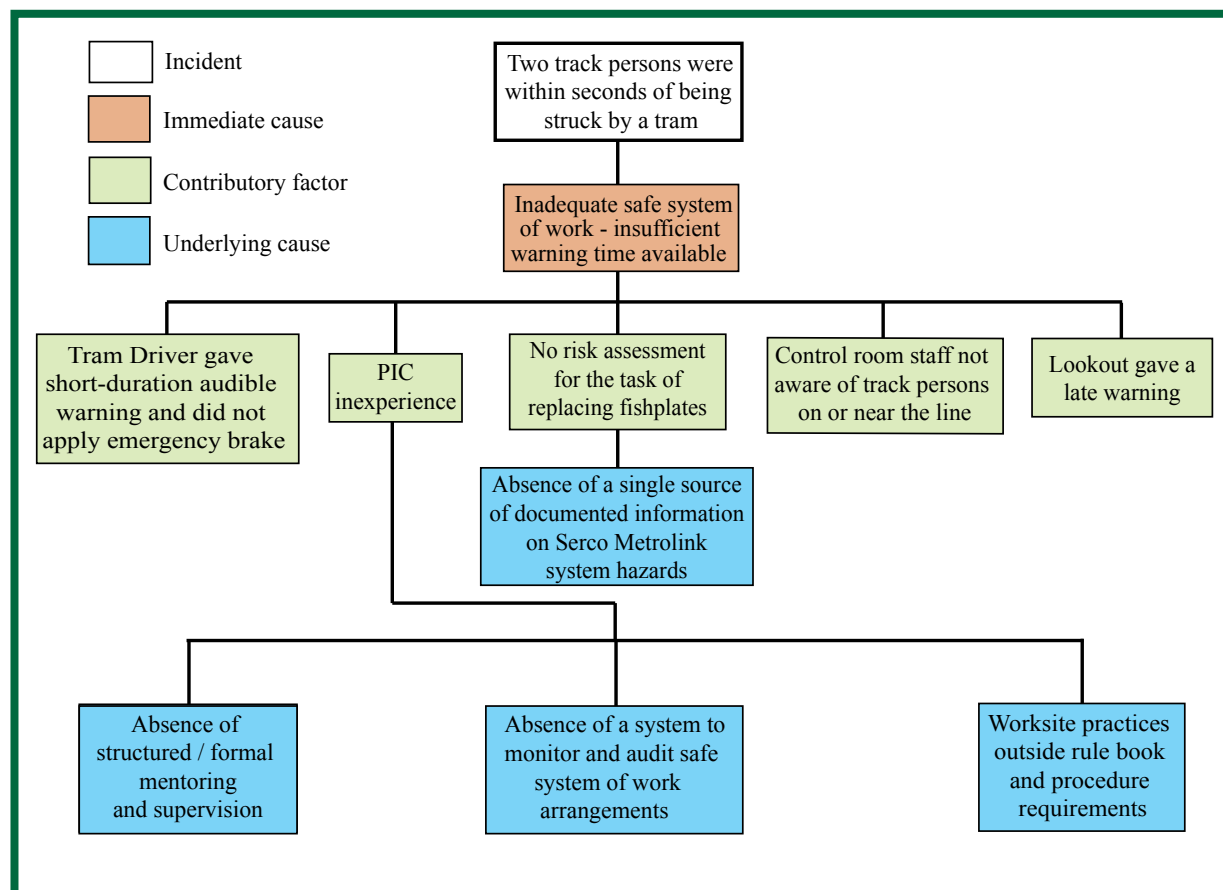
Figure 7: Summary of causal analysis

- 73 The causal analysis is presented below.
