# Rail Accident Report

## Station over-run at Haywards Heath 12 January 2006

This report is published by the Rail Accident Investigation Branch, Department for Transport.

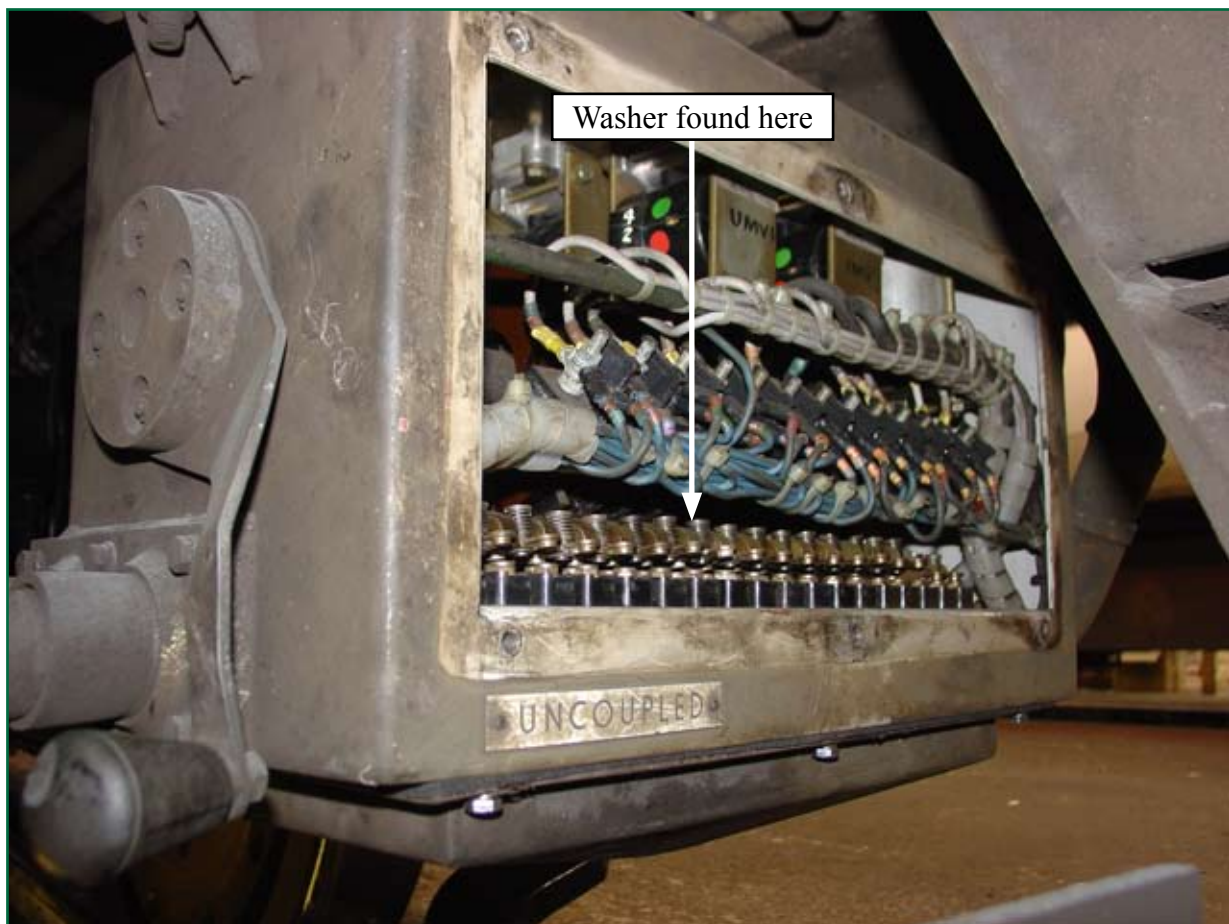
- 14 The fault was traced to the presence of an extraneous 6 mm washer in the *drumswitch* adjacent to the coupler on vehicle 77297 of unit 319004 in the centre of the train. The washer was causing a short circuit, and therefore a false feed, between two wires operating the brakes.

- 15 Figure 2 shows the drumswitch with a cover removed to reveal the terminals where the washer was found.
- 16 Class 319 units have a brake with 4 positions, Steps 1 – 3 and Emergency, Step 1 providing the lowest braking rate.

- 17 The false feed caused by the washer was such that when the brake controller was placed in either Step 2 or 3 positions no brake application occurred. Step 1 and Emergency brake positions worked satisfactorily. The brakes worked correctly immediately the washer was removed. Their operation was confirmed by a functional brake test.

Figure 2: Class 319 drumswitch with cover removed showing terminals where the washer was found

- 20 The origin of the washer is not known. It is likely that it had been loose in the drumswitch and became dislodged from its resting place by the movement of the train, falling onto the terminals of the wires concerned. It is possible that it may have been originally part of the securing assembly for a pair of valves in the upper part of the drumswitch.

- 22 The rear and bottom sections of the drumswitch are reasonably accessible. Examination of the front section, where the washer was found, is severely hindered by the presence of the obstacle deflector and, unless a mirror is used, only an oblique view can be obtained. The view shown in Figure 2 was obtained by placing the camera in a position adjacent to the coupler which cannot be reached by the naked eye.

- 31 The immediate cause of the accident was the presence of an extraneous washer in a drumswitch of unit 319004 causing an electrical defect preventing the application of Brake Steps 2 and 3 (paragraph 14).
- 32 A contributing factor was the difficulty in examining the front section of the drumswitch where the defect occurred which may have led to the presence of the washer being missed (paragraph 22 and Recommendation 1).
- 33 The means by which the train was recovered to the Depot for investigation and repair did not impose an increased risk to the safe operation of the railway.

- 23 The maintenance instructions have been altered to require the use of a mirror where a direct line of sight cannot be obtained (Recommendation 1).
- 24 The maintenance records do not show any 'out of course' attention to the drumswitch on vehicle 77297 in the 12 months before the incident. However, the unit underwent classified attention at Alstom's Wolverton Works in August 2005. During that attention the drumswitches were opened to change the magnet valves.

- 34 Thameslink re-issued written instructions for the Drumswitch Examination to their maintenance staff with effect from 24 February 2006 requiring the use of ‘an inspection mirror to check any areas that are not in line of sight, to identify any foreign items.’ Any item found in the drumswitch is to be reported to the Supervisor so that the source can be established.
- 35 Southern re-issued their maintenance instructions to require an inspection mirror to be used when examining the interior of the drumswitch on 7 March 2006 to both the inspection shed and repair shop at Selhurst.
- 36 Southern have advised the class 319 owner’s site representative at Wolverton of the need to ensure that no loose material is left in the drumswitches following attention.

1. First Capital Connect (formerly Thameslink) and Southern should arrange for an inspection mirror to be used when examining the interior of the drumswitch. This recommendation has already been implemented (paragraphs 31, 32, 34 and 35).
2. Alstom to review procedures, processes and equipment in order to identify an effective means of preventing loose material from interfering with the operation of the drumswitch (paragraphs 24, 25 and 31).
