Rail Accident Investigation Branch

Rail Accident Report

**Collision at New Addington on
Croydon Tramlink,
23 November 2005.**

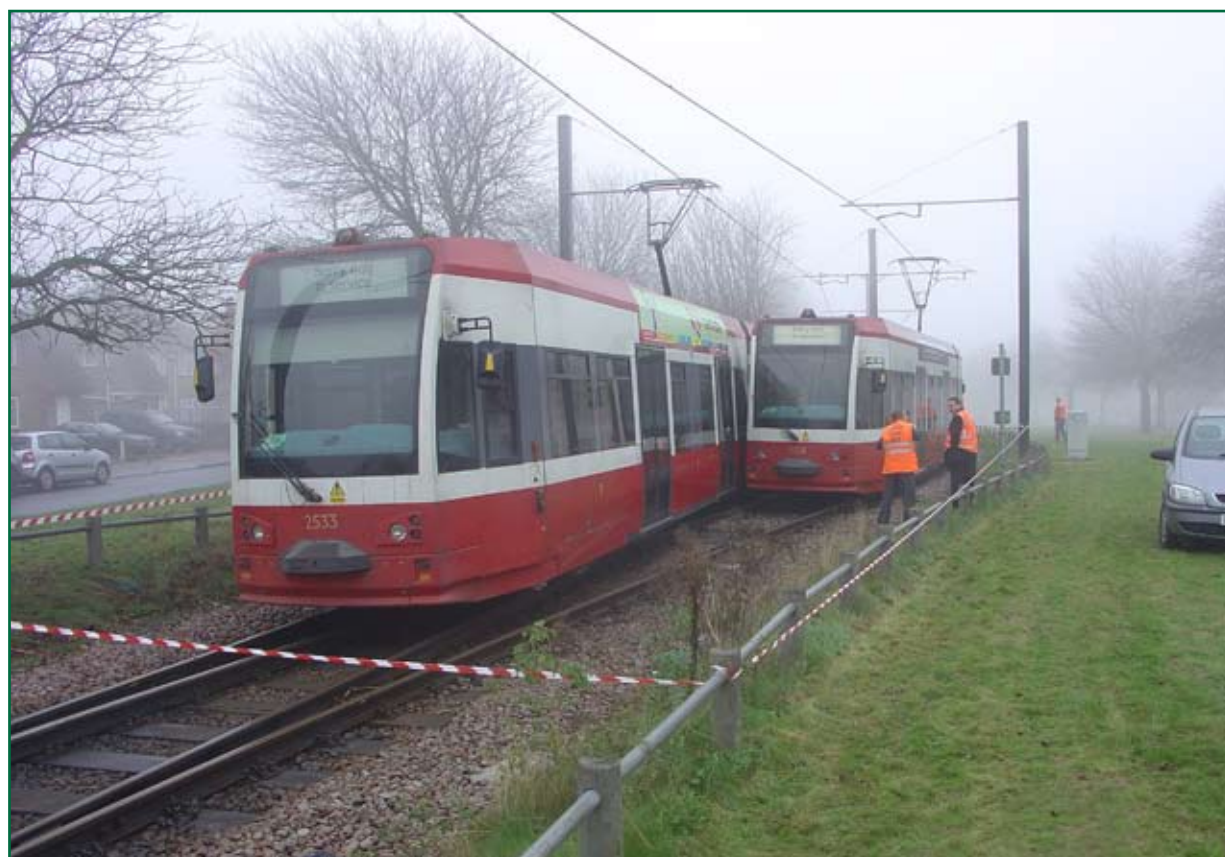
Figure 2: Site of the collision looking towards King Henry's Drive tramstop, showing the rear of tram 2533 (on left) and the front of tram 2538 (on right). The rear of KHD02 signal is on the shorter post to the right of tram 2538.

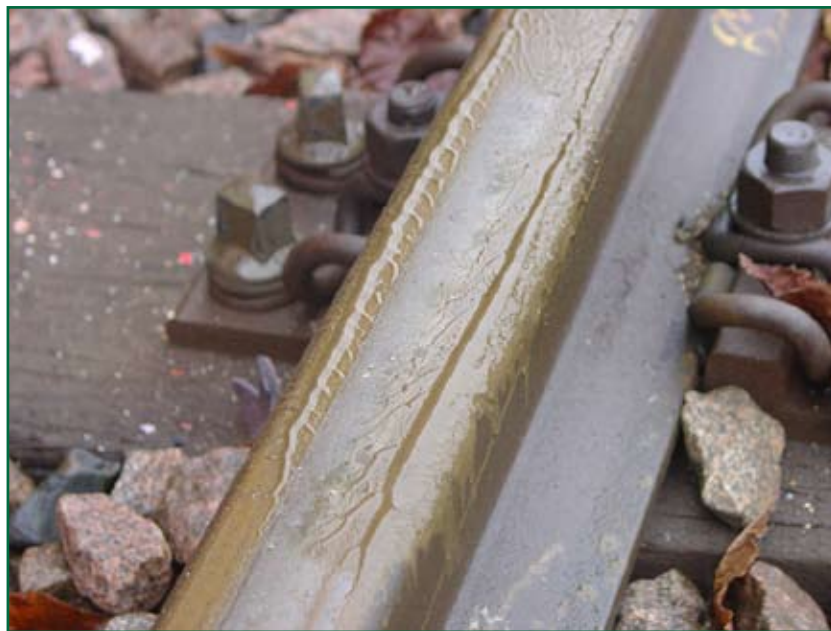
- 29 On the morning of 23 November, trams 2533 and 2538 were operating on the Line 3 service from Croydon to New Addington (Figure 3). Thick fog had descended during the night and remained in the area until late morning reducing visibility to approximately 70 m (this is estimated from witness commentaries and CCTV records). Rail conditions were very damp and the southbound line adjacent to KHD02 signal was visibly contaminated with a rusty sludge or paste. There is no evidence of poor wheel-to-rail adhesion which would have adversely affected the braking capability of the tram. Consequently the presence of this sludge does not appear to have had any bearing upon the accident.

Figure 5: Rail condition in the vicinity of KHD02 signal

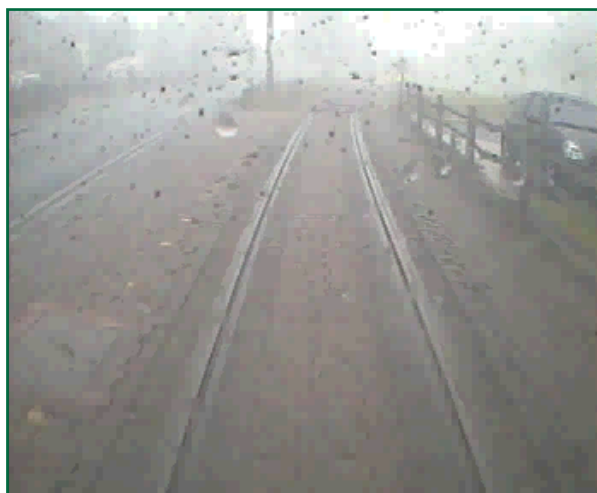
*Figure 6: CCTV record from Tram 2533.
Tram 2538 not visible.*

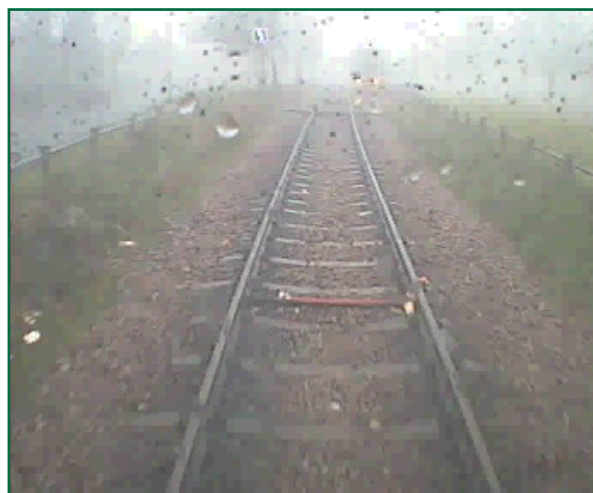
*Figure 7: CCTV record from tram 2533.
First sighting of headlights of tram 2538.*

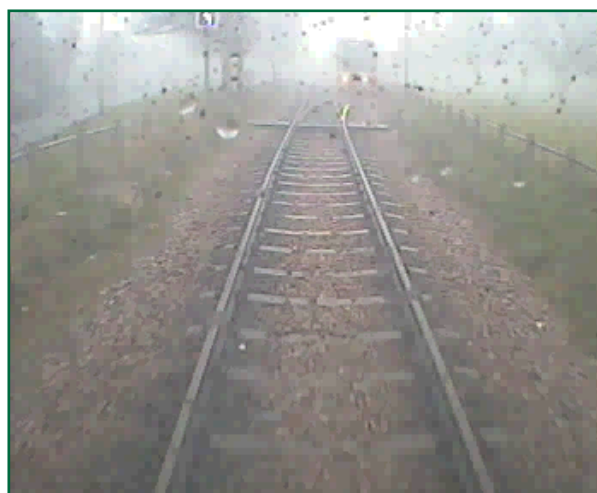
*Figure 8: CCTV record from tram 2533.
Tram 2538 outline and headlights just visible*

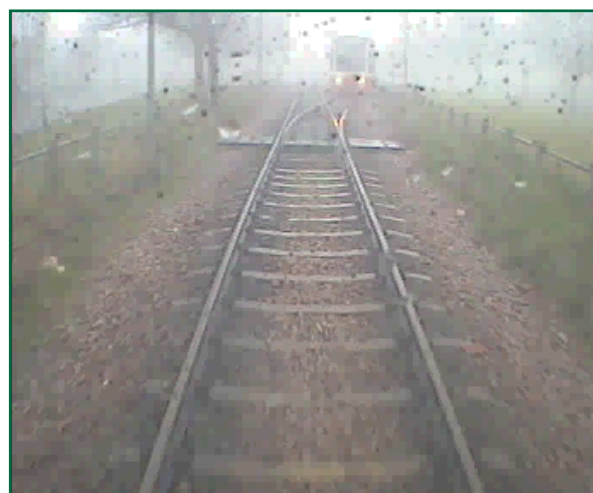
*Figure 9: CCTV record from tram 2533.
Tram 2538 clearly foul of running line*

- 48 The driver of tram 2533 departed normally from New Addington after a slightly shortened layover. From inspection of the CCTV record, at 10 m from the toe of points, even with the poor visibility then present, tram 2538 can clearly be seen to be foul of the line. Had a hazard brake application been made here, the tram would have come to rest about 15 m from tram 2538. If the hazard brake application had been made still later, at the toe of the points, a collision would still have been avoided. The driver did not take any action until the distance between the trams was only 1.5 m, only then applying a full service brake.

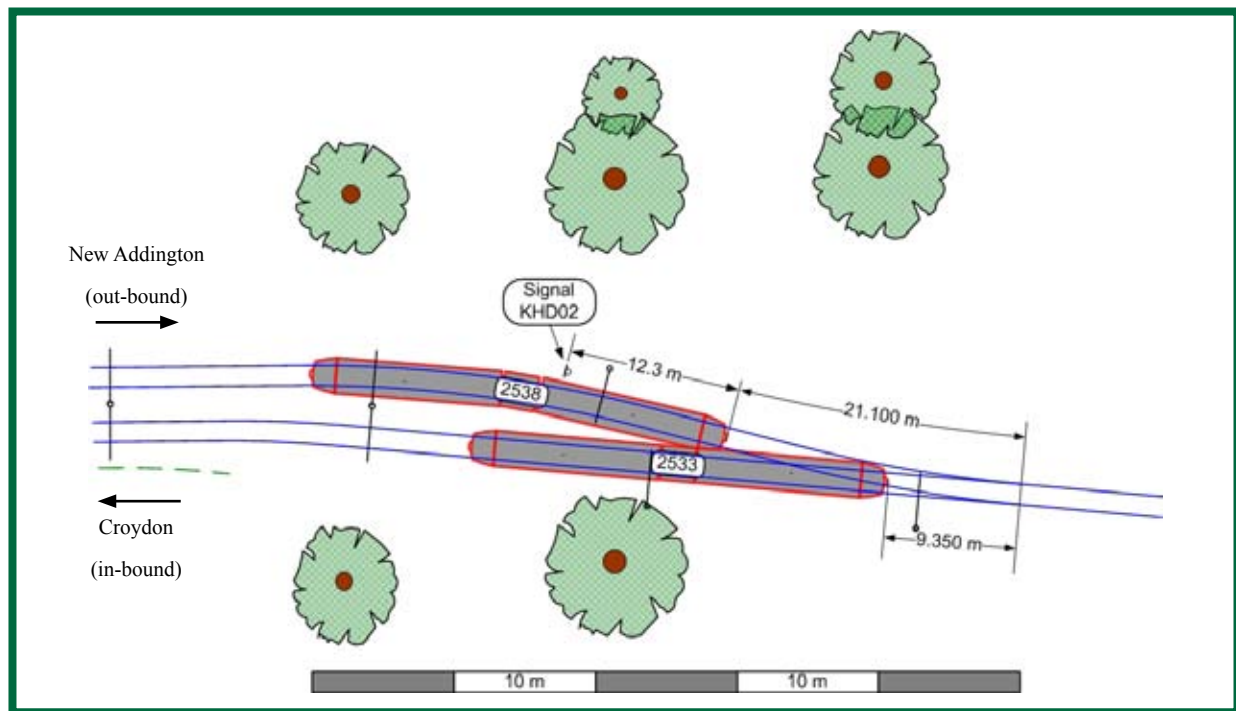
- 27 On 23 November 2005 at 08:16 hrs, tram 2538, a three-section articulated unit, was travelling southbound with about ten passengers from Croydon towards the New Addington terminus on the 'out-bound' line in conditions of thick fog. The tram passed KHD02 signal, which was displaying a STOP aspect. This signal, positioned near the end of the double track section from King Henry's Drive tramstop, protects the entry into the short single line section just before New Addington. The tram came to a stand 12.3 m beyond the signal partially blocking the adjacent 'in-bound' line, see Figure 14 following Paragraph 46.

Figure 14: Diagram showing final positions of trams 2533 and 2538 in relation to toe of points

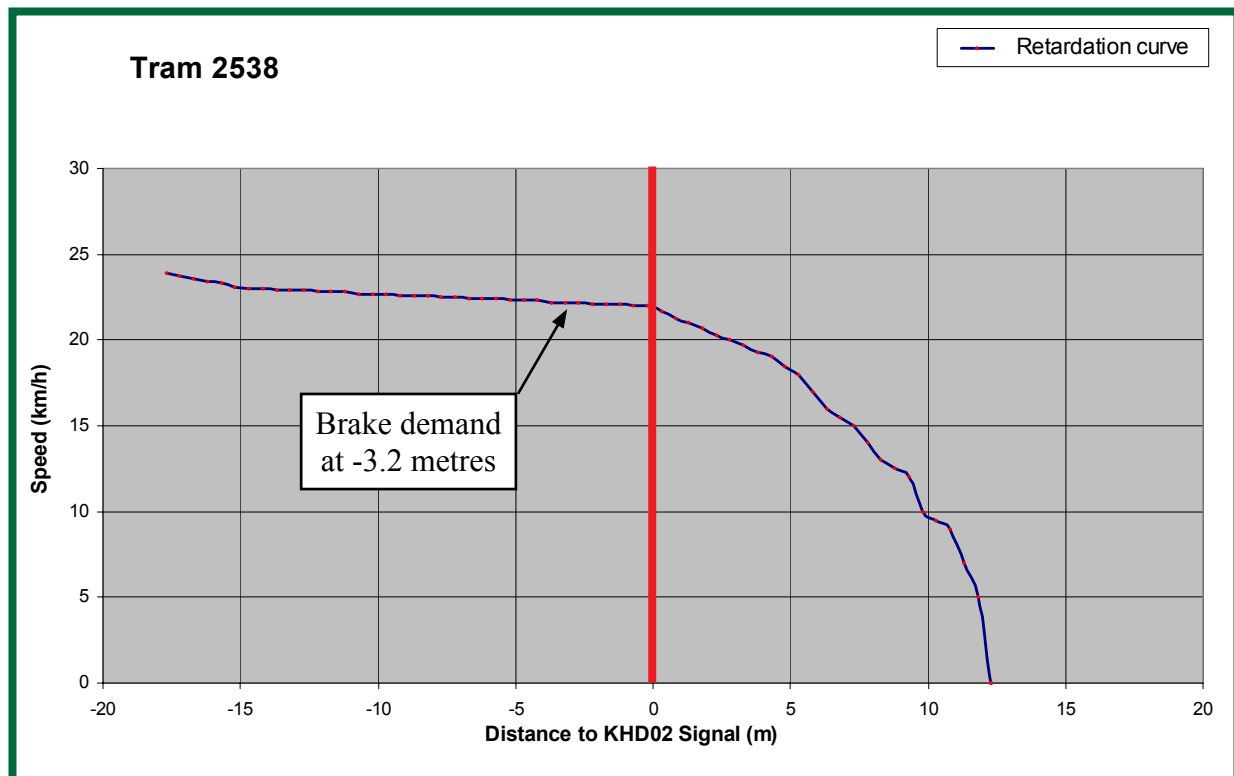
- 47 Prior to the accident the driver of tram 2538 was fully familiar with the approach to KHD02 signal which usually cleared on approach to show a proceed aspect. This was a feature of the timetable which for much of the operating day plans for one tram to arrive at New Addington followed quickly by the departure of another. This provides a layover time of about 6 – 7 minutes and ensures that a tram is waiting for intending passengers. It is only when the service is slightly disrupted that the sequence is altered. Just prior to the collision, KHD02 signal did not clear because the ‘Ready-to-Start’ switch had already been operated at New Addington, clearing signal NAD04 and giving authority for tram 2533 to proceed over the route. The driver of tram 2538 expected signal KHD02 to clear as evidenced by the traction brake controller only being moved to a service braking condition when the tram was 3.2 m from the signal. Using a service brake, the tram came to rest 12.3 m beyond the signal and approximately 2.3 m beyond the fouling point. Had the driver applied the hazard brake at the same position as the service brake was applied the tram would have come to a stand at least 1.5 m before the fouling point – see calculations at Figures 16 and 18. The conditions for a collision would thus have been avoided.

Figure 15: Speed - Distance record for tram 2538, (Negative distances are on approach to signal)

Predicted over-run of KHD02 = (11.4 - 3.2) m
= **8.2 m**
(assuming same location for application of the brake)

Predicted distance short of fouling point = (10.0 - 8.2) m
= **1.8 m**

- 2 Tramtrack Croydon Ltd should assess the possibility of moving signal KHD02 to a position at least 21 m from the fouling point, and if it is reasonably practicable should carry out that relocation (paragraph 54).

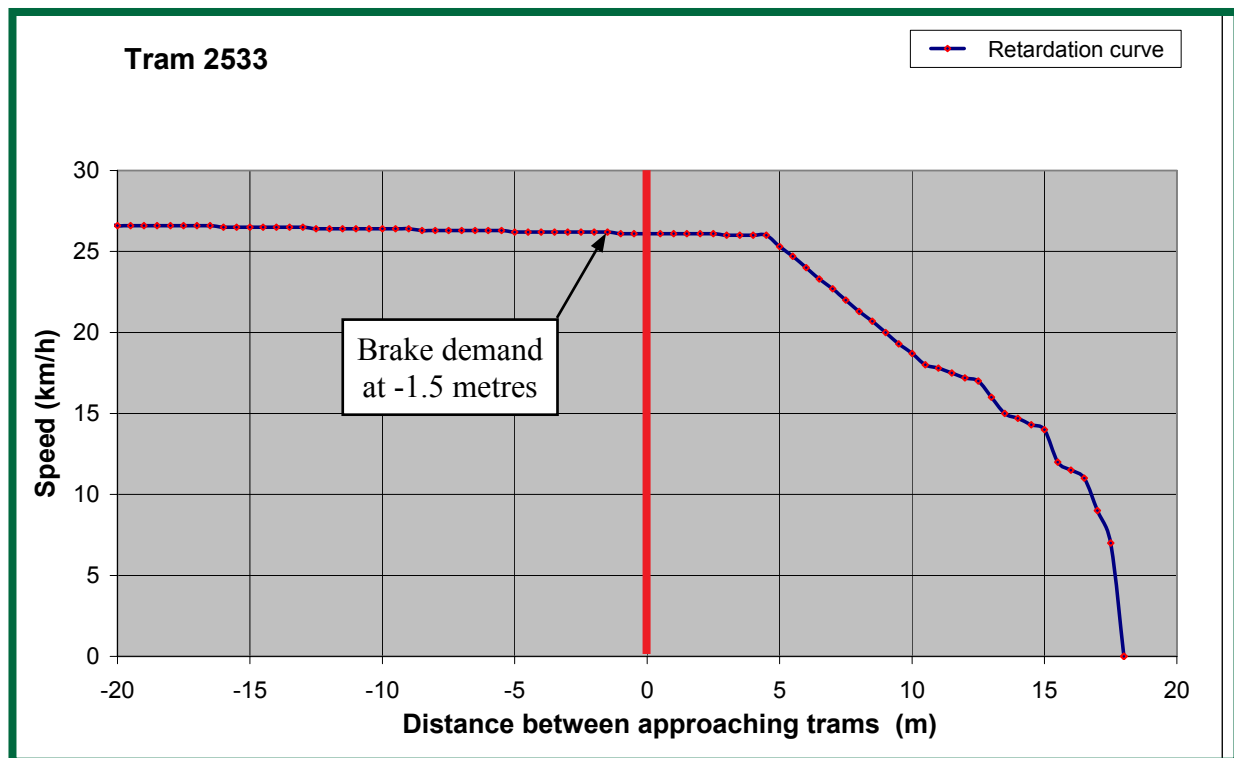
Figure 17: Speed - Distance record for tram 2533 (negative distances are on approach to point of collision)

Predicted distance between trams = (20.9 – 15.5) m
= 5.4 m

- 1 Tram Operations Ltd should carry out a programme to re-train all their drivers on the necessity to use the hazard brake in an emergency. Training and routine assessments should include understanding and demonstration by the driver in the operation of the hazard brake. The process of ‘feathering’ to avoid the final jerk should be retained (paragraph 50).
