Rail Accident Investigation Branch

Rail Accident Report

**Collision at Black Horse Drove Crossing, near
Littleport, Cambridgeshire
19 October 2005.**

Collision at Black Horse Drove crossing, near Littleport, Cambridgeshire, 19 October 2005

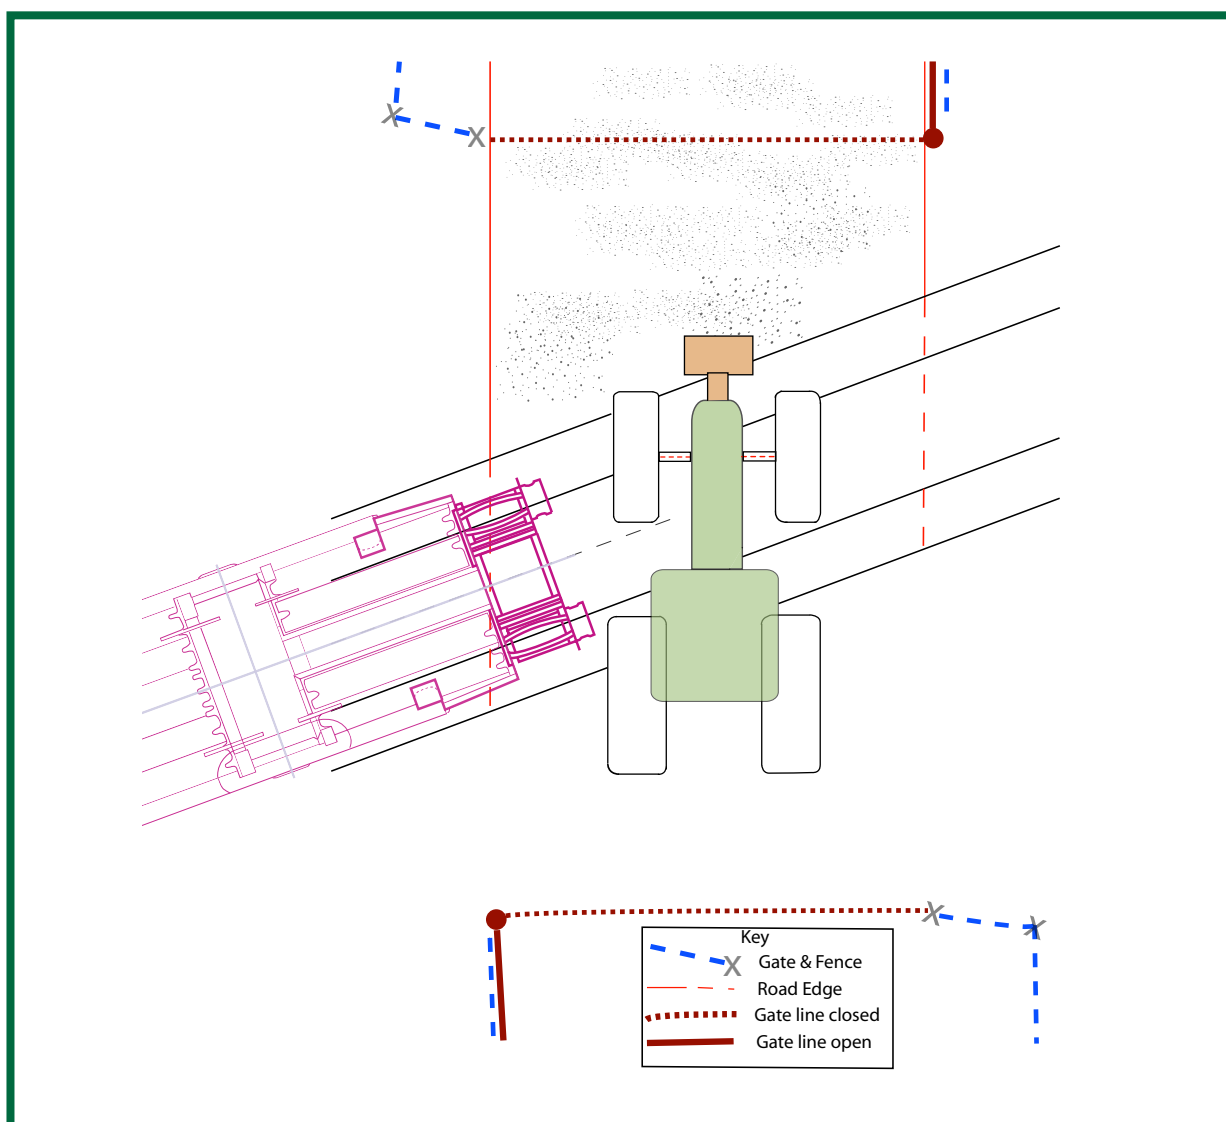
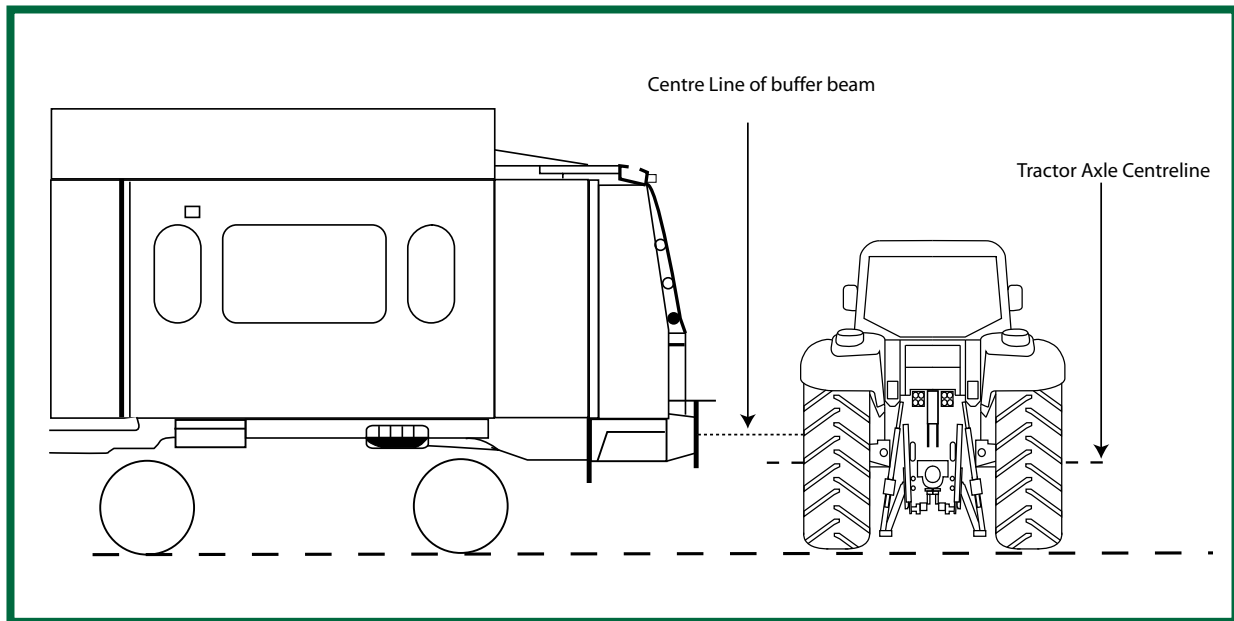
- 50 The relative orientation of the train and tractor are shown in Figures 6 and 7 in plan and elevation respectively. Figure 7 shows how the rear axle of the tractor was at the same height as the right side *anticlimber* on the train. This meant that the initial impact force was borne by the train on the members that were designed for this purpose. The skew of the level crossing meant that the initial impact was between the GRP fairing over the right side anticlimber and the back wheel tyre of the tractor. This impact would not have been severe and the anticlimber continued into the main structural core of the tractor, bursting the fuel tank. The main tractor units; chassis, gearbox and back axle, are all aligned at the height of the rear axle and were broken apart by the right side anticlimber.

Figure 6: position of tractor and train just prior to impact (plan)

Figure 7: Position of tractor and train just prior to impact (elevation)

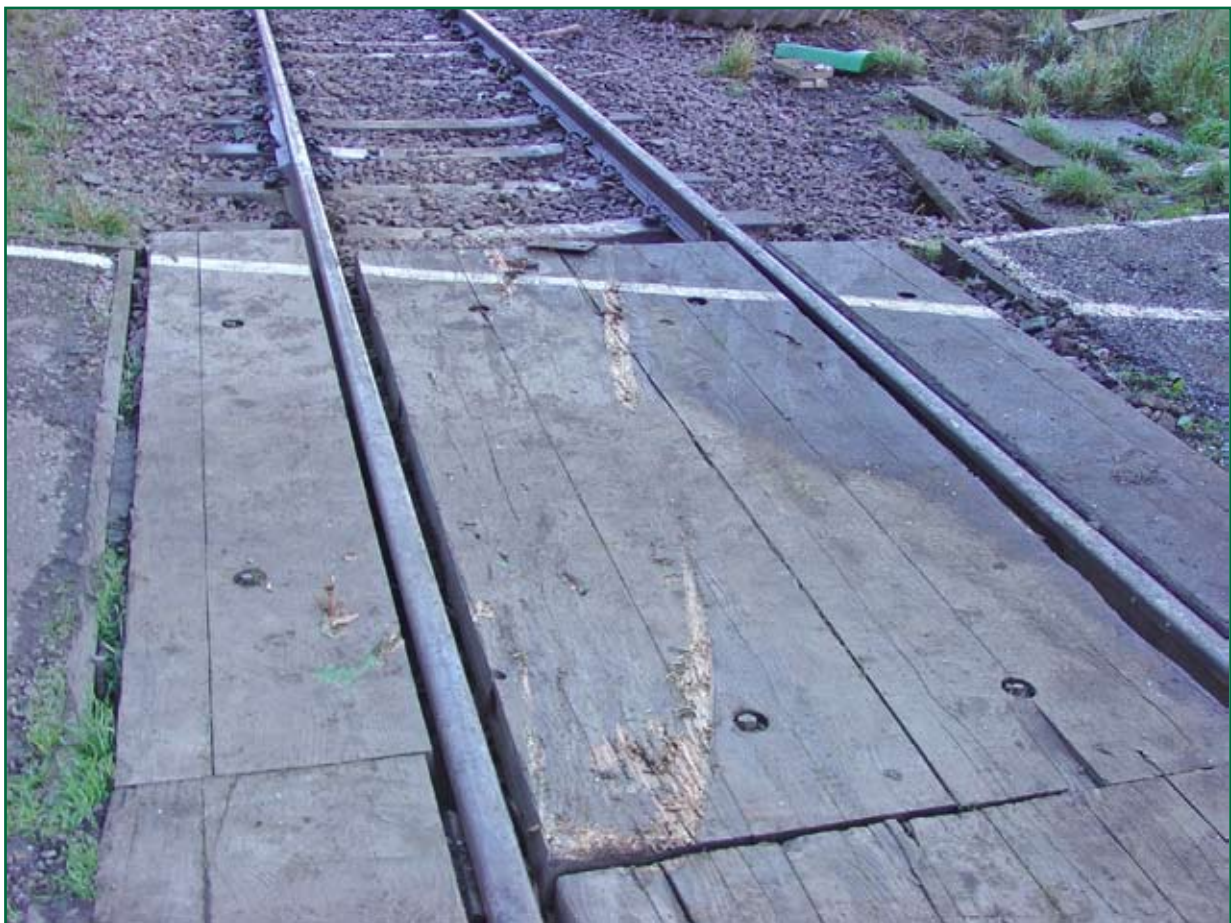
- 49 The train driver saw that the tractor driver was continuing onto the crossing. Realising a collision was imminent, he applied the brake in the *step 3 (full service)* position. The brake application started 151 m (3.7 sec) from the crossing and the *brake handle* reached step 3 at 119 m (2.9 sec) from the crossing. The train struck the tractor on the crossing at which moment the train speed was 90 mph (144 km/h). The position of the tractor relative to the train at the moment of impact is shown in Figure 6. The position was determined from the scrape mark left on the road surface by the trailer drawbar. This drawbar fell to the ground and the trailer ran back under gravity leaving a gouge in the road surface.

Figure 8: Gouge marks on crossing surface

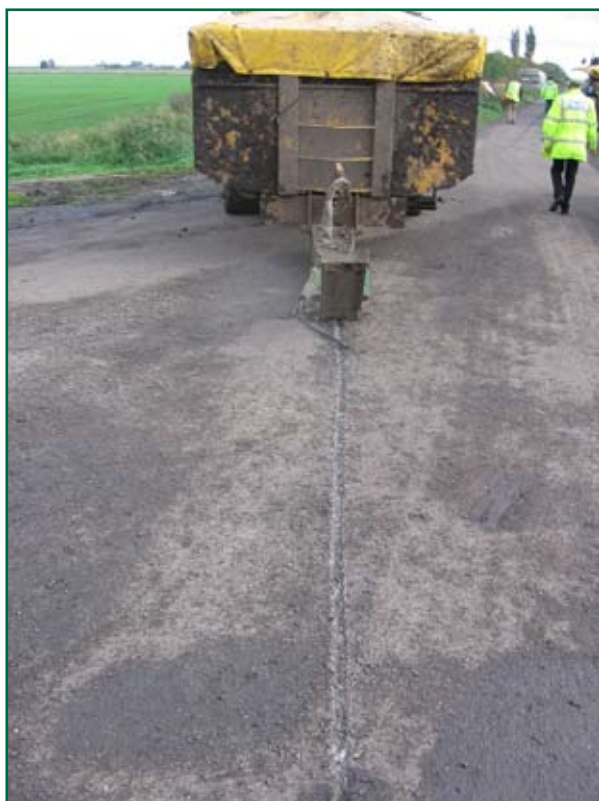
- 52 Very early on in the collision, the coupling between tractor and trailer was broken though the drawhook connection to the trailer remained intact. The failure occurred where the drawhook assembly attaches to the tractor, this assembly remaining attached to the trailer (Figure 9). The trailer then rolled back down the slope clear of the line.

Figure 9: Trailer with part of the tractor drawbar still attached

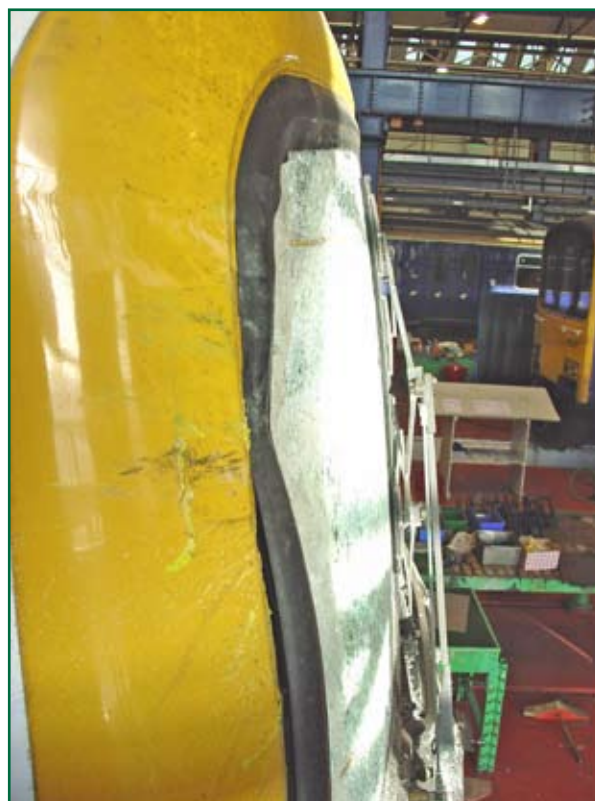
Figure 10: Front of train showing impact marks from tractor cab

- 53 The top of the tractor cab impacted the GRP fairing of the train cab high up, breaking the train windscreen (Figure 10), though the glass remained in place. The rear section of the tractor was then pushed aside to the right of the train impacting heavily with the train driver's door and breaking the glass, which showered into the train cab.

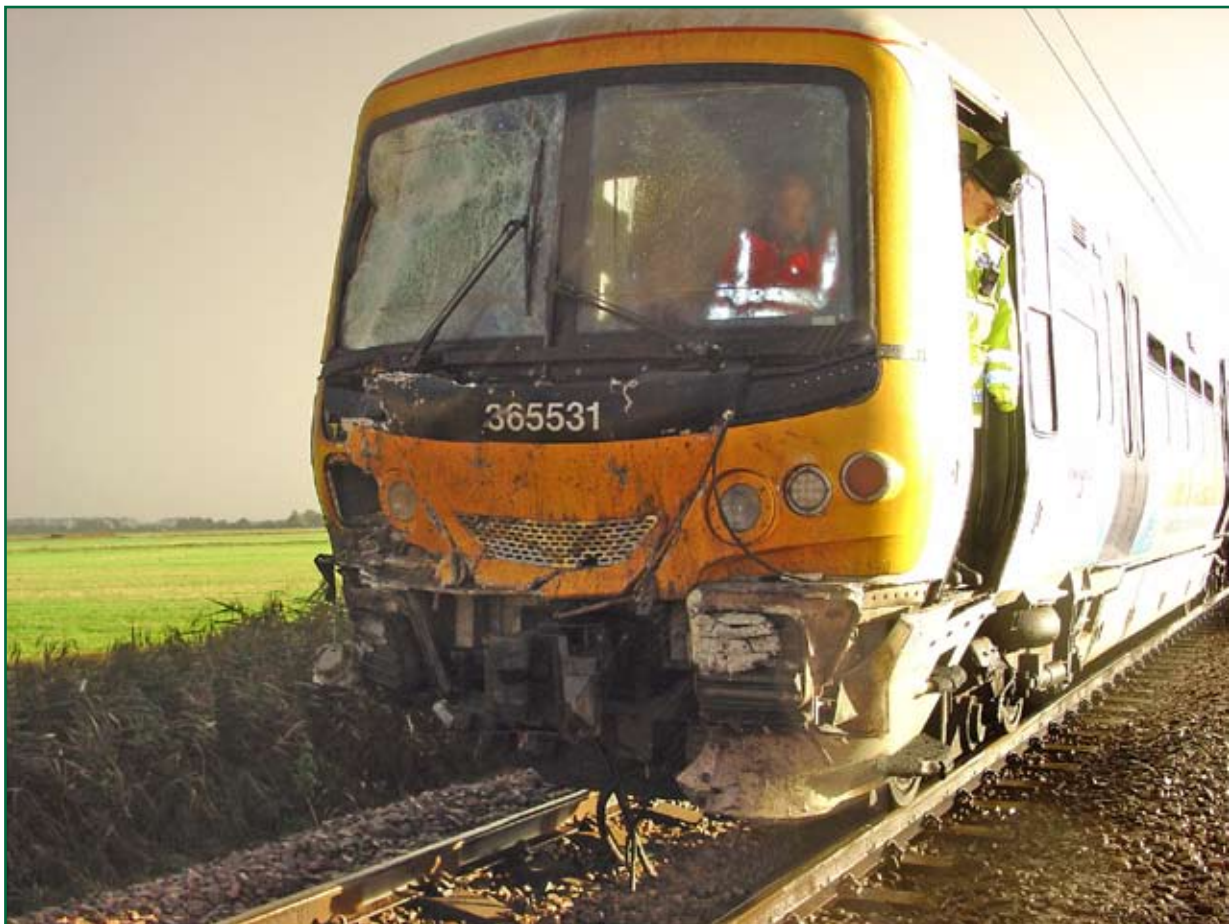
Figure 11: Damage to front of train

- 56 The train front was built to comply with the *crashworthy principles* of GM/RT 2100 and so had anticlimbers in the position where a conventional train has buffers. The offside anticlimber struck the tractor at the front of the rear tyre then impacted on the plastic fuel tank. This caused the diesel fuel from the tractor to be ejected and the spray obscured the train from the view of some witnesses. Despite the presence of 25 kV overhead electrification, this fuel cloud did not ignite.

- 57 The relative height of the train's structural underframe members and the tractor's main masses meant that the centre of gravity of the large parts of the tractor aligned with the axis of the train underframe. The underframe was therefore able to resist the impact loading with the energy absorbing members deforming in the process. If the relative heights of the underframe and tractor were different, the consequences of the accident could have been much more serious for the train driver and passengers as the cab could have been severely damaged or the train derailed.

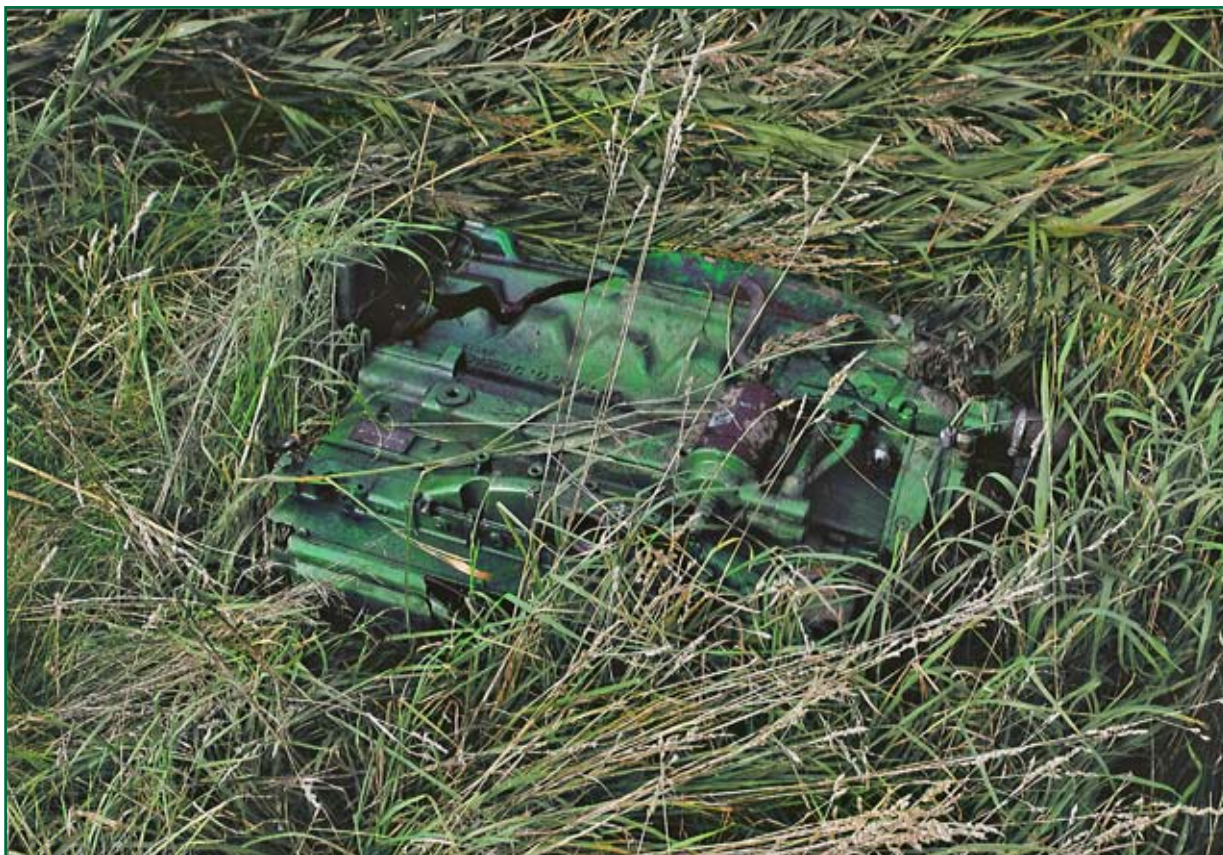
- 60 The tractor engine was mounted on top of the main chassis member and this raised it above the level of the train's anticlimbers. The engine was struck by the front section of the cab where the two GRP skins are at their maximum separation and the collision imparted a considerable amount of energy to the engine. The engine was thrown a total distance of 171 m, ricocheting off a gate before coming to rest in reeds at the lineside. The engine was almost complete (Figure 12); the weight of a complete engine is 537 kg. The impact pushed the cab front inwards, causing a panel to dislodge from the driver's desk.

Figure 12: Tractor engine

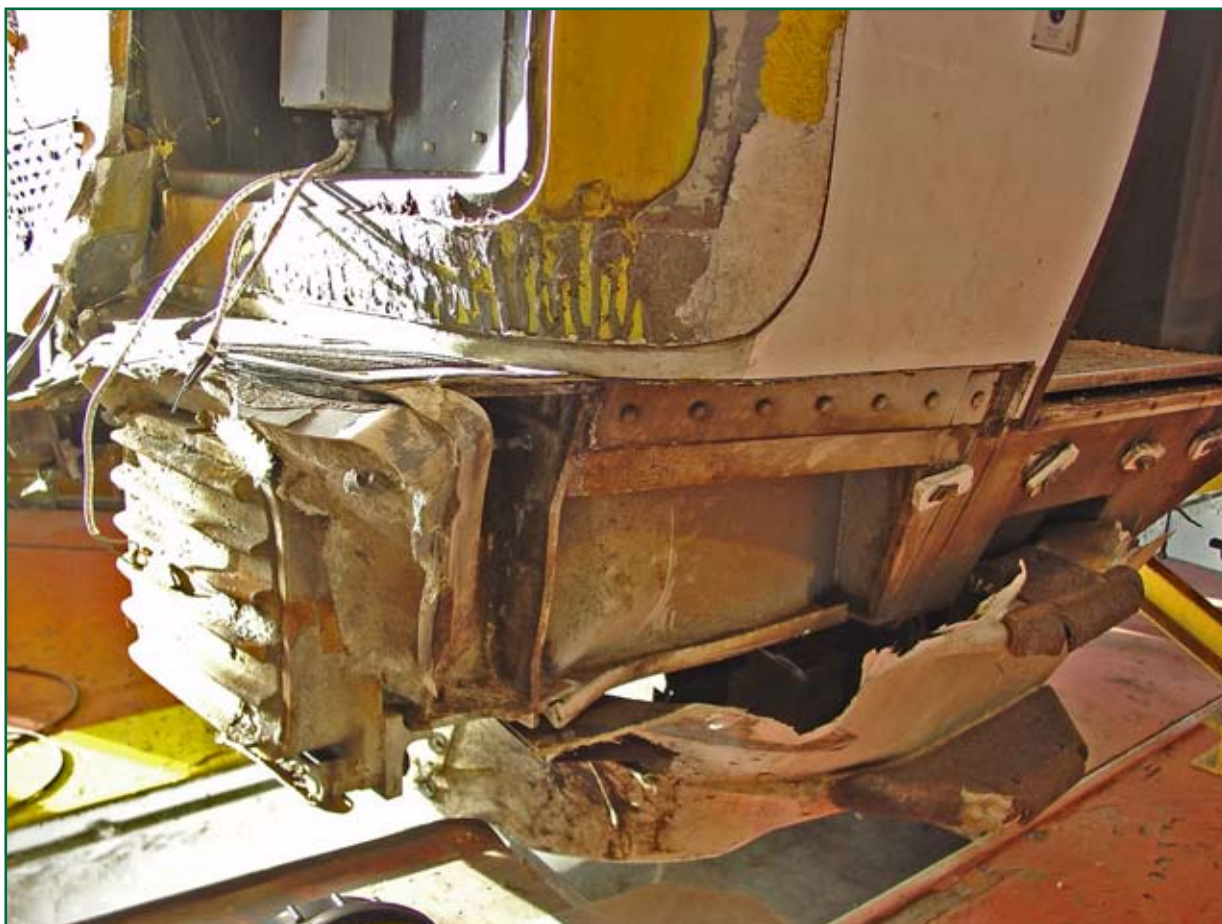
- 61 The GRP cladding on the lower part of the front of the train was broken up and the electrical connection box at the coupler was destroyed. The anticlimbers suffered heavy impacts and their supporting structure was distorted. This supporting structure consists, in part, of curved plates behind the anticlimbers whose purpose is to absorb energy. These were distorted (Figure 13). The cab structure had shortened such that the left side anticlimber moved back by 22 mm and the right side anticlimber was pushed back a maximum of 382 mm, though it was rotated to the right side. This shortening of the cab structure was evident in the buckling of the floor plate (Figure 14).

Figure 13: Damage at left side of train

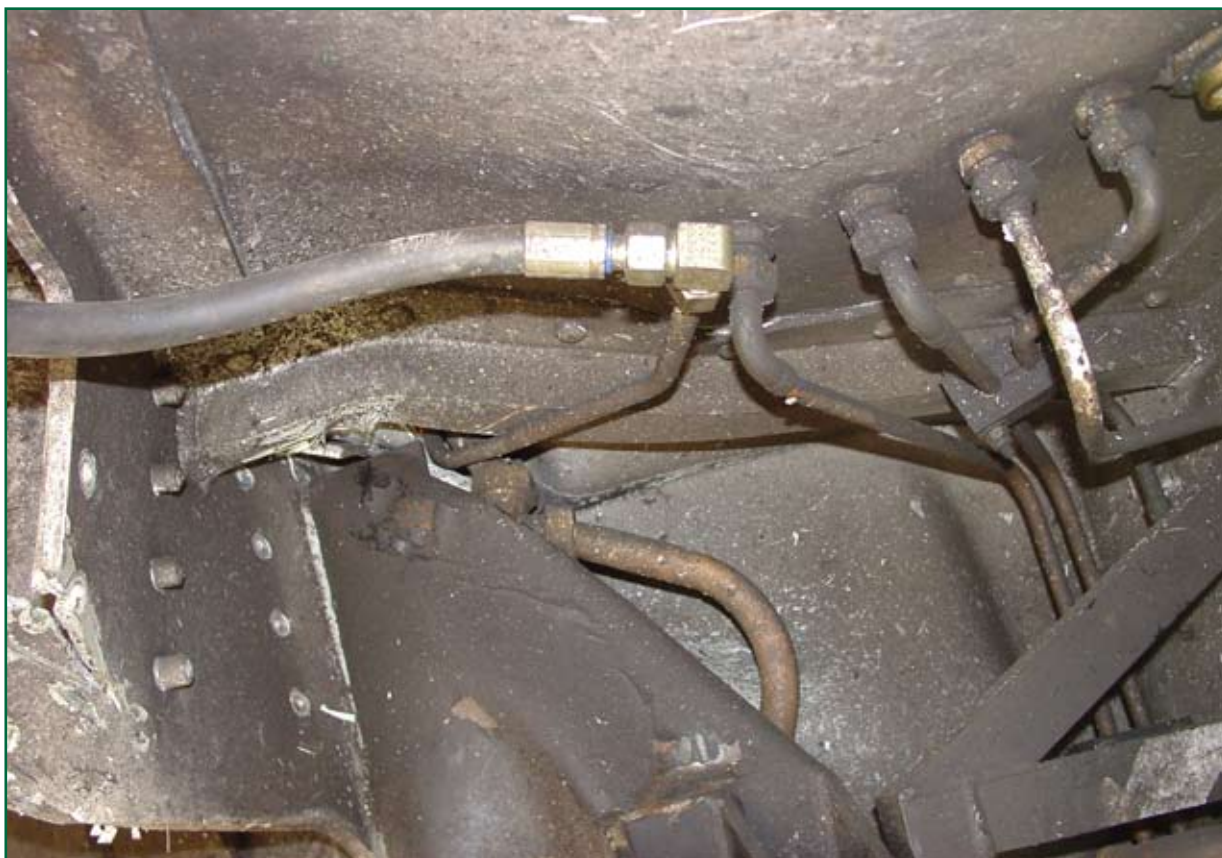
Figure 14: Buckled floor plate beneath train cab

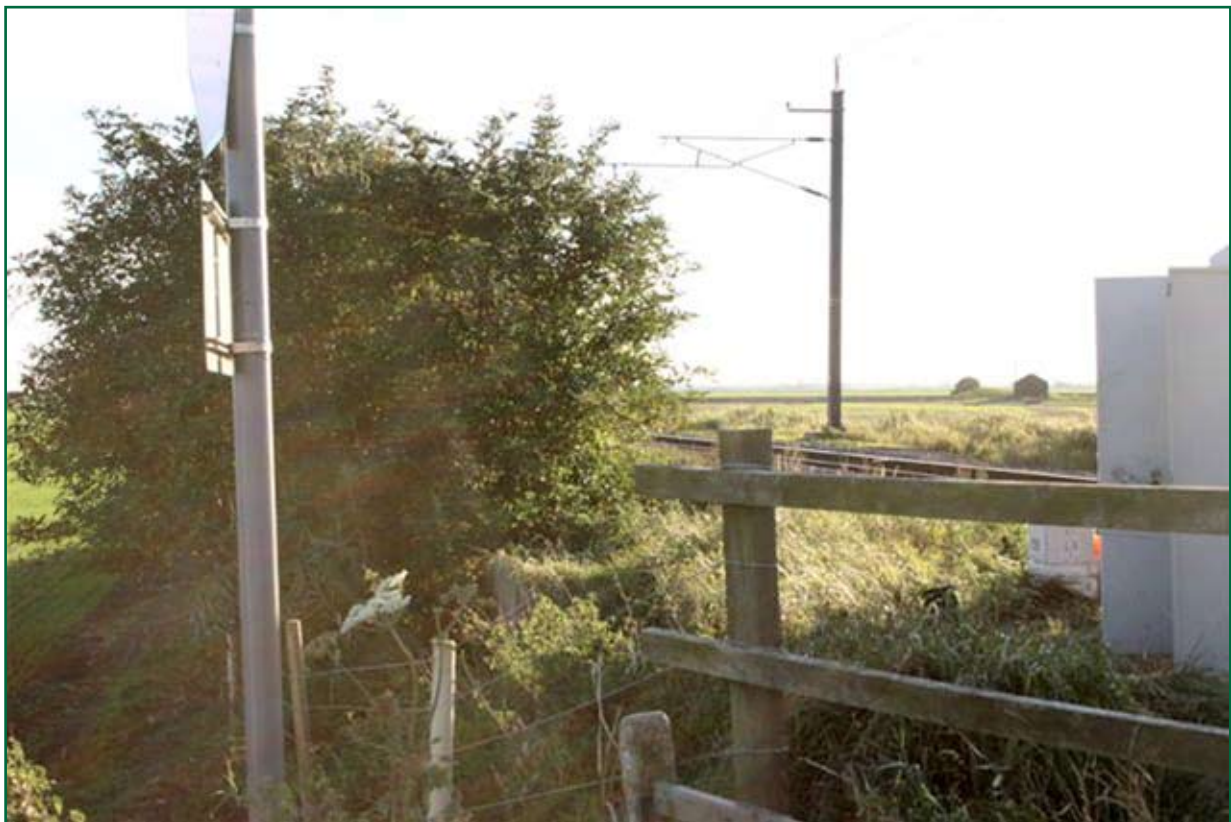
112 The lineside bushes obscured the view of the line from the point when the tractor approached the stop line to the point when the front of the tractor was just over the gate line. Figure 17 shows the view from the stop line towards Littleport. If the bushes had not been present, then the tractor driver would have had a clear view of the train approaching. However, the requirement to have a clear view of the line is not necessary if other means of warning of a train's approach are provided. Miniature stop lights provide this means of warning. Nevertheless, if the bush had not been present, the tractor driver could have easily seen the train approaching and so the presence of the bush has been considered as causal.

Figure 17: View towards left from stop line

- 144 The view of the line towards Littleport was obscured by vegetation. Whilst not a requirement at a user worked crossing with miniature stop lights, the maintenance of clear sight lines by removal of lineside vegetation is a reasonably practicable measure that could have prevented this accident (Recommendation 1).

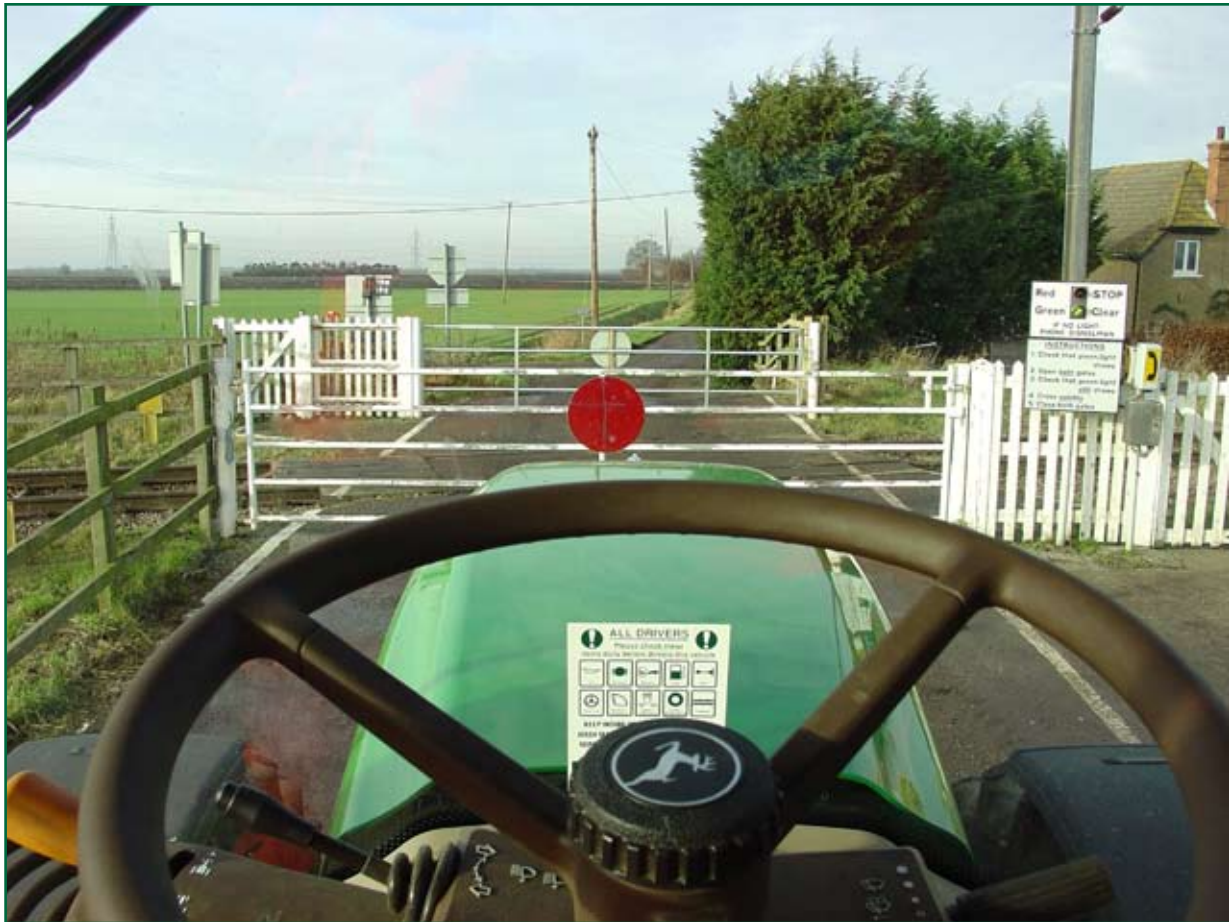
Figure 18: Level crossing from tractor parked on the stop line

119 The conspicuity of the miniature stop lights was considered and assessed by an RAIB Inspector sitting in the cab of the tractor on the stop line. Figure 18 shows the view of the crossing from the tractor cab. The board containing the miniature stop lights can be seen quite clearly, although the lights are not as large as conventional traffic lights. It was concluded that the conspicuity of the lights was not causal.

- 140 The conspicuity of miniature stop lights has been studied by RSSB and it is understood that a new, larger, design of lamp based on LEDs is undergoing development and approval by HMRI. This would be an improvement on the present design and should be implemented as soon as possible (Recommendation 2).
