Rail Accident Report

Derailment near Liverpool Central underground station **26 October 2005**

Derailment near Liverpool Central underground station, 26 October 2005

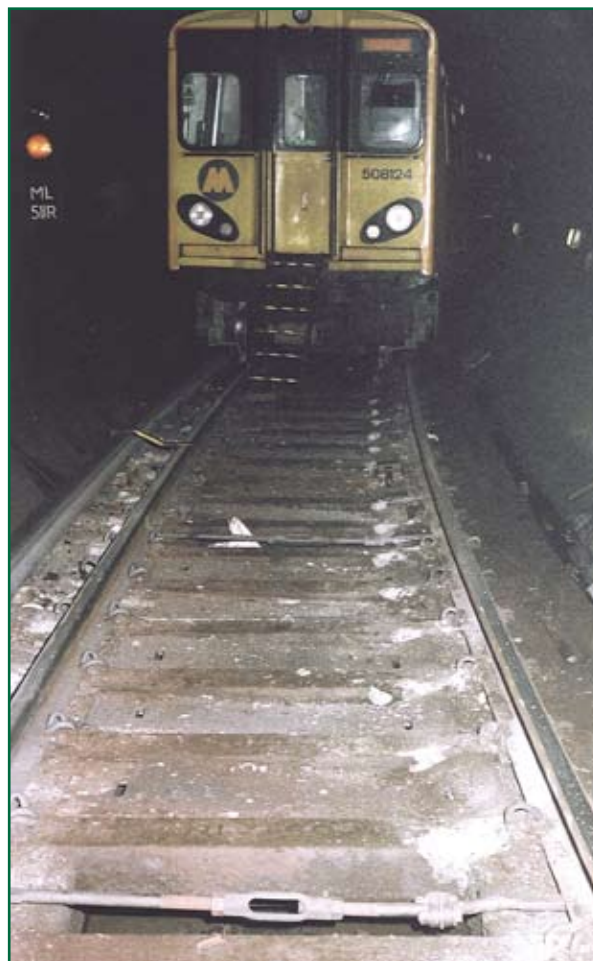
- 37 Between Lime Street and Central stations, as the train was already starting to slow for the station stop and running at only 12 mph (19 km/h), the driver felt the emergency brake apply automatically, some juddering and saw smoke go past the cab windows. The guard, who was travelling in the rear cab, felt the effects of the derailment to a much greater extent and was flung about the cab. The train came to rest about 200 m before the platform at Liverpool Central station, following the emergency brake application. Figure 2 shows the path taken by the derailed train following its derailment and some of the fitted tie-bars.

Figure 2: View of the rear of train 2W43 following its derailment (courtesy of British Transport Police)

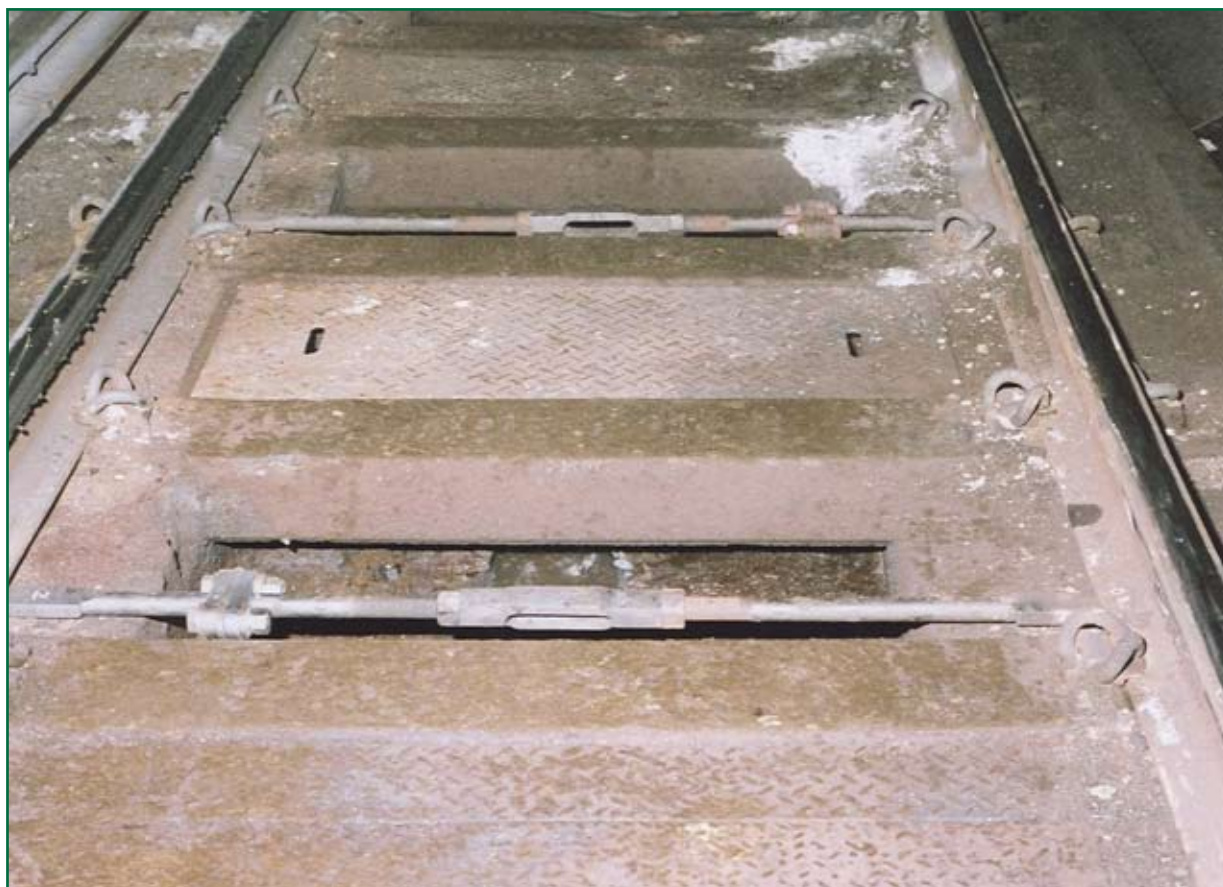
- 51 The *Point of Derailment* (POD) was measured at 392 m (429 yards) from the *headwall* of Lime Street station, located at 1 mile 204 yards. The POD was therefore at 1 mile 633 yards. Both before and after the POD, the track condition was found to be poor, with loose Pandrol clips due to corrosion or wear, and broken or missing *insulators*. There were many tie-bars fitted, including five that had broken. At the POD, a tie-bar had previously failed at the left hand end retaining lug. Figure 3 shows the track in the vicinity of the derailment and tie-bars that had been fitted just after the POD.

Figure 3: Tie-bars fitted to the track close to where the derailment occurred (courtesy of British Transport Police)

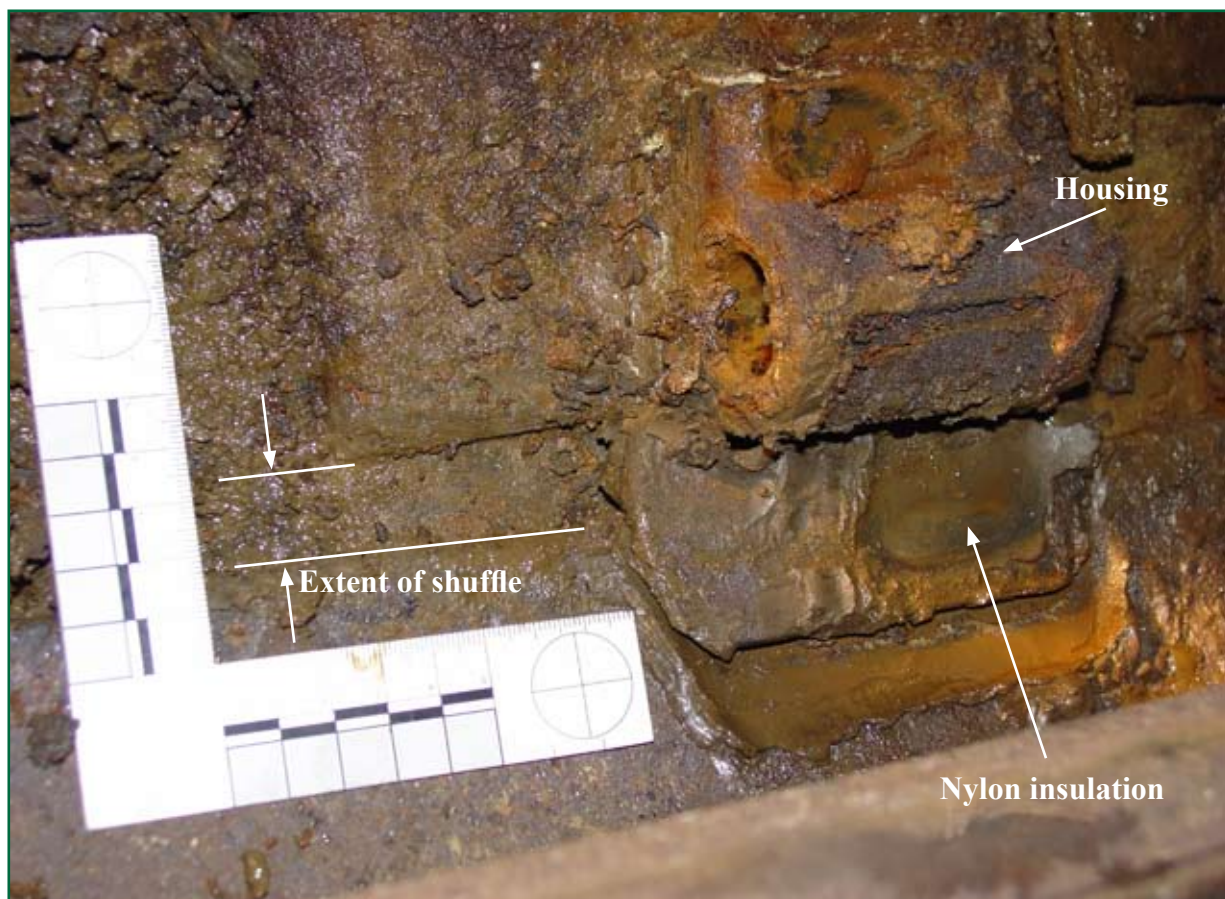
- 52 Both the right hand rail (the low rail) and left hand rail (the high rail) showed evidence of movement ('shuffling') away from the track centre-line (see Figure 4). This was greatest where rail insulators were either broken or missing.

Figure 4: Sleeper 105 showing the degree of rail shuffle that had taken place (note the missing Pandrol clip)

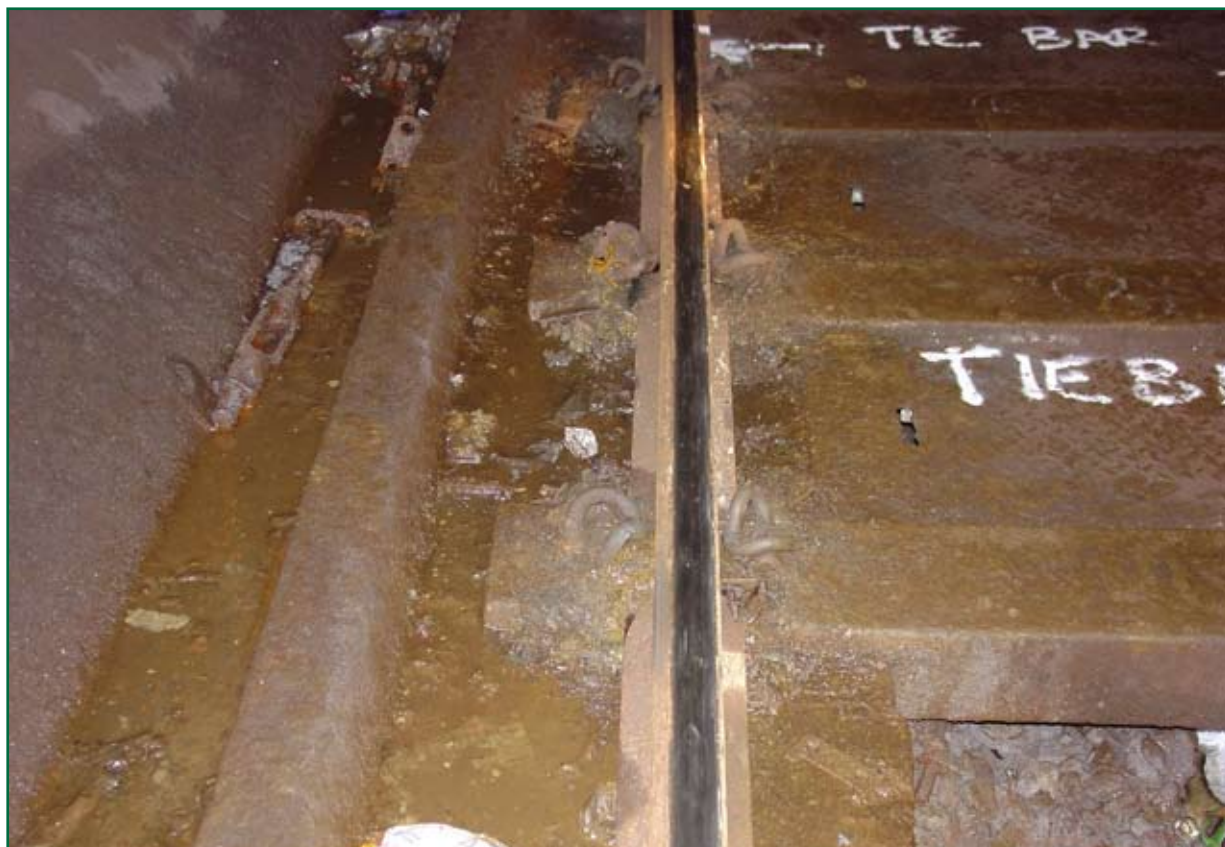
- 54 The trackbed around the rail foot and the housings for the Pandrol clips was heavily contaminated with detritus, causing corrosion of the rail foot over time, resulting in loss of width and depth as well as corrosion of the housings. Figure 5 shows the degree of contamination and also areas of track marked up by the maintainer for further tie-bar fitment, which was not carried out before the derailment occurred.

Figure 5: Showing the degree of contamination around housings and locations marked for further fitment of tie-bars

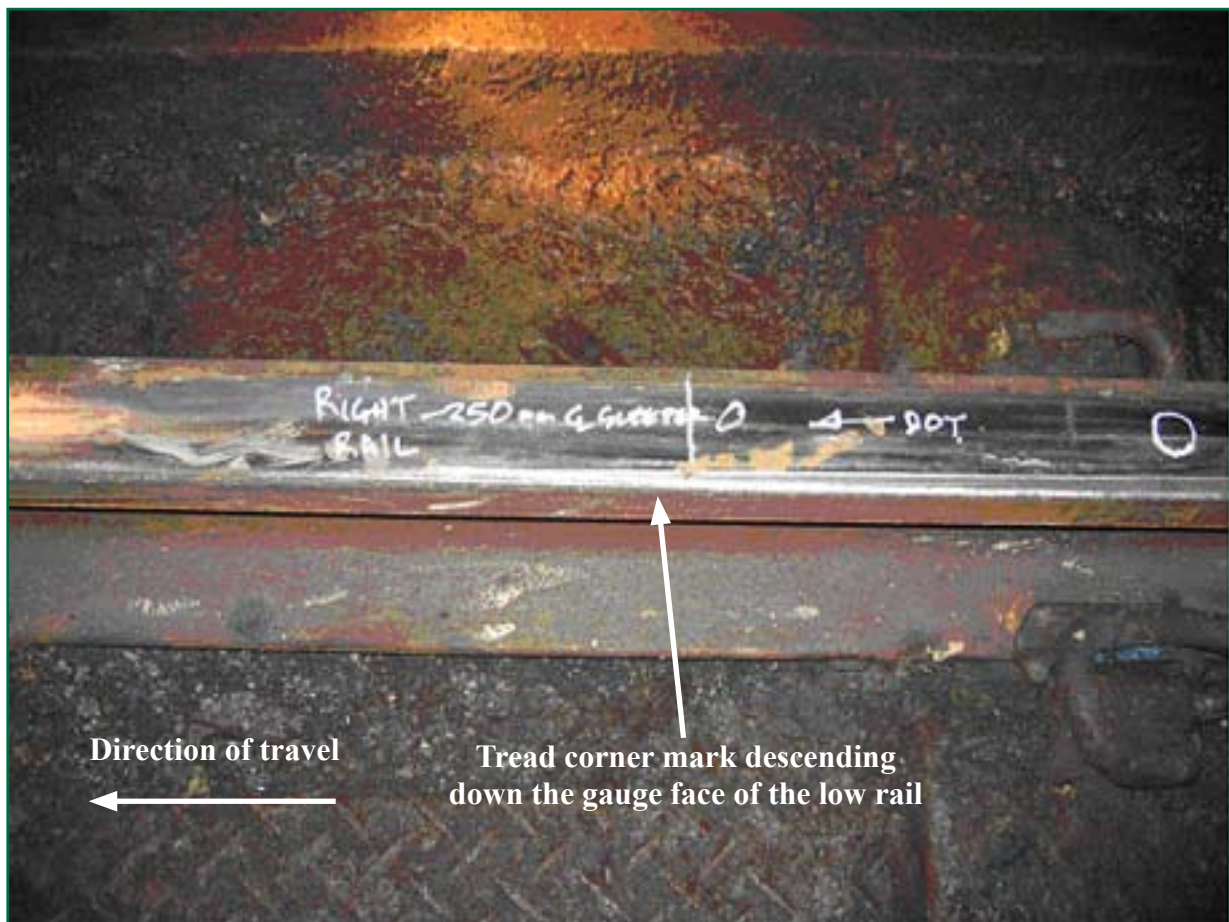
- 79 The derailment occurred when the leading right hand wheel of the last bogie of the train partially descended down the gauge face of the low rail at a location where a tie-bar had previously broken. Initially, the lateral restraint provided by the track prevented the wheel from wholly dropping onto the trackbed or the track fastenings, and the left hand wheel remained in its normal running position, but with its flange in hard contact with the gauge face of the left hand high rail. Figure 7 shows the *tread corner* mark where the right hand wheel descended the gauge face.

Figure 7: Tread corner marks descending down the gauge face of the right hand rail head

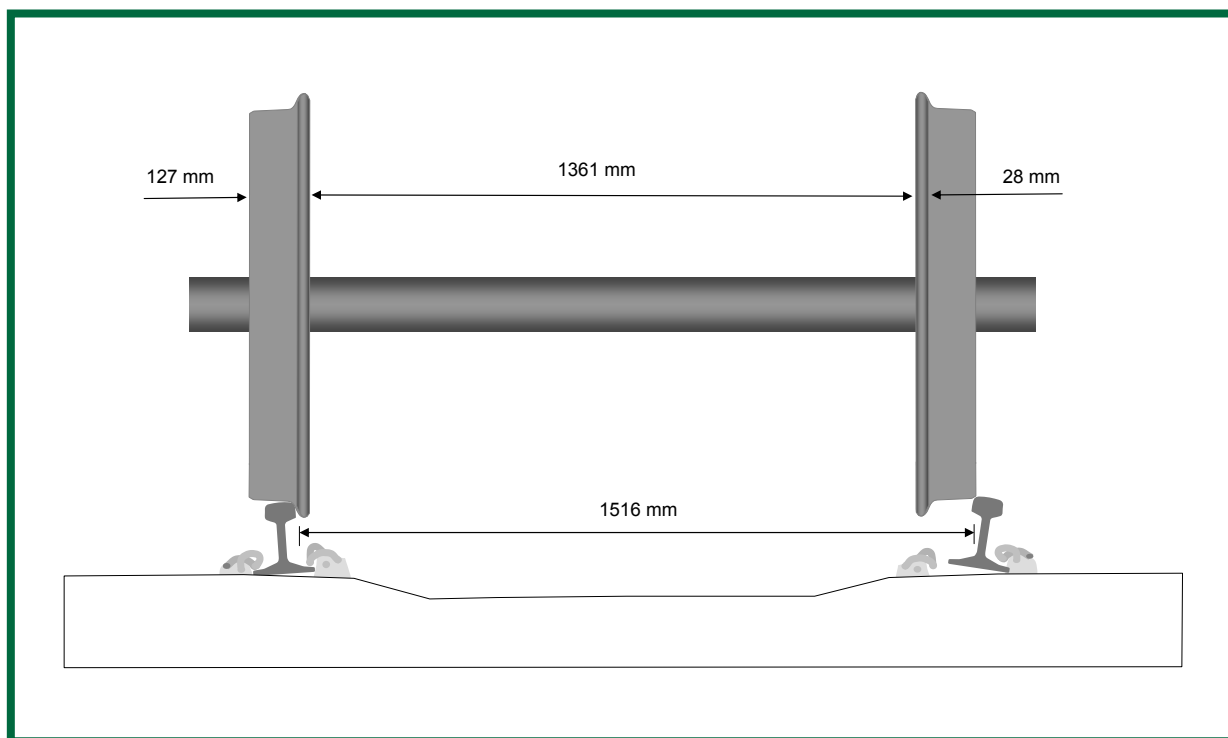
- 80 Figure 8 shows the situation that existed just as the derailment occurred. From the measurement of static gauge at the POD (1465 mm), and the wheelset dimensions that were measured, the gauge faces of the rails displaced by a further 51 mm (1516 mm – 1465 mm) as a result of the gauge spreading forces arising from the train.
- 81 Between the second and third sleepers beyond the initial POD, the flange of the left hand leading wheel of the trailing bogie climbed the gauge face of the high rail and, in doing so, relieved the high lateral *gauge spreading forces*. This allowed the leading right wheel of the trailing bogie to continue its descent down the gauge face of the low rail into full derailment between the third and fourth sleepers from the initial POD. Figure 9 shows the flange climb marks and Figure 10 shows the derailment of the right hand wheel.

Figure 8: Diagram of critical gauge spread dimensions to cause derailment

- 102 Although just less than the 51 mm of gauge spread required to cause derailment (1516 mm – 1465 mm = 51 mm; see also Figure 8; 1465 mm being the static gauge measured on site – see Table 2), the calculated dynamic gauge spread of 50.3 mm would be sufficient to cause the derailment of the third wheelset. Also, given that the outside edge of the wheel was chamfered, the lateral force generated would be increased when the wheel and rail contact were within 5 mm of the right hand rail.

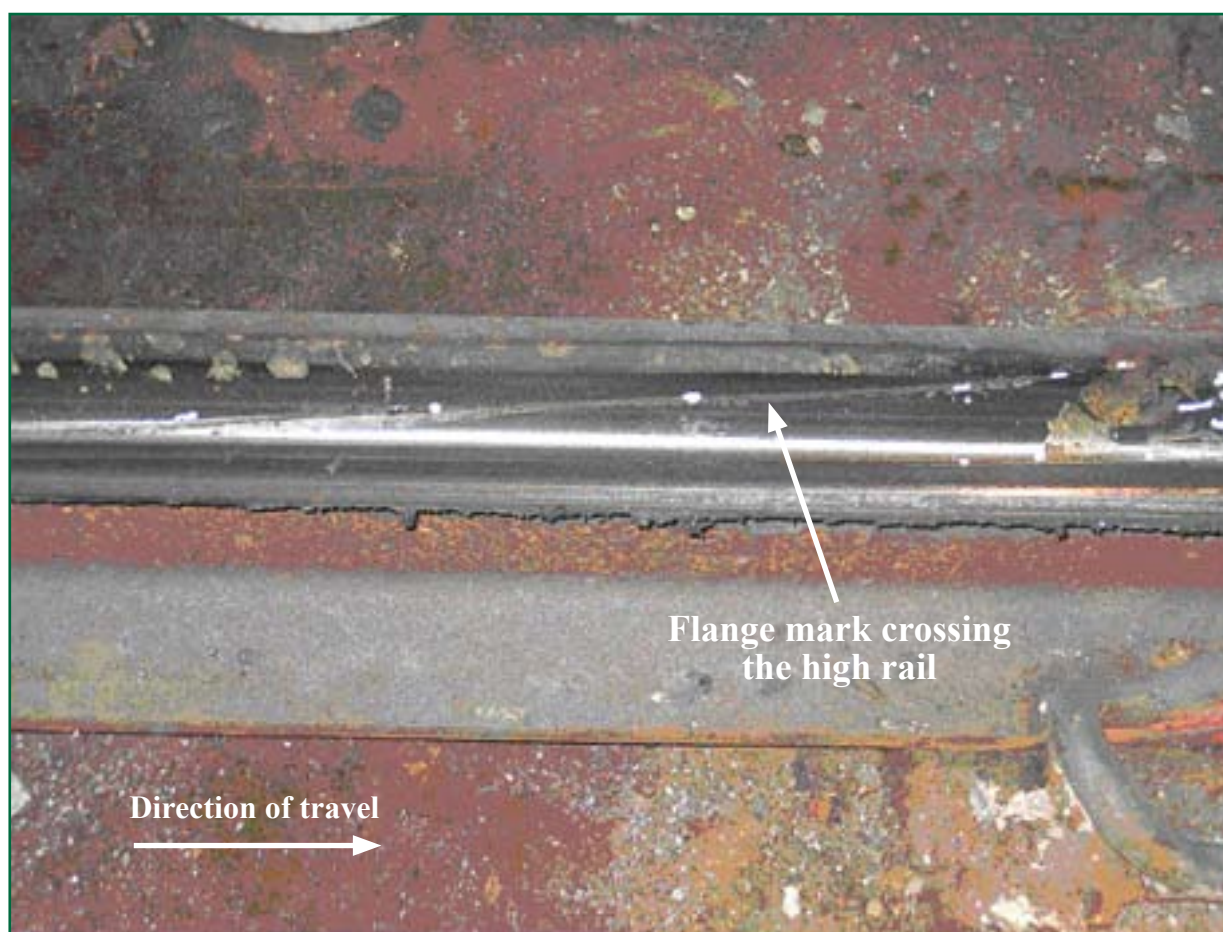
Figure 9: Flange climb mark up the gauge face of the high rail between the second and third sleepers

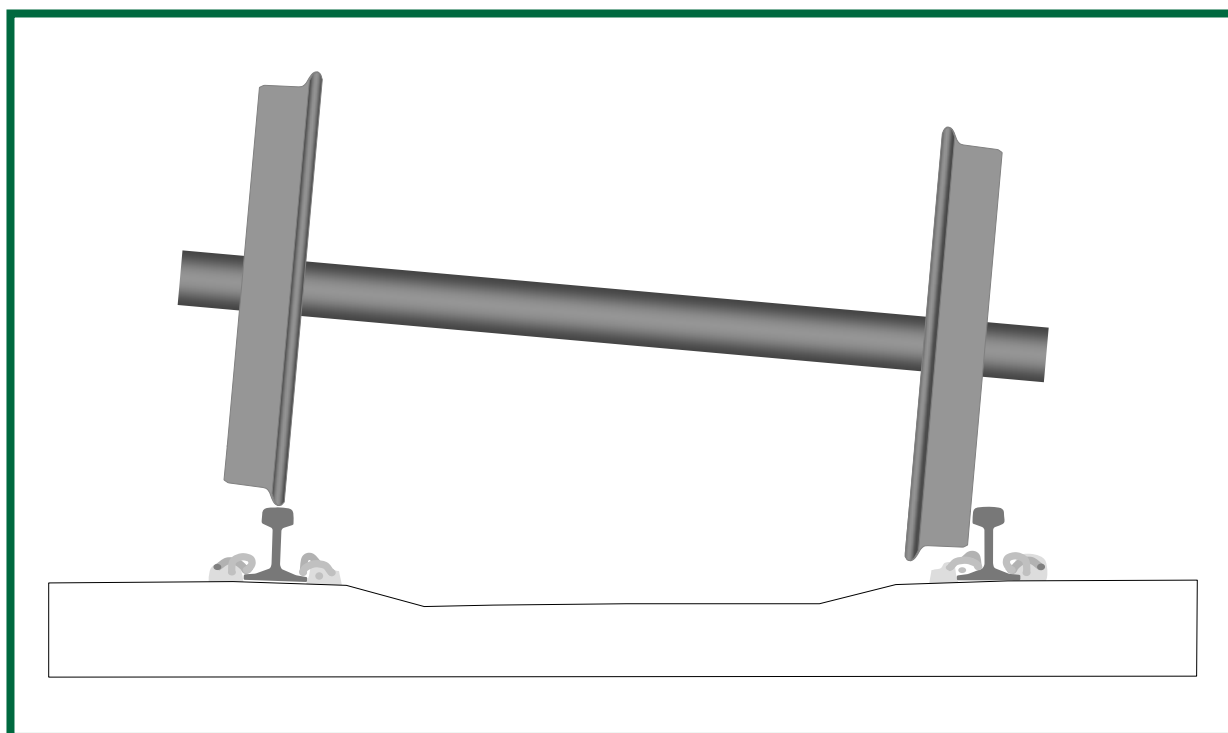
Figure 10: Diagram of wheelset showing how the left hand wheel has flange climbed onto the rail head allowing the right hand wheel to fully derail

- 82 The left hand wheel crossed the rail head and ran into full derailment to the left of the high rail, 100 mm before the leading edge of the fourth sleeper from the initial POD.
- 83 The wheelset continued to run derailed, contacting the track fastenings and sleepers, until the train was brought to a stand, having run about 30 m from the initial POD.
- 84 The trailing wheelset of the trailing bogie was dragged into derailment by the derailed leading wheelset, close to where the train finally came to rest.
- 85 From the foregoing, the immediate cause of the accident was the dynamic spreading of the track gauge during the passage of train 2W43.

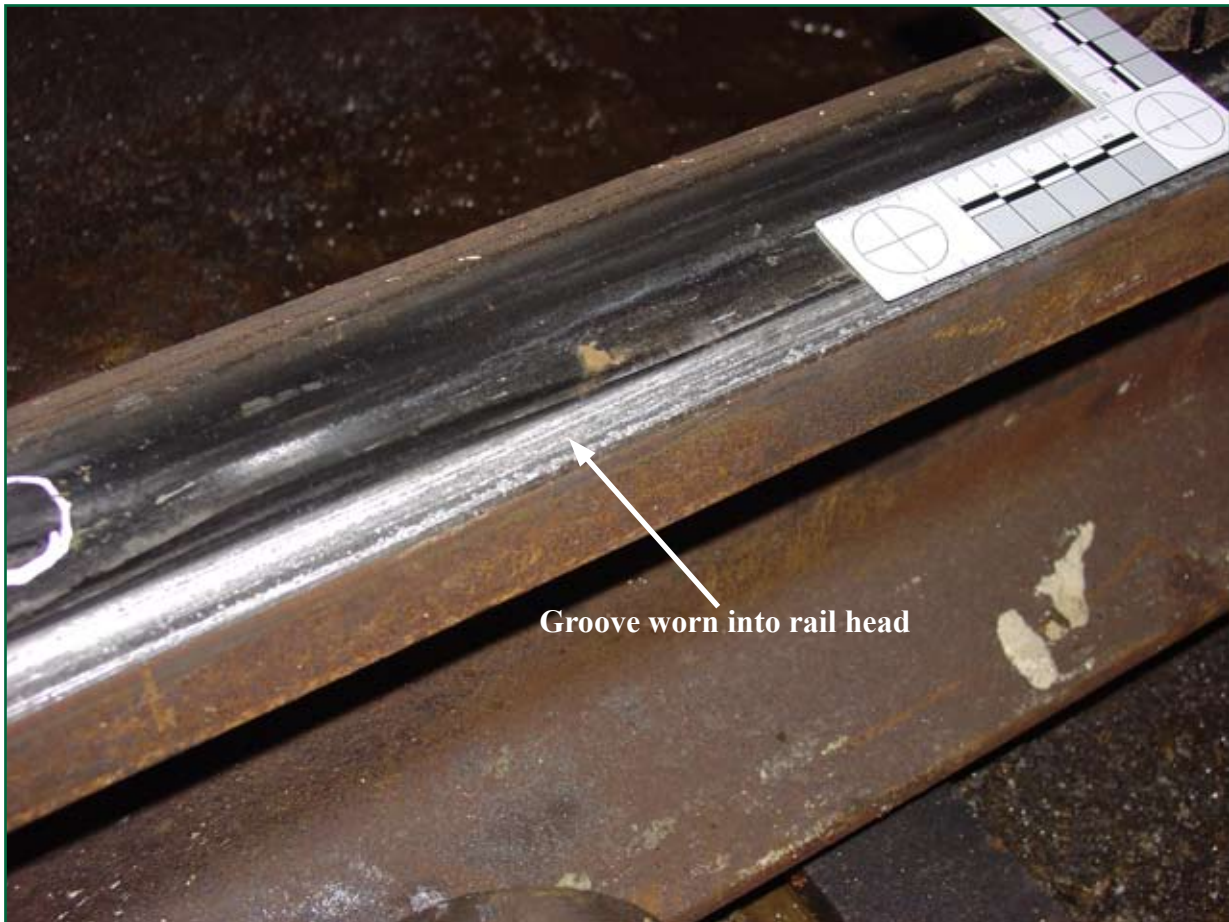
- 86 It was found that a significant groove had developed on the head of the low rail in the vicinity of the POD. It commenced about two sleepers before the POD, approximately 15 mm from the gauge face and, as the groove progressed towards the POD, it migrated towards the gauge face such that, at the POD, it had reached the *gauge corner*. Beyond the POD, the groove migrated back across towards the *field side* so that, by two sleepers beyond the POD, it was 10 mm away from the gauge face. This *witness mark* was typical of that formed by the tread corners of wheels running on track that was wide to gauge. The groove, just before where the leading right wheel of the last bogie descended down the gauge face, is shown in Figure 11.

Figure 11: Groove on the low rail just before the point of derailment

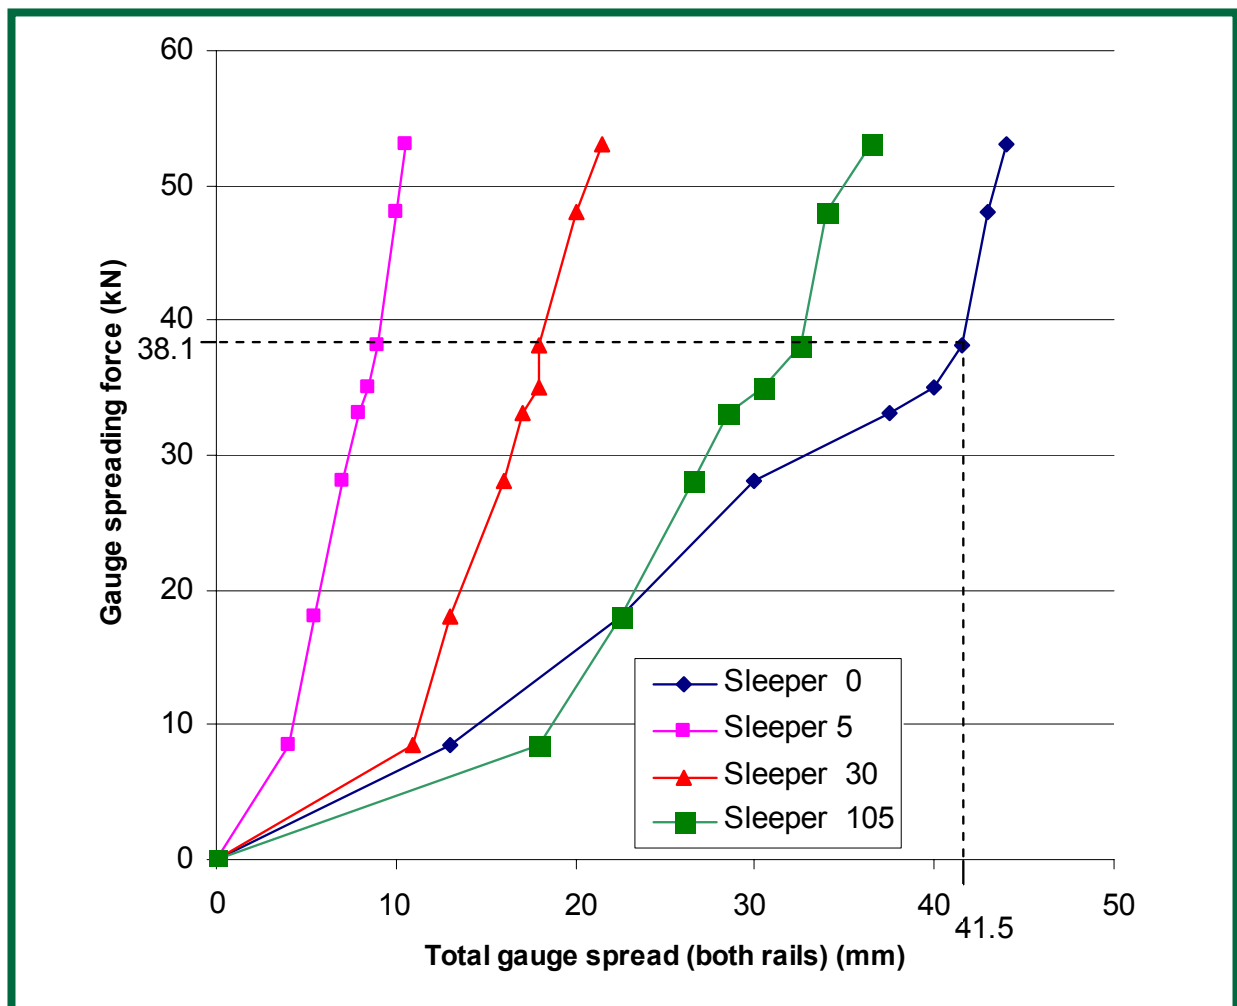
- 88 Several gauge spreading tests were carried out to provide data for the subsequent Vampire® modelling work described from paragraph 94 to paragraph 126. The tests applied lateral gauge spreading forces between the inner faces of the rail webs, just below the rail head using a calibrated hydraulic ram. The gauge spreading force was applied incrementally and, at each increment, the gauge was recorded. The tests were carried out at the POD and at sleepers 5, 30 and 105 before the derailment (the results are plotted in Figure 12).

Figure 12: Gauge spreading test results obtained from the derailment site

- 100 In a third simulation, the increase in gauge caused by the passage of earlier wheelsets was taken to be the initial slide that was possible of the rails on their baseplates. Referring to Figure 12, it can be seen that, for sleeper zero (the POD), the maximum slide on the baseplates was 41.5 mm for both rails, corresponding to a gauge spreading force of 38.1 kN. Beyond this point – the maximum extent of the relatively straight section of the graph – further gauge spreading can only occur by the rails rolling outwards.

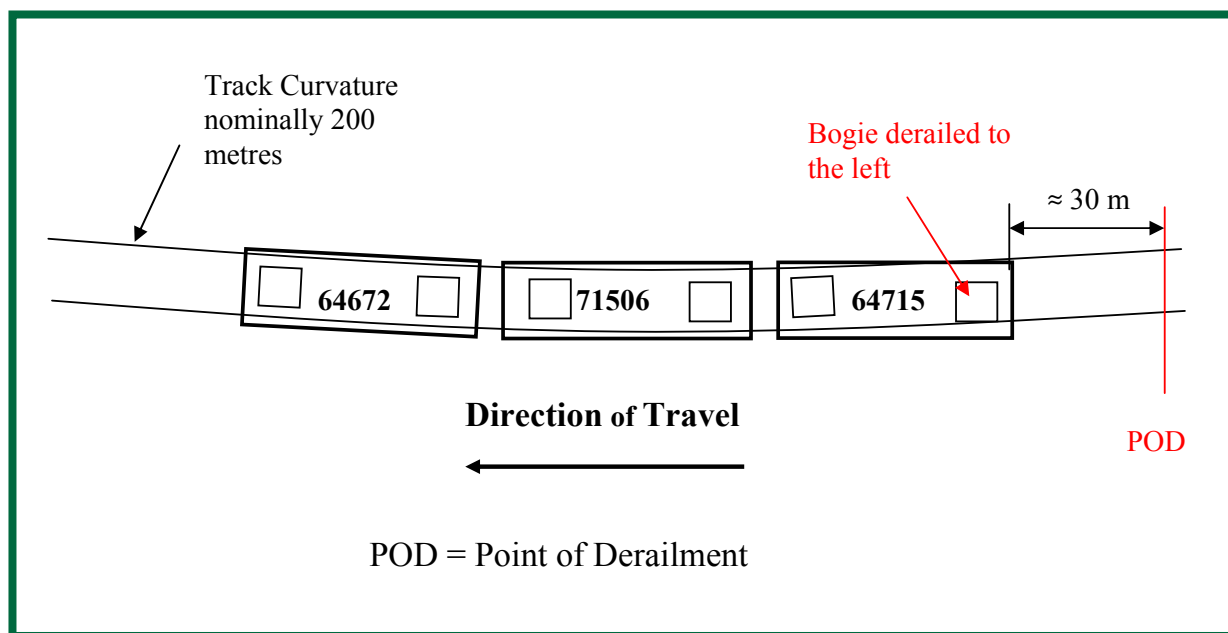
- 53 There was evidence of sidewear of the high rail, and this was found to be 6 mm at the point of derailment. Although significant, the sidewear was within maintenance limits. The degree of sidewear of the high rail at the POD can be seen in Appendix E.

Left and right hand profiles at the POD

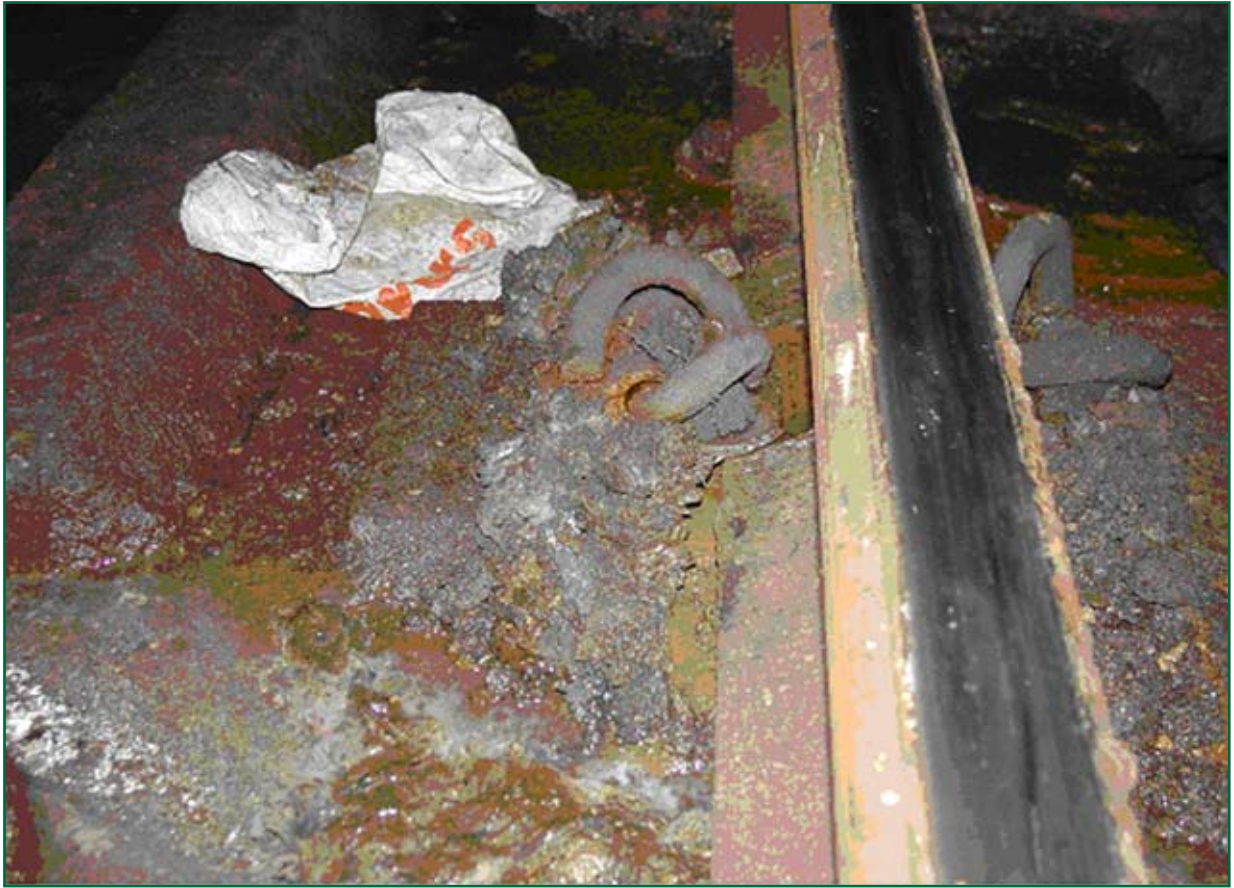
2. URGENT SAFETY ADVICE	
USA DATE:	27 October 2005
TITLE:	Gauge widening
SYSTEM / EQUIPMENT:	Pre-stressed concrete-sleepered track part embedded in concrete base. Tie bars fitted but with varying quality and effect.
SAFETY ISSUE DESCRIPTION:	Insulators pushed out and rails cut into housings combined with extensive side-wear, permitting track gauge to widen, thus allowing potential for derailment.
CIRCUMSTANCES:	Sharp curved track in aggressive tunnel environment
CONSEQUENCES	Gauge widening allowing derailment
SOURCE:	RAIB site investigations
REGULATING ISSUES:	No issues
REASON FOR ISSUE	So that duty holders with similar track forms may check for potential similar details

Photo attached to Urgent Safety Advice
