Rail Accident Investigation Branch

Rail Accident Report

**Cutting of rail from a line that was still open to traffic, near Thirsk station, East Coast Main Line.
11 January 2006**

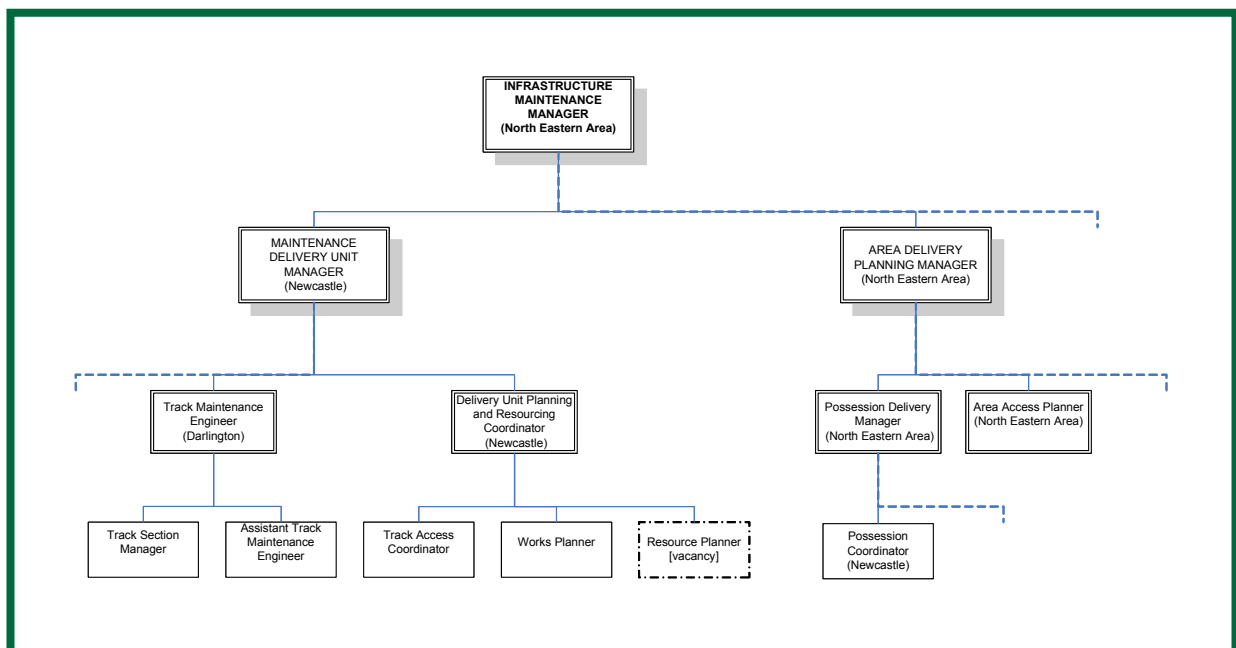
Figure 3: Organisational chart showing the Network Rail management arrangements that are relevant to this investigation

- 76 There is evidence that the various staff and managers involved in this incident were unclear on their roles and responsibilities in the area of possession and works planning (Recommendations 2). This lack of clarity has arisen in part due to the recent major changes in the way track engineering is being managed by Network Rail. Further to this there appears to some overlap between the roles of the various departments shown at Figure 3. This is exacerbated by the existence of a number of long term vacancies.

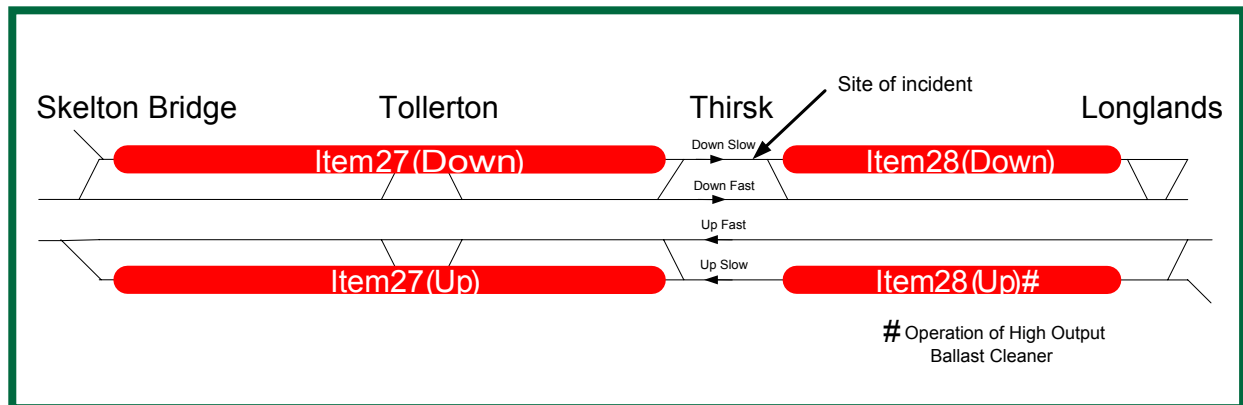
Figure 4: Overview of possessions in the area of Thirsk on the night of 11/12 January 2006

- 35 On 11 January 2006 two engineer's possessions were taken on the slow lines of the ECML in accordance with the arrangements published in the WON. The first of these (shown as item 27 in the WON) was taken between Skelton Bridge and 872 points. The second (shown as item 28 in the WON) was taken between 875 points and Longlands Junction. Each of these possessions had a separate PICOP. The PICOP for the item 28 possession was located at Longlands Junction.
- 36 An overview of the possessions taken on the night of 11/12 January 2006 is to be found at Figure 4.

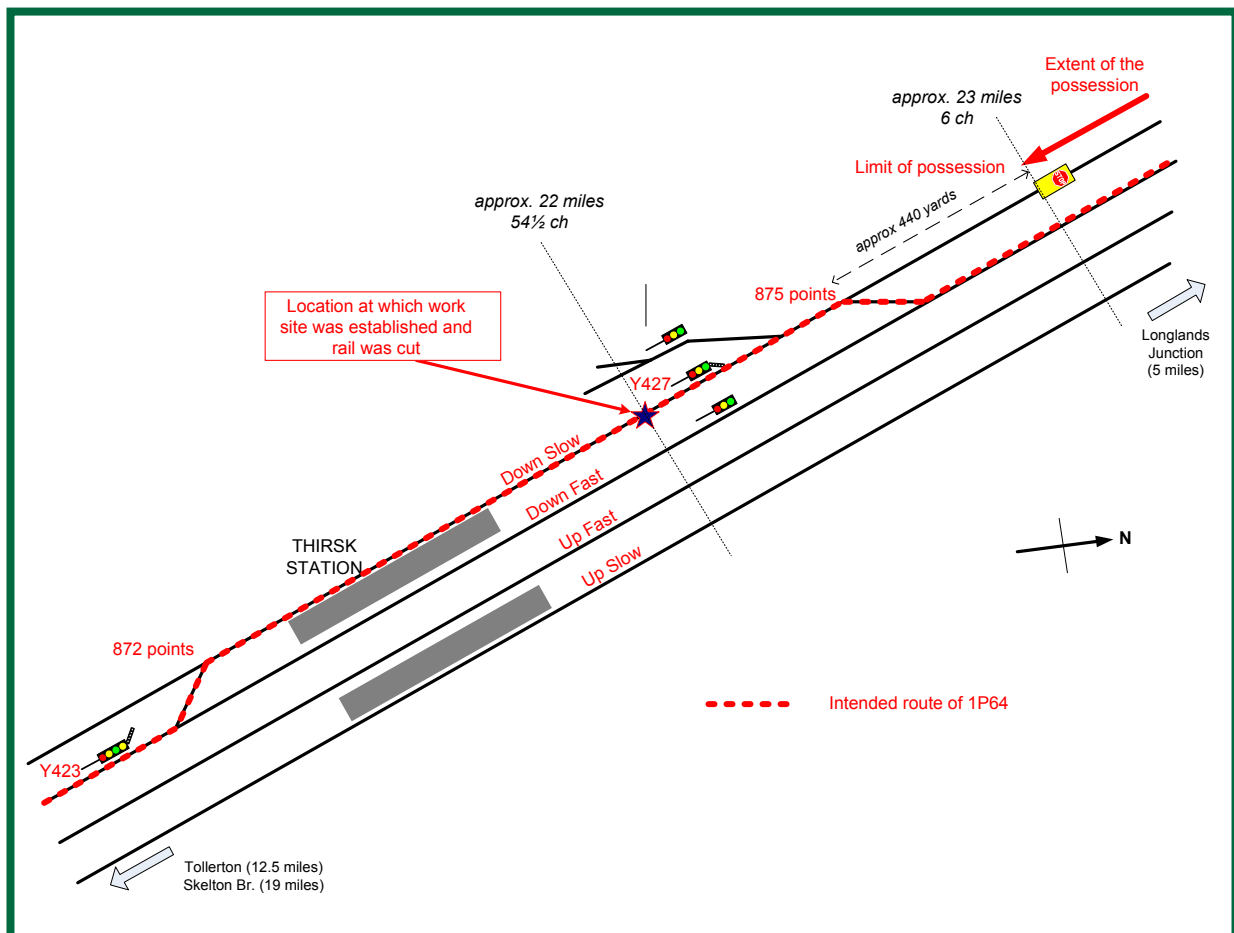
Figure 5: Overview of the incident

- 42 At about 23:35 hrs the track circuit on the approach to signal Y427, 'TT', showed occupied. As a consequence the signaller was unable to set the route between signals Y423 and Y427 for train 1P64. This train was by now on the final approach to the Y423 and within two minutes was at a stand awaiting the route to be set across 872 points. (See Figure 5 for a general overview diagram of the incident).

- 43 At this point the signaller asked the PICOP of the item 28 possession if there was any work taking place that might have affected track circuit 'TT'. It was at this point that the PICOP realised that the location of the worksite he had previously authorised was outside the possession (at 22 miles 54½ ch).

- 44 The ES to the north of Thirsk station was immediately contacted by the PICOP. The ES reported that he had set up the worksite and the section of defective rail was in the process of being removed. At the time of this call the suspect rail had been cut and preparations were being made to remove it.
