# Rail Accident Report

## **Derailment of a Ballast Plough Brake Van at Carlisle 6 February 2006**

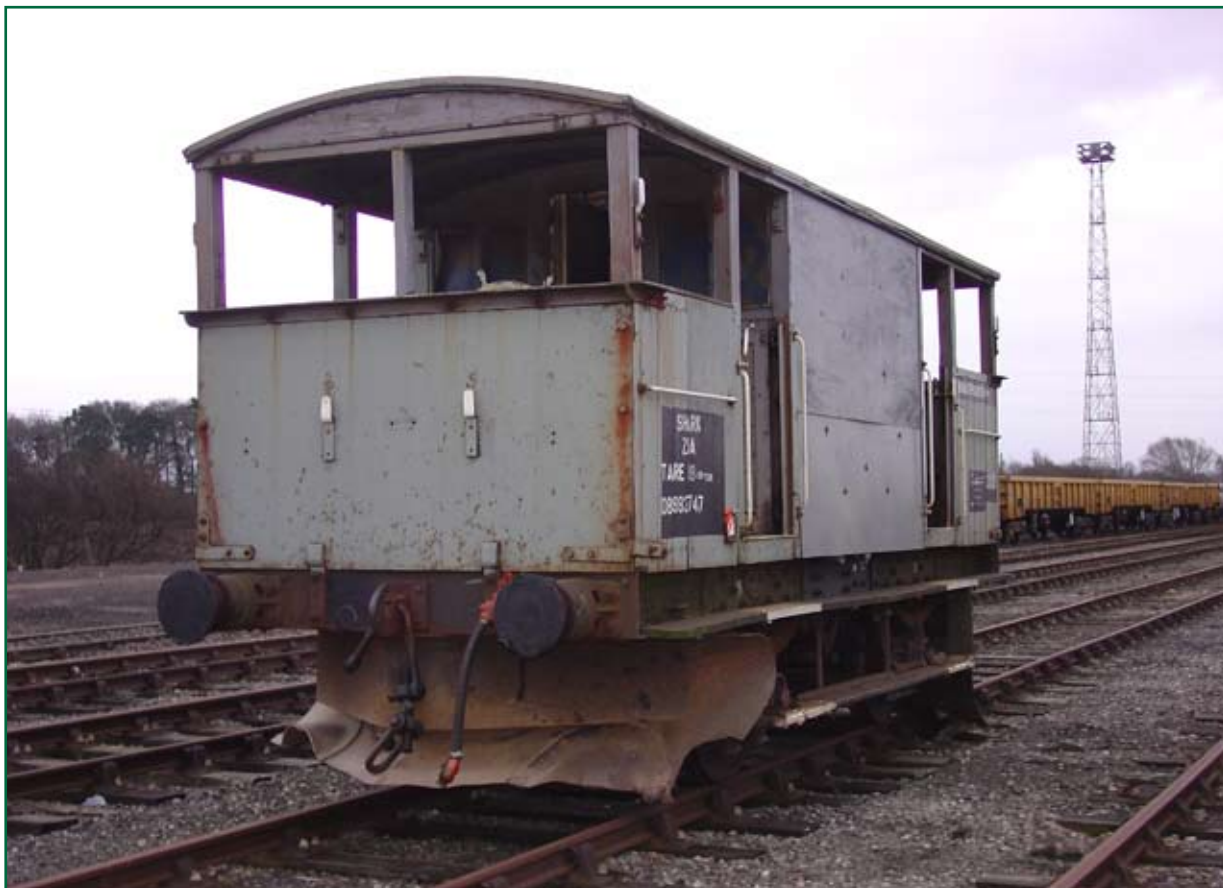
Figure 2: Shark Plough van DB993747

- 58 The left hand side of the ballast plough at the leading end of the Shark plough brake van had contacted a converging rail on the approach to 756A points and derailed the vehicle all wheels. This had caused the brake pipe between the brake van and the wagon immediately in front to part and initiate the brake application.

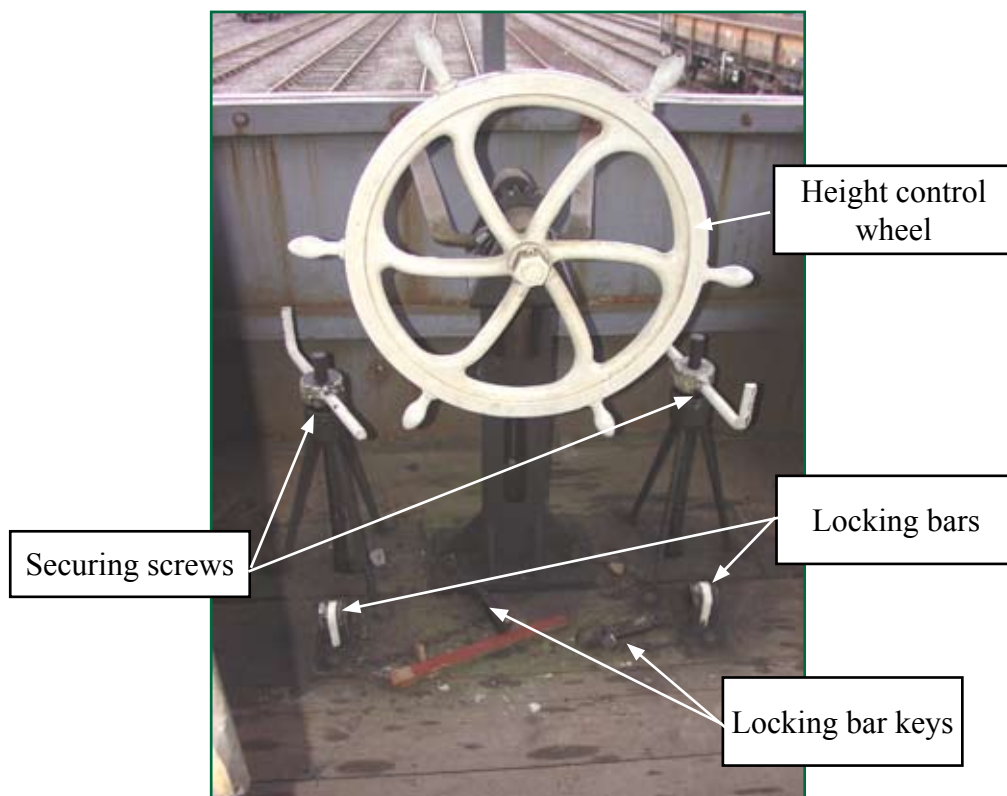
Figure 4: Inside view of a Shark plough brake van showing height control wheel, securing screws and locking bars with plough in working position

- 15 Plough brake vans are unpowered and are towed or propelled. When in use the height of the plough is adjusted using the control wheel, shown in Figure 4 and Figure 5, to achieve the desired degree of ballast distribution and level. The plough must be raised above railhead height where obstructions exist in the four foot or on the sleeper ends, eg at points or at *AWS magnets*.

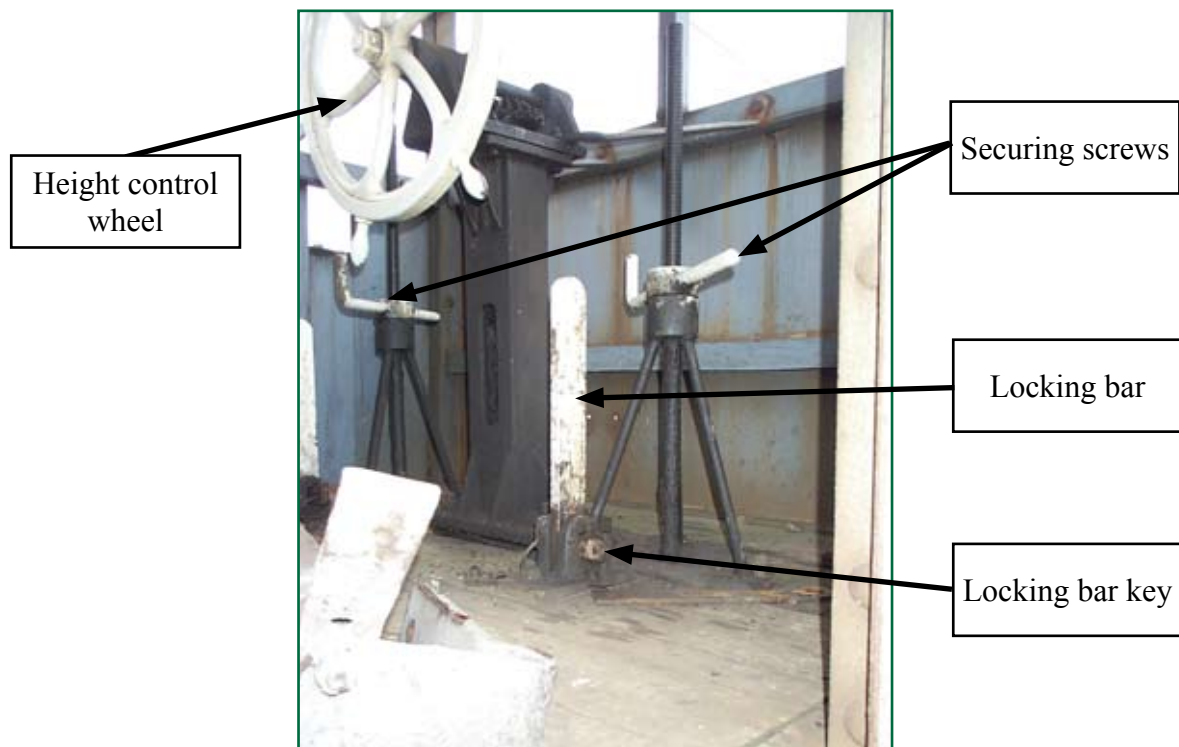
Figure 5: Inside view of a Shark plough brake van, with ballast plough in travelling position, showing securing screws and locking bars with keys inserted.

- put both keys into the locking bars – these will only fit with the plough fully raised.
- 61 The design of the locking bars and keys is robust and proven. There was no damage to the locking or securing system and therefore a failure of these is discounted. The keys, which are inserted into the locking bars, have a ‘drop end’ latch to prevent keys vibrating or falling out or being displaced unintentionally. They are also retained to the vehicle by short chains, to prevent loss. These are shown fitted in Figure 4. Both keys being properly inserted and subsequently coming adrift is discounted.

- 63 A subsequent trial was carried out to establish the securing capability of the plough height control system. The vehicle was static and the locking keys and securing screws released. The height control wheel and its gear mechanism together with the securing screw handles and their screw threads were free to move and adequately lubricated. With the plough in the raised position a small amount of rotational input to the control wheel resulted in the plough descending easily and the wheel continued to rotate for a short period of time. It is considered in a moving train, with the added vibratory input, the plough would descend rapidly to rail level. Because this did not occur in this incident it is reasonable to conclude that the securing screws were wound down before the train left the site.

- 1 EWS should ensure that the advice and instructions given to site train preparers' in Operating Digest Advice Number 121 (Actions already taken or in progress: paragraph 80) are incorporated into normal working procedures.
- 2 EWS should consider providing further assistance to train preparers in regard to plough stowage by painting locking keys a bright colour and/or placing reminder/warning notices on the exterior of the vehicles.
