Rail Accident Investigation Branch

Rail Accident Report

Derailment near Moy, Inverness-shire on 26 November 2005

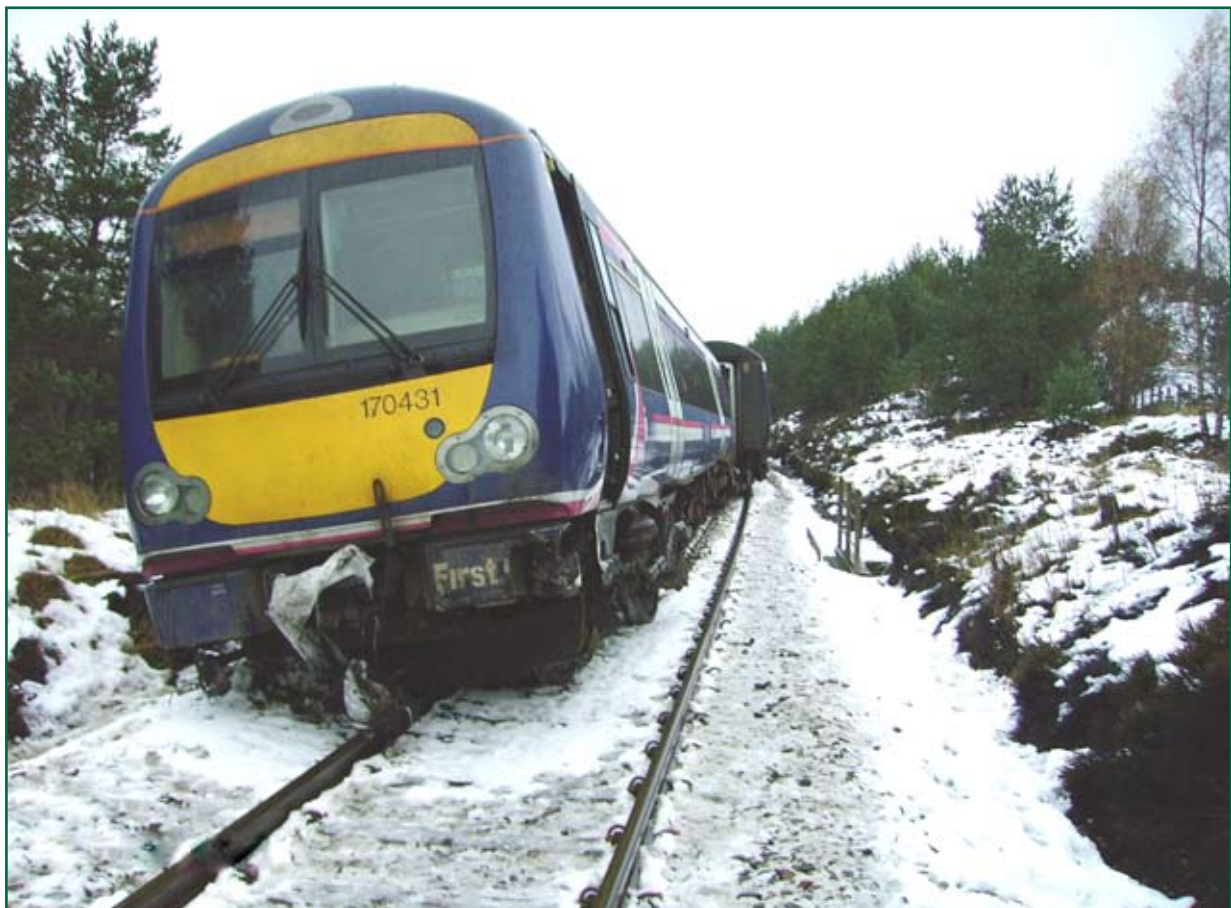
32 At approximately 07:02 hrs the train encountered a landslip in the cutting north of Moy. All wheels on both bogies on the leading vehicle derailed to the right, the down cess. No other wheels were derailed. The train came to rest upright after travelling a further 122 m, Figure 2. (There was found to be timing mis-match between recording equipment fitted on the train; it is possible that the time of encountering the landslip was up to four minutes later).

Figure 2: The derailed train.

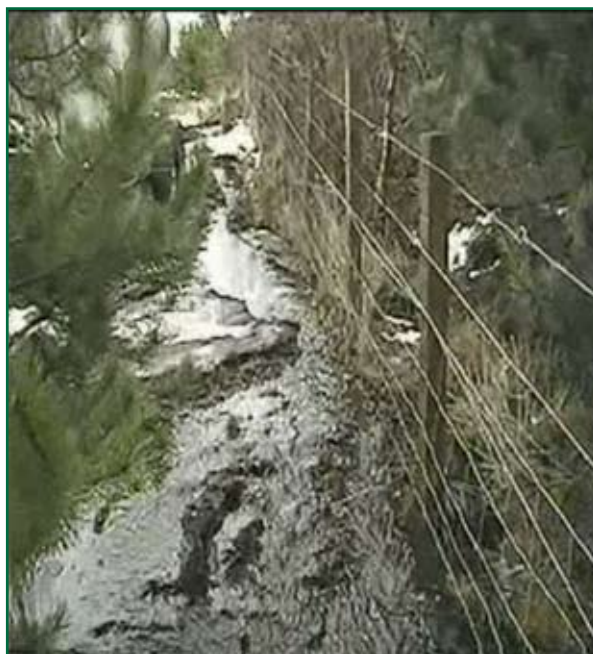
- 63 Some surface water runs off the northern end of the Parking Area. There is evidence that a portion of the run-off then breaches the boundary fence and enters the Network Rail crest drain, as shown diagrammatically on Figure 4 and also on the video image at Figure 5. Just north of this location, a tree was found growing which blocked the drain. No water flowed past the blockage; it was observed to infiltrate into the ground via an apparent 'sink hole' in the drain invert. There was no evidence of ponding due to the blockage or water then overspilling onto the cutting slope. (A portion of the remaining run-off was observed to enter the 3rd party V-drain indicated on Figure 4. Water overflowed from this drain and entered the Network Rail crest drain via an additional breach of the boundary fence north of the tree blockage. However, at this location both drains appeared to be free-flowing and therefore effective in taking the water away from the cutting slope).

Figure 5: Still image from the site video showing water breach through the boundary fence and into the Network Rail crest drain (Image: Network Rail).

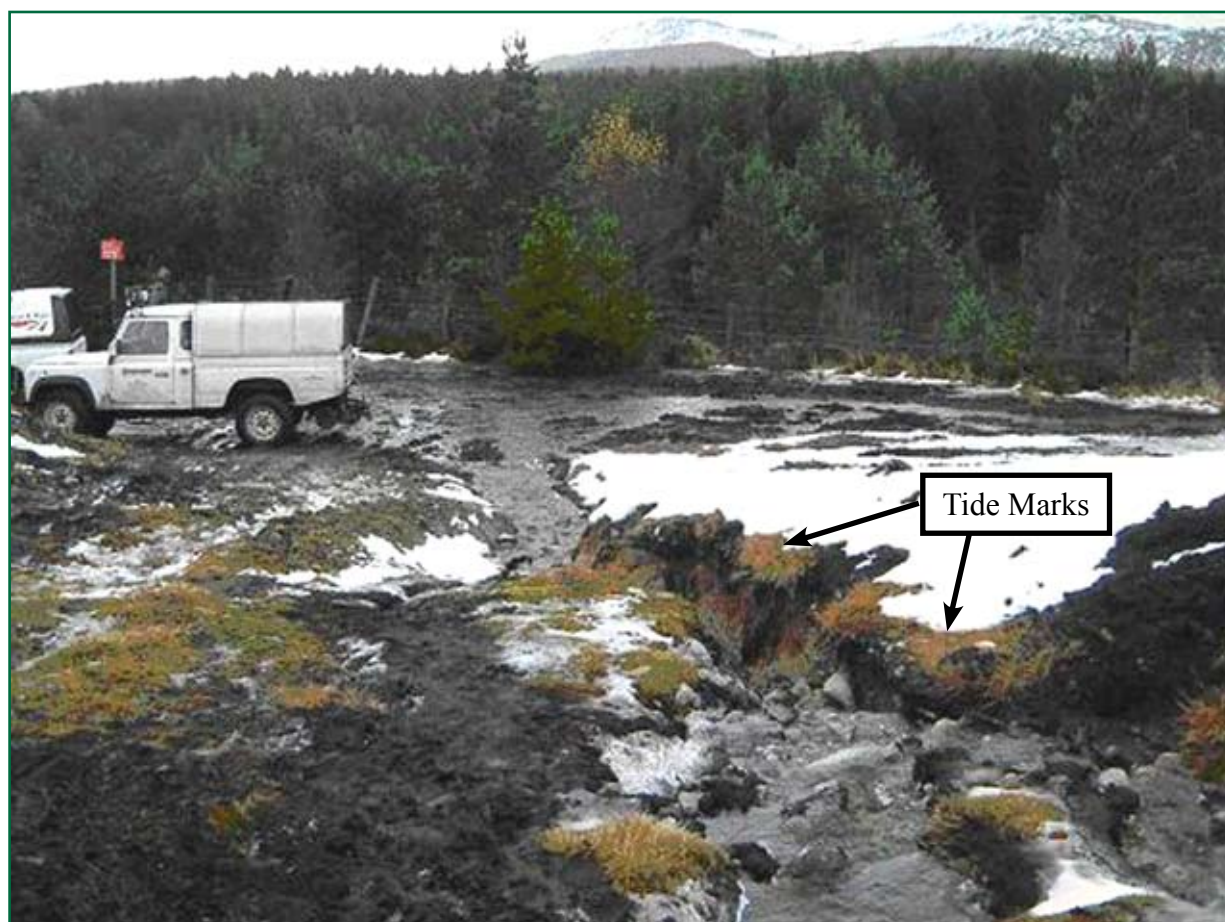
- 64 Site photographs taken by the Site Witness immediately after the incident show a significant amount of water flowing onto the Parking Area (Figure 6). The presence of tide marks in the snow can also be seen again indicating that the flow had been higher.

Figure 6: Water observed flowing onto the Parking Area.

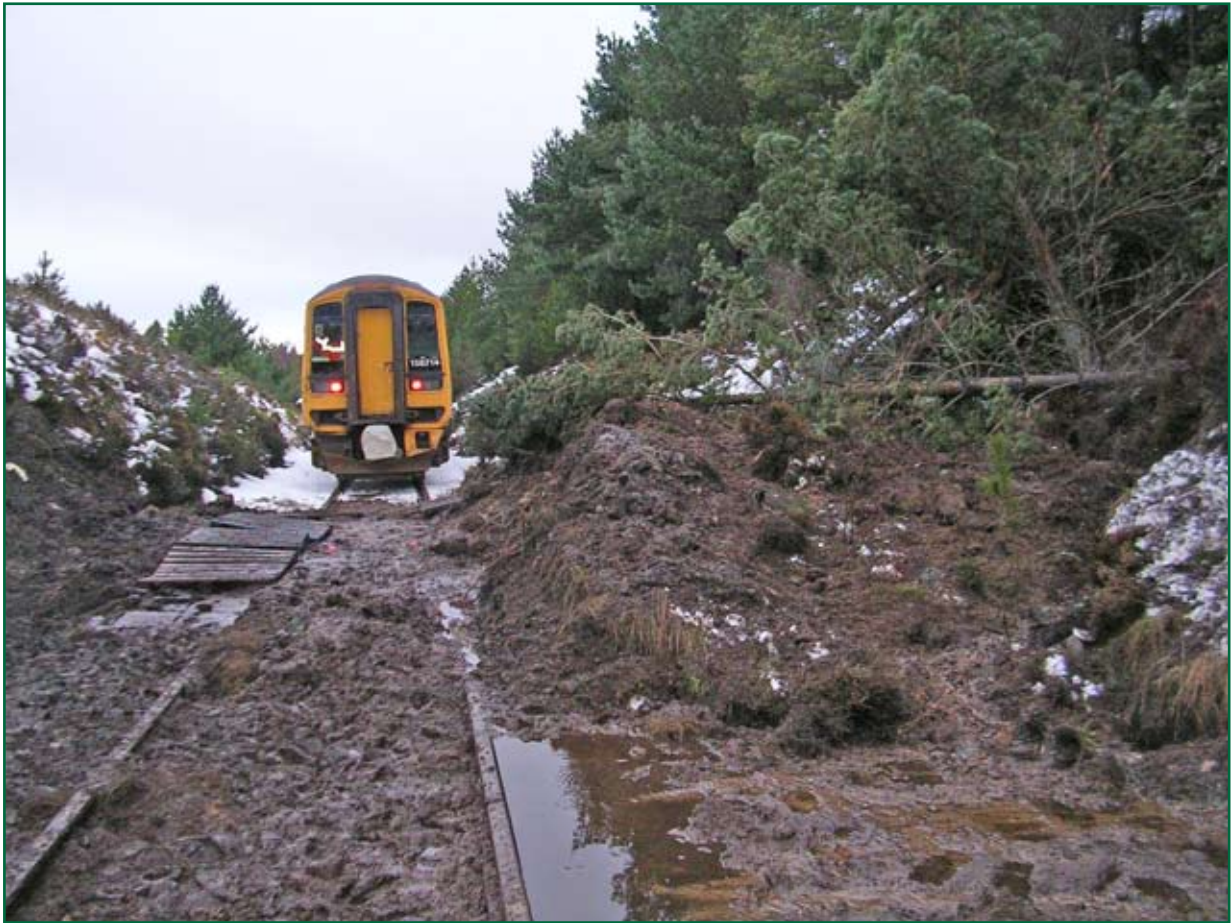
- 77 A fan shaped debris pile was observed spreading out from a slip bowl. This resulted in the deposit of a pile of mixed soil material between 1.5 and 2 m high across the track, Figure 7. The observed landslide is typical of an initial deep rotational failure followed by an *earthflow*.

Figure 7: Debris pile from landslide (the train shown is the one sent to site for rescue). (Photograph: Network Rail)

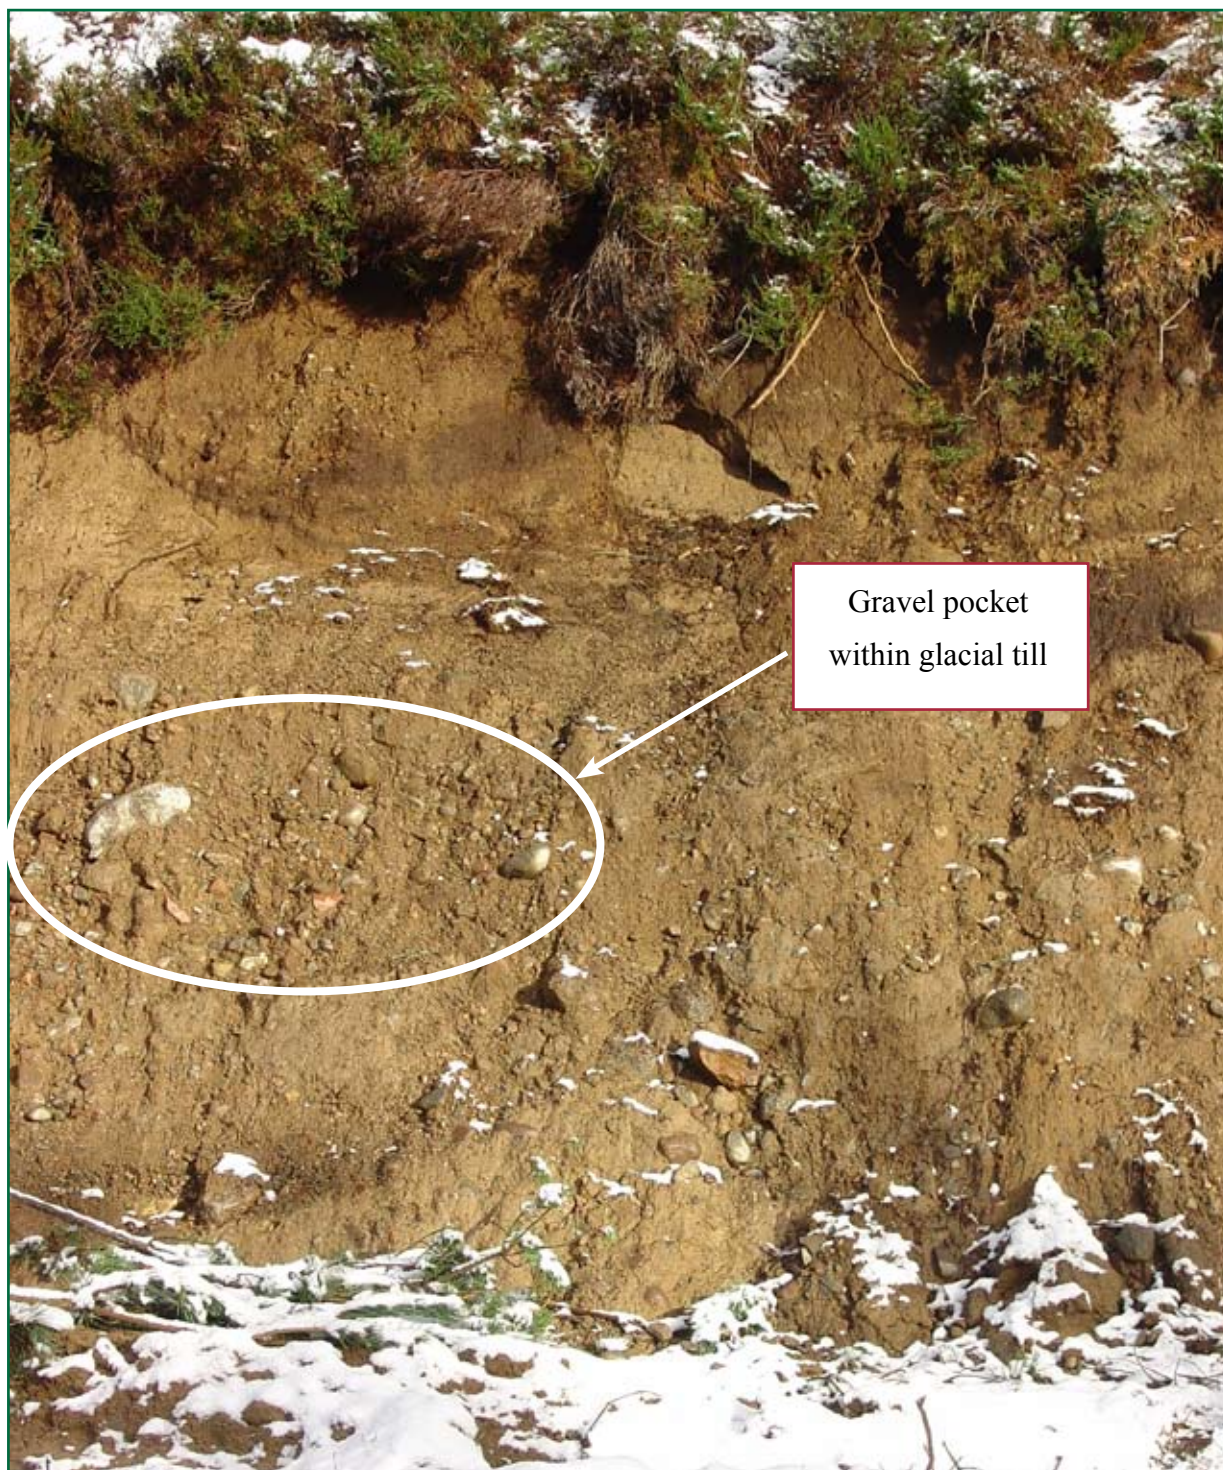
- 78 Site photographs taken on 28 November showed significant local variation within the glacial till exposed in the backscar; this included the presence of pockets of sand/gravel in the uppermost 3 m band, Figure 8.

Figure 8: Backscar resulting from the landslide.

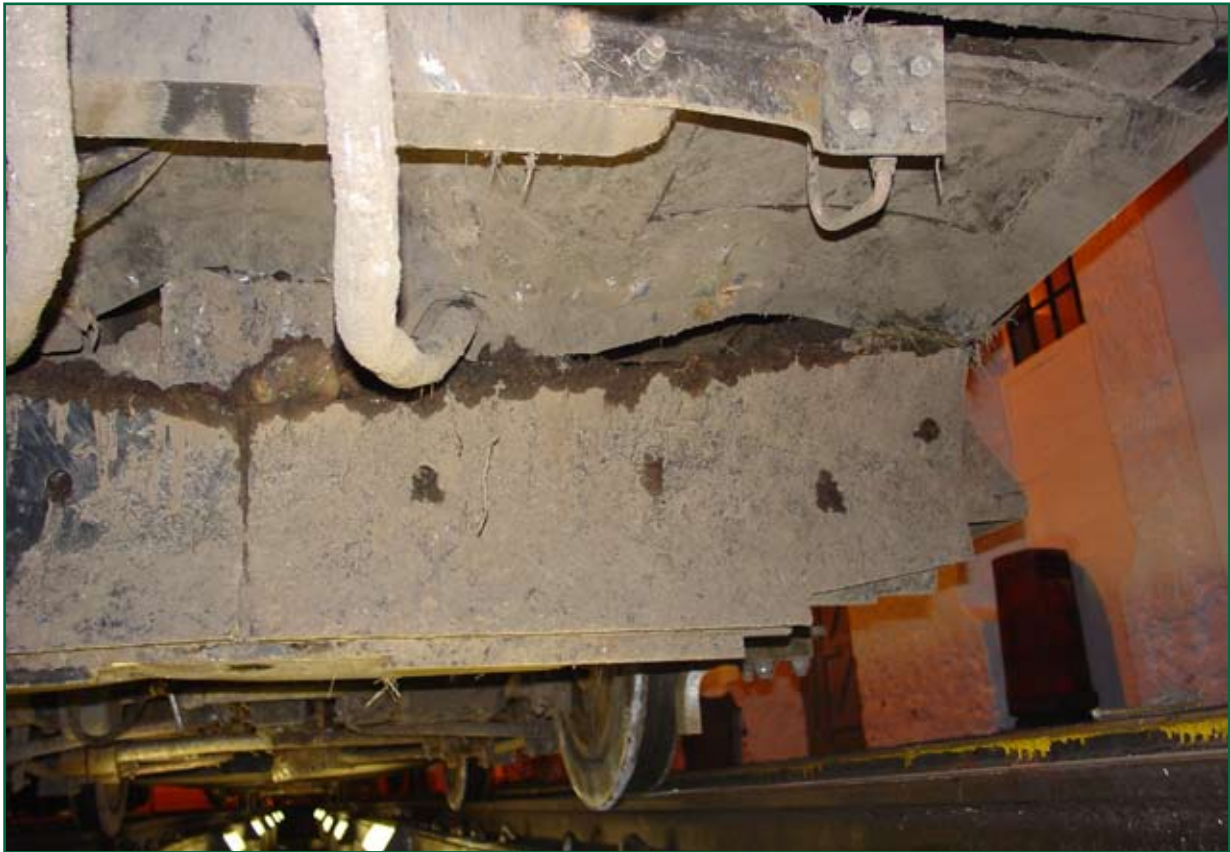
- damage to the head of the leading coupler and cab valence (more significant on the left hand side);
 - deformation of enclosure plates forward of the *obstacle deflector*, deposition of soil, and damage and detachment of equipment fitted underneath the cab; Figure 10 shows the damage to the underside of the leading cab, by contrast Figure 11 shows the underside of the trailing cab which did not directly encounter the debris pile;

Figure 10: Underside of leading cab showing damage as a result of encountering the debris pile.

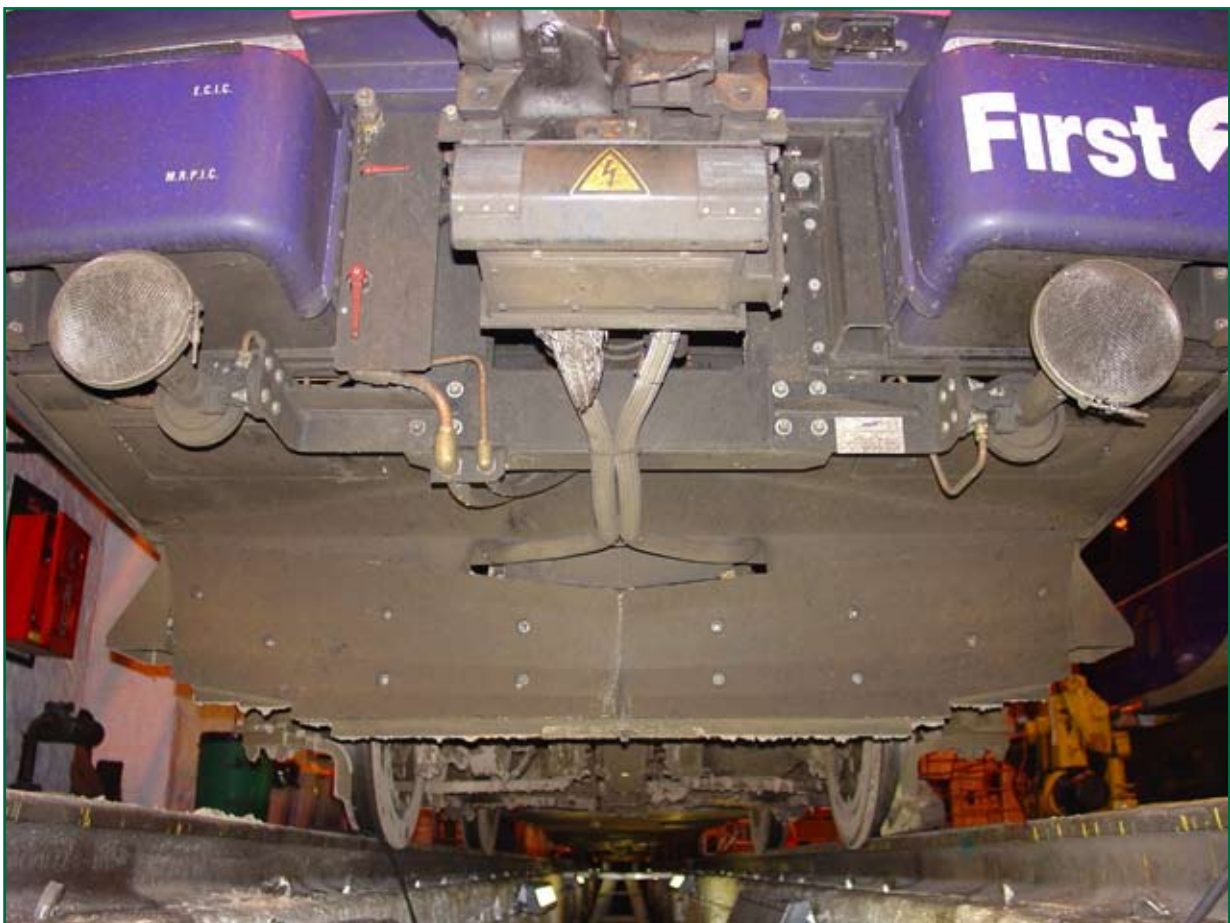
Figure 11 : Underside of trailing cab.

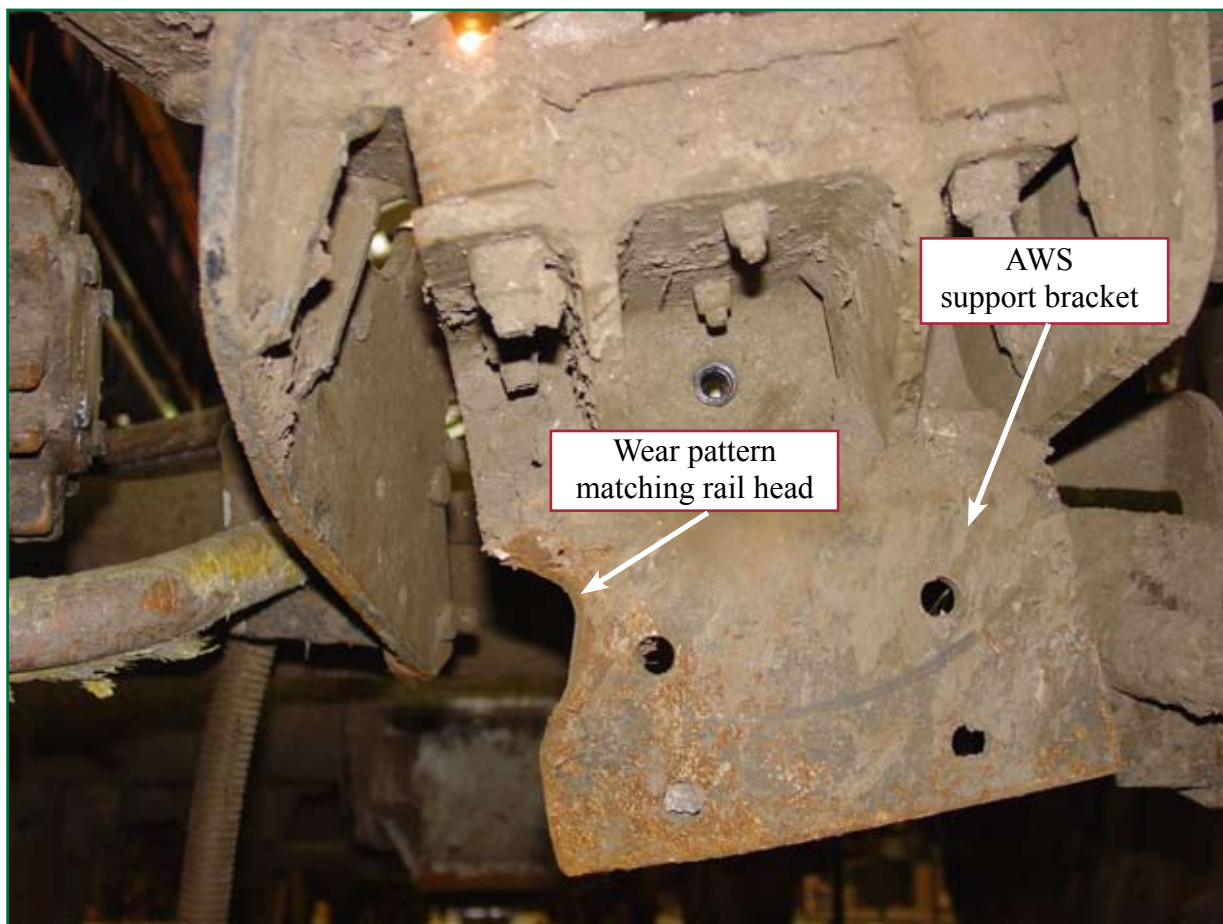
- deposition of soil and distortion of a *secondary traction link* on the trailing bogie;
 - deformation of the AWS support bracket on the leading bogie indicating that it ran pressed against the inner face of the down cess rail, Figure 12;

Figure 12: AWS support bracket on leading bogie.

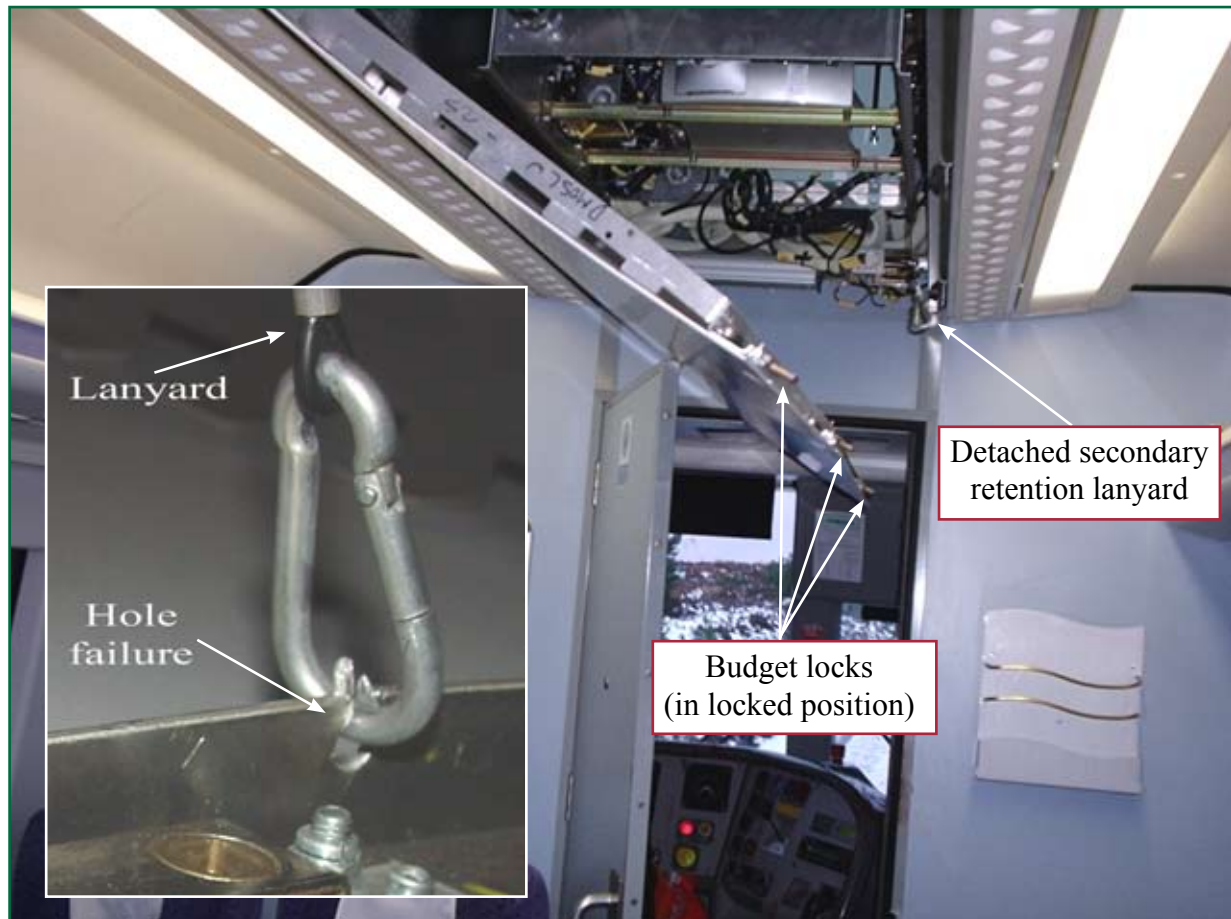
- 171 Site photographs taken after the incident showed that the primary system (key operated budget locks) used to retain the released passenger saloon ceiling panel had been correctly operated. The lanyards which provide secondary retention had also been fitted. However, the metalwork surrounding the holes used to anchor the lanyards had fractured causing the lanyards to break free, Figure 13.

Figure 13: Ceiling panel showing failed secondary retention facility.

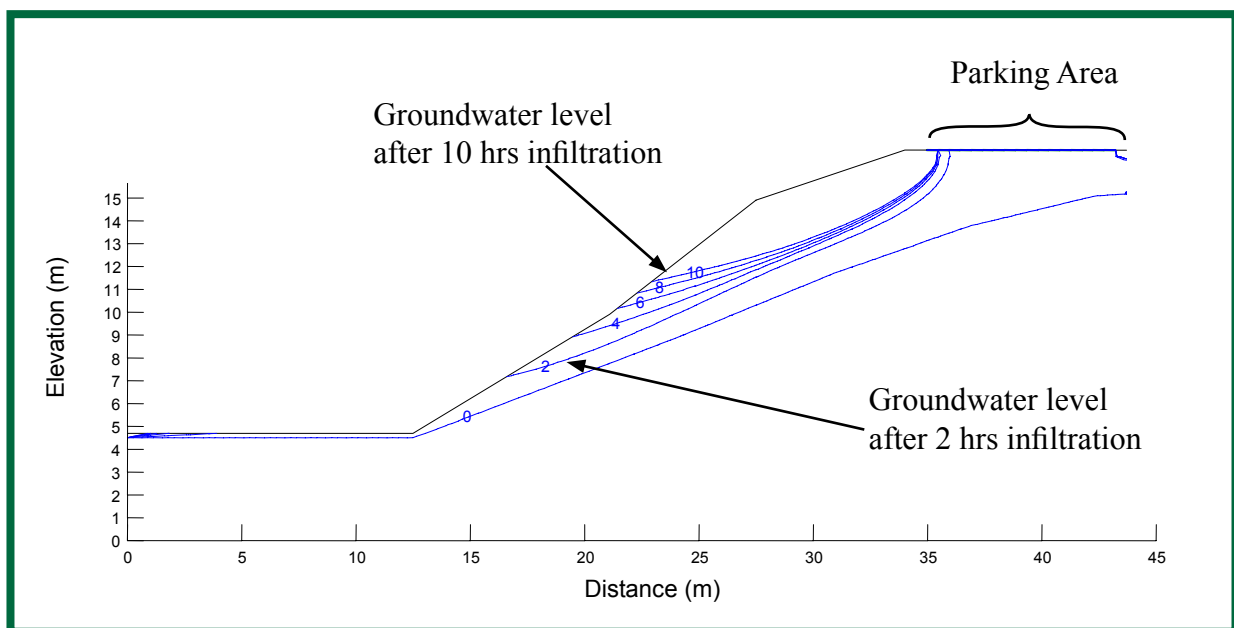
190 The groundwater seepage calculations demonstrate that, for permeability values in the upper range (for this type of glacial till), the groundwater profile would rise rapidly in response to infiltration into the Parking Area, Figure 14. Even at the lower end of the range, there would be a significant rise in groundwater level.

Figure 14: Seepage calculation showing rise in groundwater level in response to infiltration on the Parking Area.

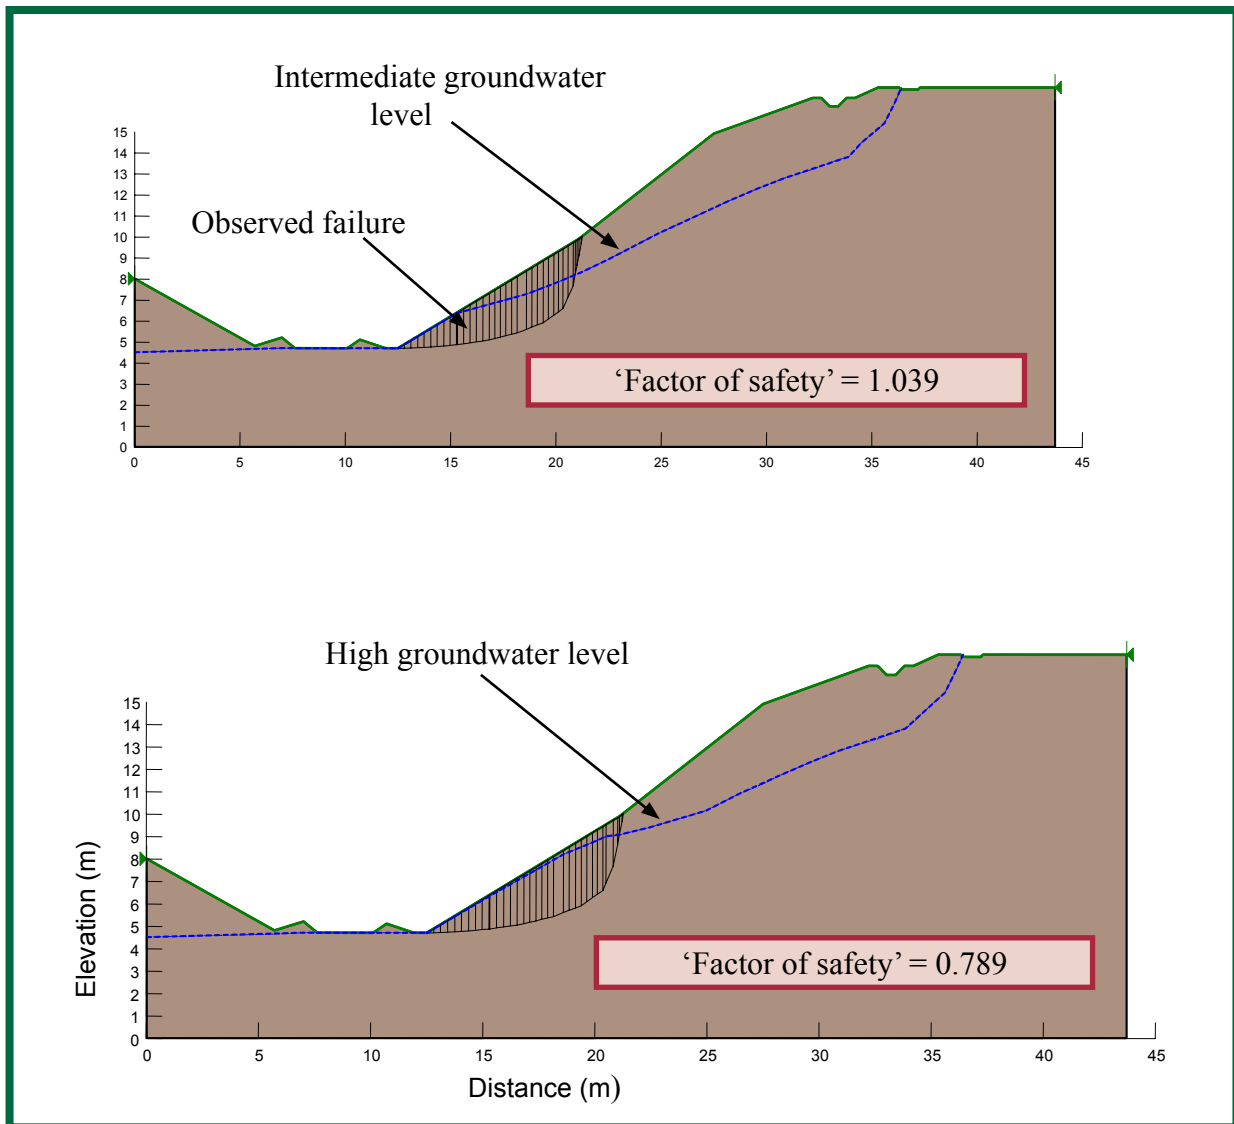
- 212 The slope stability analysis undertaken indicates that the slope is stable, albeit only marginally, during normal conditions.
- 213 Evidence from the Special Examination indicates that a deep failure occurred, similar in nature to a rotational failure. The slope stability analysis shows that a failure of this magnitude would require a high groundwater level, see Figure 15.

Figure 15: Slope stability calculation for the observed failure with assumed high and intermediate groundwater levels. Factor of safety of less than 1 indicates instability.

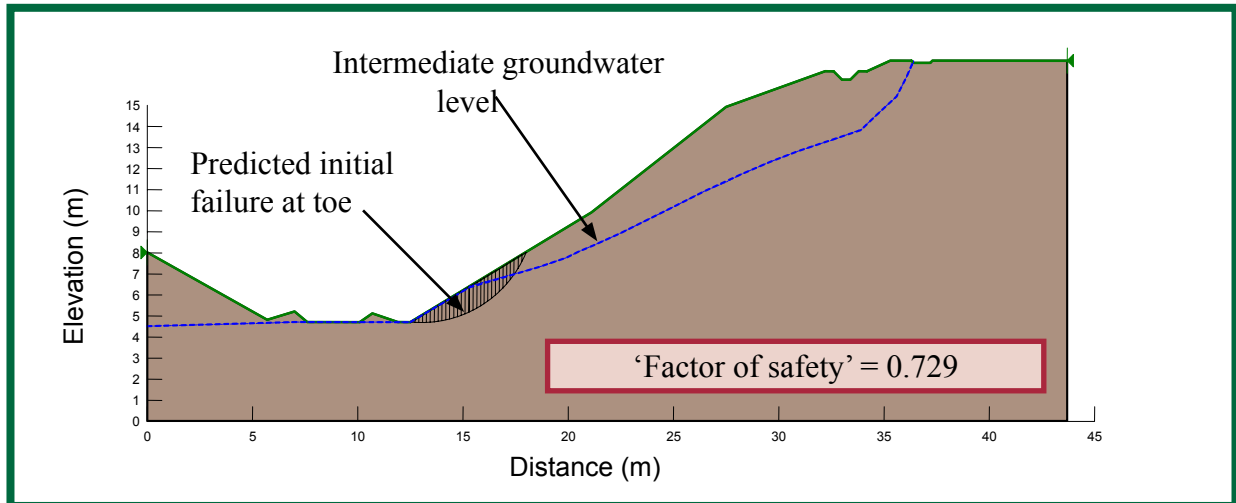
215 The slope stability analysis indicates that as the groundwater level rises, a small rotational failure would be expected at the toe of the cutting slope before the groundwater level reached a height sufficient to result in a failure of the magnitude observed. This is shown in Figure 16. Additionally, the predicted small failure would not have exhibited the steep backscar found at the site.

Figure 16: Slope stability calculation indicating likelihood of a small failure on the cutting slope toe at an intermediate groundwater level.

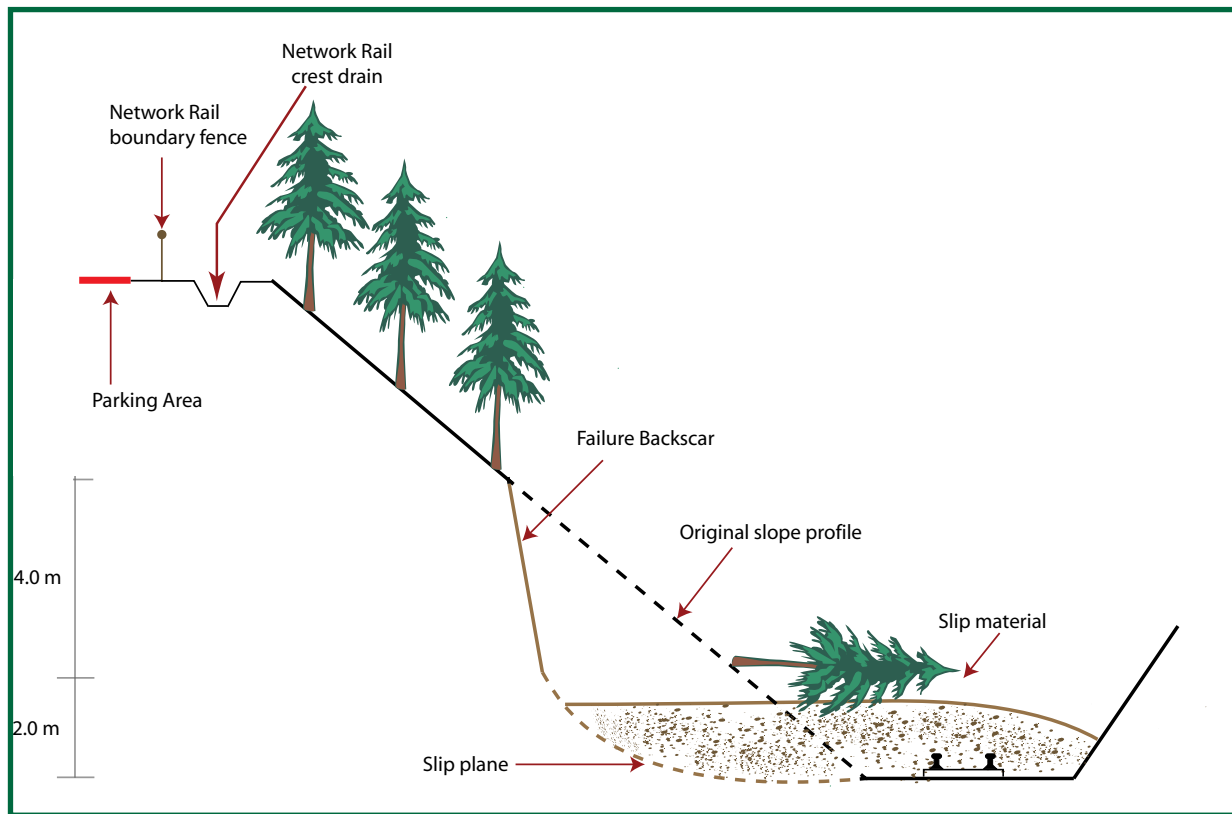
218 The soil continued to flow across the cutting until it reached the toe of the opposite cutting slope. Once the flow movement stopped the water within the material was able to drain leaving a mixture of granular and cohesive material on the track up to a height of between 1.2 and 1.5 m. The orientation (crowns predominantly toward the track) of the trees remaining within the debris pile, indicates that the only obstruction that they may have presented to the train would have been their upper branches and light foliage, Figure 17.

Figure 17: Observed landslide.

- 219 This mode of failure is consistent with the trees falling forward down the bank – i.e. due to the earthflow. A pure rotational failure would have resulted in them falling backwards against the bank.
