Rail Accident Report

Autumn Adhesion Investigation Part 2: Signal LW9 Passed at Danger at Lewes 30 November 2005

Signal LW9 Passed at Danger, Lewes, 30 November 2005

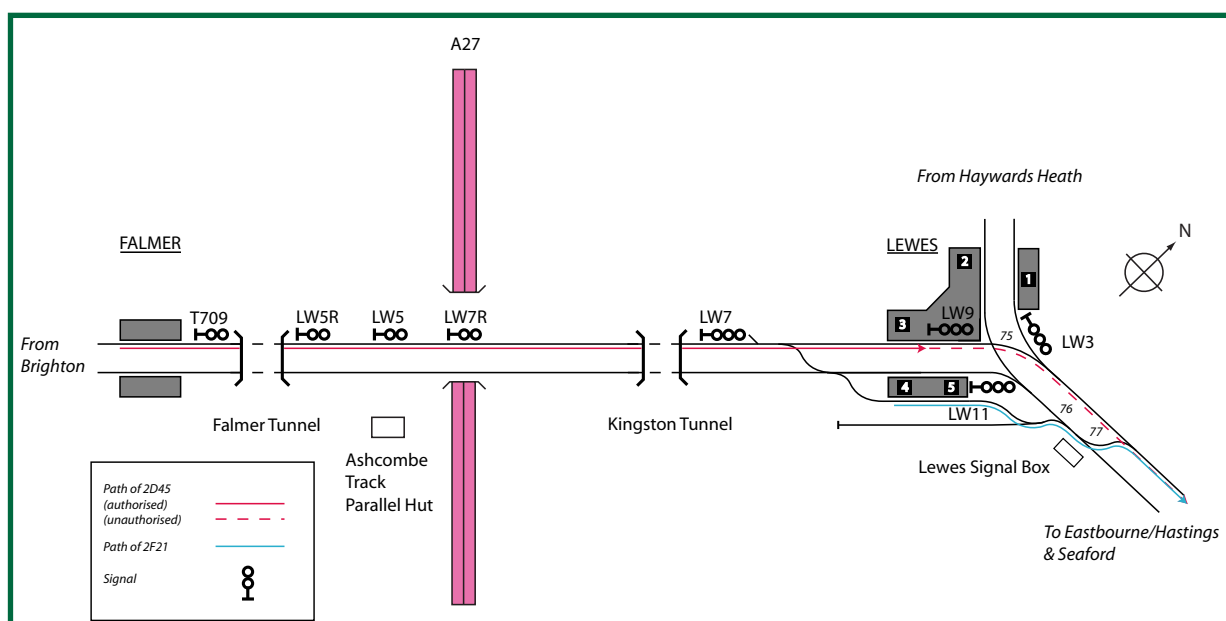
Figure 2: Track layout showing location of incident.

- 24 Figure 2 shows the general layout of the area where the incident occurred. Lewes is located at the junction of two routes, one from London via Haywards Heath and the other from Brighton. The two routes have their own platforms at Lewes, the junction being located to the east of Lewes station.
- 25 Lewes station has 5 platforms, with Platforms 1 and 2 being used by trains from and to London respectively and Platforms 3 and 4 being used by trains from and to Brighton respectively. Platform 5 can be used by trains running to and from Brighton but is also used by trains approaching from the east that terminate at Lewes.

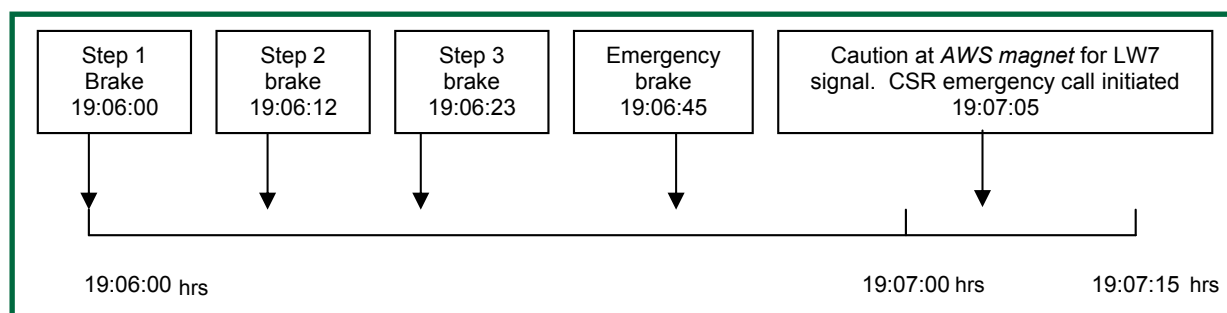
Figure 3: Timeline of key events before driver of 2D45 made CSR emergency call to signaller.

- 61 On realising that there was a possibility that signal LW9 could be passed at danger, the driver made an emergency call to the signaller via the CSR. The RAIB has considered whether the CSR emergency message could have been sent earlier, which might have allowed the signaller to stop train 2F21 before it departed from Lewes. Figure 3, shows a timeline of the key events leading up to this incident:

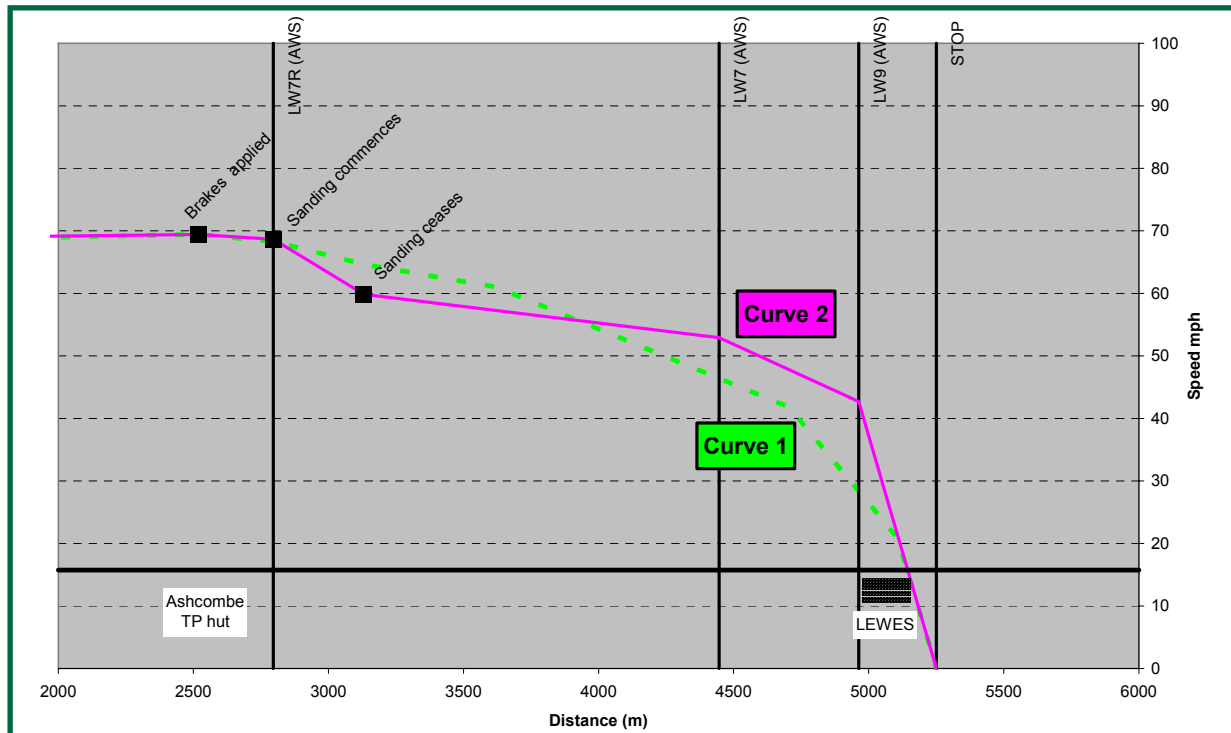
Figure 4: Distance speed graph depicting the events at Lewes on 30 November 2005.

81 Figure 4 shows estimated train speeds during the incident derived from the following sources:

82 Figure 4 shows that:
