Rail Accident Investigation Branch

Rail Accident Report

Autumn Adhesion Investigation Part 1: Signals WK338 and WK336 Passed at Danger at Esher 25 November 2005

Signals WK338 and WK336 Passed at Danger, Esher, 25 November 2005

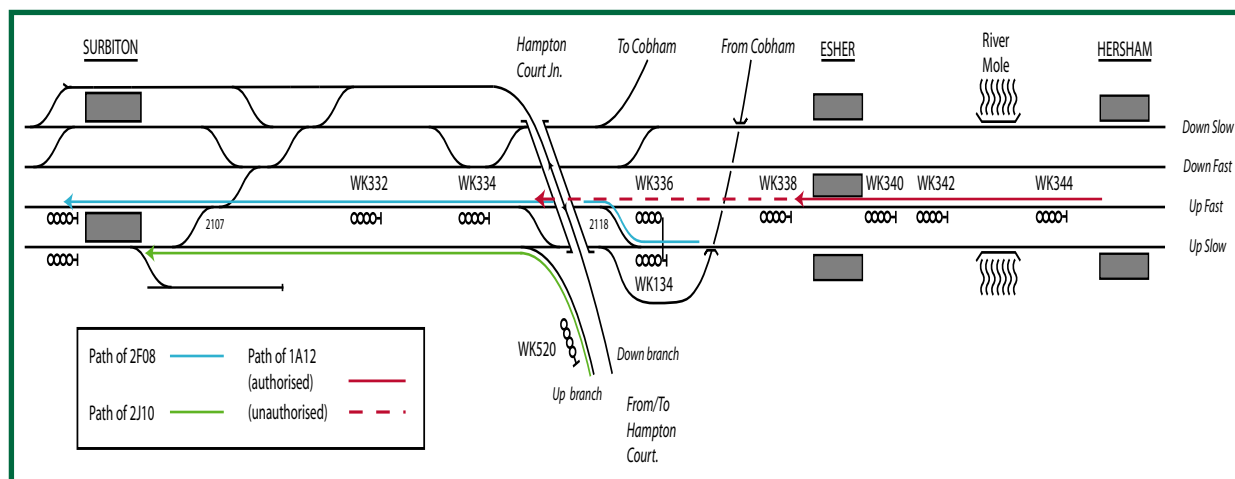
Figure 2: Key features of the track layout between Hersham and Surbiton.

- 21 Esher is located 14 miles and 31 chains from London Waterloo on the south western main line that runs between Waterloo and Weymouth. At Esher there are four tracks designated down slow, down fast, up fast and up slow. Approximately one mile to the east of Esher is Hampton Court Junction, where, in the up direction, trains from the Cobham line converge on the up slow line, closely followed by another junction where trains from Hampton Court also converge onto the up slow line. Trains are signalled in accordance with the *Track Circuit Block Regulations*, controlled by Woking Area Signalling Centre (ASC). *Four aspect signalling* is provided and line speed on the up fast line is 90 mph (144 km/h). Figure 2 shows key features of the railway in the area where the incident occurred.

- 27 The movement of train 2F08 onto the up fast line was protected by Signal WK336 being placed to danger. Signal WK338 was also placed to danger because 2118 points (over which train 2F08 was routed) lie within the *overlap* of Signal WK336. Working back towards Woking on the up fast line, Signal WK340 displayed a single yellow aspect and WK342 a double yellow aspect. Figure 2 shows the general layout including the location of the relevant signals.

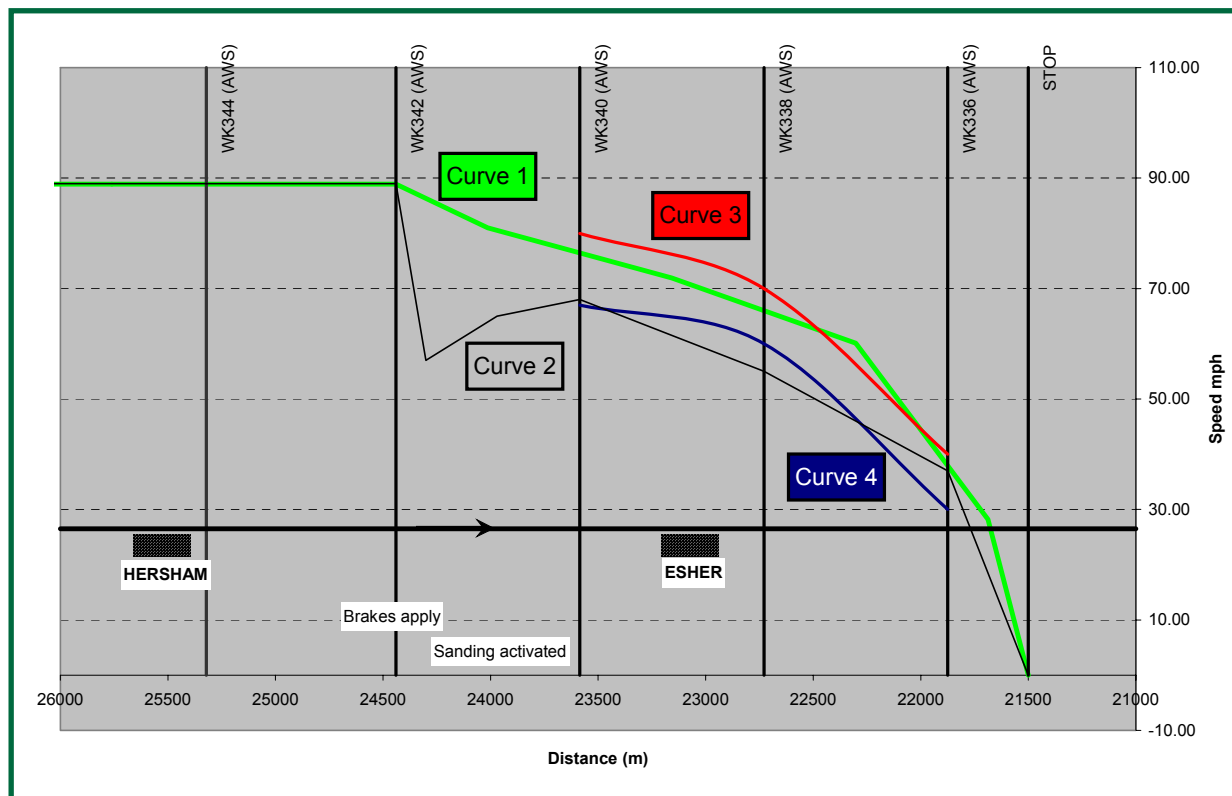
Figure 3: Distance speed graph depicting the events at Esher on 25 November 2005.

- 67 The OTMR download for unit 450 022 indicates that WSP activity commenced from the moment the brake was applied and continued throughout the duration of the slide until the train stopped. The OTMR download does not identify how many of the four vehicles on the train experienced WSP activity, but confirms that it happened continuously on at least one of the four vehicles.

- 68 Figure 3 shows train and wheel rotational speeds derived from the following sources:
- Calculated speeds based on the times at which the train passed the Automatic Warning System (AWS) magnets, which are normally located 183 metres on the approach to the signal (Curve 1, green). This has been used as a measure of train speed that is independent of the figures estimated by the WSP system and reflected in the OTMR data.

69 Figure 3 shows that:
