# Rail Accident Report

## **Derailment of a freight train at Brentingby Junction, near Melton Mowbray 9 February 2006**

## **9 February 2006**

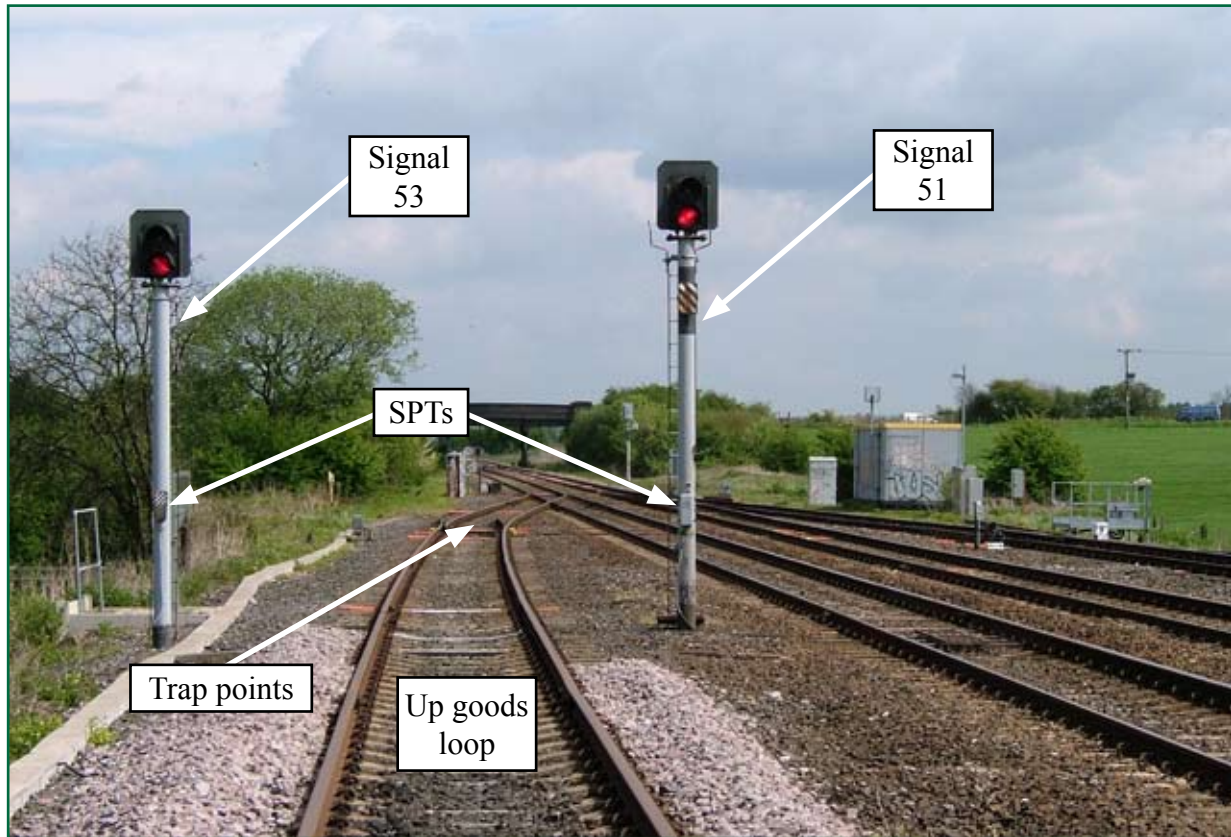
Figure 4: Signals 53 and 51 (by courtesy of Network Rail)

- 28 The signalling at Brentingby Junction is controlled by Melton Station signal box at Melton Mowbray located at 105 miles 27 chains. Signal 53 is a *two-aspect colour light signal*, and signal 51 (adjacent to signal 53) on the Up Main line is also a two-aspect colour light signal. The signals, which do not carry identification plates, and the trap points beyond signal 53 are shown in Figure 4.

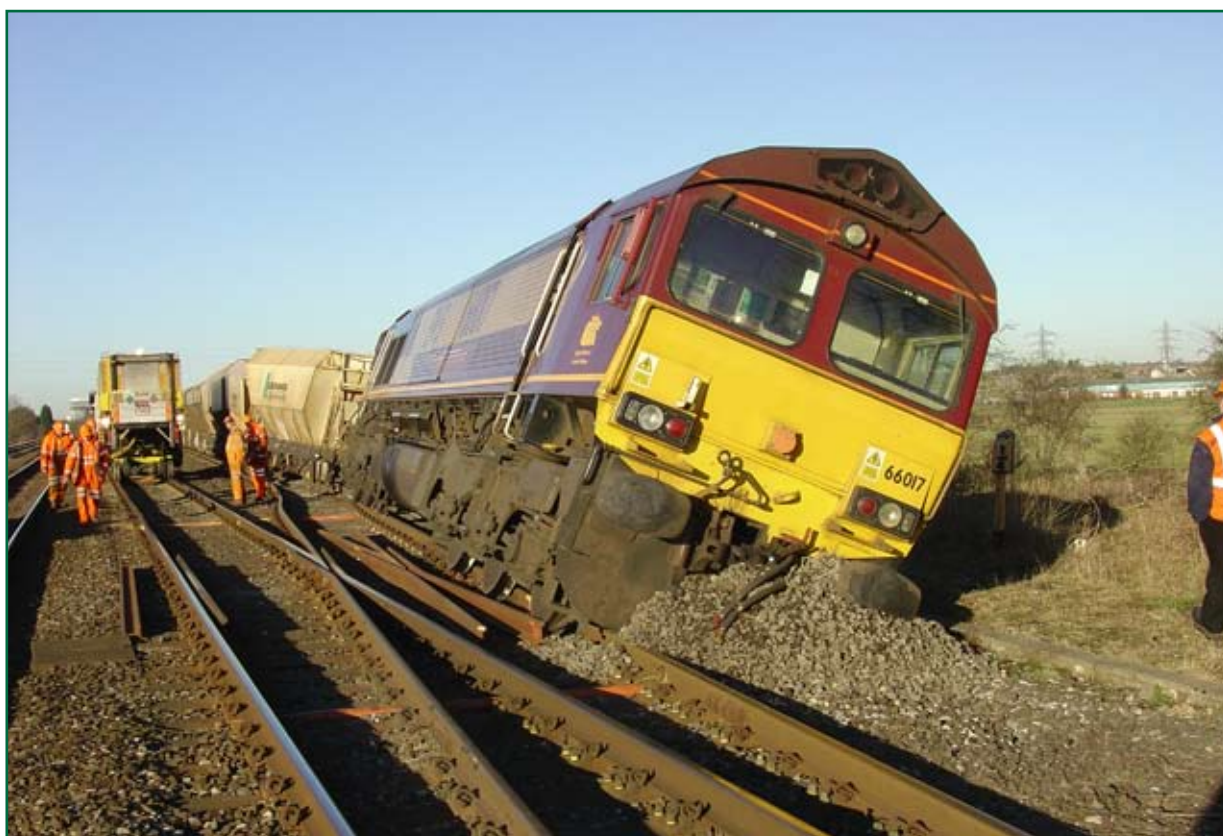
Figure 8: Derailment of train 6Z41, Brentingby Junction

- 62 No one was injured as a result of the derailment.
- 63 The damage caused to locomotive 66017 was superficial and included a damaged buffer, damaged *traction motor covers*, slight bruising to the underside of three traction motors and sheared bolts to a *rail guard*.
- 64 The damage to the first two wagons that derailed was the most extensive, while the third wagon that derailed was damaged least. Damage to the first two wagons variously consisted of damaged buffers, brakegear, couplings, pipework, hoses and brake end cocks; as well as damage to the *underframes* of each vehicle.

- 65 Track damage required the replacement of 13 concrete sleepers and the replacement of two 60 foot rails in the Up Goods Loop and one 30 foot rail in the Up Main line.
- 66 Damage to signalling equipment required the renewal of two single core cables and the renewal of the track circuit interrupter fitted to the Up Goods Loop exit trap points.

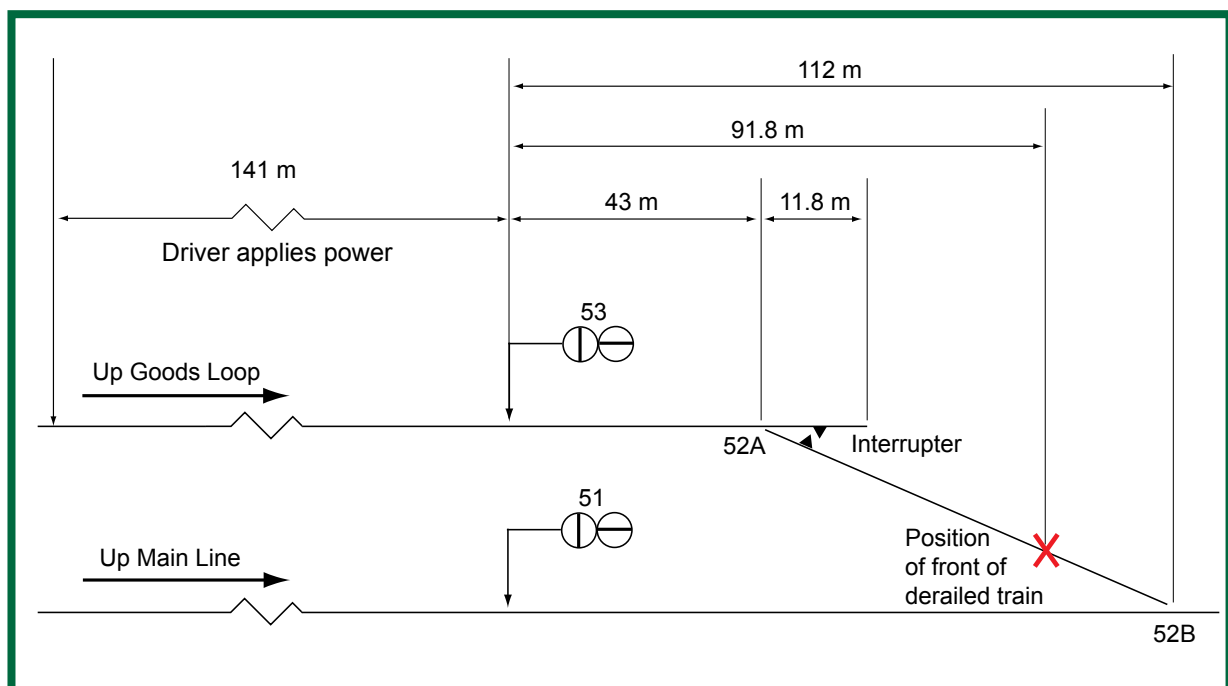
Figure 9: Critical measurements - Brentingby Junction

- 72 Measurements were taken on site of the subsequent path taken by train 6Z41 after it had passed signal 53. The results of these were:
- distance from signal 53 to the *switch toes* of the trap points (52A): 43 m;
  - length of *switch blades*: 11.8 m;
  - distance travelled by the locomotive beyond the trap point switch blades: 37 m;
  - the train therefore travelled 91.8 m beyond signal 53 before it came to rest;
  - distance from signal 53 to the switch toes of 52B points: 112 m.
- 73 The critical measurements in paragraph 73 above are shown in Figure 9.

- 74 Whilst the derailed locomotive infringed the normal *passing clearance* between two trains, it would not have been struck by a passing train.
- 75 The alignment of the light beam of signal 53 was checked on site and found to be acceptable.
