Rail Accident Investigation Branch

Rail Accident Report

Derailment of a freight train at Cricklewood Curve 31 January 2006

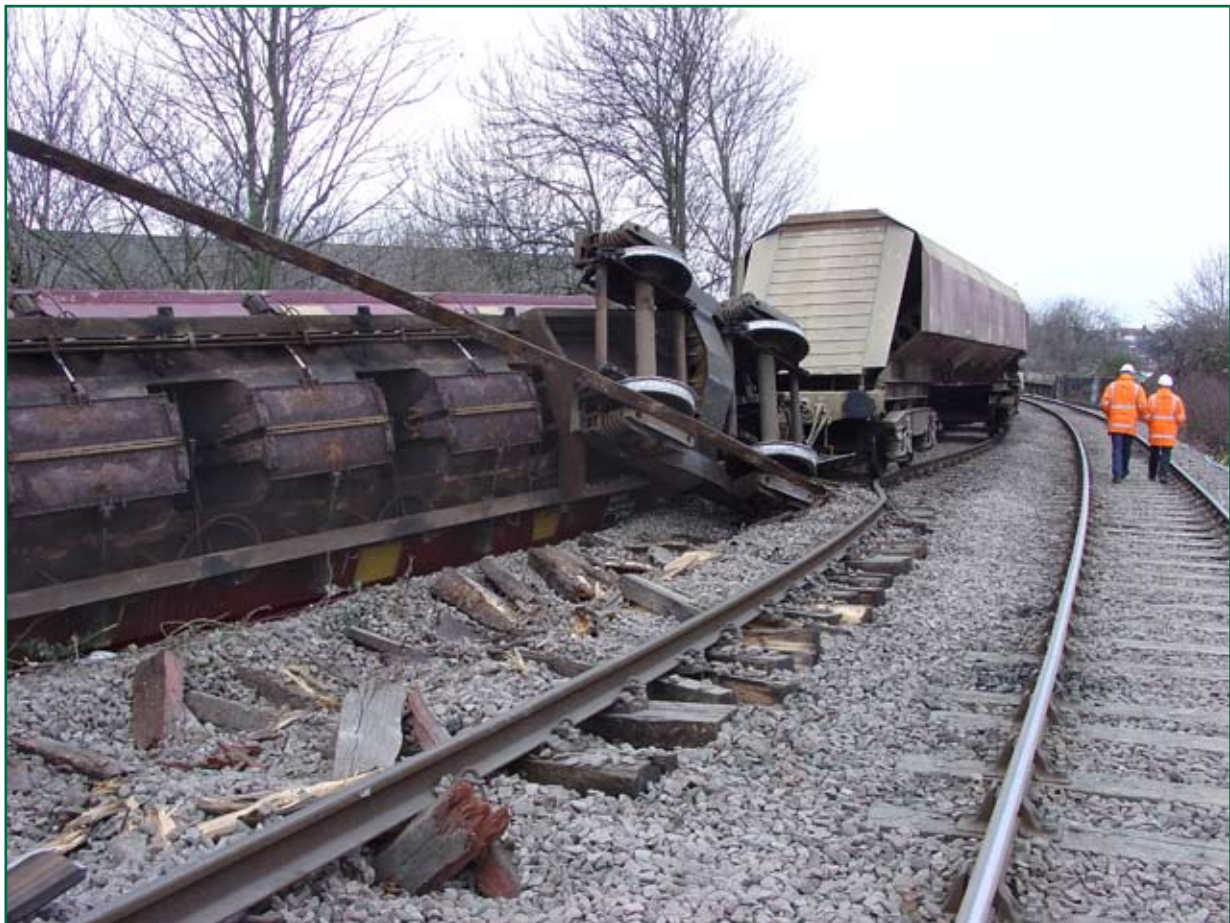
Figure 5: Leading derailed vehicle and track damage.

- 39 The two derailed wagons overturned and started to slide down the embankment. Figure 5 shows the leading derailed wagon and some of the damage to the track.

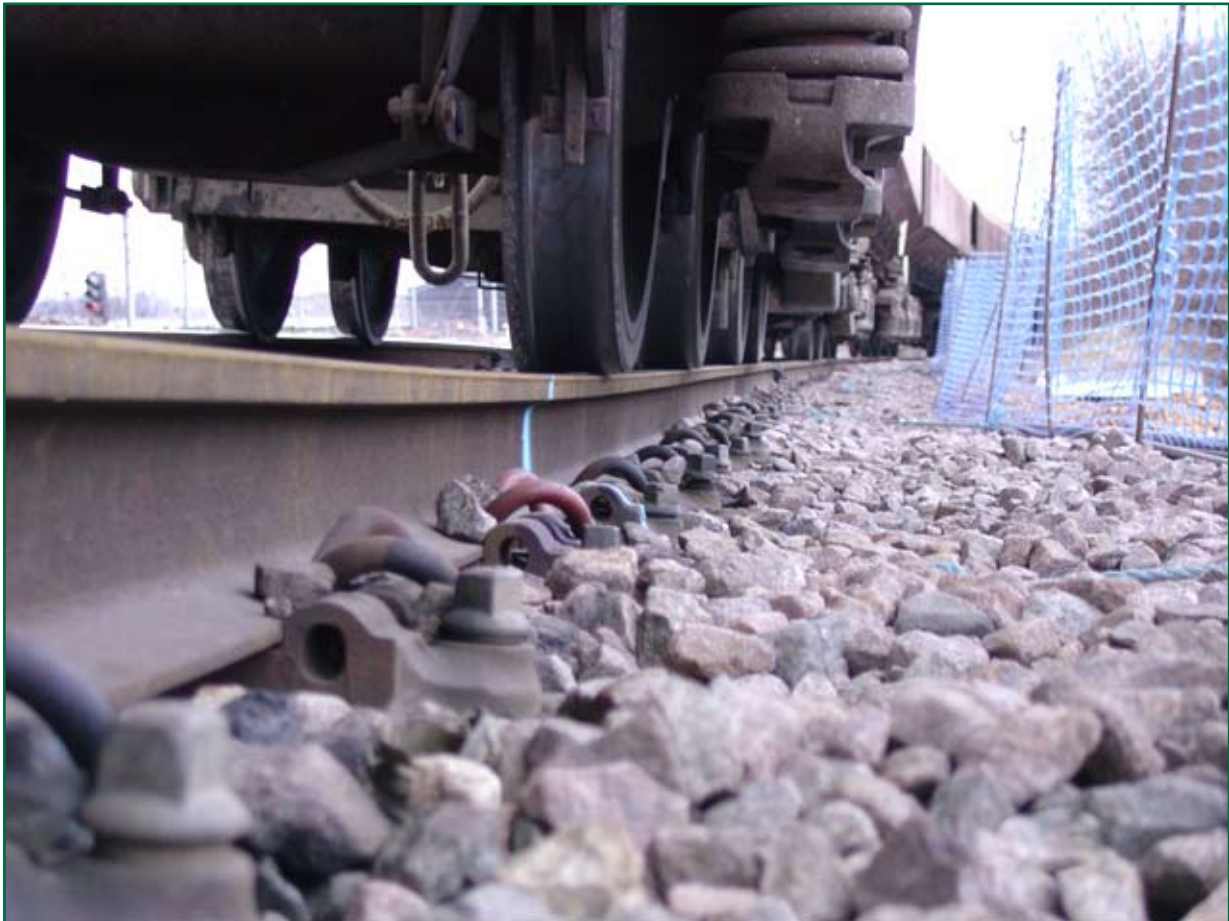
Figure 6: track twist beneath rear part of train.

45 The immediate cause of the derailment was severe track twist near to the end of the bank repair site. This twist came about as a result of the loss of vertical support to the cess rail over the area of the bank slip leading to a long dip in the cess rail. This loss of support ended abruptly close to the end of the site where a large tree root system had stabilised the bank. The passage of the loaded wagons over the site caused the cess rail to dip further, increasing the cant up to 160 mm, except where the bank was supported by the tree root system. Here the cant remained close to the design value of 55 mm leading to a track twist of 29 mm (1 in 68) over the 2 m wheelbase of the freight train's bogies. The limit value of twist (over a 3m base) in the Network Rail track maintenance business process document NR/SP/TRK/001 is 1 in 200 (ie 15 mm over a 3 m base, 10 mm over a 2 m base) for a curve of under 400 m radius (as here). If the twist is more severe, time limits are given for the correction of the fault; a twist between 1 in 200 and 1 in 126 must be rectified within 7 days, between 1 in 125 and 1 in 91 it must be rectified within 36 hours and a twist of 1 in 90 or worse requires immediate closure of the line. The severity of the twist following the derailment can be seen in Figure 6.

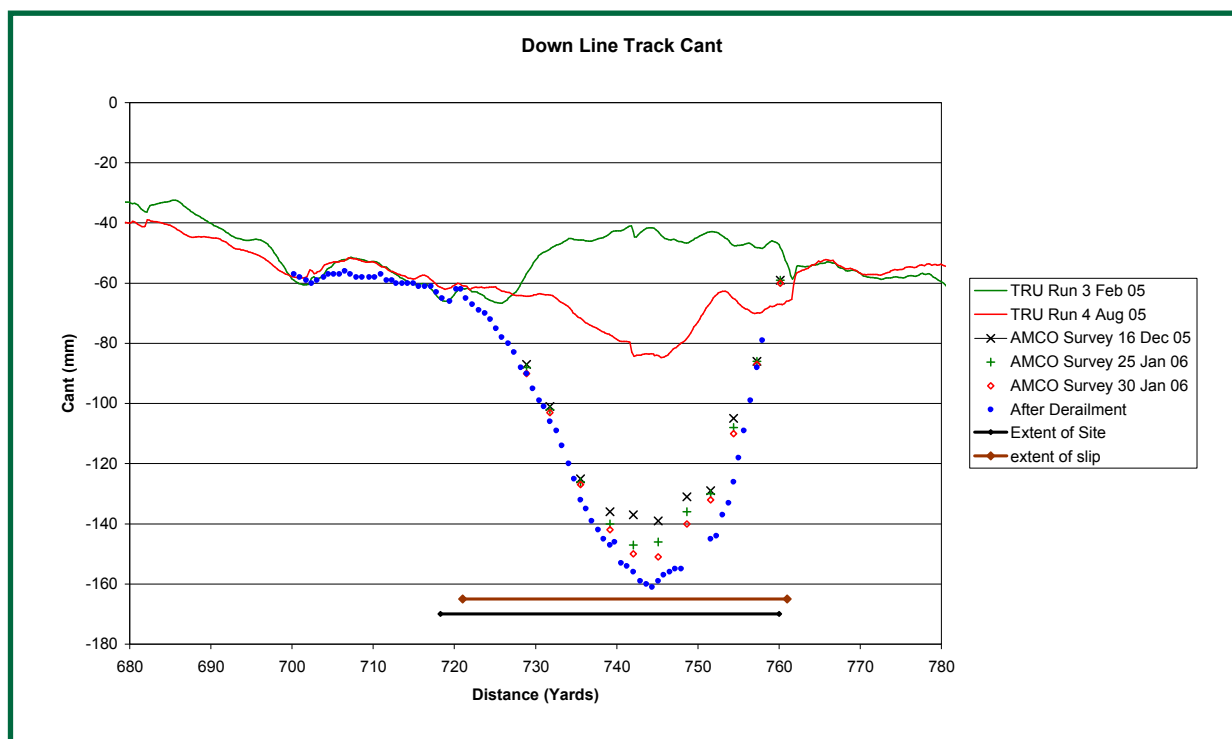
Figure 7: Track cant plotted against distance over time.

48 The Network Rail *Track Recording Unit* (TRU) recorded the track geometry of this line on 3 February 2005 and again on 4 August 2005. The first of these runs revealed some vertical alignment defects at the site that required attention within 10 days. These were attended to by manual maintenance and by tamping. The run on 4 August 2005 showed no alignment defects at the site. However, if the actual numerical alignment data is examined in detail, the effect of the bank slip can be seen as an increase in cant. Figure 7 shows the cant measurements from the two track recording unit runs along with the cant measurements taken after the incident. The traces show how the cant has increased at the site from 45 mm in February, to 80 mm in August and over 160 mm at the time of the derailment. The design cant for the curve was 55 mm. These traces show that the movement of the bank was continuous throughout 2005.

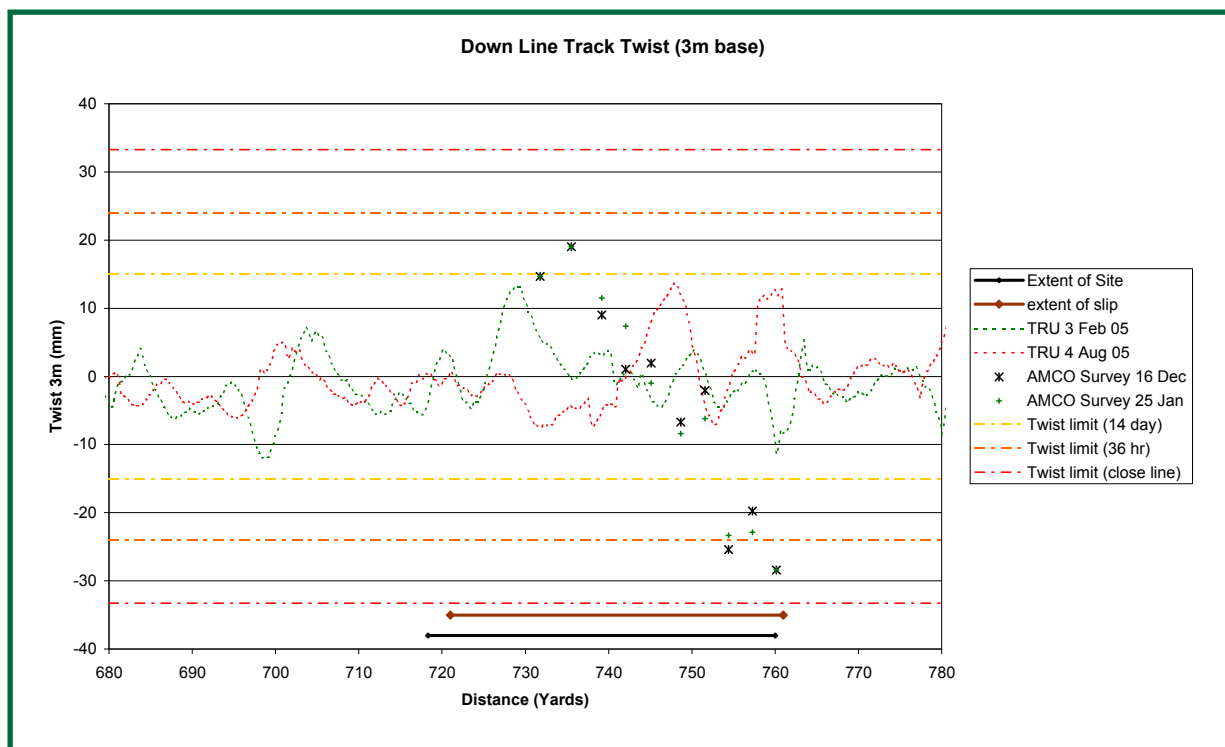
Figure 8: Track twist plotted against distance.

49 The track twist was output by the TRU and the twist over a 3 m base is plotted in Figure 8. Discrete values of twist over a 3 m base were also calculated from the AMCO cant readings, using the measured distance between the AMCO monitoring points rather than the 'nominal' 3 m spacing. These twist values have also been plotted in Figure 8. The limits on twist given in NR/SP/TRK/001 (and in paragraph 45) are shown in Figure 8 as broken horizontal lines. It is evident from Figure 8 that the track twist at the time that AMCO started monitoring was at a level where a twist fault existed that should have been attended to within 36 hours. As AMCO were not calculating track twist, this fault went unnoticed.

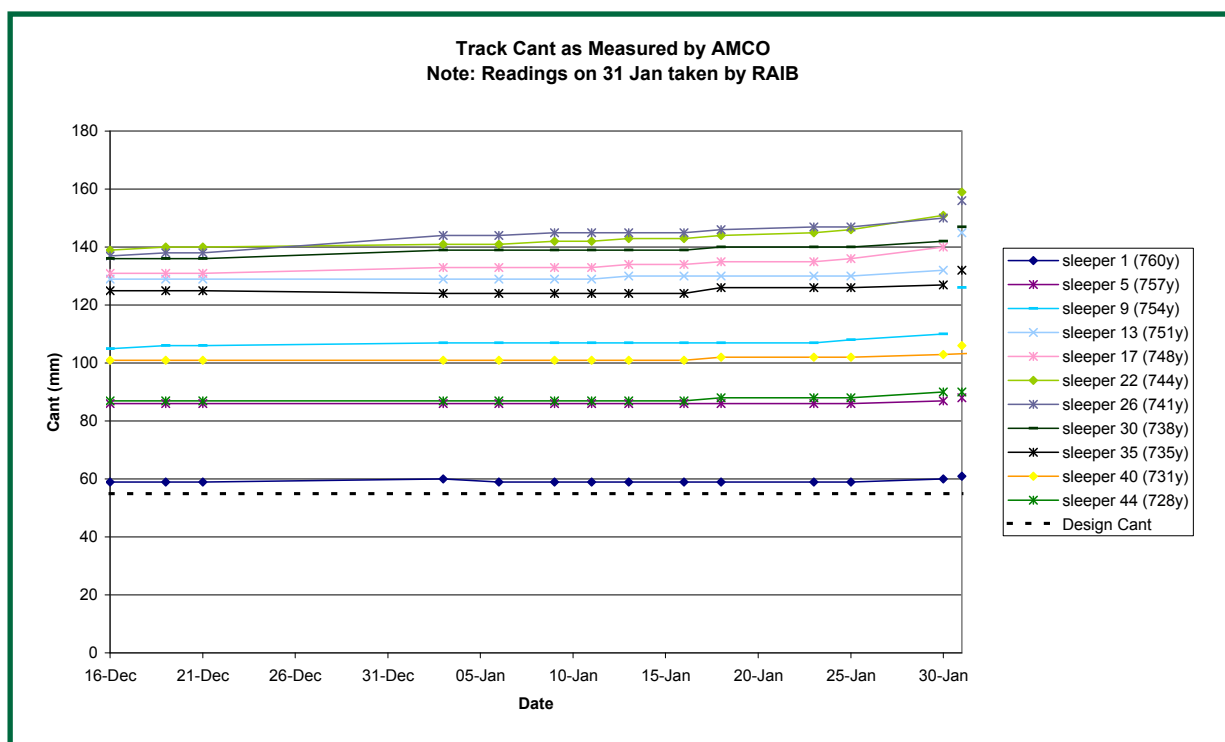
Figure 9: Cant readings taken by AMCO plotted against time.

50 The AMCO cant monitoring results have been plotted in Figure 9. These show a slow movement at most of the monitoring points up to 25 January when the apparent rate of movement increases slightly, which might indicate that the bank has become more unstable. The AMCO figures have been plotted with the figures derived from the TRU results in Figure 10 to show the relative rate of movement after the work started on site in December 2005. The apparent rate of movement is greatest at points where the cant is high, points 22, 26 and 30. However, the readings taken from 25 January onwards were taken with the new cant gauge and no correlation was done between the new cant gauge and the old, defective, cant gauge. Therefore the change in cant could be due, at least partly, to the change of instrument. However, in the area away from the derailment, the readings taken by AMCO were within 3 percent of those taken by the RAIB, so the AMCO cant gauge was in reasonable calibration. The only clear conclusion that can be drawn from this is that the bank was unstable and was moving throughout 2005.

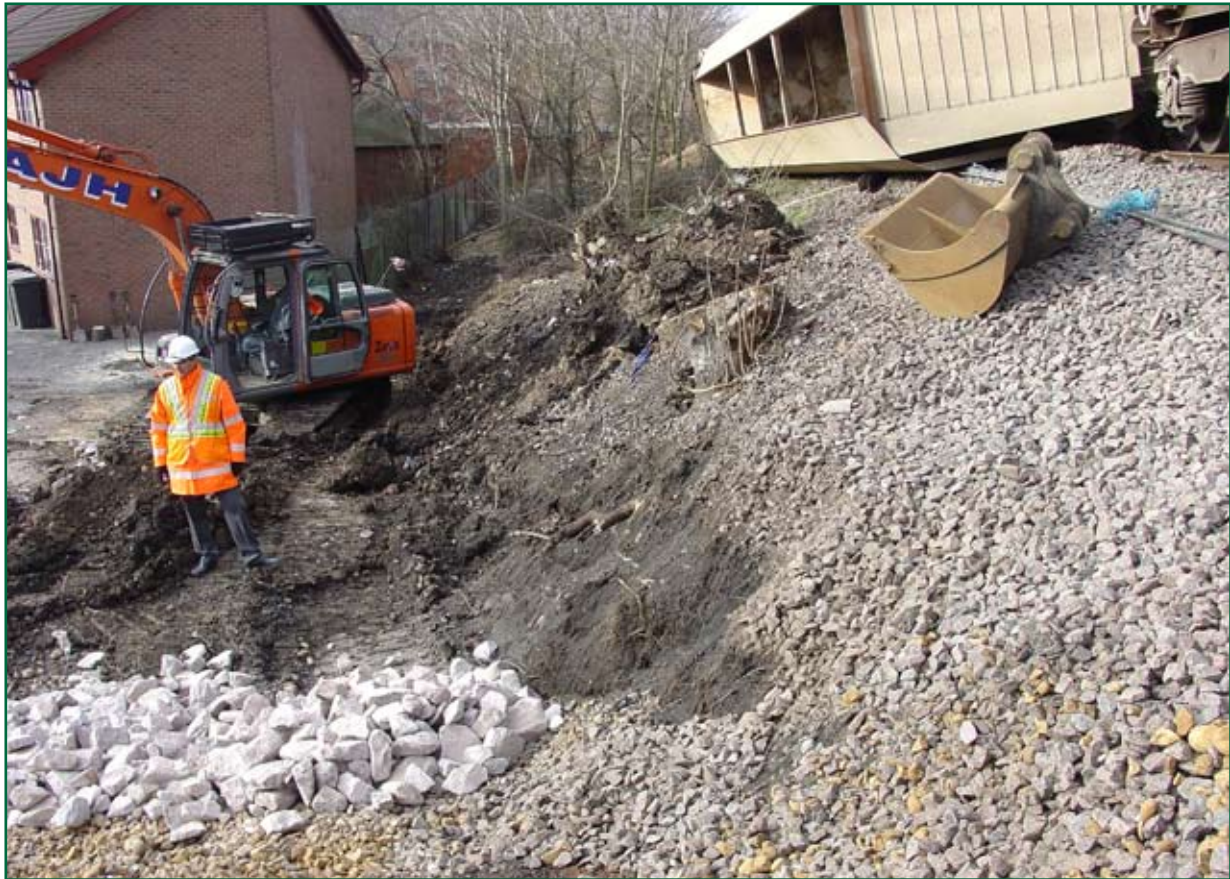
Figure 11: Cut face beside access road at site of derailment.

- 69 The excavation works for the embankment repair included the excavation of an access road along the length of the repaired section. This roadway was to provide access for an excavator and a dumper. The width of this roadway was about 2.5 m and a level surface was created, partly by placing fill material on the lower part of the bank and partly by cutting into the bank. This cutting-in left a near-vertical face in the embankment fill. At the site of the derailment, adjacent to the tree stump, this face was 1 m high. On completion of each stage of the repair work, this cut face, and the access road, was buried under the stone fill that forms the repaired embankment. At the time of the derailment, this cut face was exposed over a distance of 5 m. The cut face was approximately 3 m from the cess rail (Figure 11).

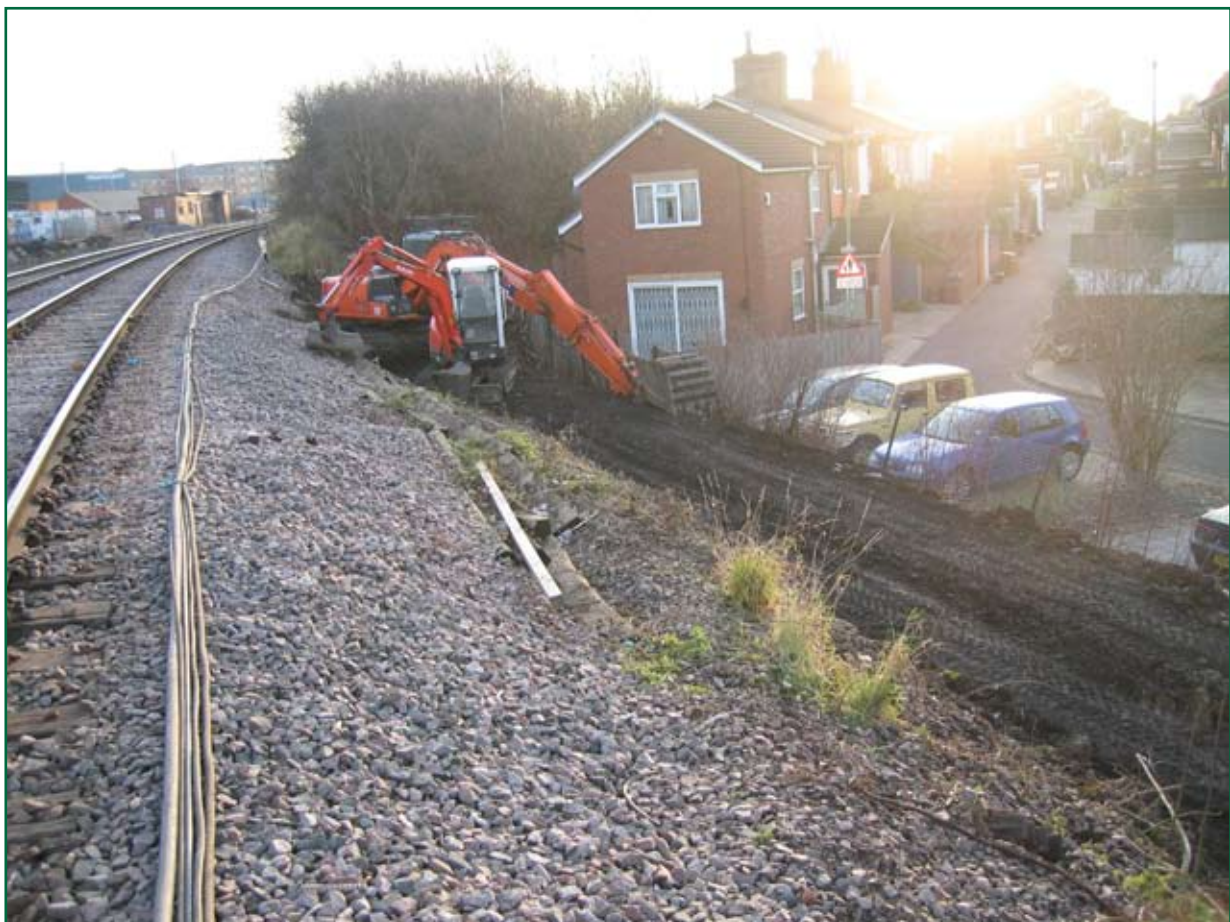
Figure 12: Access road through site, looking towards Cricklewood Junction, in early stage of works.

- 70 The construction of the access road was mentioned in the method statement but its position was not defined. An AMCO progress photograph (Figure 12) shows the roadway to have been situated part way up the bank. The steep face cut into the bank on the track side of this access road would have reduced the stability of this part of the bank. It is not possible to determine whether the bank movement under the train was due to its inherent weakness or whether presence of the access road cut made it unstable.
