# Rail Accident Report

## Unauthorised train movement and subsequent derailment at Haymarket, Edinburgh 14 January 2006

## **14 January 2006**

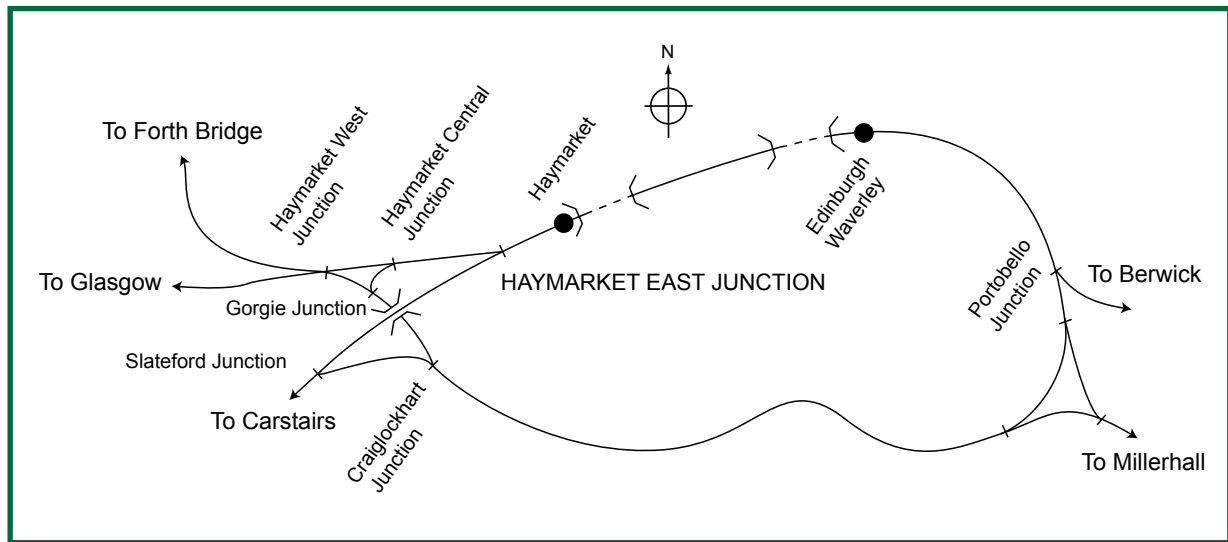
Figure 2: Diagram of the area.

- 20 The two principal rail routes from Edinburgh to Glasgow diverge at Haymarket East Junction, which is about 300 m west of Haymarket station. The line from Haymarket East Junction to Midcalder Junction is double track, electrified at 25 kV on the overhead line system, and is used by, among others, West Coast Main Line services between London Euston and Edinburgh. Signalling is by the track circuit block system using three and four aspect colour light signals, controlled from Edinburgh Signalling Centre. A diagram of the railway routes in this area is to be found at Figure 2.

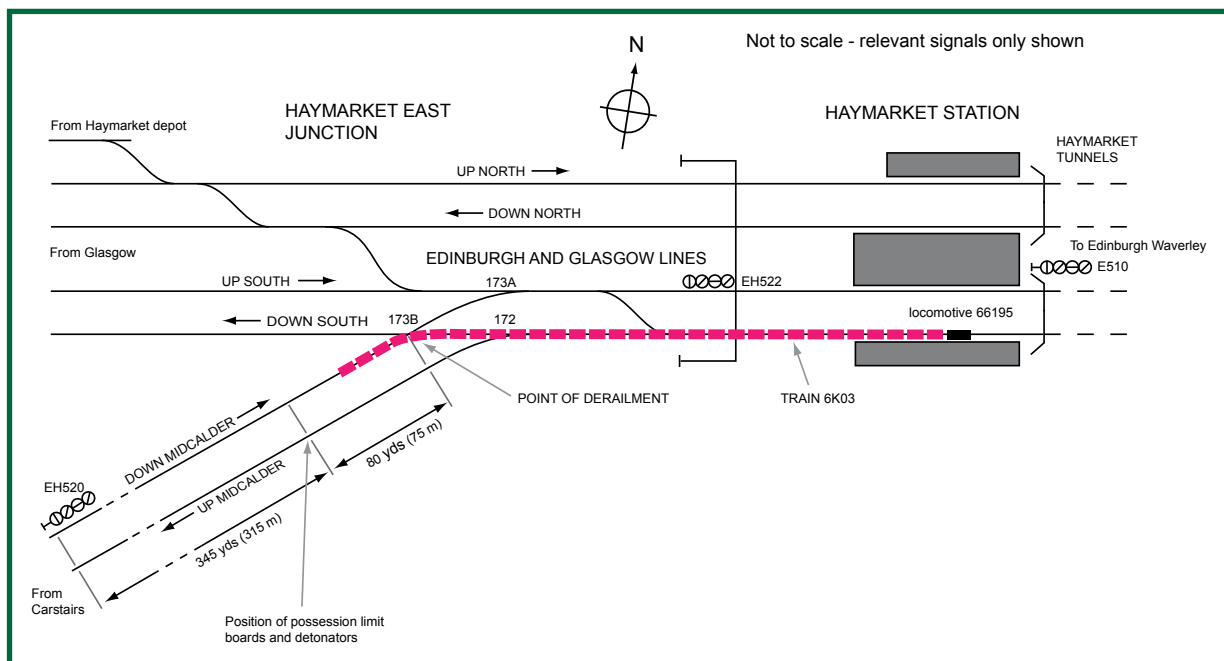
Figure 3: Track layout and possession limits.

- 23 The last signal on the down Midcalder line protecting Haymarket East Junction, EH520, is located at the 100¼ milepost, 390 m (425 yards) on the approach to the junction. At Haymarket East Junction the designation of the eastbound direction of travel changes from ‘down’ to ‘up’. The next signal for a train travelling in this direction is EH522, which is between the junction and Haymarket station, followed by EH510 at the east end of Haymarket station.

## **Consequences of the incident**
