# Rail Accident Report

## The blowback of a locomotive fire at Grosmont on the North Yorkshire Moors Railway 16 April 2006

# **The blowback of a locomotive fire at Grosmont on the North Yorkshire Moors Railway 16 April 2006**

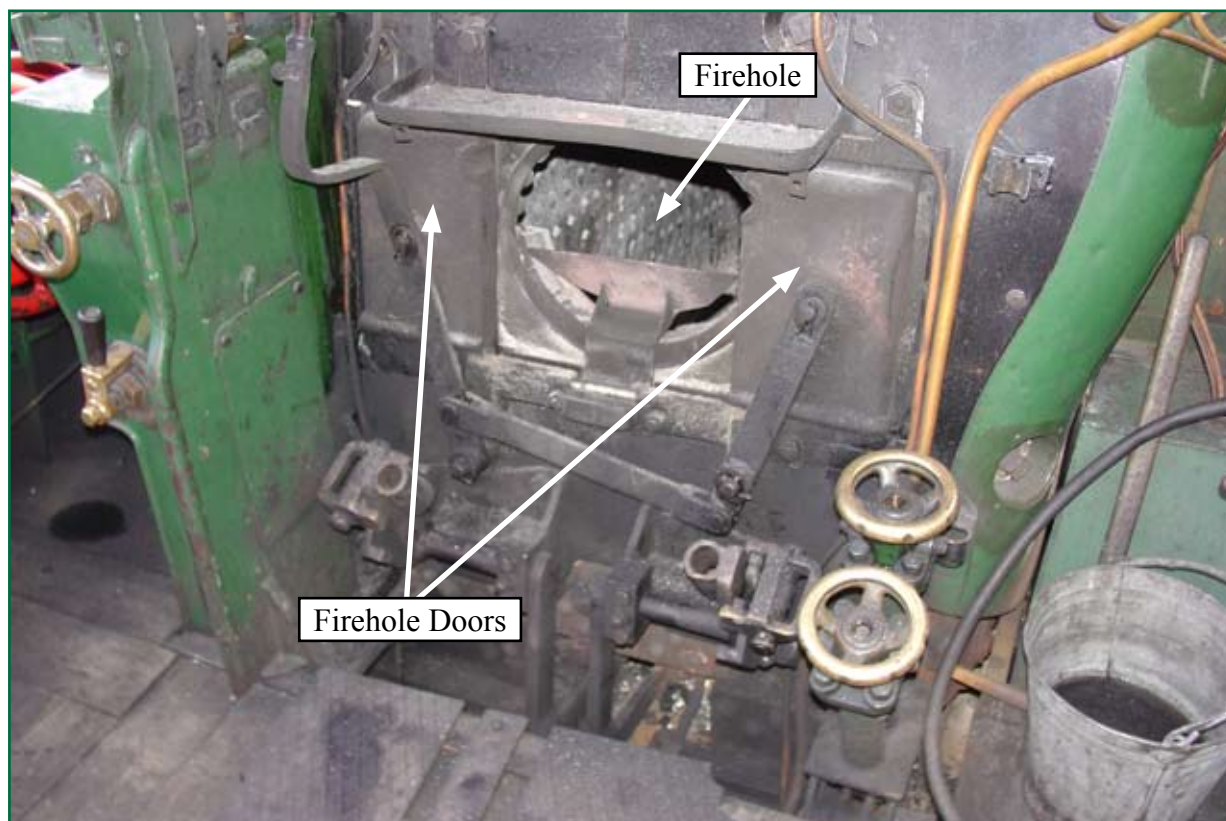
- 44 On hearing the warning, the driver turned back towards the footplate and saw the flames. The driver immediately shut the regulator, opened the blower and applied the train brake, the last action causing him to receive a minor burn to his right hand. The flames started to abate and the fireman was then able to kick the firehole doors shut finally stopping the blowback. By the time the train had stopped, the blowback had finished. The firehole doors and driver's controls are pictured in Figures 4 and 5.

Figure 4: Locomotive 75029 footplate showing the firehole doors open

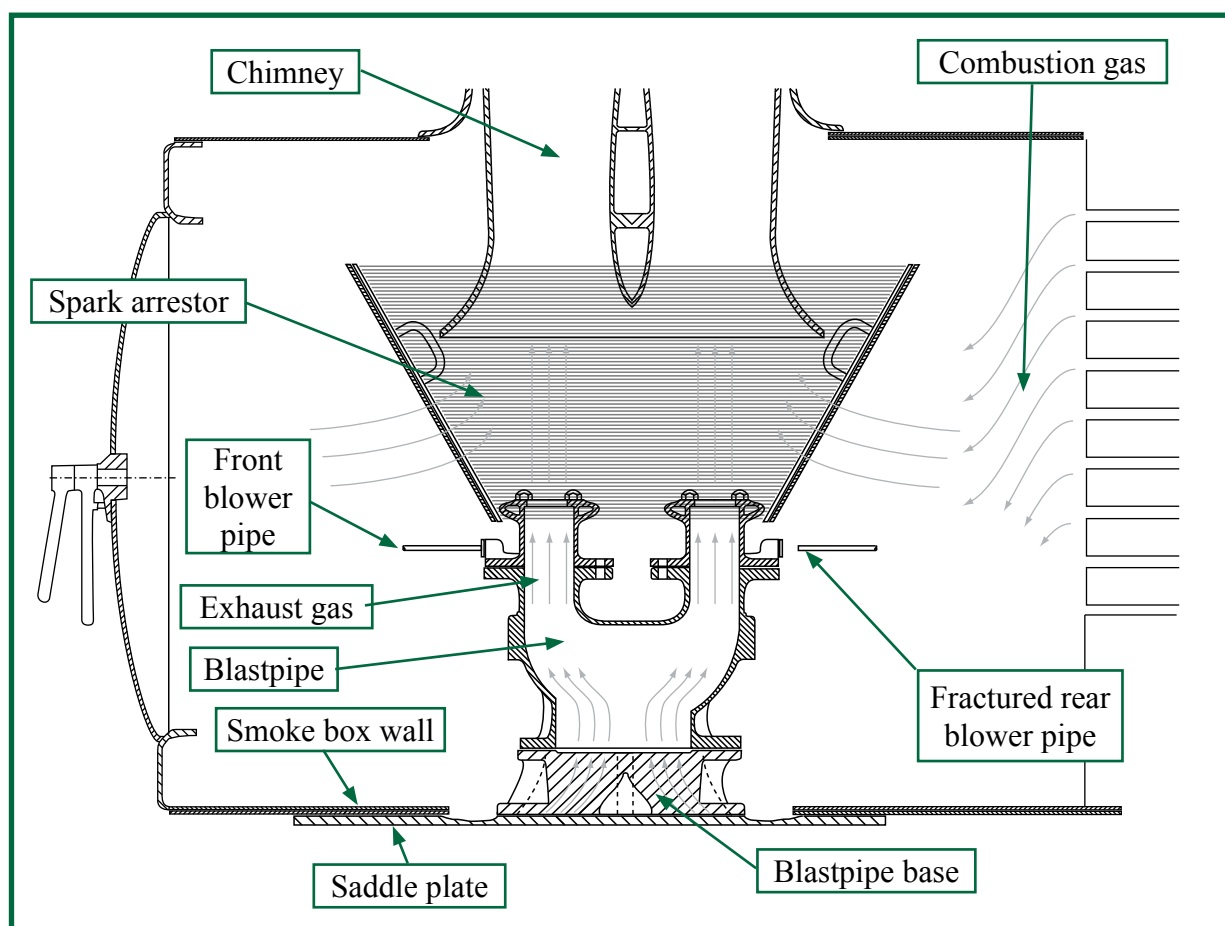
Figure 6: Simplified drawing of Locomotive 75029 blastpipe and associated smokebox components

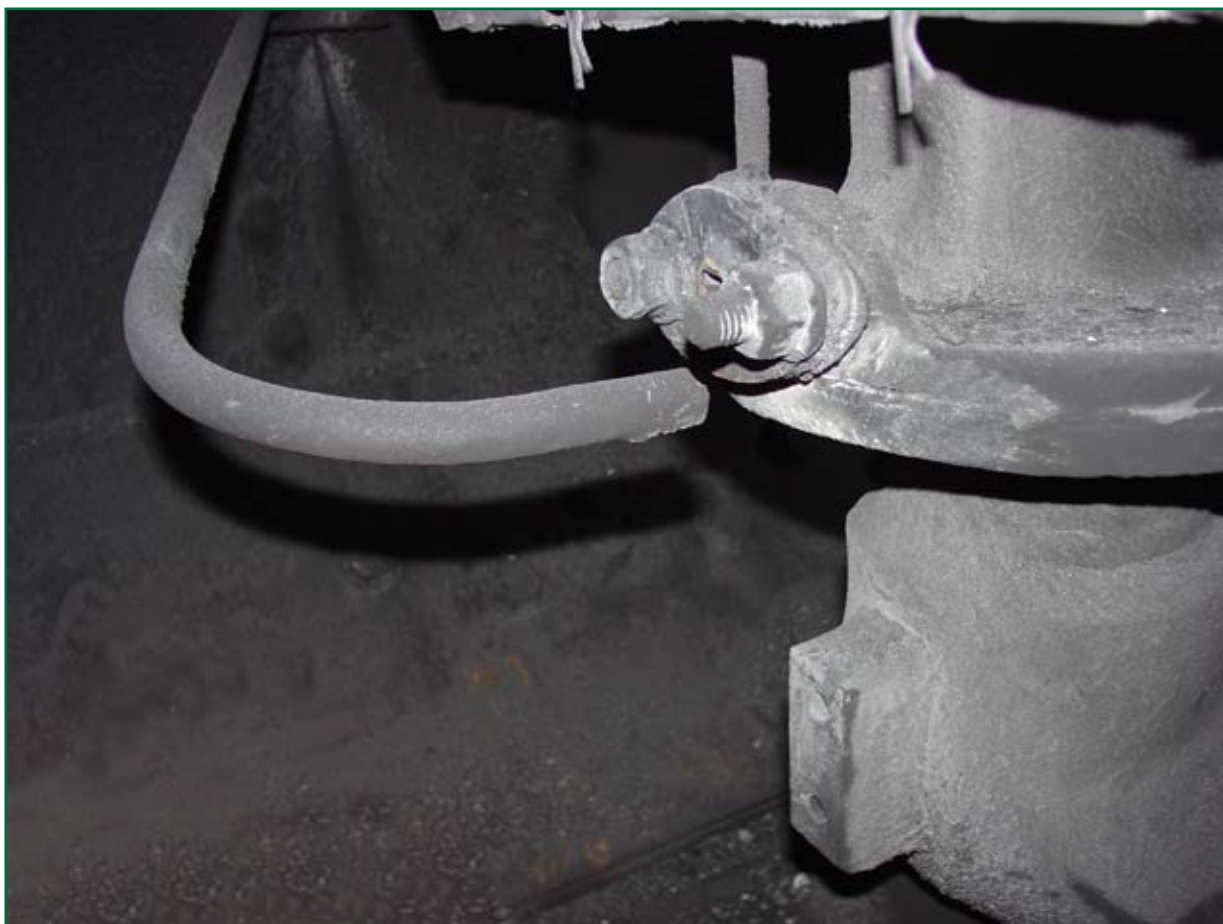
- when exhaust steam was vented through the blastpipe during testing, some was seen to leak into the smokebox through the cracks in the concrete;
- the rear blower feed pipe was fractured (see Figure 7), but had only been fractured a relatively short time as evidenced by the bright surface observed on one fractured face on 17 April 2006 that had dulled significantly within ten days of the accident. This was confirmed by metallurgical examination (paragraph 60 refers);

*Figure 7: The fractured rear blower feed pipe in-situ*

- 69 Calculations show that the steam pressure within the rear blower feed pipe, even if the blower valve was fully open, is insufficient to cause its final ductile overload failure (described in paragraph 60). Calculations also show that once the pipe had failed, it would not have displaced by much, either by the jetting action of leaking steam, when the blower was fully opened, or by the action of its own weight. Thus, any steam coming from the fractured blower pipe would have either been aimed at the flange or close to it. Marks on the flange and the clean fracture surface (see Figure 7) also suggest that steam was jetted in that direction after the pipe fractured. It is thus clear that steam jetting from the rear blower feed pipe would not have been aimed back at the *tubeplate*, which is another possible cause of blowbacks.

- 70 It is therefore concluded that the blower feed pipe most probably finally failed during the incident, as a result of blastpipe movement, at a time when the blower valve was slightly open. Whilst theoretically that may have resulted in a slight increase in smokebox pressure, this would have been negligible compared to the increase in pressure as a result of the blastpipe moving (paragraph 74 refers) and can therefore be discounted as a causal factor. This is further confirmed by the fact that when the blower valve was fully opened, it helped to reduce the blow back, rather than increase it.

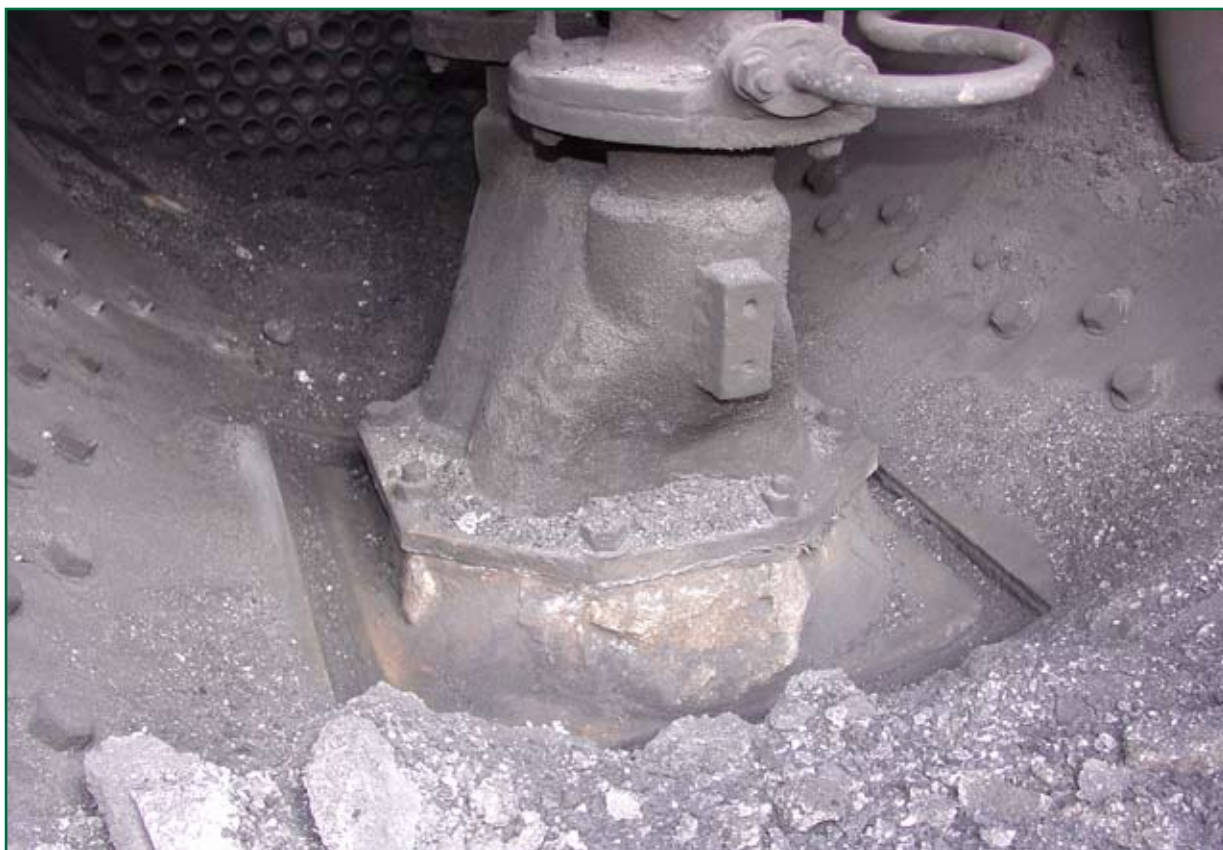
*Figure 8: The blastpipe in-situ*

- 71 After the incident, the blastpipe base was found not secured to the saddle plate and to have moved around 5 mm to the left relative to the direction of travel. Whether this movement was a direct result of the incident, the result of removing the refractory concrete with a bar by NYMR or by post incident vibration cannot be determined. However, what is clear is that the unsecured blastpipe/blastpipe base assembly could move relatively easily.
