# Rail Accident Report

## Derailment near Waterside, East Ayrshire 21 January 2006

# **Derailment near Waterside, East Ayrshire**

## **21 January 2006**

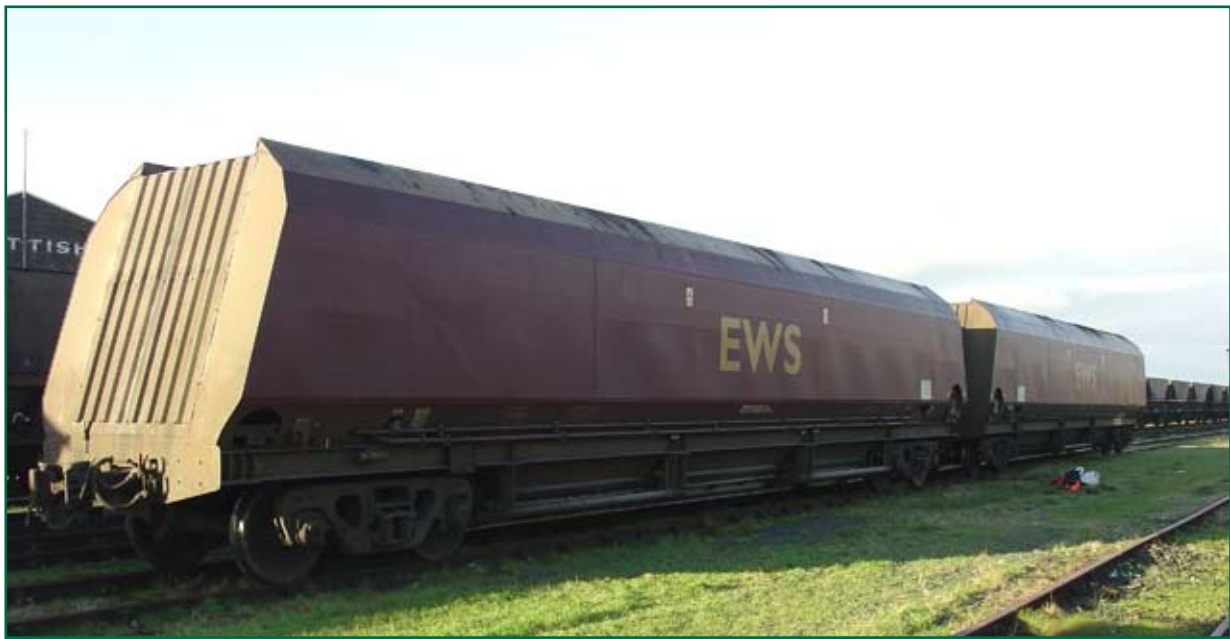
Figure 4: HTA wagons 310724 and 310711 at Falkland Yard, Ayr, following recovery.

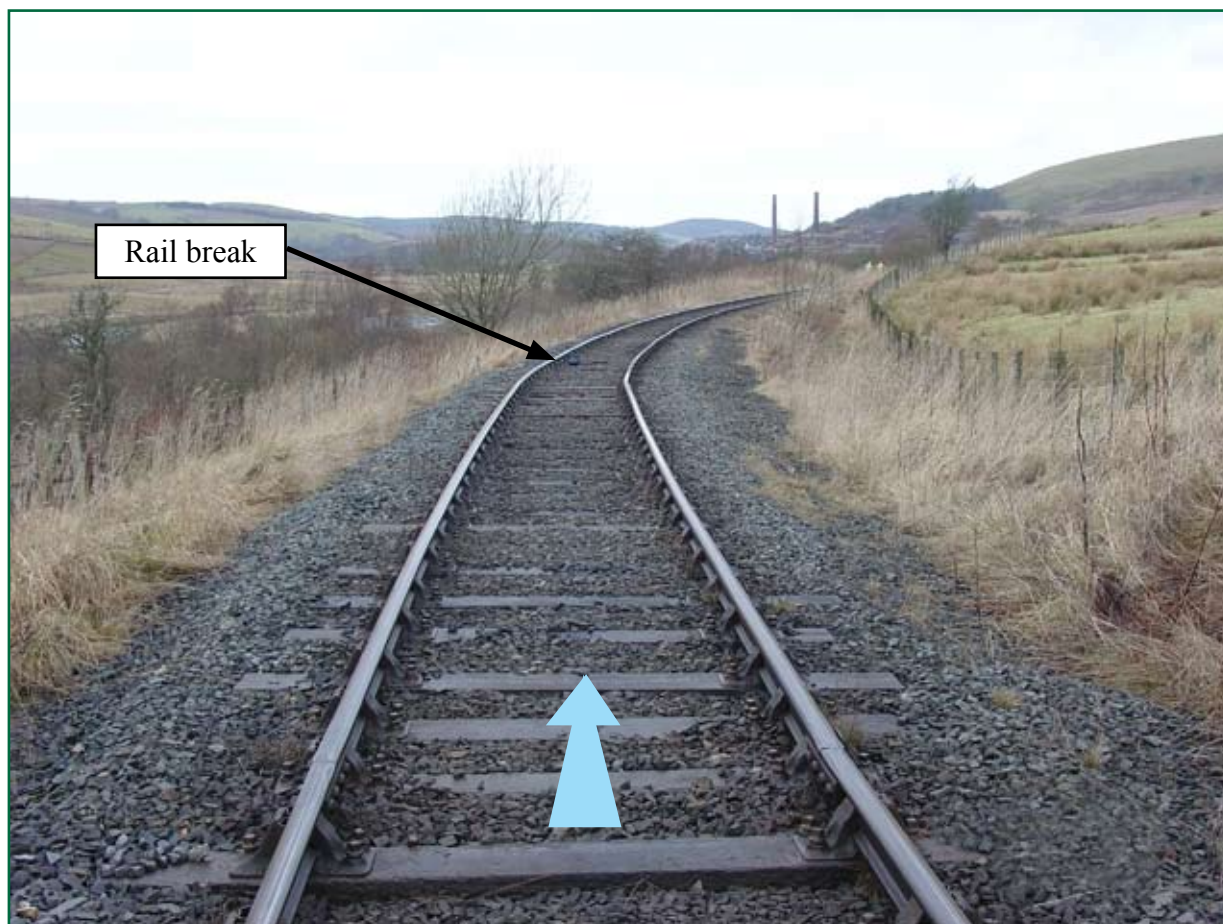
- 29 The derailment occurred at 03:19 hrs when the leading left wheel on wagon HTA310724 climbed onto the head of the left hand rail on encountering a transverse rail fracture located at 53 miles 889 yards, some 1130 yards (1034 m) before the Network Rail boundary. As the train negotiated a 200 metre radius right-hand curve on a 1:67 downhill gradient, the leading axle on wagon 310724, positioned 16<sup>th</sup> in the train of 21 wagons, became derailed to the left as it passed over a broken rail.

Figure 5: Overview of the point of derailment looking in the direction of travel.

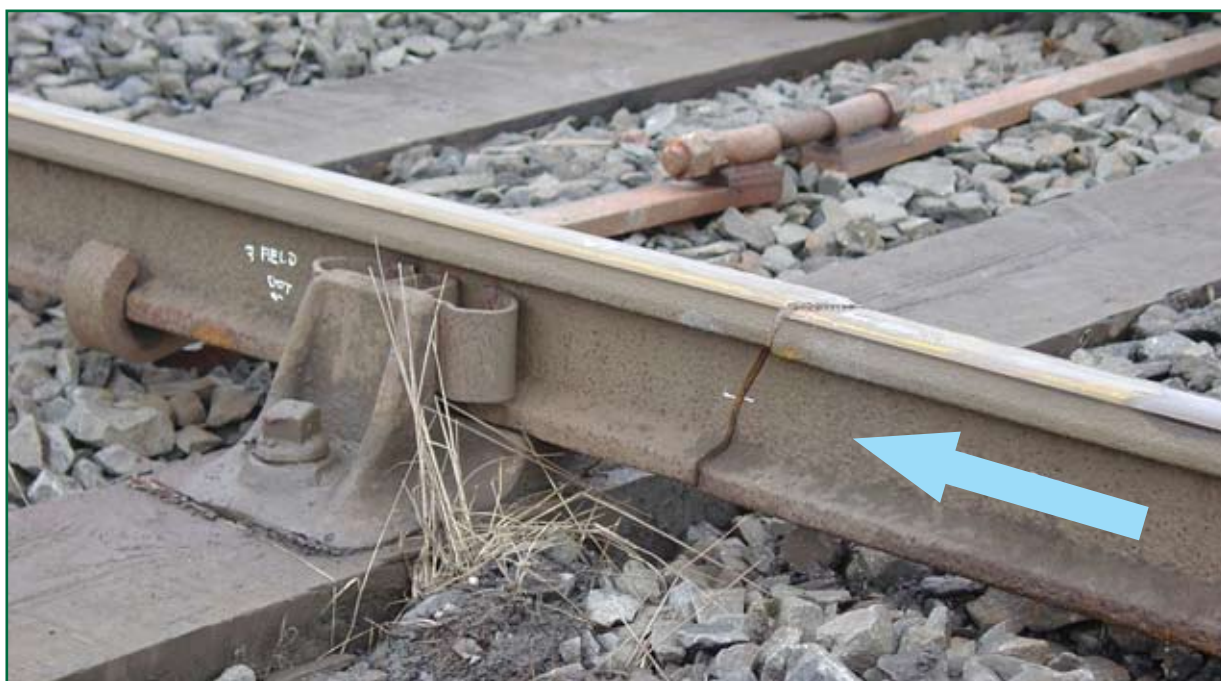
Figure 6: Rail break viewed from the field side.

- 68 Marks made by the chair on the seating faces suggested that rail creep of up to 65 mm had occurred.
- 69 Examination of the fracture face indicates that the rail failed from fatigue cracks that initiated from pitted areas on the underside of the rail on the field side. Multiple fatigue cracks had initiated from two pitted areas on the underside of the rail foot. These cracks had propagated by fatigue on a transverse path until they joined to form two single crack fronts on a slight plane to each other. Once the cracks had reached a critical size, the rail cracked rapidly upwards and stopped when the head section was reached. Based on an assessment of the impact damage due to wheels passing over the broken section and the amount of corrosion on the fracture surface, it is considered most likely that the final break occurred under train 6C64. This opinion is supported by the relatively rust free fracture surface of the head and the fact that if the previous train had broken it, then the running-on side of the fracture would be expected to have suffered more extensive damage.

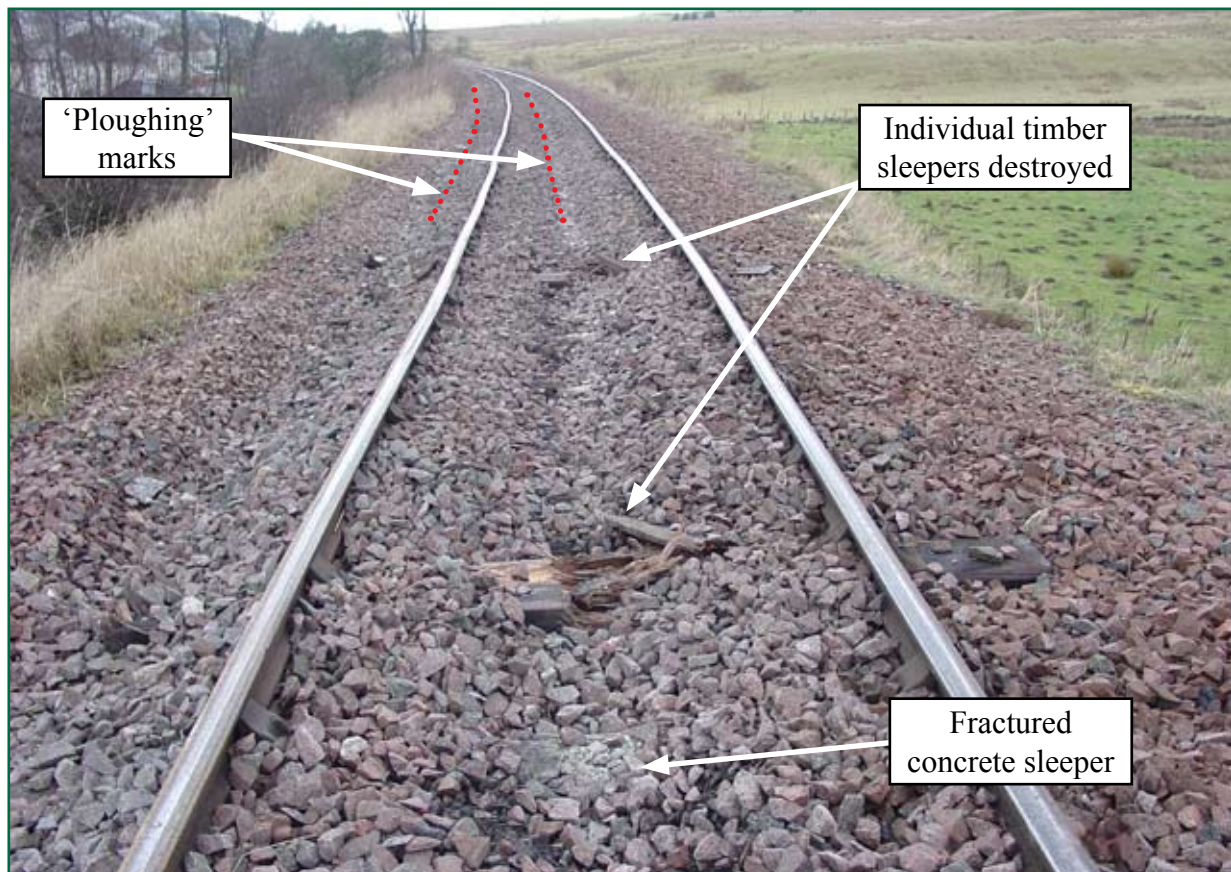
- 35 Between the 52 and 51½ mileposts, the derailed wheelset encountered deep ballast laid across the track (see Figure 8). This resulted in a ploughing action developing, forcing the bogie further to the left until a yaw angle estimated at 18° was realised, contrasting with a normal maximum of 5.2° (corresponding to the displacement when negotiating a 70m radius curve). At this angle, both right hand wheels on this bogie came into contact with the wagon's underframe causing damage and reducing their ability to rotate freely.

Figure 8: Track damage on the approach to Patna village near the 51½ milepost.

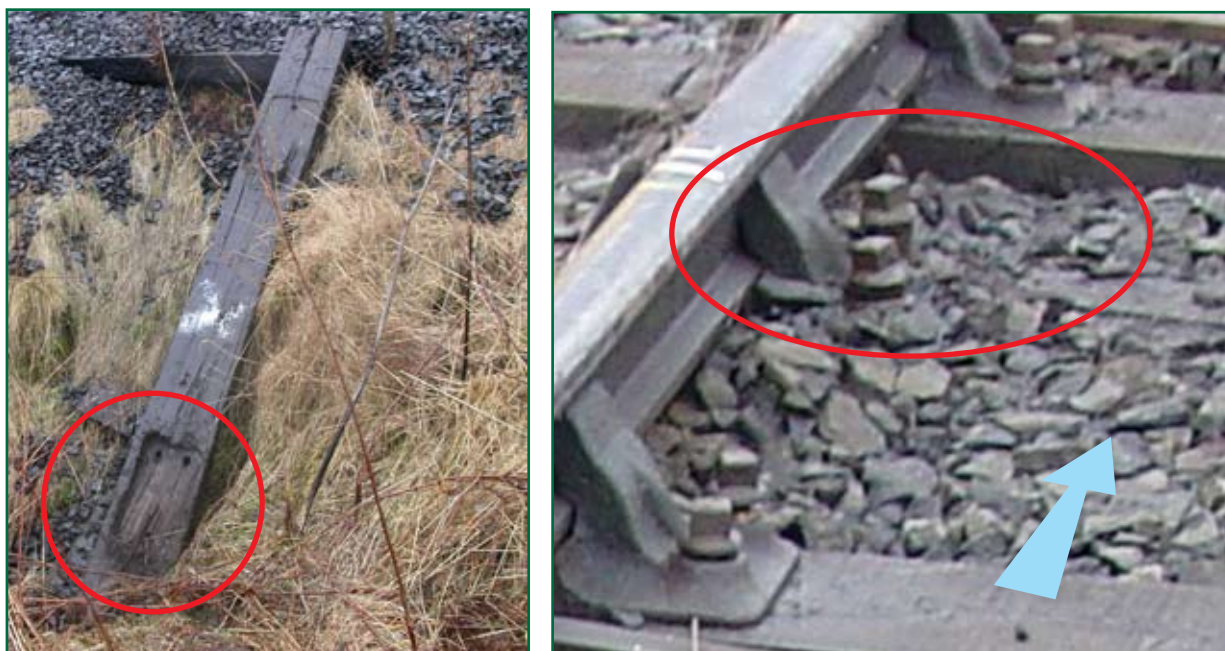
- 63 However, the wooden sleeper immediately before the rail break was not new. Whilst generally sound, inadequate ballast support had allowed movement to occur during loading by the passing of trains, but this went unrecorded in the 4-weekly inspection reports. This movement caused the chairscrews to ratchet upwards and become loose, allowing moisture to ingress beneath the chair and resulting in gradual loss of support due to softening of the wood. When removed from the track following the derailment, a 45 mm deep indentation was identified, together with evidence of up to 15 mm lateral movement (Figure 11). Whilst masked by the chair, the securing chairscrews had been partially ejected giving a visual clue as to the presence of this void and making it possible for track inspection staff to detect. When loaded by the weight of a train, the void would have caused the supporting chair to drop and move laterally. The reduced lateral and vertical support in this instance is a causal factor in the failure of the rail. There is no evidence that ballast under the old sleeper was packed when new sleepers were installed on either side of it during 2003. The November 2005 condition report recommended the renewal of ferrules throughout this section, which requires the removal of chairscrews and would have resulted in the sleeper defect being identified. However, as this section was not on the priority list, it is not known when this work would have been done.

Figure 11: 45 mm indentation in sleeper preceeding rail break following its removal from the track. The lack of support offered by this sleeper was significant. The displaced chairscrews and broken rail can be seen in the right hand picture.

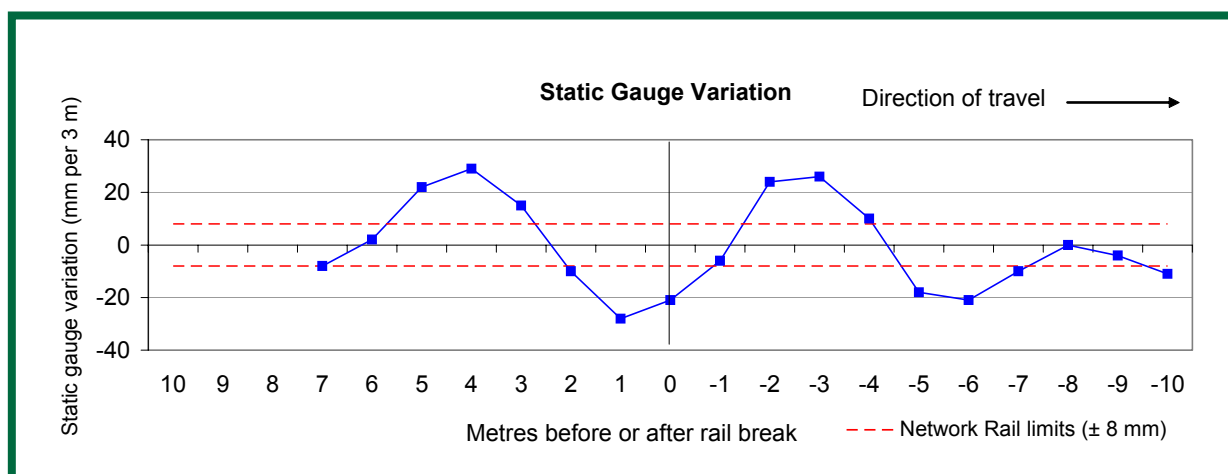
- 76 The variation in track gauge over a 3 metre length is not specifically addressed by the EWS Standard for maintenance. By comparison, Network Rail Standard NR/SP/TRK/001 Appendix E gives an intervention limit of 8 mm over a 3 metre length for a 10 mph line speed. Site measurements indicated gauge variation of up to 32 mm in 3 metres as illustrated in Figure 13. Gauge irregularities over short lengths of track can lead to bad riding and can develop into a state of cyclic *sidewear* increasing the stress imposed on the rails and the rate at which the asset dilapidates.

Figure 13: Graph of gauge variation over 3 meters. The Network Rail limit of 8 mm over a 3 m length is indicated by the dashed lines.

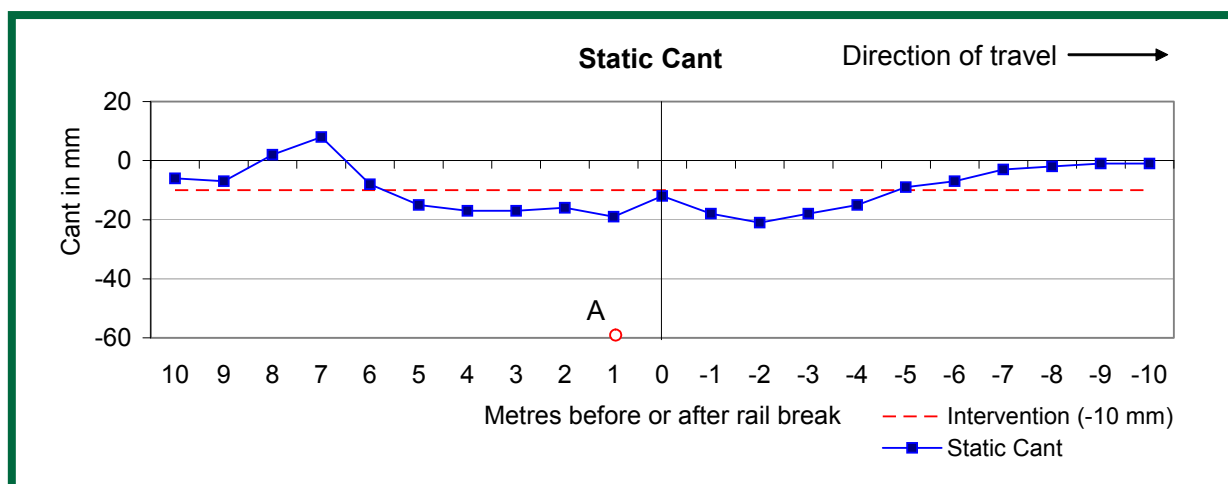
- 78 The cross-level (or cant) at the site was found to be predominantly negative, meaning that the outer rail was, unusually, lower than the inner rail of the curve. This will have had the effect of forcing vehicles to the outside of the curve. At 10 mph, this does not significantly increase the *dynamic loading* or *cant deficiency* but will have increased the rate of rail wear. Figure 14 shows the static cant for 10 metres either side of the break.
- 79 The EWS Standard for maintenance prohibits adverse cant on curves and requires negative values in excess of 10 mm to be rectified.

Figure 14: Graph of static cant showing negative values for the section leading up to the rail break.

- 80 Point A in Figure 14 represents a theoretical dynamic cant value that shows the effect of the 45 mm deep indentation discovered beneath the left-hand rail chair in the sleeper immediately preceding the rail break (see paragraph 63) when superimposed on the measured values. This assumes the left-hand rail deflected by the full 45 mm. The adjacent sleepers on both sides were installed new in 2003 and had no corresponding indentation marks.

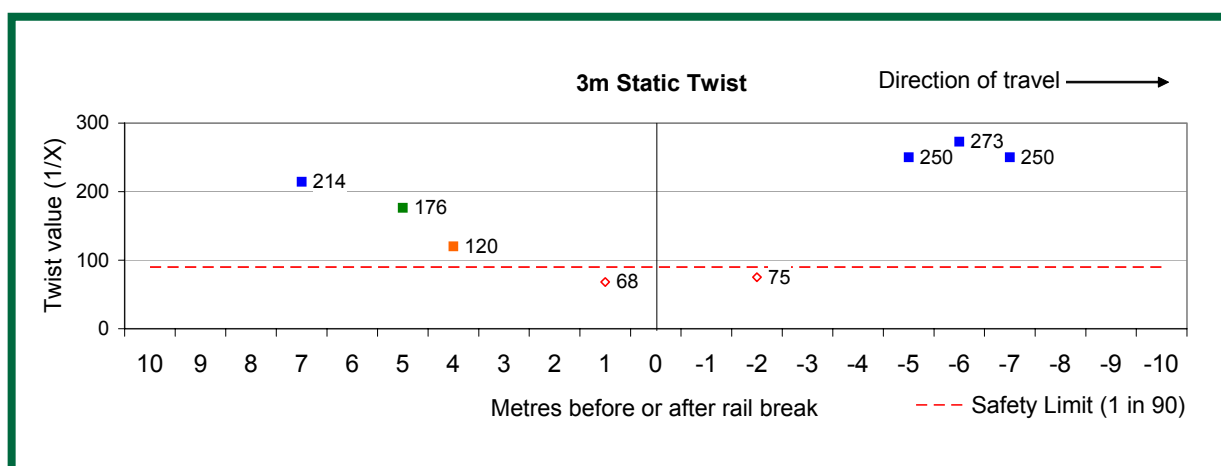
- 81 Twist measures the rate of change of cant over a 3 metre length, with values below 1 in 90 requiring all traffic to be stopped in accordance with the EWS Standard 0190. The static twist values at the site remained compliant although in need of immediate attention as detailed in paragraph 83. When the dynamic effects are considered, as would be experienced by the wheels of a loaded train, the effects of the indentation at the sleeper would become apparent. The rail dip at this point would be compounded once the break propagated to the surface, and this will have contributed to the leading axle of wagon HTA310711 climbing onto the rail head.

- 82 Figure 15 shows the static twist (solid markers) superimposed with theoretical dynamic twist values (hollow markers). The theoretical values assume the left-hand rail deflected fully into 45 mm deep indent in the sleeper preceding the rail break.

Figure 15: Twist measured over 3 metres showing values below 1 in 300.

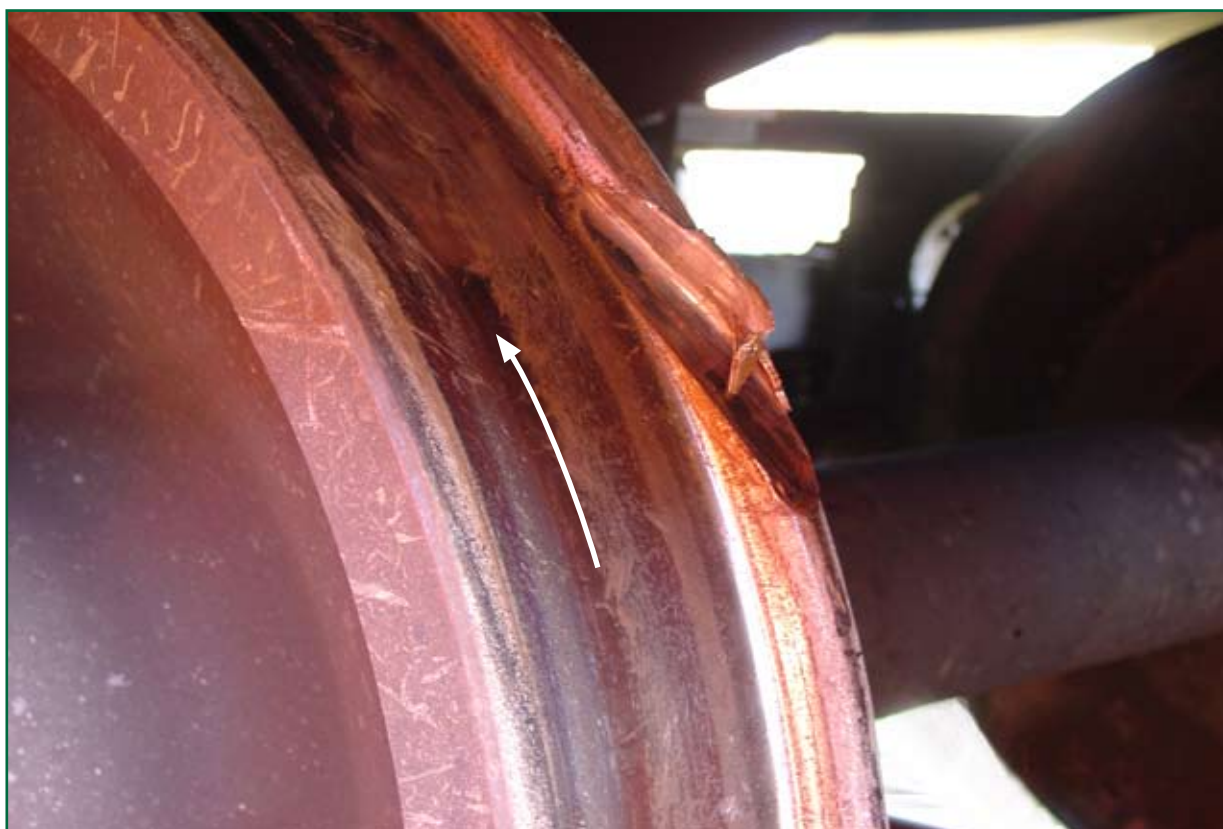
- 94 The final seven wagons in the train were examined by the RAIB following recovery. The inspection and weighing of the critical wagons involved in the derailment revealed no defects which could have caused this incident.
- 95 Wagon 310724 travelled for over 2¼ miles (3,800m) with the leading axle derailed to the left. As the bogie's rotation, or yaw angle, increased beyond the permitted maximum, both right hand wheels on the leading bogie came into contact with the wagon's underframe causing damage and reducing their ability to rotate freely. The trailing wheelset eventually became jammed, preventing rotation of this axle. The trailing left hand wheel, which remained on the track, suffered deep gouging to its flange as it was forced against the rail head at an angle but without being able to rotate. Figure 16 refers.

*Figure 16: Left trailing wheel on leading bogie of wagon HTA 310724 showing deep flange damage.*
