Rail Accident Investigation Branch

Rail Accident Report

Derailment at Long Millgate, Manchester 22 March 2006

22 March 2006

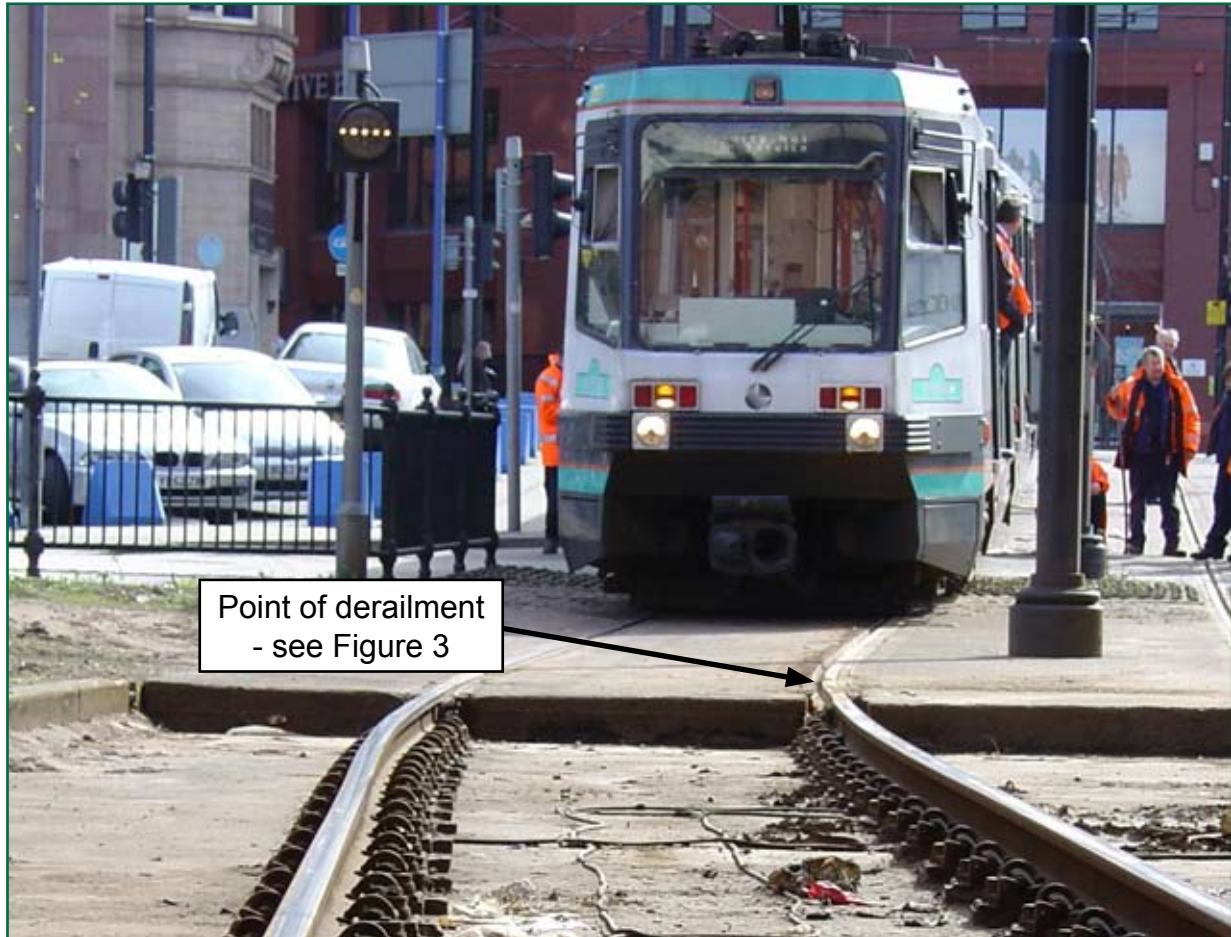
- 18 After liaising with the Metrolink control room the driver got out of the vehicle to assess the problem and discovered that the front axle of the centre bogie was derailed to the left.

Figure 2: Derailed tram seen from the rear

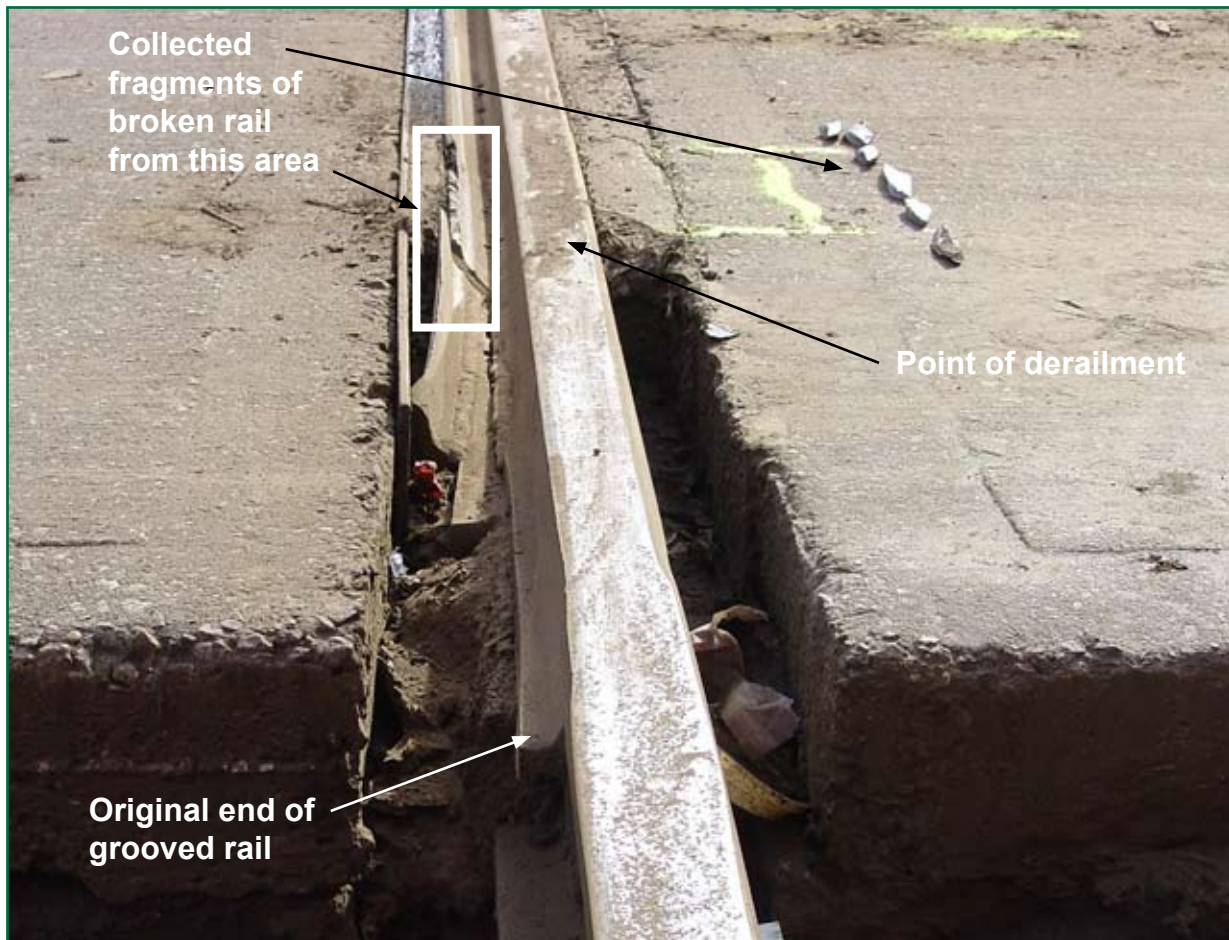
- 23 There were no injuries to staff or passengers, and no damage to the tram. The track was damaged over a length of about 0.6 m (see Figure 4), and the right-hand rail in this area required replacement.

Figure 3: Right hand rail at transition showing extent of cutting-back from original end of grooved rail (see paragraph 27 for a description of the rail).

- 54 The welding-in of this wedge was sub-standard. The weld applied to the top of the wedge had not been sufficient to join the rails together, so the wedge was connected to the flare but not to the body of the rail. When the flare broke, it did so largely along this weld (Figure 3).

- 79 Serco Metrolink removed the defective flare and the keep on the remainder of the curve, which had the effect of relocating the entry to grooved rail on to the straight section. The side worn rail opposite the new entry to the groove was built up by weld repair to tighten the gauge.

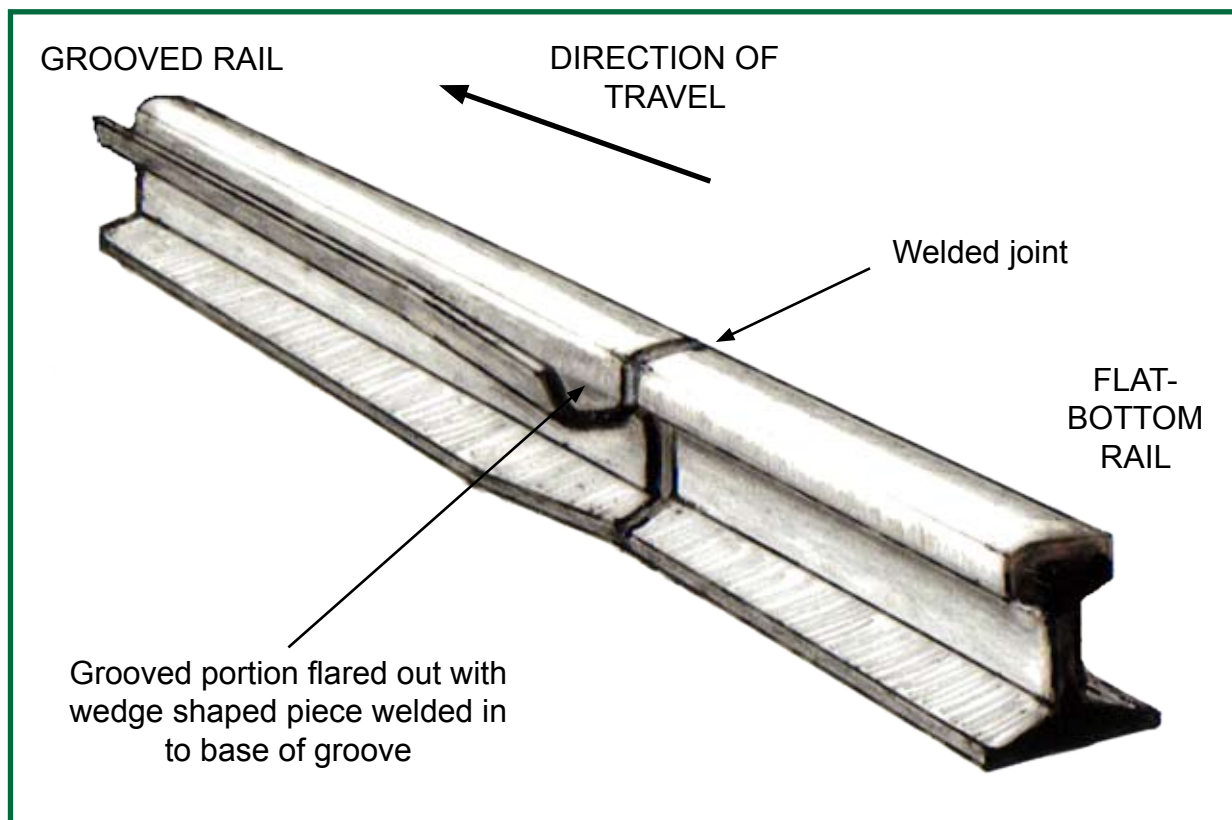
- 26 The derailment occurred at the point where the track changes from flat-bottom rail to grooved rail. The track through Victoria Station consists of a reinforced concrete slab with an 80 lb flat-bottom rail clipped into baseplates that are bolted to the slab. The track formation alters just outside the station entrance (known locally as the 'hole in the wall'), where the rails change to Ri59 grooved rail embedded in 'Edilon' polymer and surrounded by a pavement surface.
- 27 The transition from flat-bottom to grooved rail is made by the use of transition pieces; these were originally fabricated by *flash butt welding* the two rail sections together and adapting the rail foot to create a tapered section. The transition pieces included a 'flared' arrangement to the end of the *keep* section of the rail to provide a wider groove where the wheel flange enters the grooved rail (Figure 4).

Figure 4: Simplified sketch of transition between rail profiles

- 2 GMPTE should ensure that the risk of transitions between flat-bottomed and grooved rail on curves on the system is assessed, and that they are repositioned on to straight track where this is warranted and it is reasonably practicable to do so.

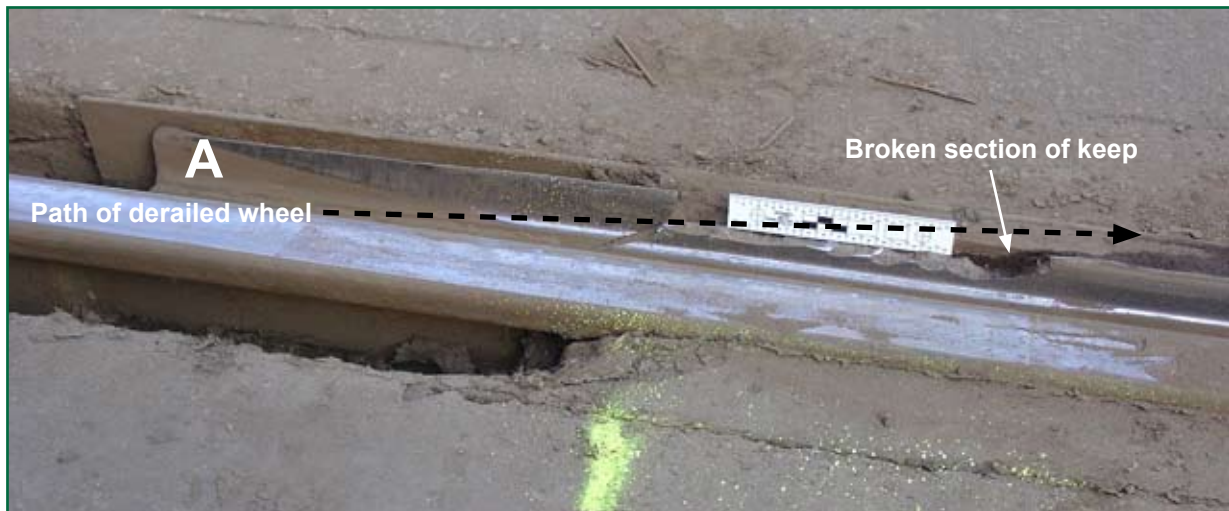
- 28 As tram 1011 passed over it, the flared portion of the grooved right-hand (inner) rail broke away from the rest of the rail at the weld, and consequently the keep was shattered over a further length of 230 mm by the force exerted by wheel flanges which were no longer being guided and restrained by the flared portion. This permitted the flanges of the right-hand wheels of the leading wheelsets of the centre and trailing bogies to pass the wrong side of the keep, forcing the left-hand wheel over the railhead and into derailment (Figure 5).

Figure 5: details of broken rail

- 31 At the Victoria curve, the back of the flanges of the inner (right-hand) wheels of trams had been contacting the keep of the grooved rail, commencing at the point where the groove narrows in the flared portion of rail ('A' in Figure 5). This had placed a load on the flared portion, and the combination of the load and the consequent wear eventually caused the *flare* to break under the tram which derailed on 22 March. The flare had previously cracked and had been cut back and remade in October 2005. This work was not designed or carried out to a good standard (paragraph 54), and consequently the flare was weak and had a relatively short life before it failed again. The flare was not, however, intended to be of sufficient strength to withstand being struck by passing wheelsets.
