Rail Accident Report

**Train collision with a road vehicle at Bratts
Blackhouse No 1 User Worked Crossing, near
Sizewell, Suffolk
22 May 2006**

Train collision with a road vehicle at Bratts Blackhouse No 1 User Worked Crossing, near Sizewell, Suffolk, 22 May 2006

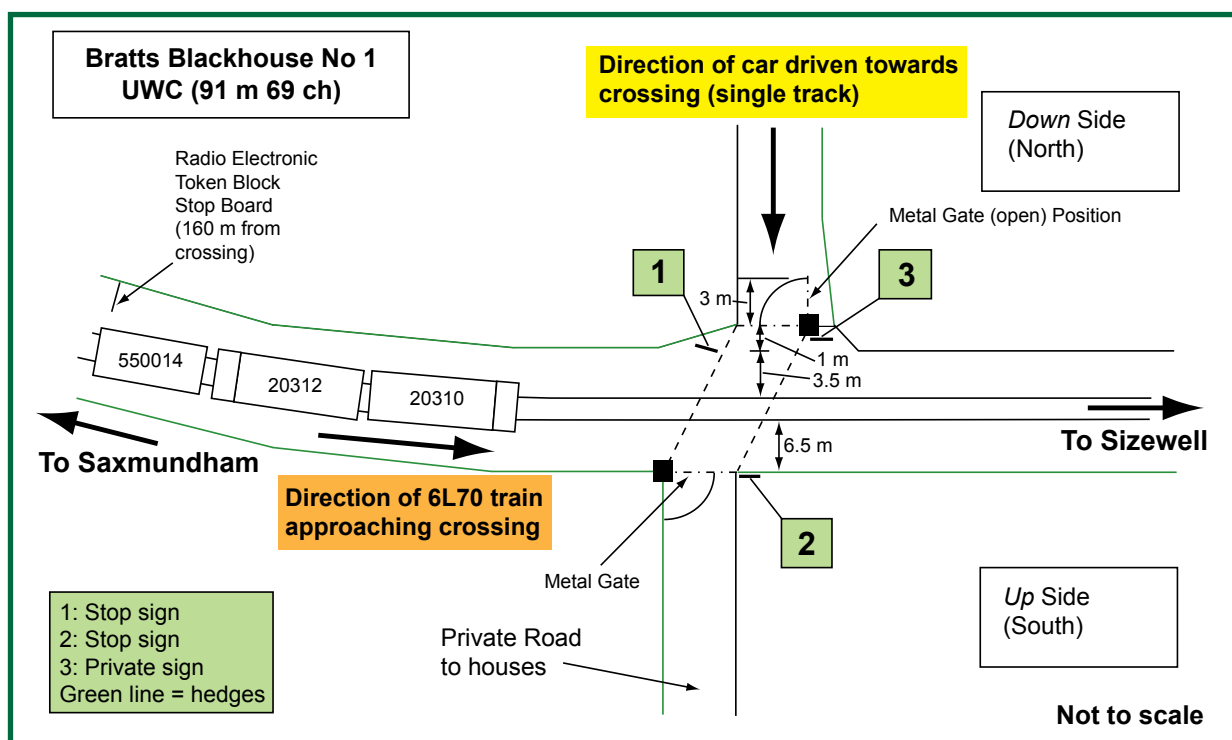
Figure 2: Sketch plan of Bratts Blackhouse No 1 UWC

- 23 The north side gate is hinged on its left hand side and opens towards oncoming road traffic and when closed is 4.5 m from the edge of the nearest running rail. The stop sign is positioned within the railway boundary at 3.5 m away from the edge of the nearest running rail. On the south side, both the gate and stop sign are 6.5 m from the nearest running rail (see Figure 2).

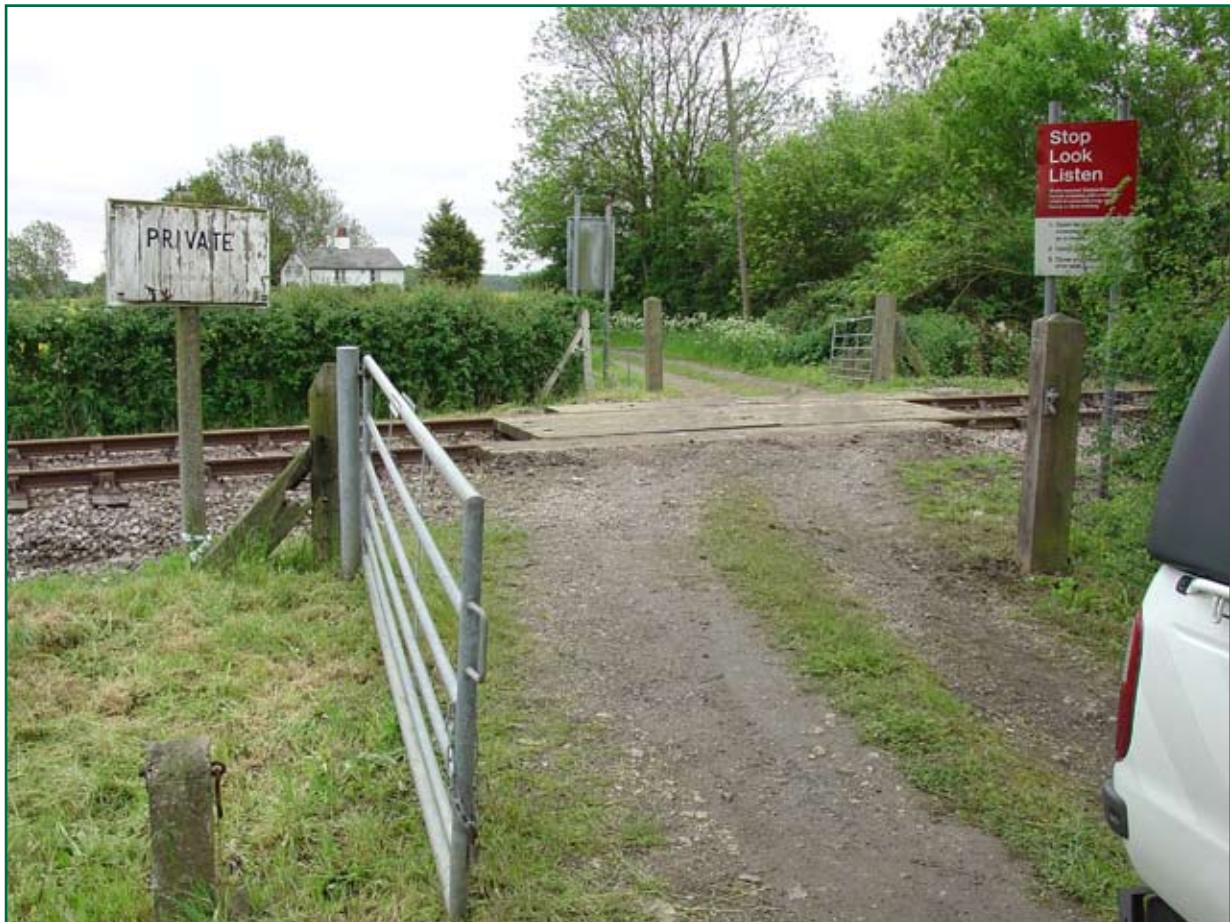
Figure 4: Bratts Blackhouse No 1 UWC as seen from the road track on the north side.

- 22 The crossing has two stop signs, one either side, facing oncoming road traffic. On the approach to the crossing from the north side, the dirt track from the public road is approximately 250 m long with a small chicane in it at 50 m from the crossing gates. The stop sign for users is positioned to the right hand side of the dirt track; the bottom of the sign is 1.5 m above ground level. The view of the sign for oncoming traffic is obscured by vegetation and foliage. There is also a sign marked 'Private' on the left hand side, near to the gate hinge post (see Figure 4).

- 90 The metal crossing gates at Bratts Blackhouse No 1 UWC on both sides were found open to road traffic after the collision. At the time of the incident they were unable to be closed. They had become partly buried by overgrown vegetation and had been left open for some time.
- 91 There is evidence that the gates were not in regular use. Users often left the gates open but did not explain their reasons for doing so. However the RAIB considers it likely that users feel it unnecessary to close gates given the low traffic levels on the line. Over time, this lack of use combined with inadequate maintenance, resulted in the gates becoming unusable. At the time of the accident the gates could not be closed (see paragraph 46).
- 92 The behaviour of crossing users in leaving the gates open and the condition of the gates were causal factors.

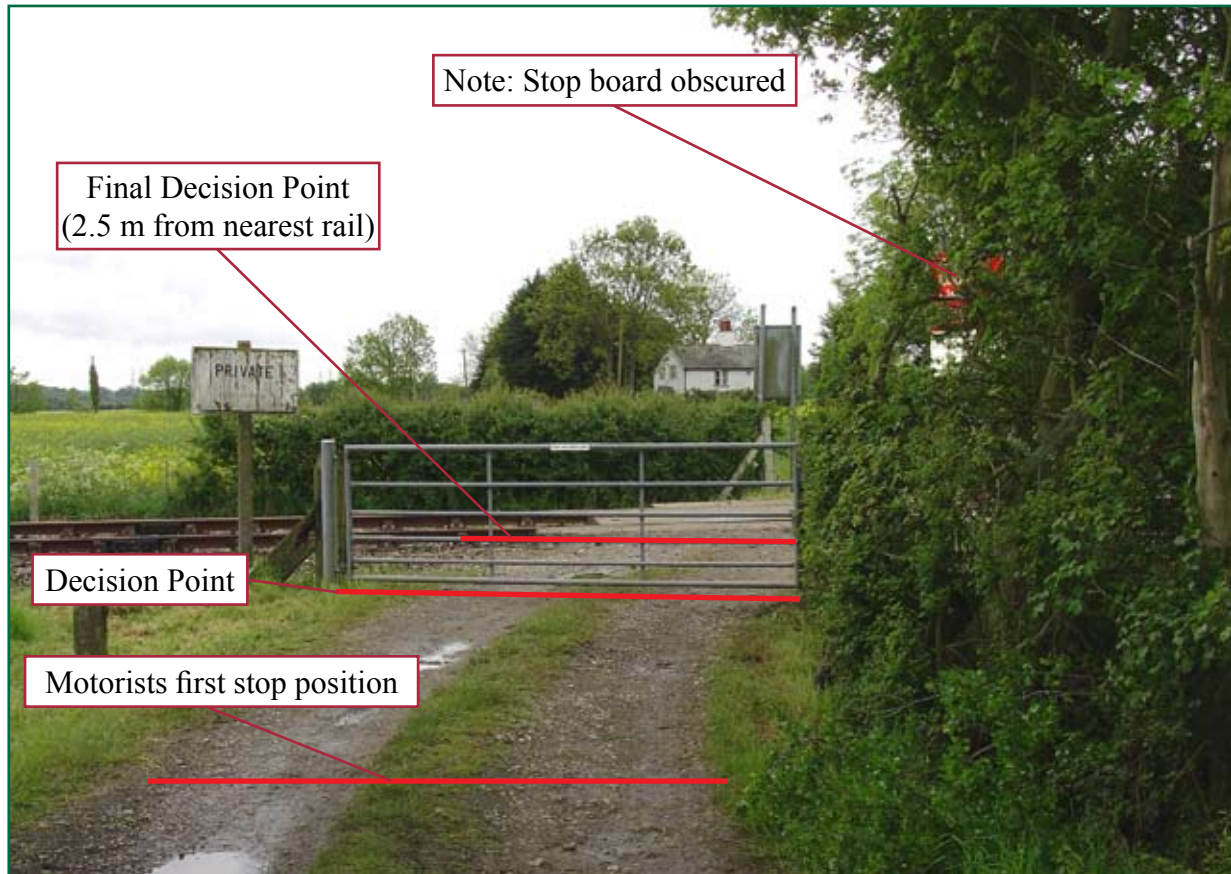
Figure 5: Decision points on the north side. Note the Stop Board to the right hand side hidden by foliage. (Photograph taken from motorist's perspective).

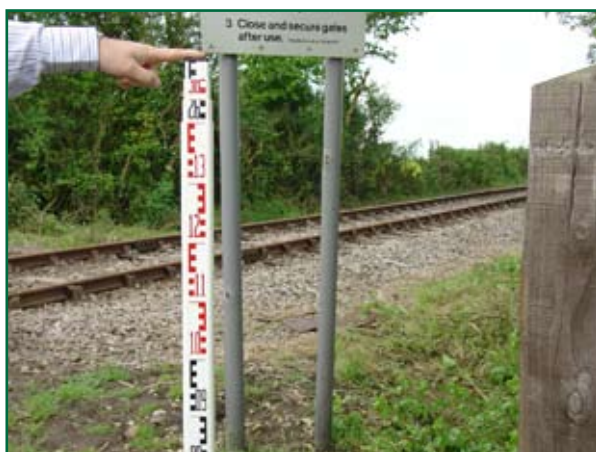
Figure 6: Motorist's view of approaching trains when at decision point

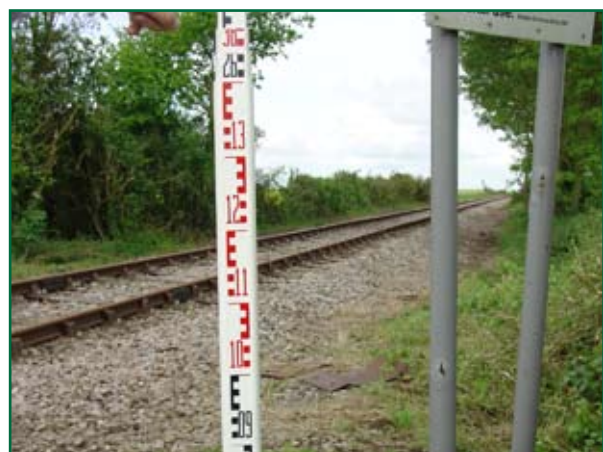
Motorist's view of approaching trains when at final decision point. (Motorist's eye level at 1.2 m)

104 If the safety of the crossing is reliant on condition (a) above, then there would be benefit in installing a Stop sign or some other marking at the final decision point and modifying the instructions to users. This is consistent with the findings of the recent research into 'Determining the final decision point at UWCs by RSSB in 2004'.

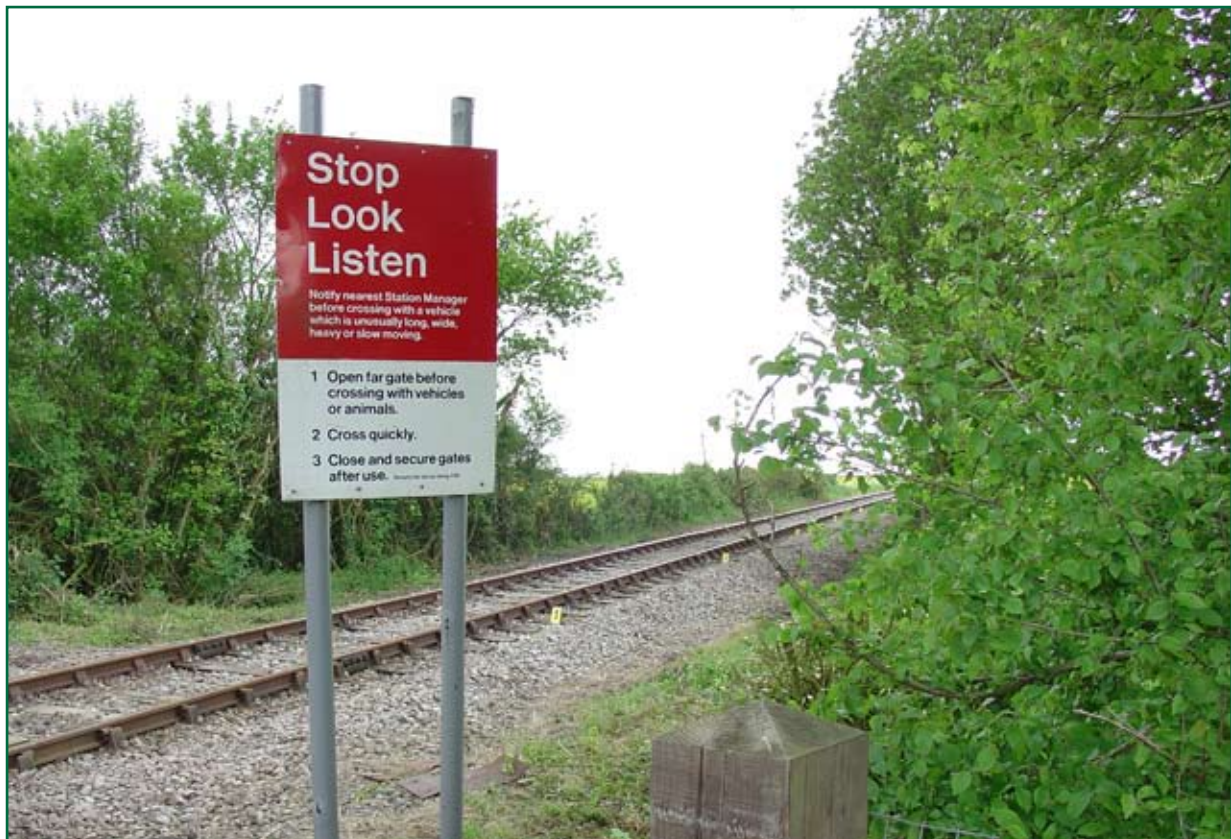
Figure 7: Bratts Blackhouse No 1 UWC vehicle and Pedestrian Stop sign

- 108 The wording on the sign at Bratts Blackhouse No 1 UWC is as shown in Figure 7 and is not compliant with The Private Crossings (Signs and Barriers) Regulations 1996 (Diagram 102). The existing sign requests that persons crossing with a vehicle which is unusually long, wide, heavy or slow moving should "notify nearest Station Manager".

- 109 No telephone number is provided on the sign.

- 110 The wording on the sign should read as shown in Figure 8.

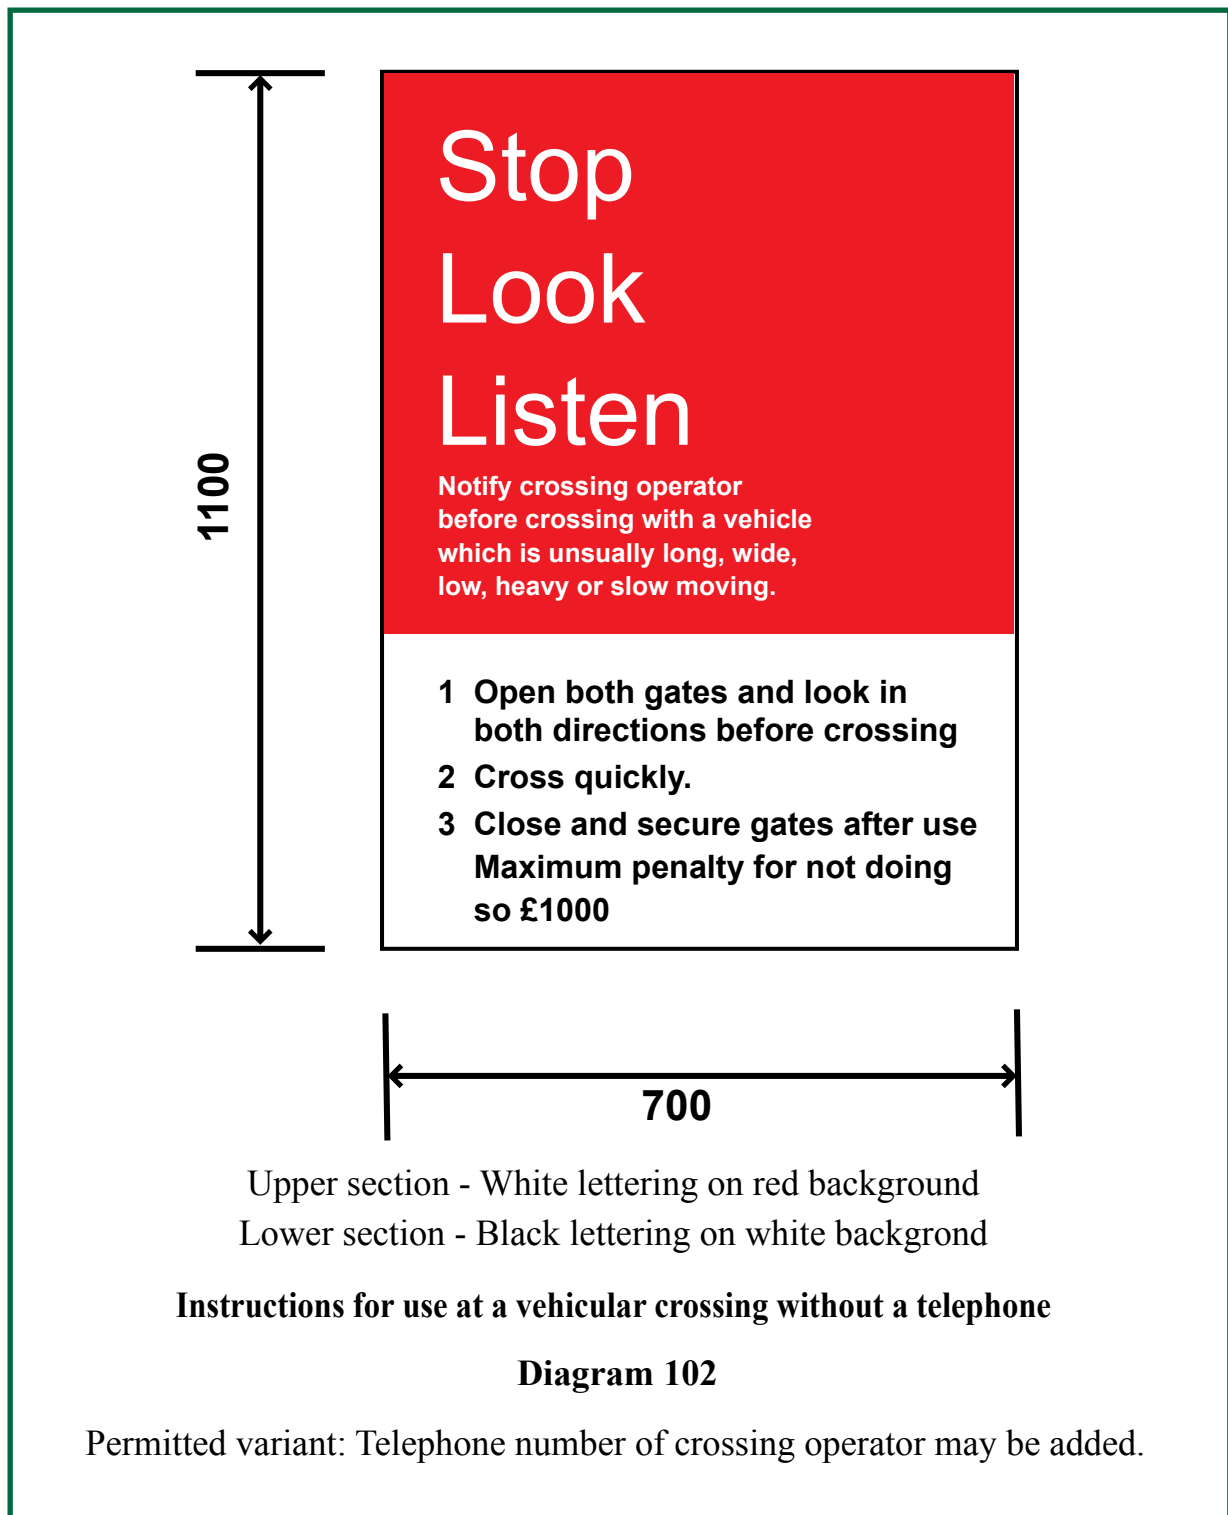
Figure 8: Diagram 102 from Private Crossings (Signs and Barriers) Regulations 1996 (Note permitted variant for telephone number to be added).
