Rail Accident Report

**Traction control failure causing a signal to be
passed at danger, Camden Road
7 April 2006**

Traction control failure causing a signal to be passed at danger , Camden Road, 7 April 2006

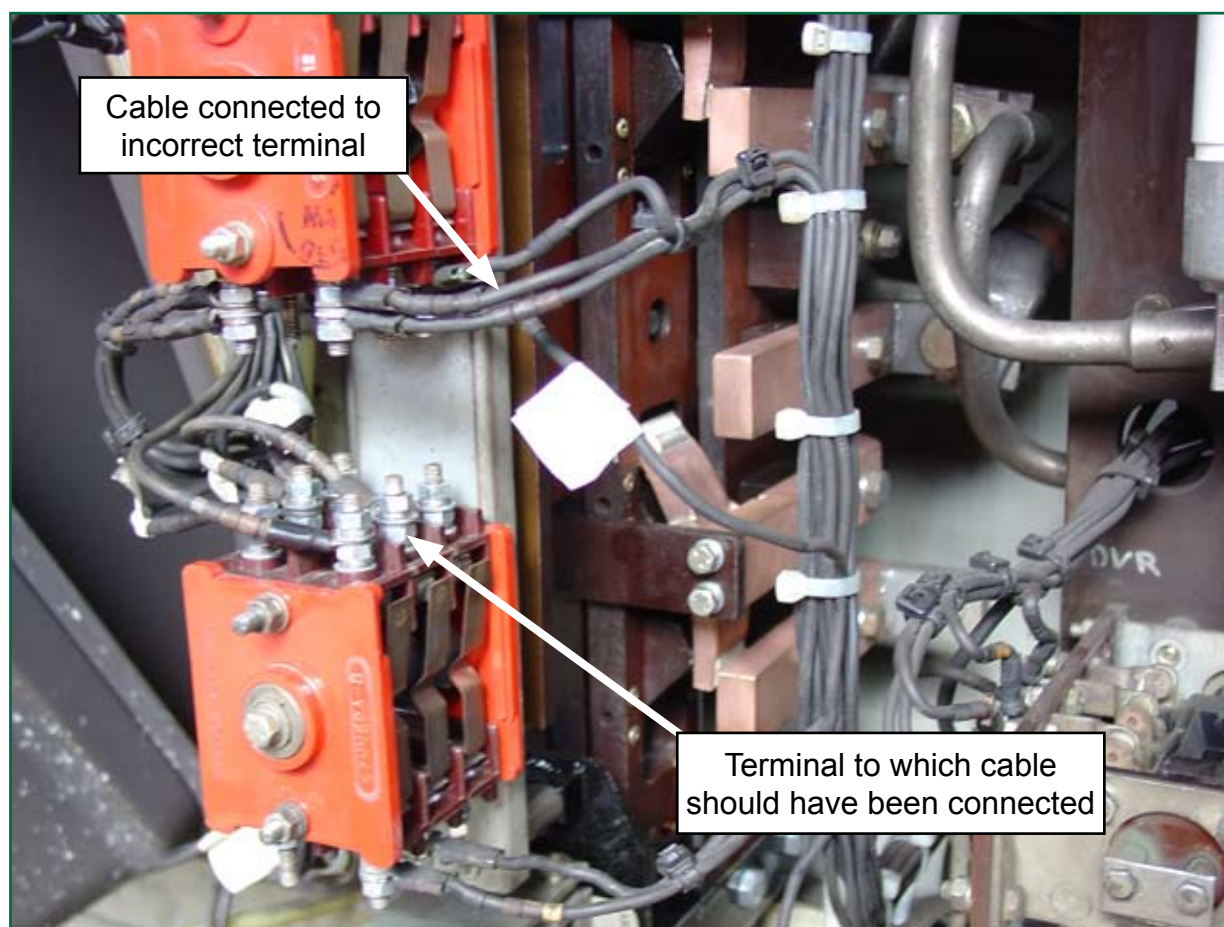
- 36 That examination established that the immediate cause was an incorrectly connected wire attached to an interlock terminal on the Supply Changeover Switch of 'B' coach, number 62596. This resulted in the Traction Motors being permanently powered when the unit was operated from a direct current (dc) power supply and when the control sequence reached '*Full Series*' for the first time.

Figure 2: The Supply Changeover Switch and connections as found during fault investigation

- 62 The cable concerned had a masking tape identification lettered 'TRM' on it and the number 5305. The original cable identification numbers were no longer visible.
- 63 The identity of the cable was established, indicating that it should have been connected to the top of the lower interlock block as shown in Figure 2. It was re-connected accordingly and this eliminated the fault.
- 64 After testing, including movement on both ac overhead and dc third rail systems to ensure that the unit operated correctly, it was returned to traffic.

- 65 The wrongly connected wire explained the behaviour of the unit.
- 66 The incorrect connection by-passed various relays used to control the power *contactors*. This caused the power contactors to remain closed, when the control sequence reached 'Full Series' for the first time after the dc supply was selected.

- 67 Due to the wiring error, the power contactors remained closed when the driver put the controller to 'Off' and commenced braking. The traction power was sufficient to overcome the unit's full service brake application.

3. While cable and terminal identification remains illegible, Railcare (Wolverton) should develop and implement a documented method of recording the terminals from which cables have been removed during the component replacement process (paragraph 112).
