# Rail Accident Report

## Huntingdon train door incident 15 February 2006

# Huntingdon train door incident

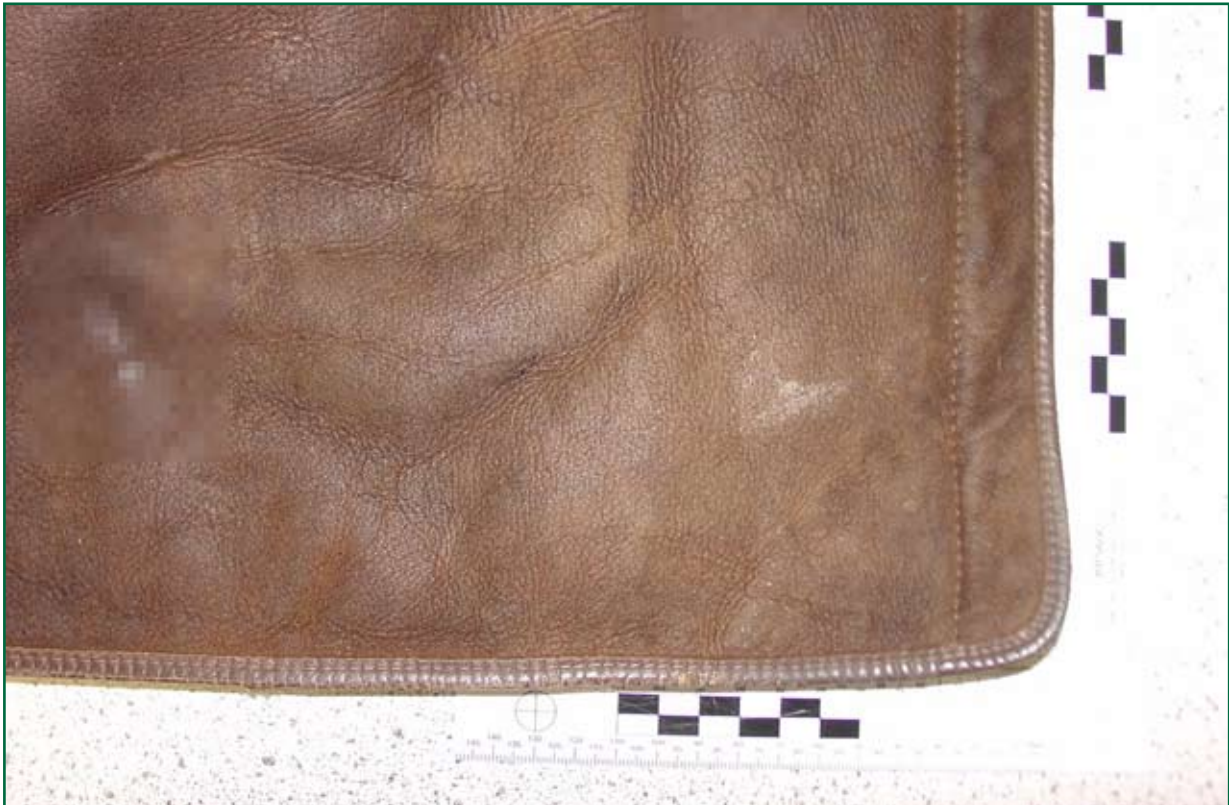
- 30 A key feature of the incident investigation was the ability of the Class 365 Unit doors to trap and hold the fabric from the coat worn by P2. The video records from security camera 7 confirm that it was the right-hand side of the open coat that became trapped in the closing door. Figure 5 shows the right-hand corner of the coat worn by P2.

*Figure 5: Right-hand corner of coat worn by P2*

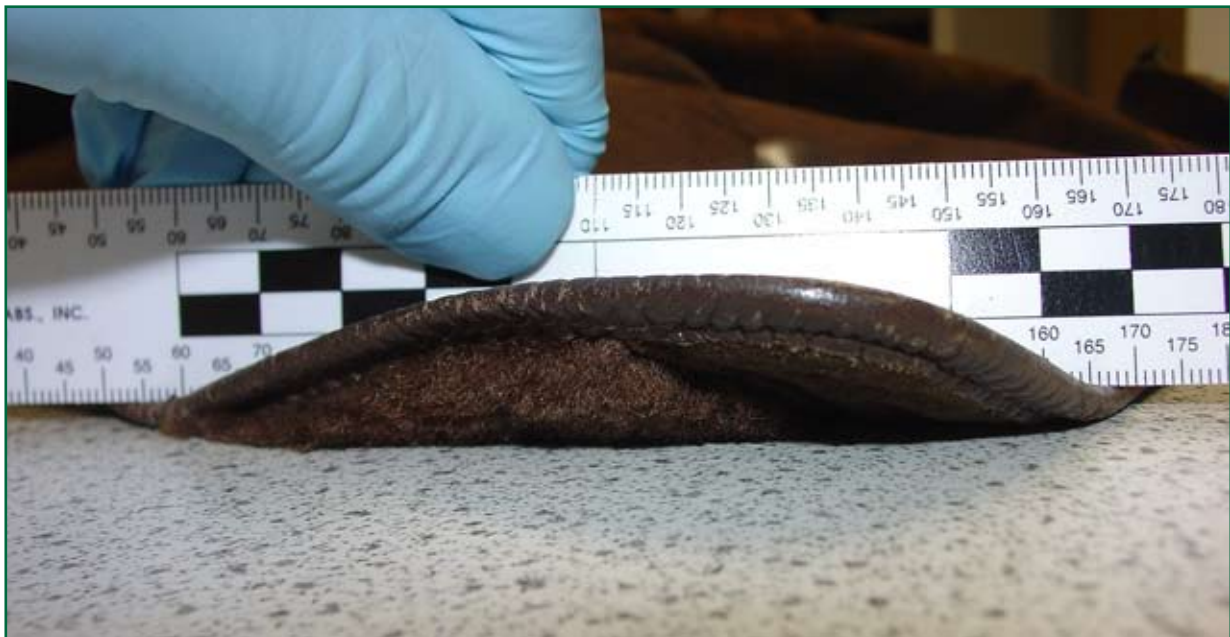
- 31 The coat was made from a heavy suede type fabric lined with a fur type material, as shown in Figure 6. It is possible that one of the coat buttons became trapped either in the door or behind the closed door during the incident. For the purposes of assessing the force required to extract the trapped fabric it was assumed that this button had not played a part in the trapping process. Had it been trapped behind the closed door then the extraction forces would have been greater than those recorded during the tests. The tests were configured to establish if the lower force to extract the coat in the scenario where the coat button was not trapped were significant.

*Figure 6: Coat material*

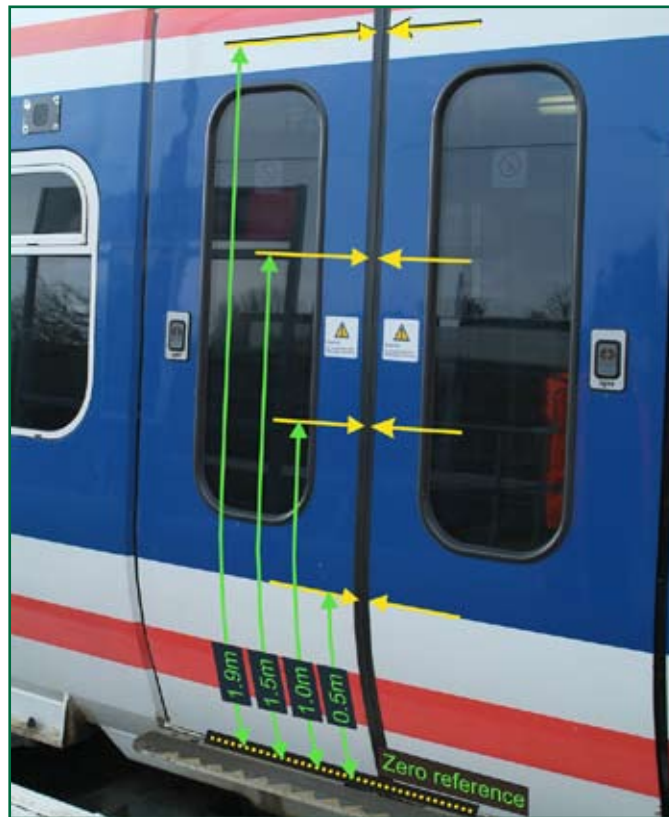
- 34 The door closing forces were recorded from two door sets. These were the trailing doors - vehicle [72242] and the incident leading door – vehicle [72243]. The forces were recorded at a number of positions as shown in Figure 7. It should be noted that 1.0 m from the door tread was the estimated position where P2's coat became trapped in the door.

Figure 7: Positions where door closing forces were measured

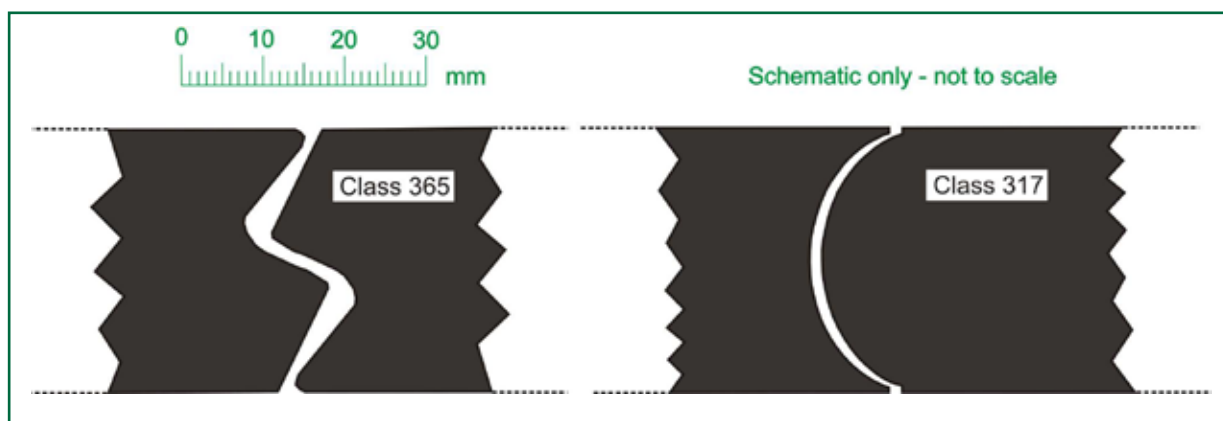
- 49 During the door closing tests the seals from the incident door were measured and casts were taken. Figure 8 shows a plan section through the seals taken from these casts.
- 50 The Class 365 Unit has a door seal design such that when the door is closed the two seals interlace. This improves the sealing and reduces any lateral movement but has the effect that when any fabric or clothing is trapped the forces required to extract the trapped material are likely to be greater than the simpler seal found on the Class 317 Unit.

Figure 8: Schematic of Class 365 and Class 317 door seal configurations

- 104 A combination of the design of the Class 365 Unit door seal and the closing forces of the Class 365 Unit door permitted the coat fabric to be trapped such that it could not be removed (paragraphs 34-52 and Recommendations 3 and 5).

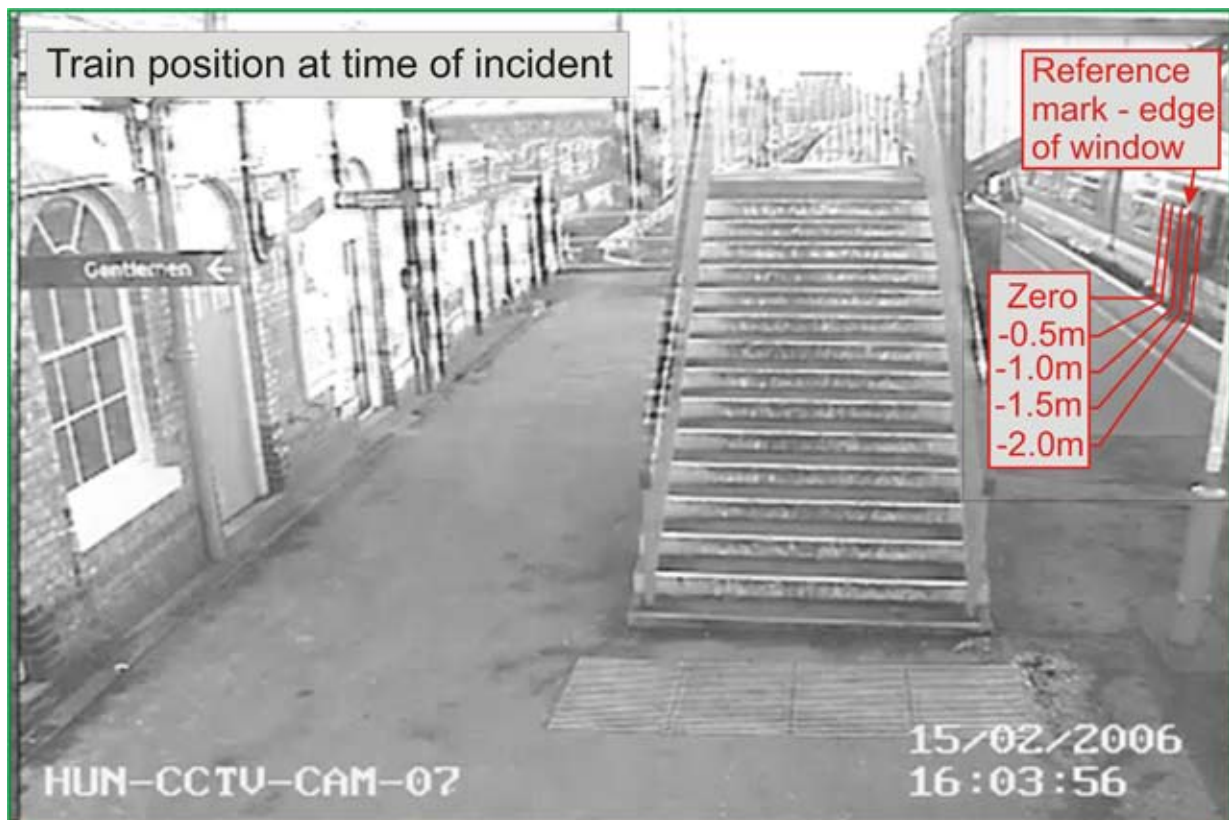
Figure 13: Image from security camera 7 showing train position at the time of the incident

- 105 The action of the Driver (P1) in pulling up short of the DOO four-car monitor bank is likely to have reduced the image contrast on the CCTV monitors (paragraphs 53-66 and Recommendation 1).

- 1 FCC should ensure that driver training is reviewed with a view to increasing the emphasis placed on, and understanding of, aligning the unit correctly with the optimum viewing position of the monitor bank. The training should also identify what actions the driver should take if a person is observed to be in close proximity to the side of the train when the driver is taking power (paragraphs 102 and 105).

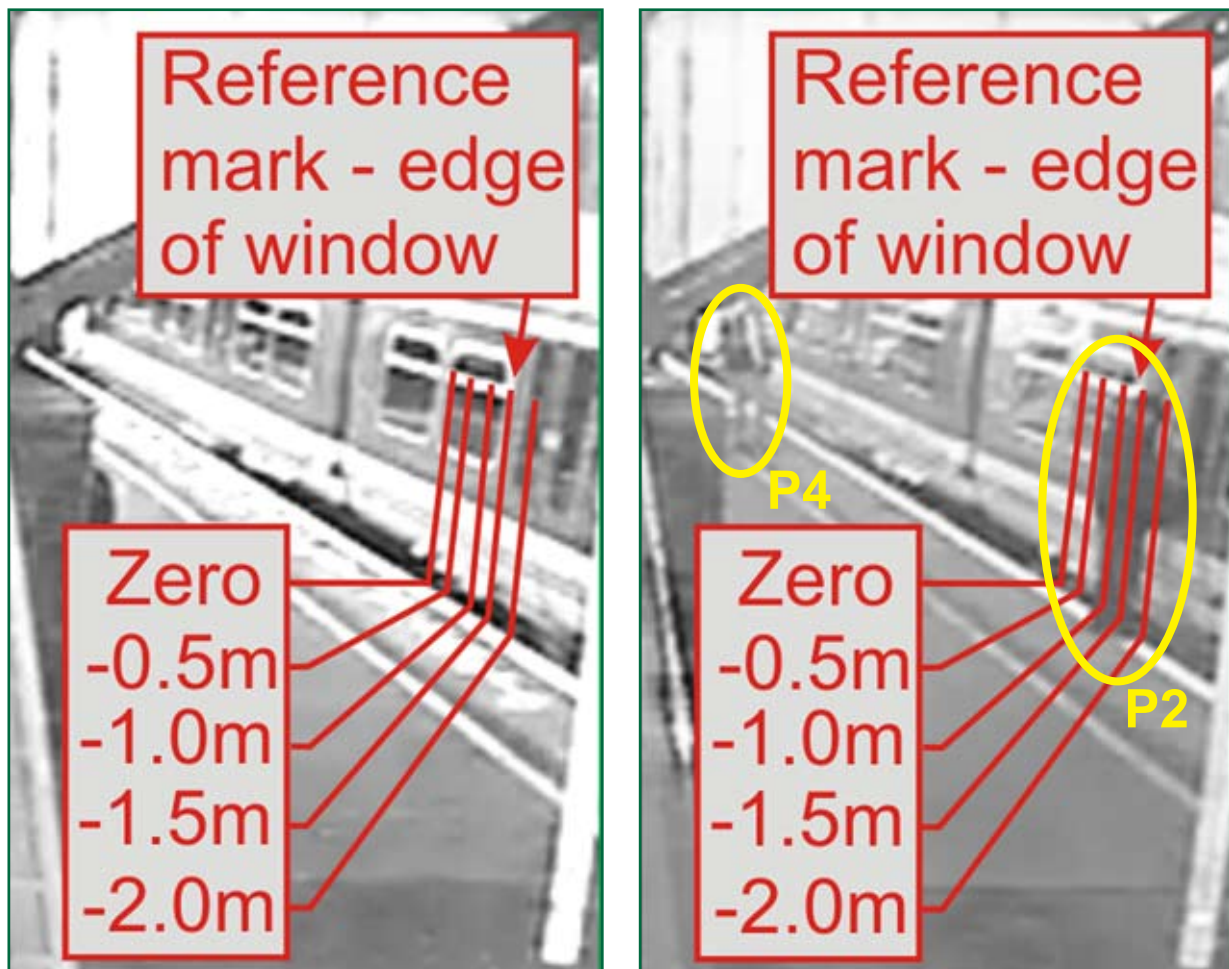
Figure 14: Enlarged images showing train comparison positions – incident train right-hand image – reference test train left-hand image

- 75 The right-hand image in Figure 14, shows the presence of a person, P4, stood in close proximity to the trailing door of the second vehicle [72242]. P4 appears to be dressed in an anorak with a light coloured stripe down each arm. The security camera video frames reveal that P4 also appears to be seeing someone off (P5). When the train doors close P4 moves away from the closing doors and stands within the area bounded by the painted yellow stripe and the platform edge.

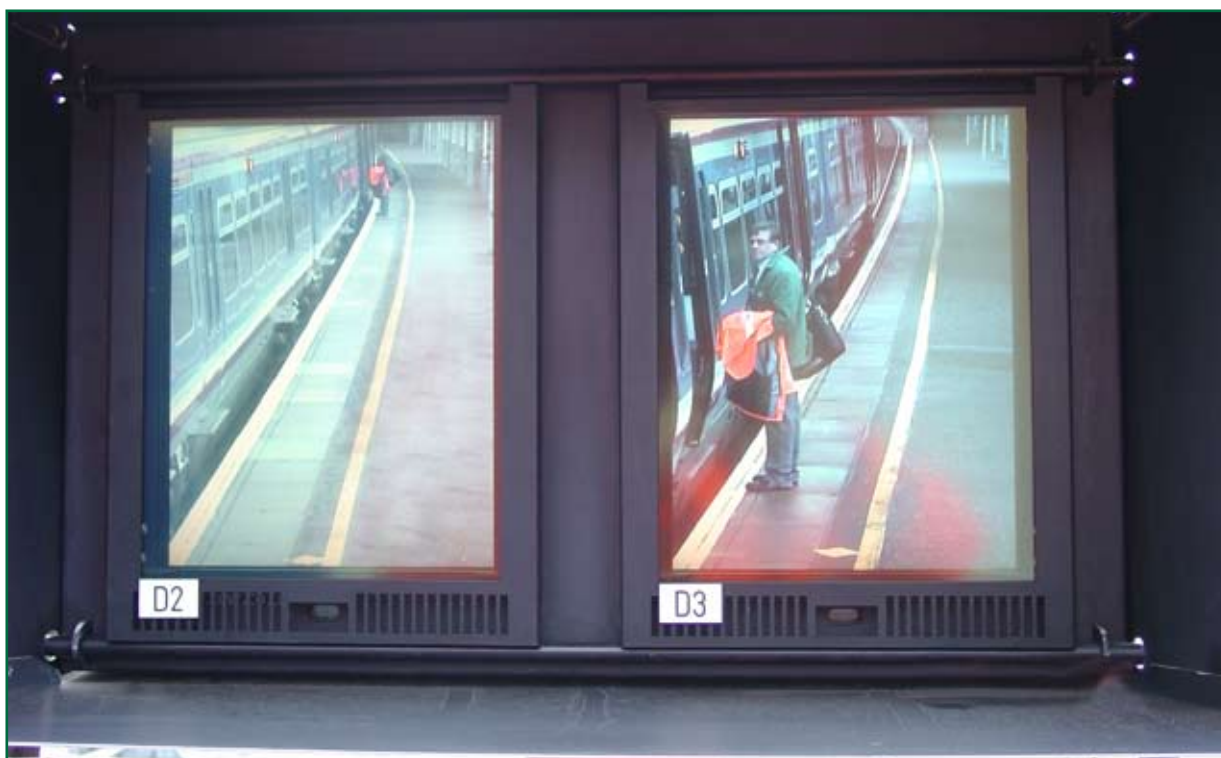
- 71 The left-hand monitor in Figure 17, D2, shows that a person standing at the leading door of the third vehicle should, under good daylight conditions, be visible to the driver. This photograph gives an indication as to where the D3 camera is positioned and the extent of the platform two curve.

- 72 The right-hand monitor in Figure 17, D3, shows clearly the person standing at the leading door of the third vehicle. Under good visibility conditions a person standing at this door should have been readily observed (the orange flare in each image is from the jacket worn by the RAIB Inspector photographing the scene).

Figure 17: View from four-car monitors with a person stood at the incident door

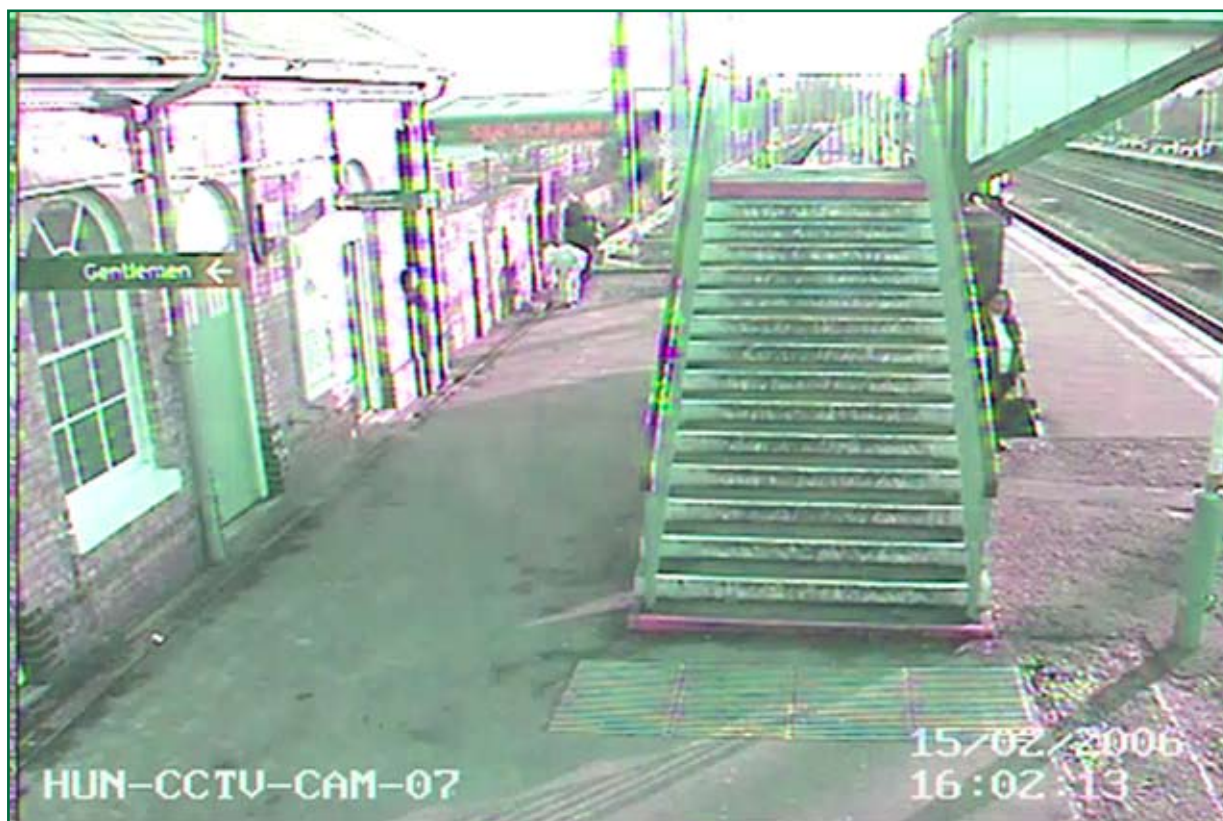
- 74 The weather on the day was reported as being cold with bright sunlight and good visibility. This can be observed in Figure 18 which is an image recorded at 15:57 hrs (corrected time) and shows bright sunlight from the setting sun at a low angle approximately from the west. The effects of bright sunlight on the monitors was considered. After discussion with the manufacturer this was thought not to be significant because the monitors were fitted with filters and the monitor hood was designed to reduce the effects of sunlight. Figure 24 shows the likely position of the sun and the shadow from the leading end of the unit when the incident occurred. The sun therefore was shining onto the two monitors, particularly the right-hand side D3 monitor.

Figure 18: Image from security camera 7 at 15:57 hrs

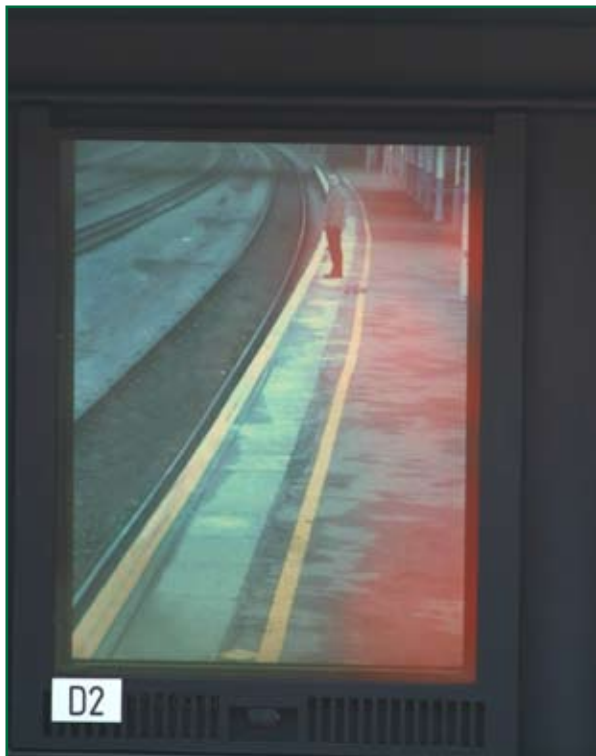
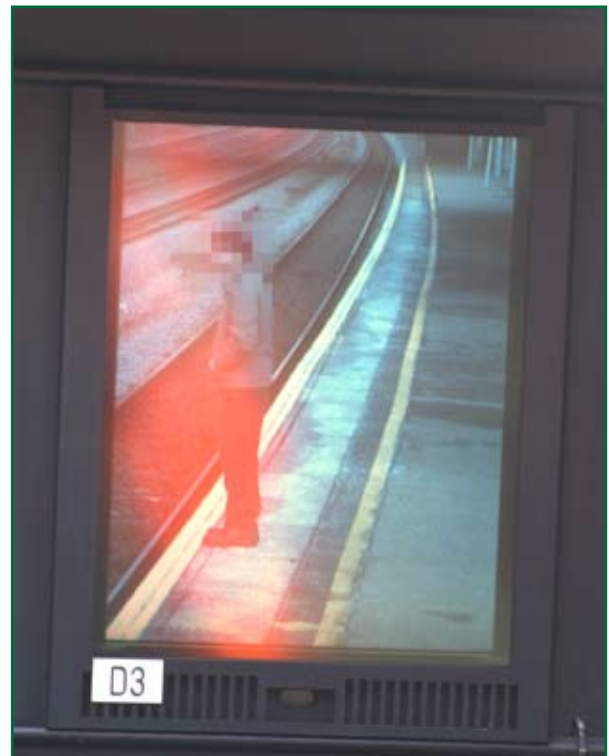
- 77 One set of observations is shown in Figure 19. In the image on the D2 monitor only one person appears to be in view and that person appears to be within the edge of the platform edge and the yellow line and well clear of the door/platform edge. The view from the right-hand D3 monitor also indicates that only one person is present but this person is now in closer proximity to the edge of the platform edge. For clarity the image of the photographer has been removed from the D2 monitor image. Figure 19 shows that the person at the trailing door of the second vehicle can readily obscure the driver's view of a person at the leading door of the third vehicle. The effect is highlighted further in Figure 20 which is an enlargement of the image from the D2 monitor with two persons in view.

*Figure 19: Volunteers at the relevant door positions*

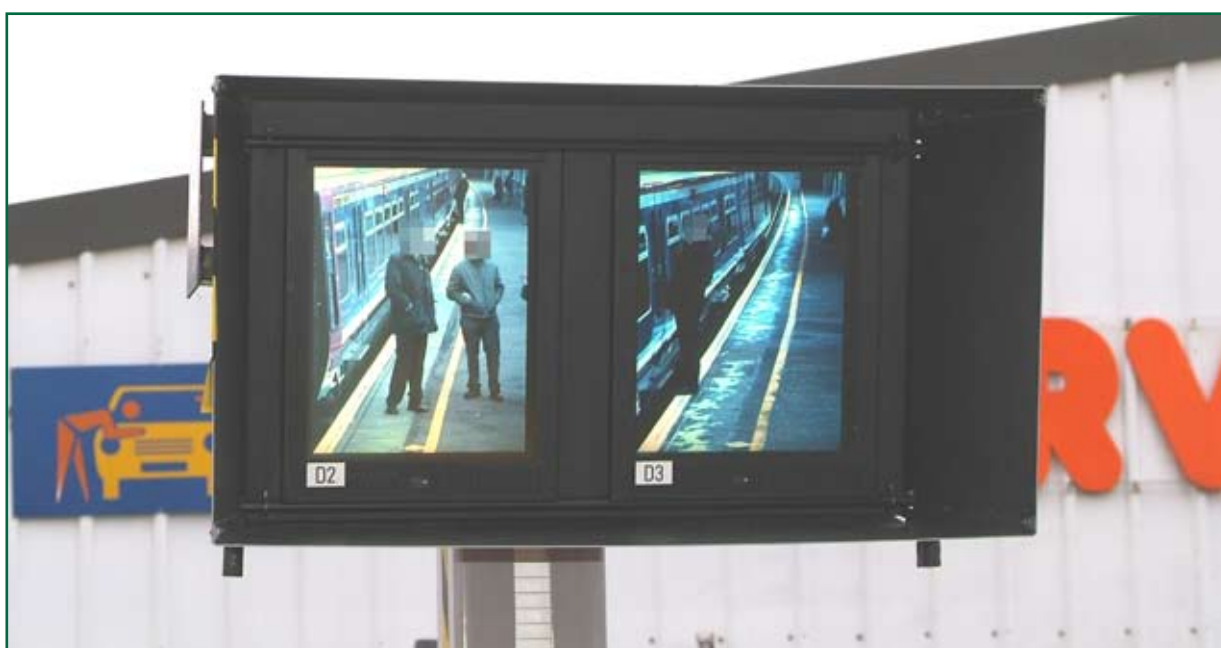
- 90 It is therefore likely that in pulling up short of the centre-line of the monitor bank the driver would have seen a reduced contrast image in the right-hand side (furthest away) D3 monitor.

Figure 23: Four-car monitor bank with a Class 365 Unit at a stand taken before the centre-line

- 2 Network Rail should ensure that the specification for replacement and new CCTV monitors require improved image contrast when viewed at an angle. The specified viewing angle should make a reasonable allowance for variation in a driver's stopping performance (paragraph 108).

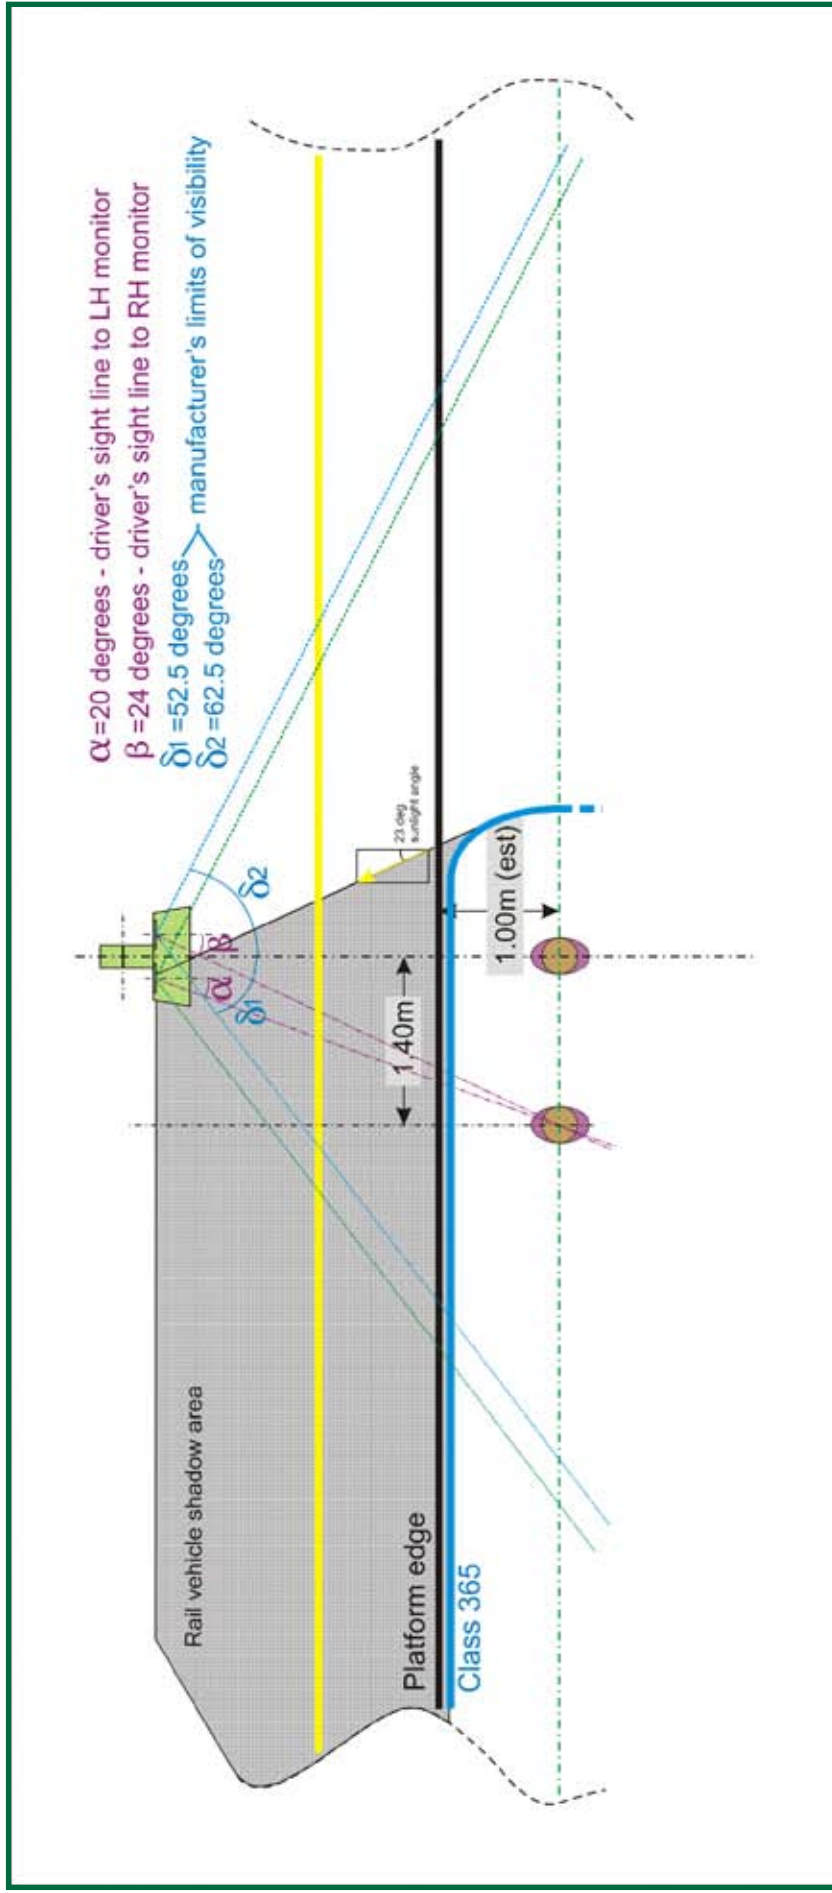
- 89 Both viewing angles are well within the manufacturer's quoted maxima of  $52.5^{\circ}$  and  $62.5^{\circ}$  respectively see (Figure 24), but when the system was demonstrated at the TEW premises on 13 March 2006 there was a noticeable reduction in contrast level when the monitor screen was observed from the left-hand side.

Figure 24: Driver sight line and position of sun/shadow information

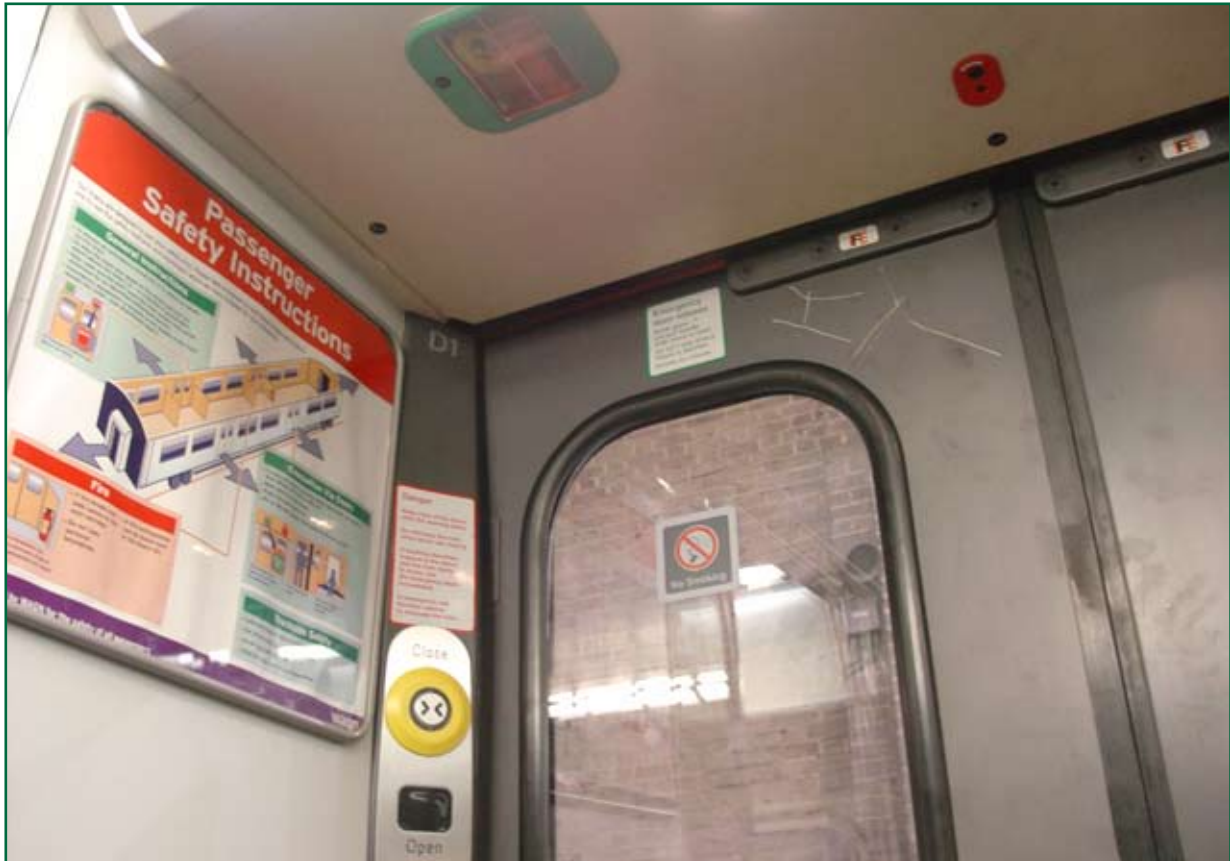
- 96 The only sign in the vicinity of the incident door relating to the Emergency Door Release is found on the left-hand door leaf (D1). If this release had been activated the train would have stopped immediately; however, passengers are instructed not to use this release if the train is moving. Figure 29 shows the text associated with both the 'Emergency Alarm' and the 'Emergency Door Release'.

Figure 25: Signage left-hand side of the Class 365 Unit door
