Rail Accident Report

Runaway permanent way trolley at Notting Hill Gate 24 May 2006

Report on a runaway permanent way trolley at Notting Hill Gate, 24 May 2006

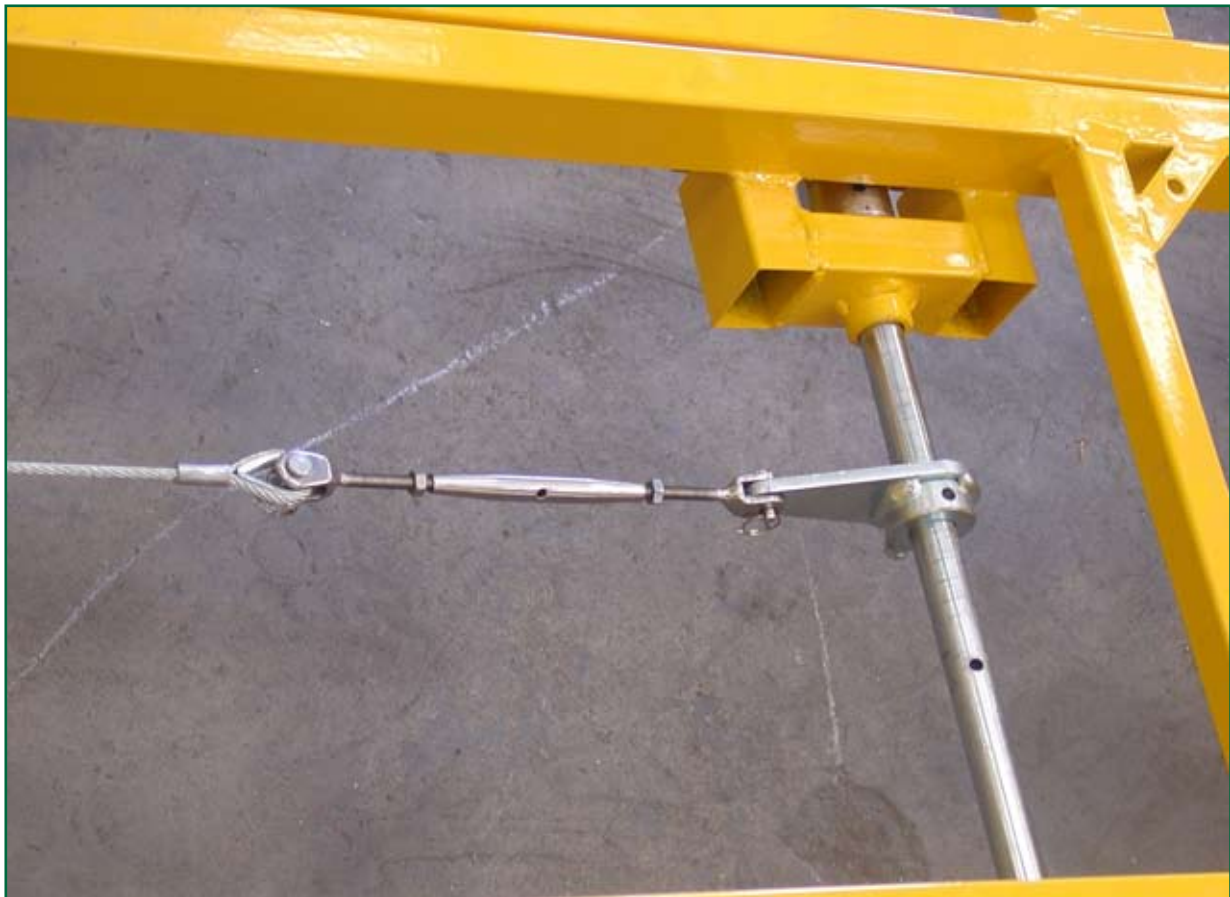
Figure 5: A Rotamag slack adjuster.

- 31 Each slack adjuster consists of a turnbuckle, the rotation of which will loosen or tighten the cable dependent upon the direction of rotation. When the correct degree of slack is achieved in the cable, the turnbuckle is locked in position using a 6 mm threaded nut. A slack adjuster is shown at Figure 5.

- 97 The slack adjusters are of simple but robust construction. It is highly improbable that four lock nuts, two on each slack adjuster, could all have become loose in the three weeks since the previous maintenance and in the case of three of the four move away from the adjuster fitting. It cannot be conclusively established if the condition of the trolley resulted from deficiencies in the preceding maintenance or as a result of some subsequent occurrence. However, the balance of evidence suggests that the adjusters had been modified after the return from maintenance and before the night of the incident. It is therefore concluded that the unauthorised modification of the brakes is a causal factor. The missing roll-pin was the likely motive for this modification and is therefore a contributory factor.

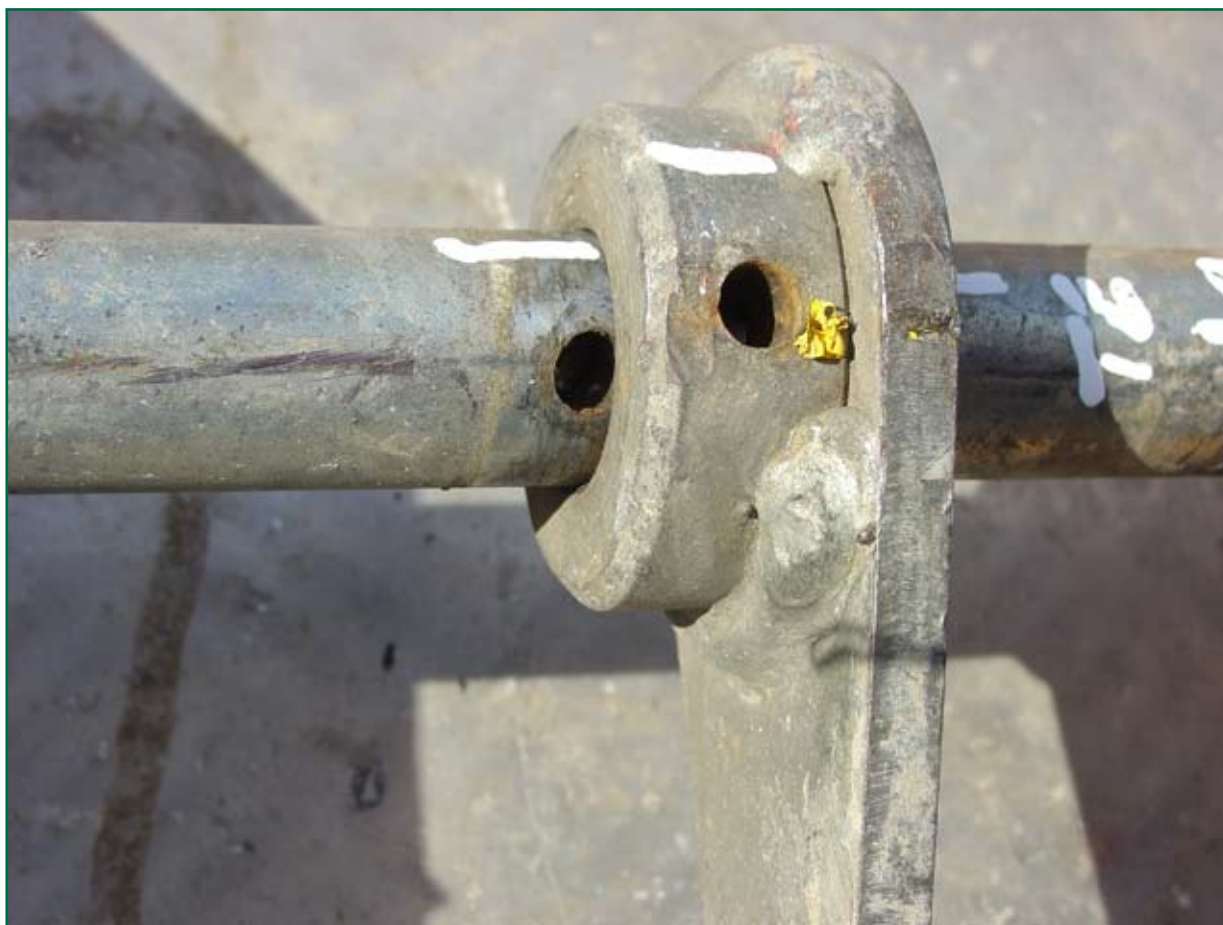
Figure 7: Detail of the release arm boss.

- 75 One brake release arm had become disconnected from the longitudinal shaft, because of the loss of the roll-pin, which passes through the boss of the arm the shaft. There was a distinct bruise and fresh yellow paint residue on the arm boss, which matched that on the frames of the trolleys. Figure 7 shows the detail of the release arm boss. There was light corrosion to the bore of the drilled hole in both the arm boss and longitudinal shaft.

- 76 Because of the loss of connection between the longitudinal shaft and the arm boss, the operation of the brake handle no longer rotated the arm to pull the cable and release the brake on the associated wheel.

- 95 The post incident inspection revealed a number of mechanical issues on the trolley.
- 96 There was visible corrosion to the roll-pin hole. This suggests that the pin had been missing for some time. If the pin had been missing at the time of maintenance three weeks earlier, it would not have been possible to adjust the brake mechanism correctly. The bruise mark to the arm, and fresh yellow paint residue, indicates that there had been an impact of some magnitude with another trolley section, probably during stowage on or unloading of the trolley from the road vehicle.

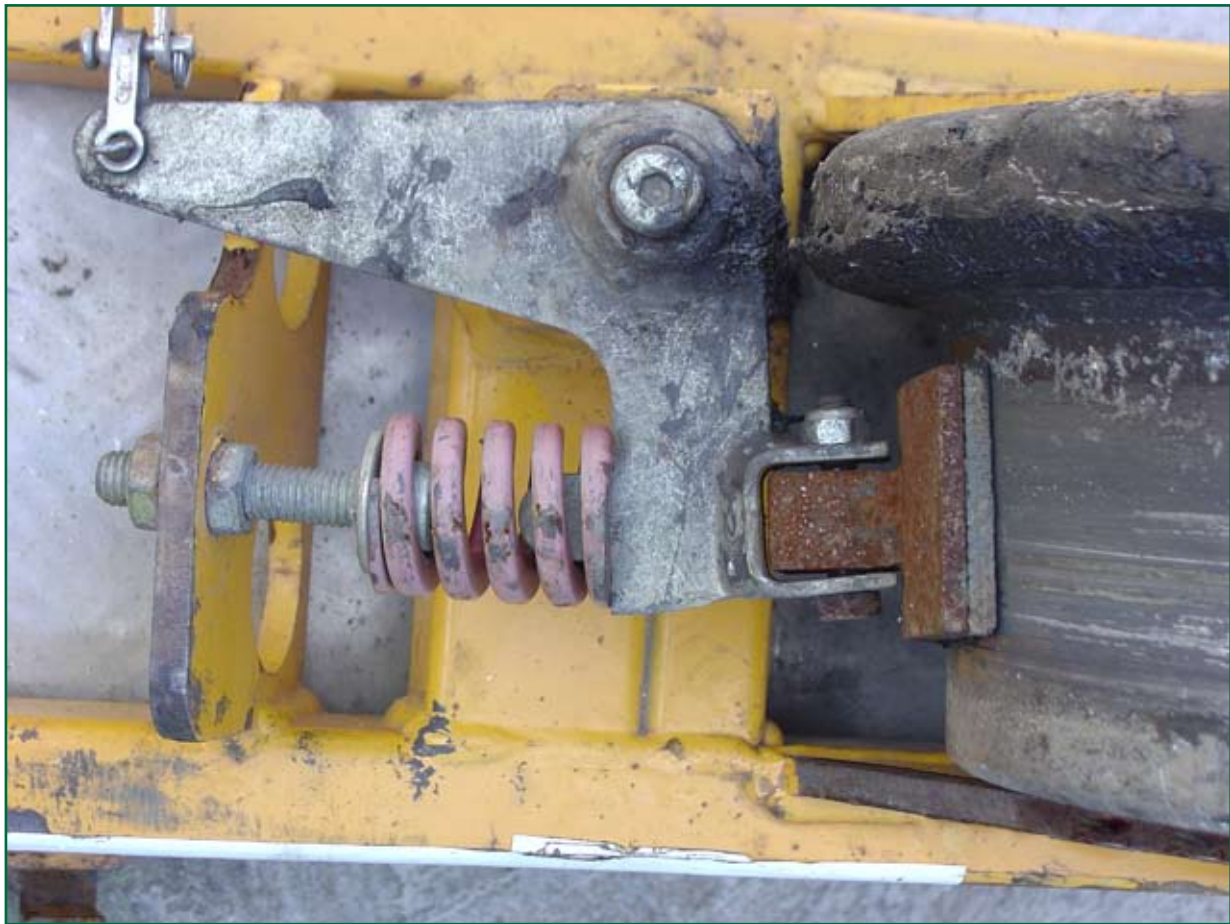
Figure 8: Detail of the application spring seat and mounting.

- 77 The lock nuts on the brake application springs were both undone. However, there was no reduction in the application spring pressure as a result. Details of the spring seat and its mounting bracket are shown in Figure 8.
