Rail Accident Investigation Branch

Rail Accident Report

Locomotive runaway near East Didsbury 27 August 2006

27 August 2006

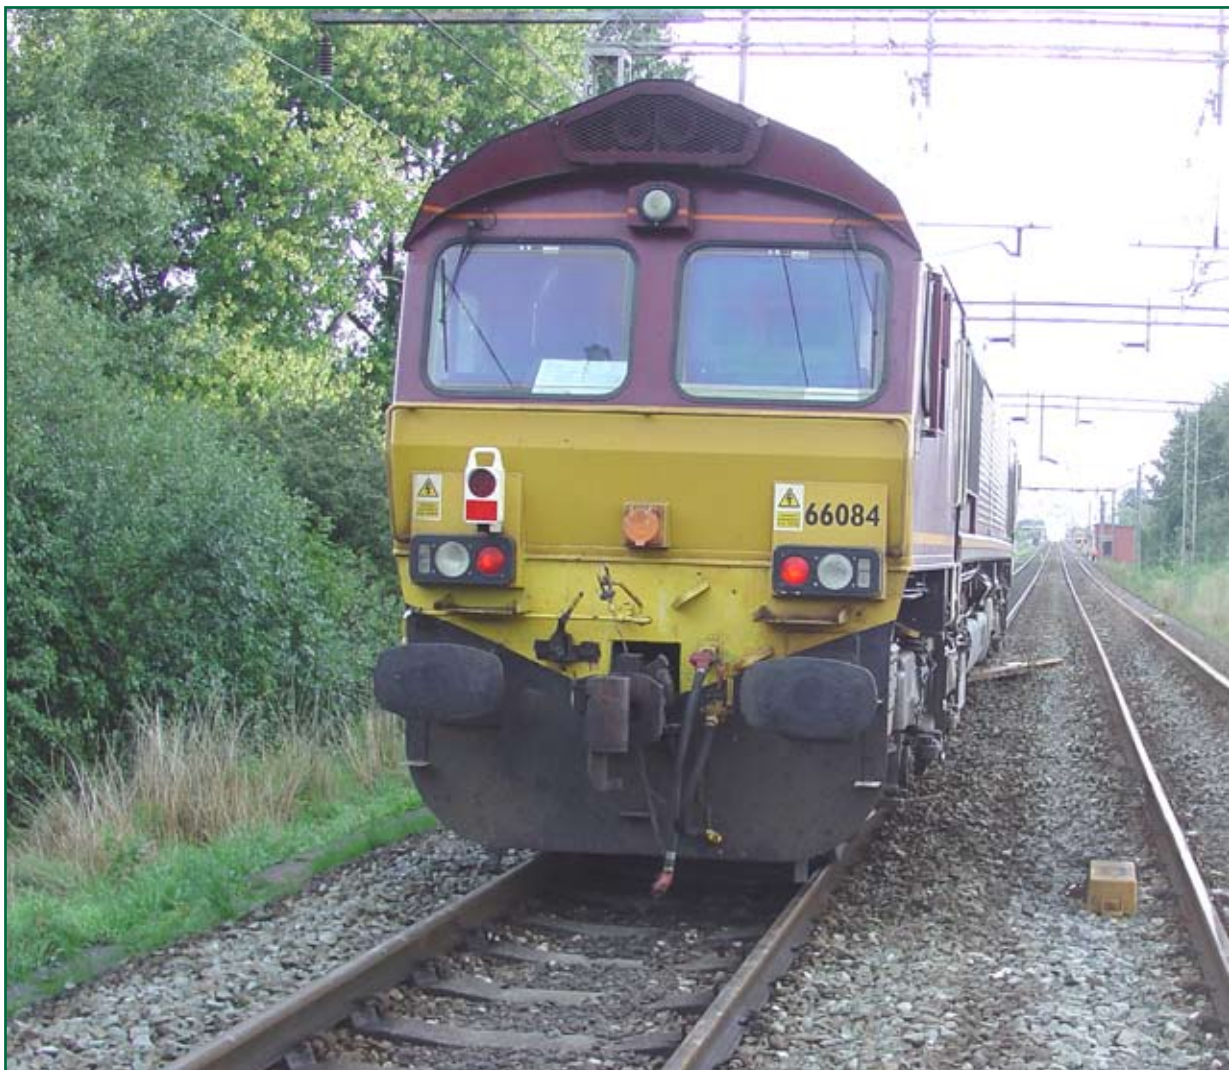
- 44 Once south of East Didsbury, the locomotive ran back and forth around the trough in the alignment to the south of East Didsbury station and was eventually brought to a stand as a result of the gradient profile and workers wedging a wooden post in front of one of the locomotive's wheels. The locomotive is shown in its final position with the wooden post protruding in Figure 3.

Figure 3: Locomotive 66 084 in its final position looking northwards towards East Didsbury

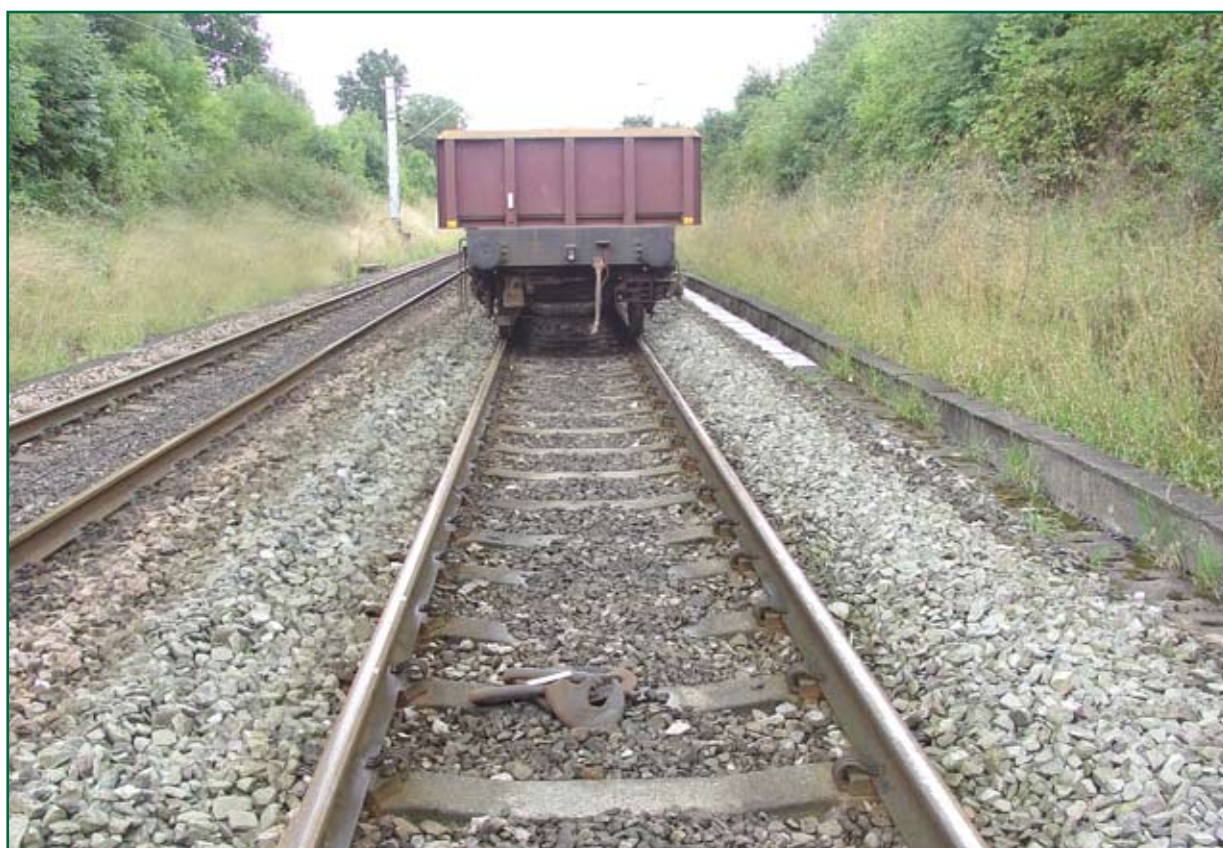
- the broken coupling was found in the *four foot*, 9 m from the back of wagon MHA 394620 indicating the approximate position at which the coupling broke (Figure 4 refers);

Figure 4: Wagon MHA 394620 and broken coupling as found after the runaway

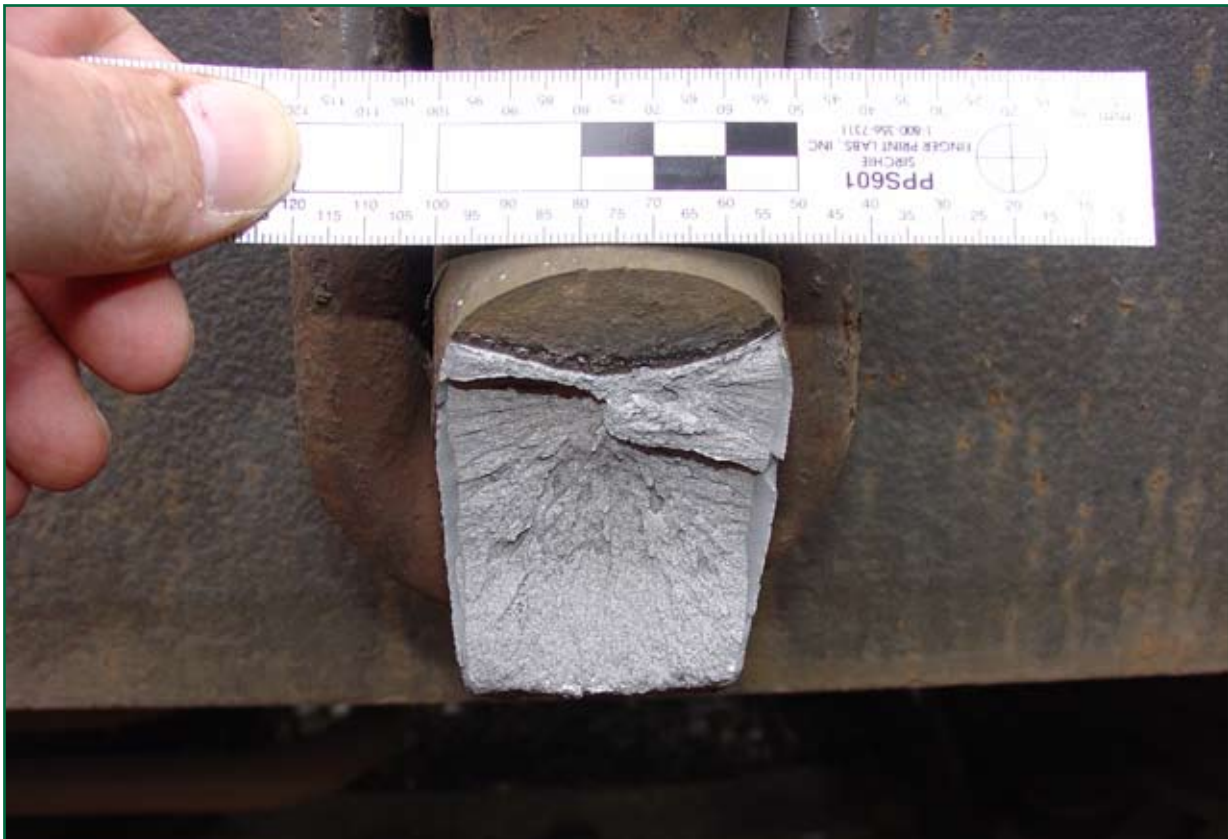
- the drawhook on wagon MHA 394620 had fractured below the gedge slot (Figure 5 refers);
- after the incident with both 6L22 locomotives shut down, the runaway locomotive, 66 084, showed zero readings on all cab air gauges and the leading locomotive, 66 185, had its main air reservoir charged at 9.5 bar (951 kPa);

Figure 5: Wagon drawhook fracture face

- 68 On-site observation and subsequent metallurgical examination (paragraphs 53 second bullet and 54 refer) indicate that the drawhook included a large, pre-existing, slow growing fatigue crack below the gedge slot reducing the effective cross section. This combined with the application of a sudden tensile load caused the drawhook to break. As the crack was slow growing, the magnitude of the tensile load must have been larger than any that the drawhook had experienced in the recent past. There is no evidence that side impacts on the coupling from an unlatched buckeye coupler occurred or contributed in any way.

- 69 The presence of the pre-existing fatigue crack and the application of a sudden, larger than recently experienced tensile load, are therefore causal factors.

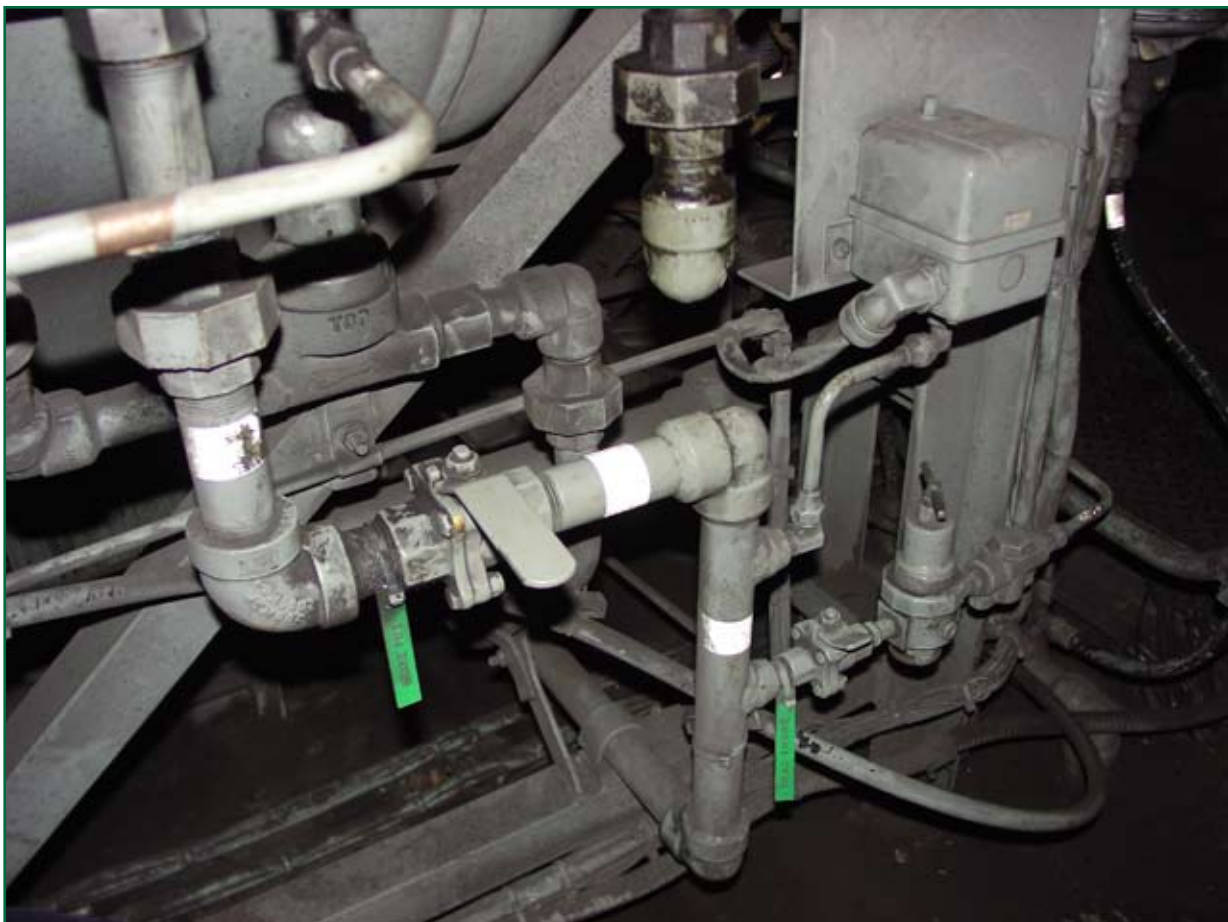
- the brake rack of locomotive 66 084 was found with the *Brake Pipe Pressure Control Unit Isolating Cock* (BPPCUIC), labelled 'BRAKE PIPE', closed, and the AFT cock, labelled 'DEAD ENGINE', closed (Figure 6 refers);

Figure 6: Locomotive 66 084 brake rack as found after the runaway

- the AFT cock was labelled 'DEAD ENGINE' and the labelling did not indicate the open and closed positions. Had the labelling been clearer, the driver's long term misunderstanding may well have been corrected (Recommendation 6).

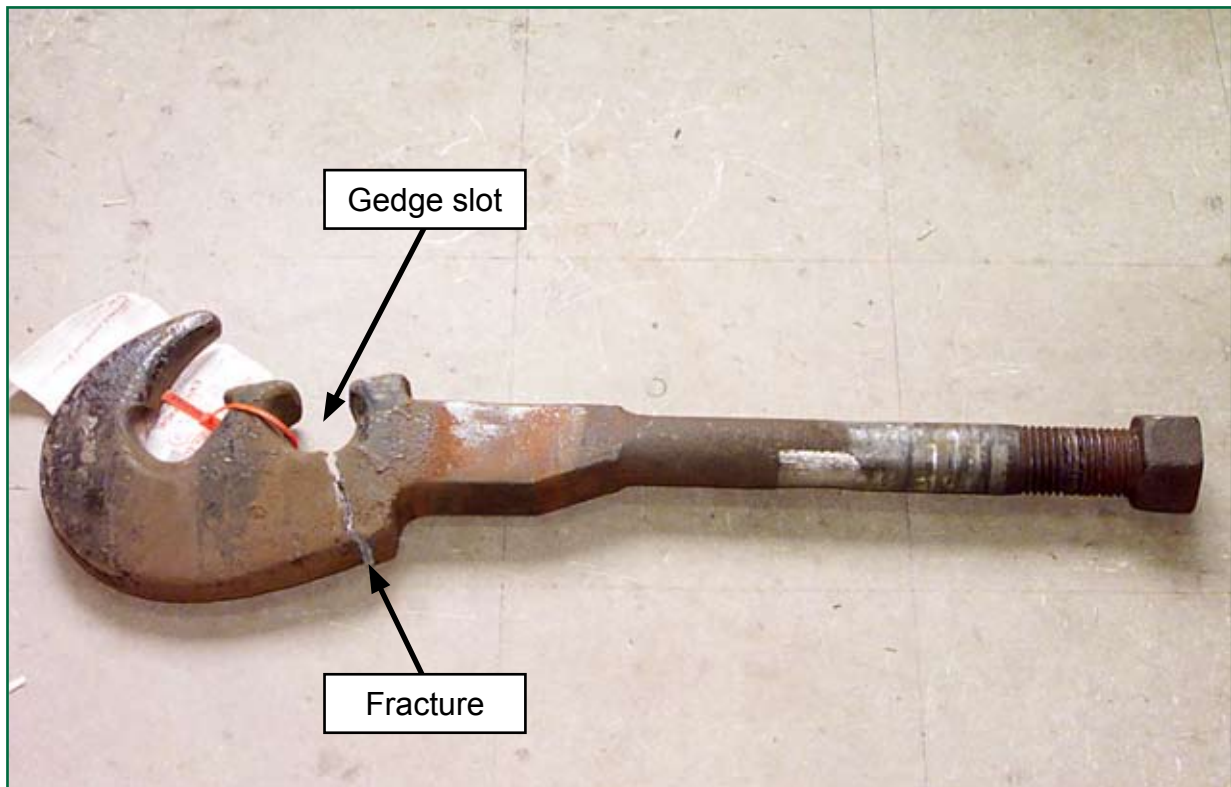
- the drawhook had fractured as a result of a fatigue crack having grown to a depth of 16 mm just to the rear of centre of the gedge slot. A sudden, larger than recently experienced tensile load then fractured the remainder of the cross section (Figure 7 refers);

- the size of the fatigue crack was larger than those generally found in other broken drawhooks;
- the extent of oxidation of the fatigue crack indicated that it had been very slow growing and had been present, likely at a detectable size, for a year or more; and

- there was another significant crack in the main hook throat and several smaller cracks throughout the drawhook.

Figure 7: View of loosely reassembled drawhook (photograph courtesy of Serco Assurance Railtest)

- 71 Metallurgical examination of the drawhook concluded the fatigue crack was likely to have existed in a detectable condition for a year or more. Thus it was very likely to have been detectable by 4 January 2006 and had the EWS maintenance procedure been correctly applied, the drawhook would almost certainly not have broken as it did. The MPI was not carried out because the MPI operative at Bescot depot was not within certification in January 2006. The omission of MPI and the reason for it are both contributory factors.
