Rail Accident Report

**Fatal accident involving a train driver, Deal
29 July 2006**

Fatal accident involving a train driver, Deal

29 July 2006

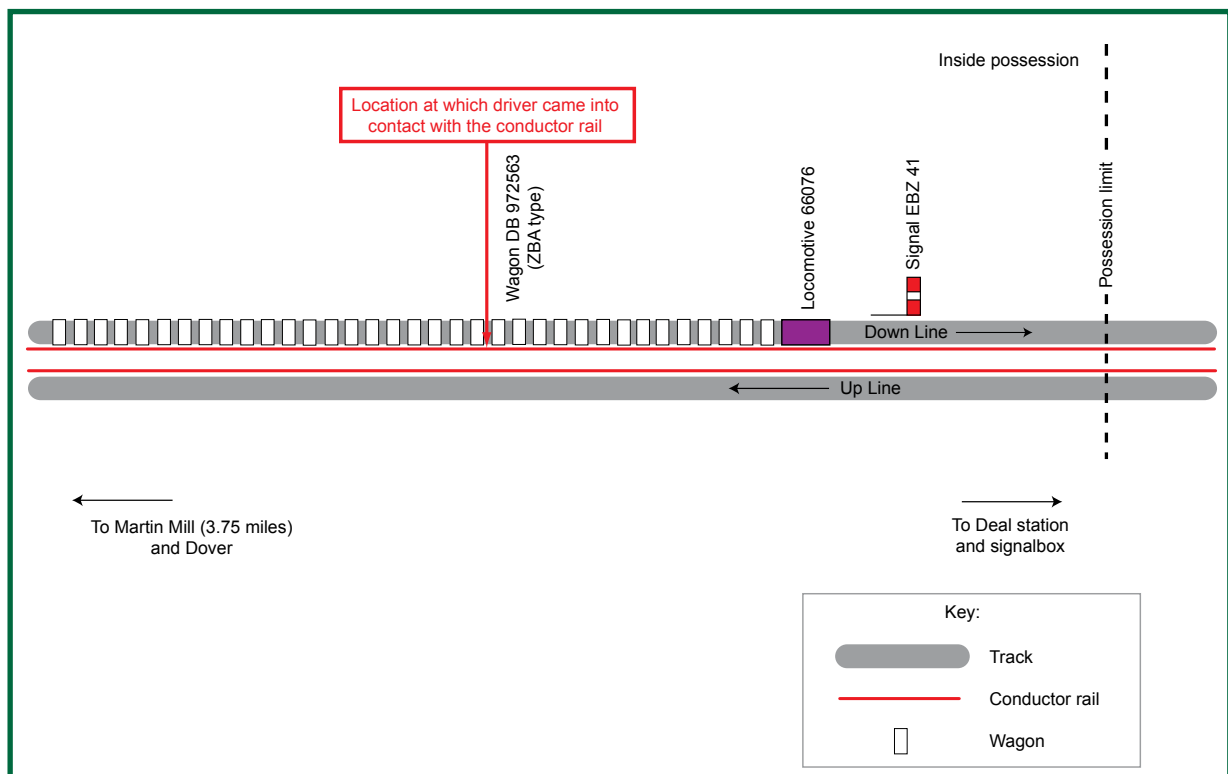
Figure 2: Overview of the accident site

- 17 The ambulance service arrived on site within 15 minutes of the first call and attempted resuscitation.
- 18 An overview of the site of the accident is to be found at Figure 2.

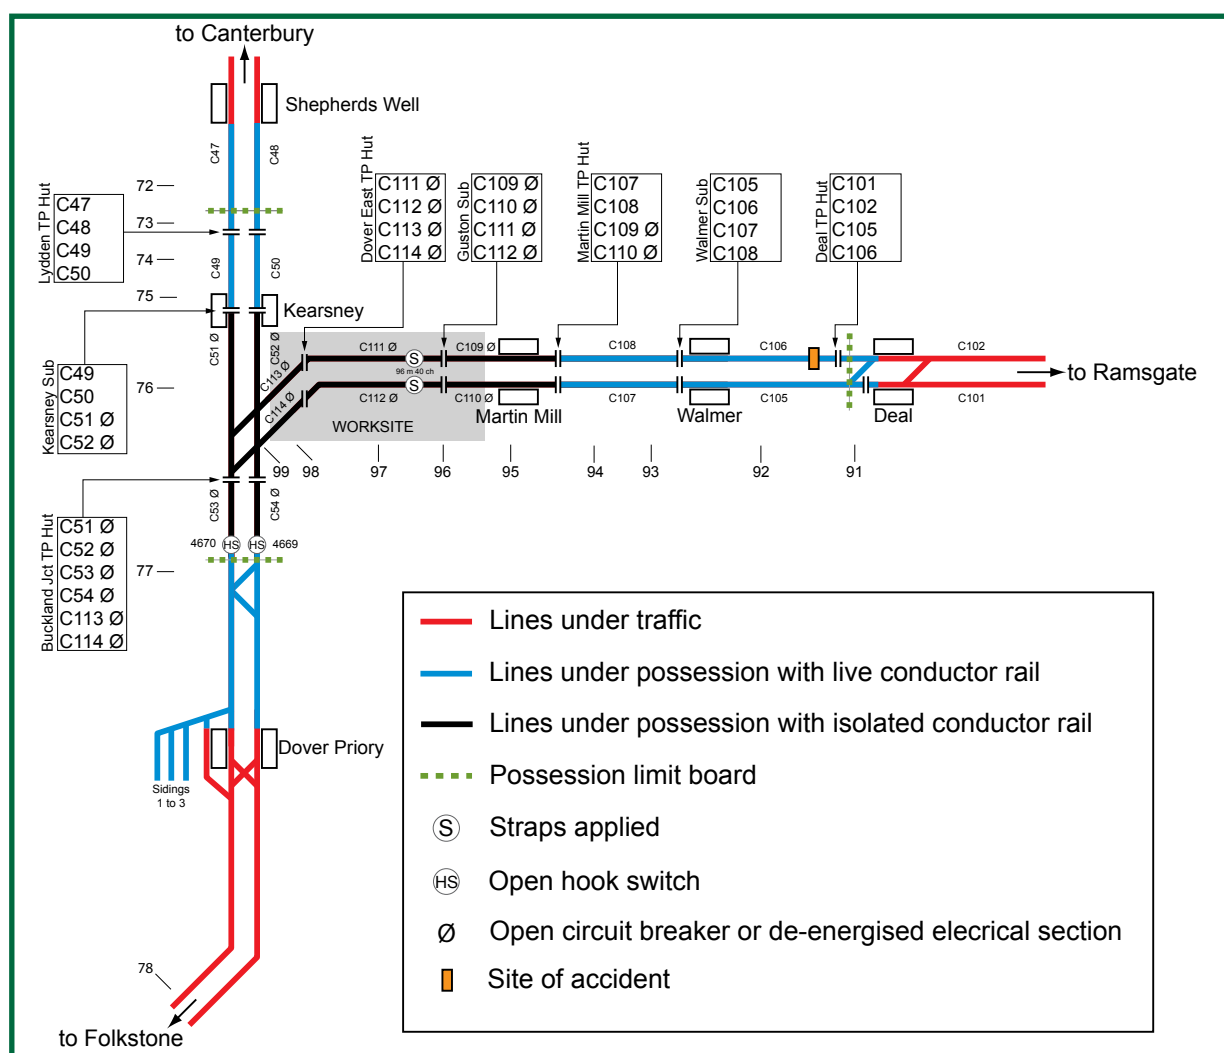
Figure 5: Protection of the engineering works associated with WON 18 item 34 on Saturday 27 July 2006

- 66 The extent of the isolation created by the above switching arrangements is typical of an isolation within an area of DC electrification and was compliant with the requirements of the DC Electrified Lines Instructions. These instructions, and the current Network Rail standard, state that the extent of the electrical isolation need only be sufficient to safely protect the work limits. Network Rail's planners will generally endeavour to limit the extent of the isolation so far as possible. This policy limits the need for the opening of remotely operated and manual switches. Since isolation procedures also require the testing of the conductor rail (using a testing device), and the subsequent application of short circuiting straps¹, this policy also limits the need for 'strapmen and testers' to be deployed.

- 67 A diagram of the WON 18 item 34 possession limits, the worksite and the associated conductor rail isolation is to be found at Figure 5.

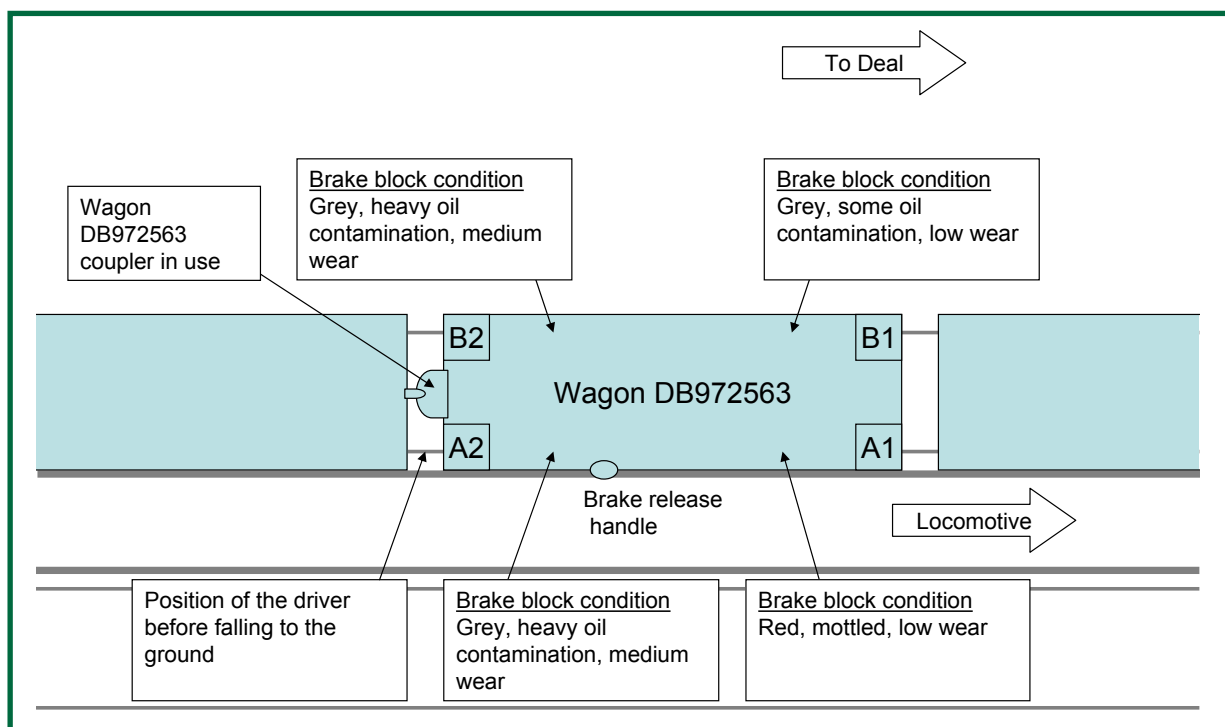
Figure 6: Sketch of wagon DB 972563

- 110 On arrival at wagon DB 972563 (the 14th wagon on the train) the blockman drew Driver B's attention to the brake block on corner A1 of the wagon (Figure 6). It appeared to the blockman that this brake block was glowing red (Figure 9).

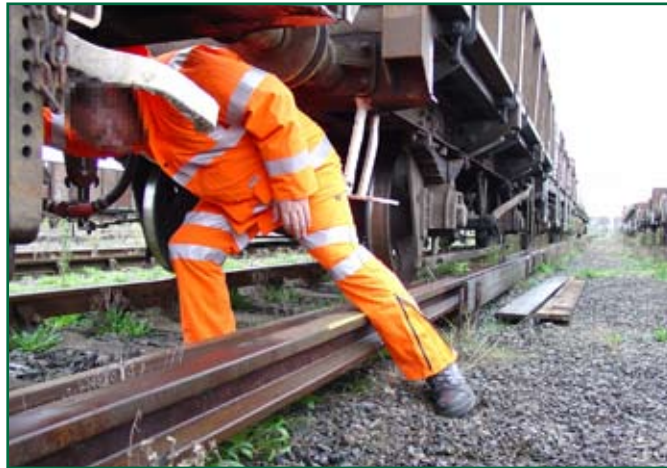
Figure 7a: Likely position of Driver B at the point he received an electric shock

- 120 The reconstruction demonstrated that simultaneous contact was possible between the inside of the left leg on the conductor rail and the back of the upper left arm on the underside of the buffers. These points of contact are closely aligned with the marks observed on Driver B's body (see paragraph 154).

- 121 Figures 7a and 7b show the likely position of Driver B at the point he received an electric shock.

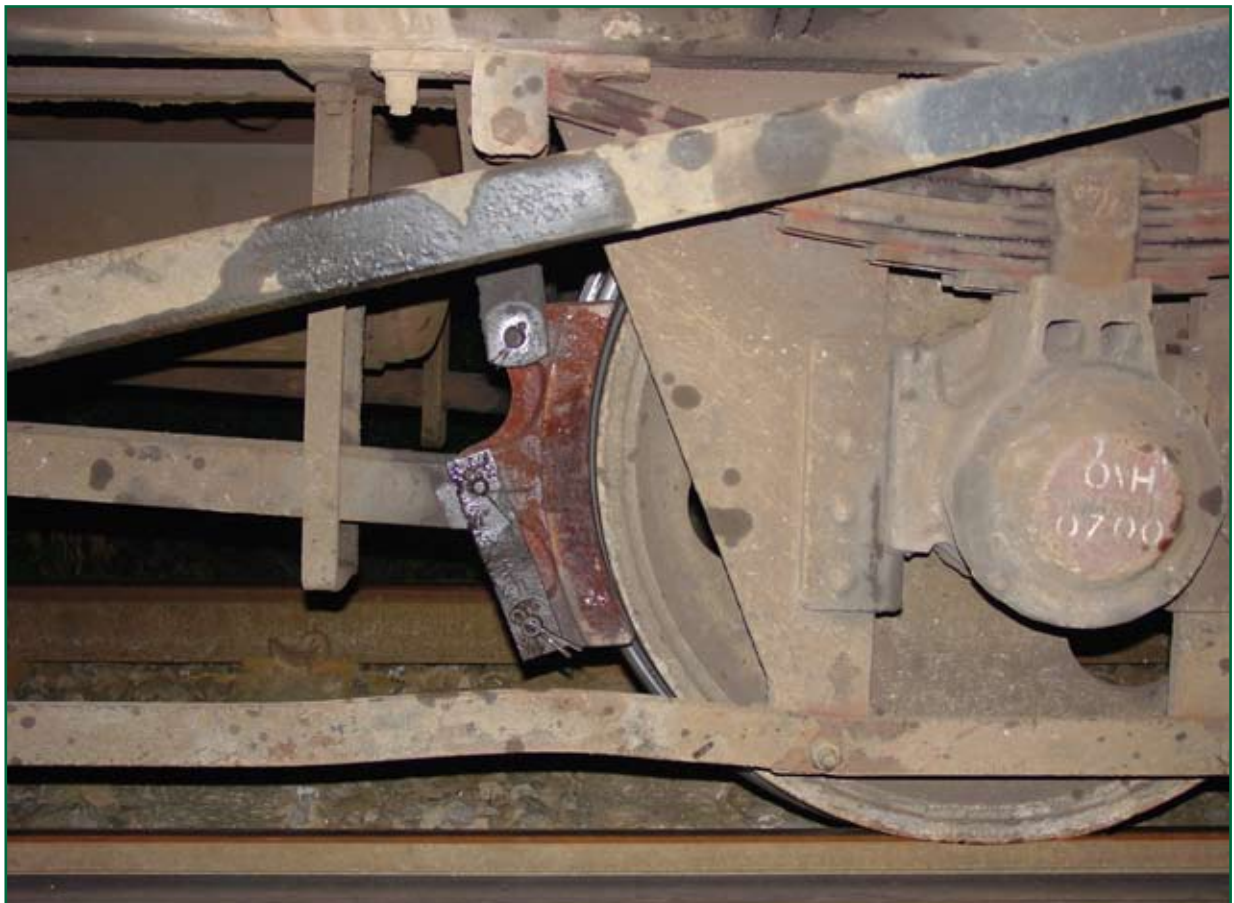
Figure 9: Brake rigging showing the brake block at corner A1

- 144 Maintenance records show that a single brake block was replaced on wagon DB 972563. This brake block was at corner A1 of the wagon. The new brake block had been stored in a damp environment for some time and had developed a thin layer of rust. This gave it a red appearance (see Figure 9).

147 Given the above, it is probable that the 'white' smoke observed by the blockman was caused by oil contamination burning off the surface of one or more brake blocks. Oil is known to produce white smoke and is likely to combust at a temperature between 300 and 400 °C. These temperatures are likely to have been generated during the long slow descent from Martin Mill.

148 The blockman recollected that the brake block at corner A1 appeared to be glowing red. Had this been the case the block would have reached a temperature in excess of 800°C. At this temperature damage would have occurred to the brake block and the wheel tread. Furthermore, the lubrication around the split pins that secure the brake block in place would have burnt away had the block reached such a high temperature. As can be seen from Figure 9, this was not the case.

149 There is no doubt that the brake block at corner A1 had become very hot during the journey towards Deal. However, the exact temperature reached cannot be determined with any accuracy. It is possible that the red appearance of this brake block was influenced by the layer of rust on its surface (see Figure 9 and paragraph 144).

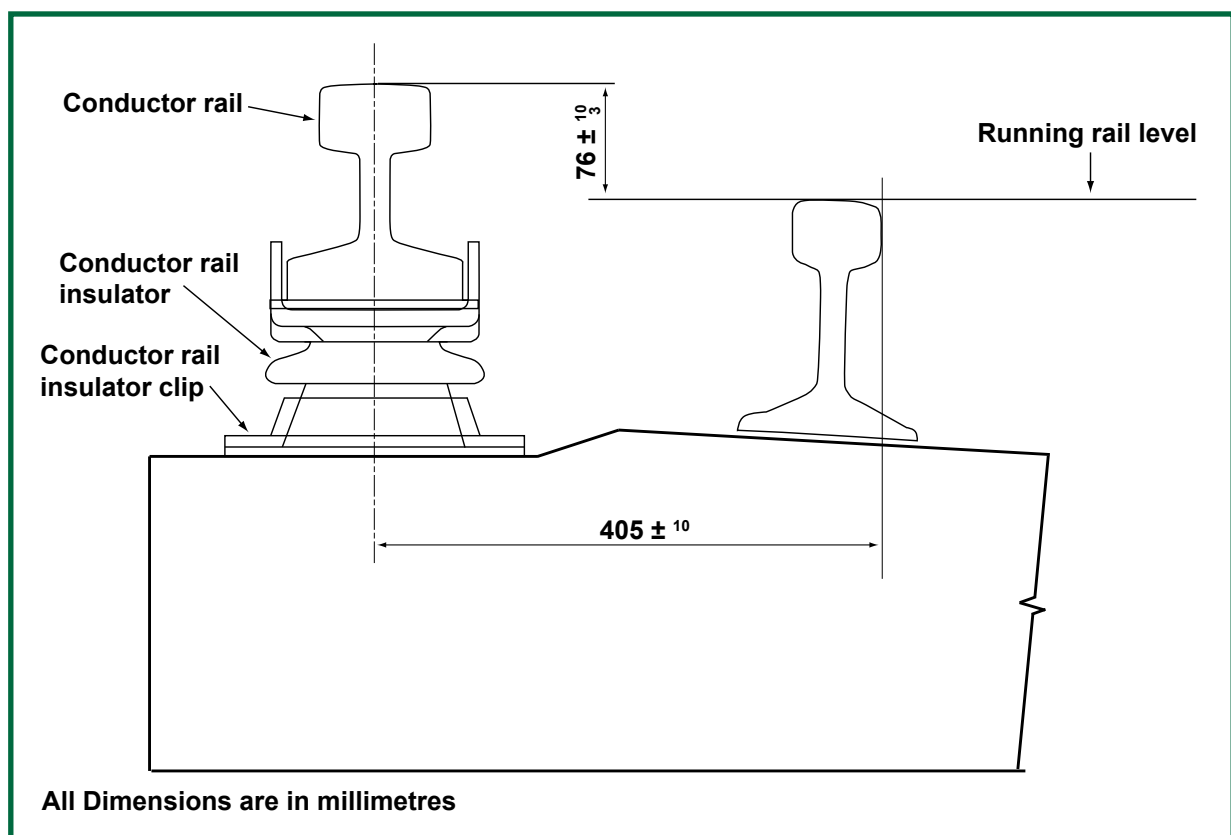
Figure 10: Dimensions of the conductor rail and its relationship to the running rail

151 Following the accident the conductor rail in proximity to Driver B's final position was measured. The position of the conductor rail relative to the running rail and sleepers conformed to the standard.

152 The overall stepping distance over the conductor rail and the adjacent running rail was no greater than might be expected at any other location with DC electrification. The ballast under and around this section of conductor rail was compact and even.
