Rail Accident Report

Derailment at Starr Gate, Blackpool **30 May 2006**

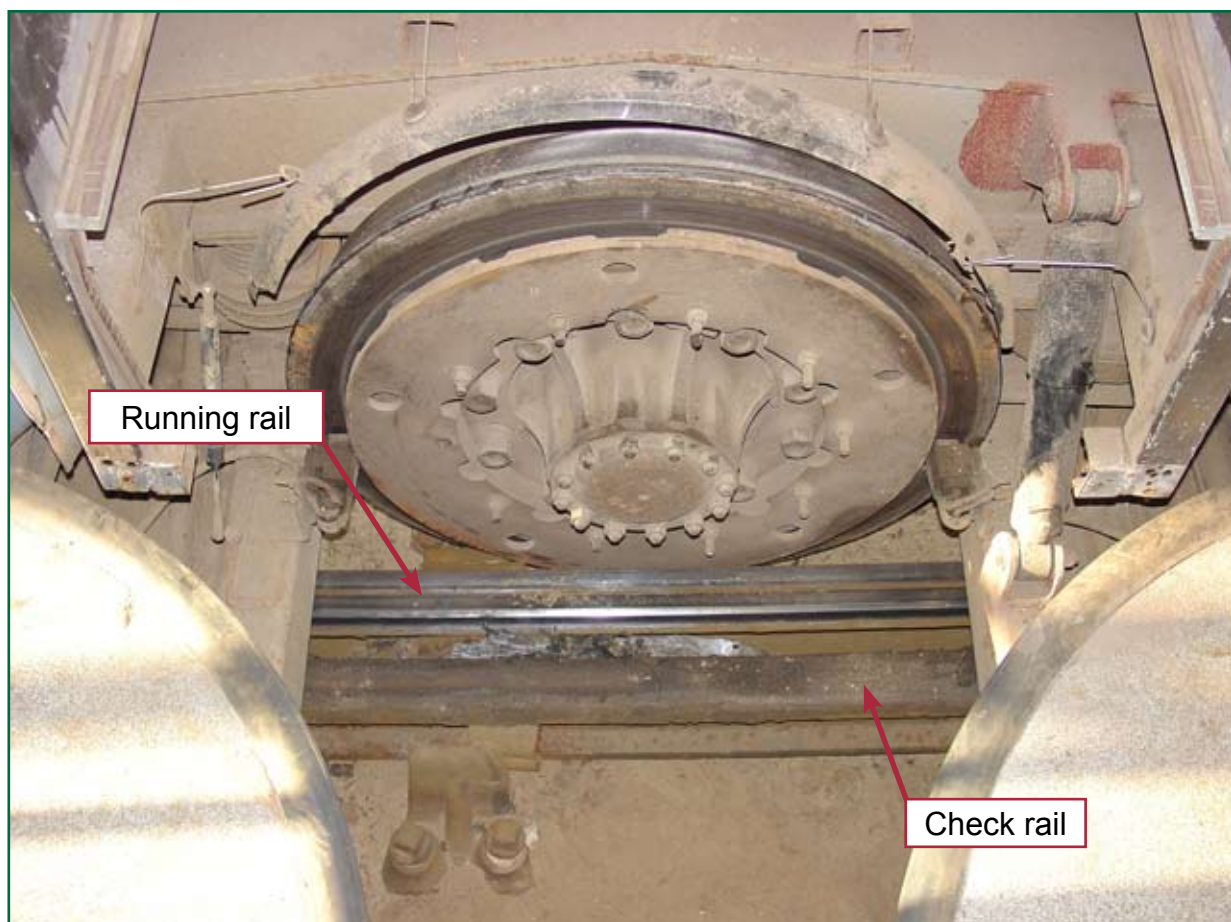
Figure 3: View from inside the articulation module showing the location of the inner derailed wheel

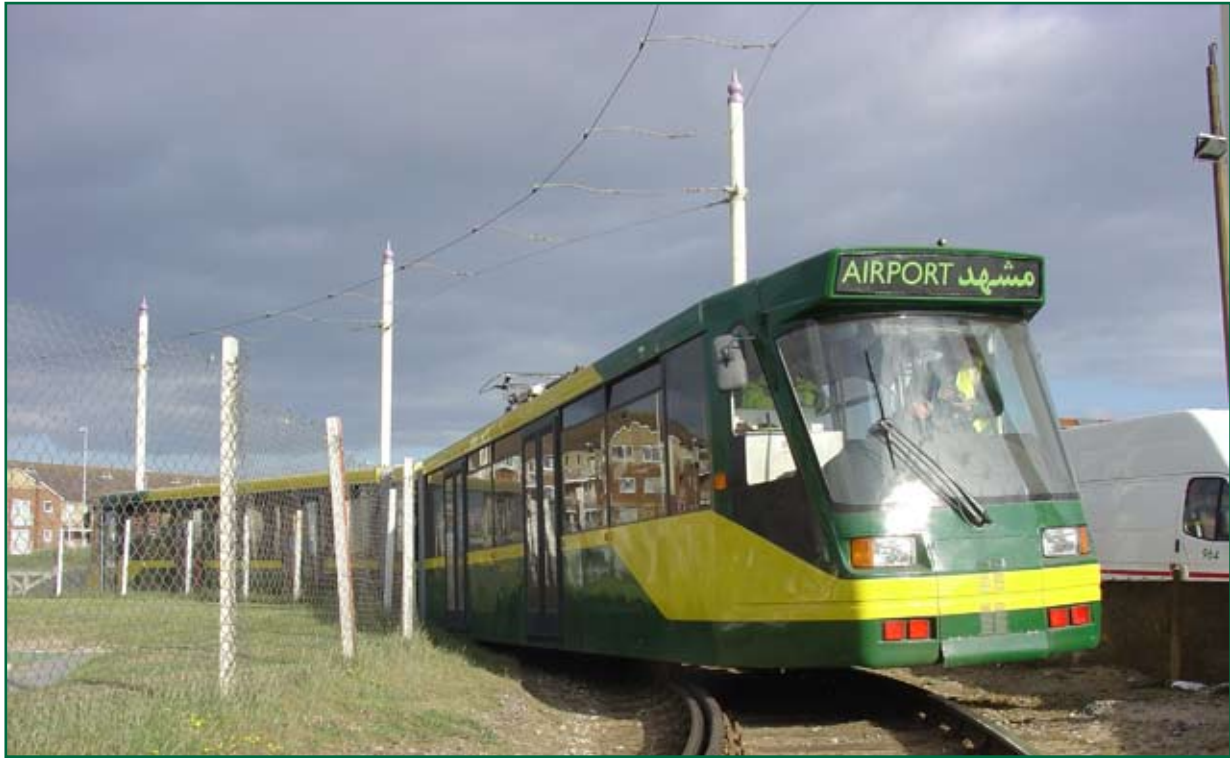
- 28 The tram remained upright and no other wheels were derailed; see Figure 4. There were no injuries and only minor marking of the track. There was no significant disruption to passenger service as arrangements were made to enable service trams to turn back at a *crossover* immediately north of the loop and continue running.

Figure 4: Derailed tram

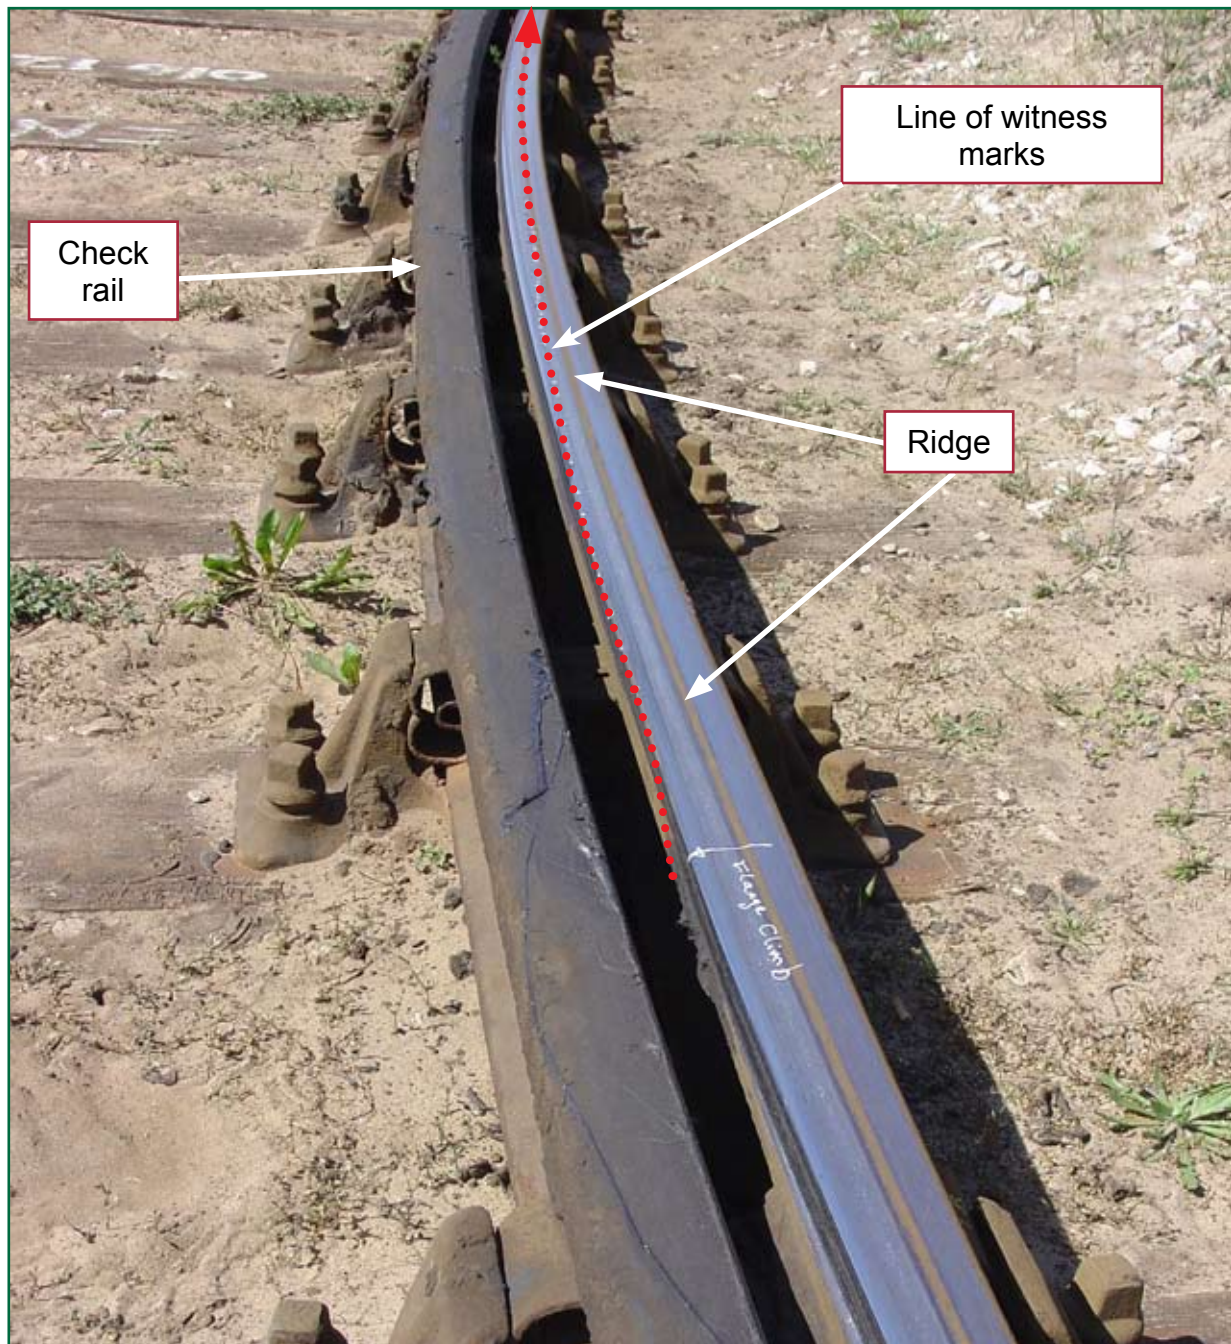
The tram

Figure 5: Witness marks on the inner rail showing the path of the wheel flange climb and its sustained running on the rail head

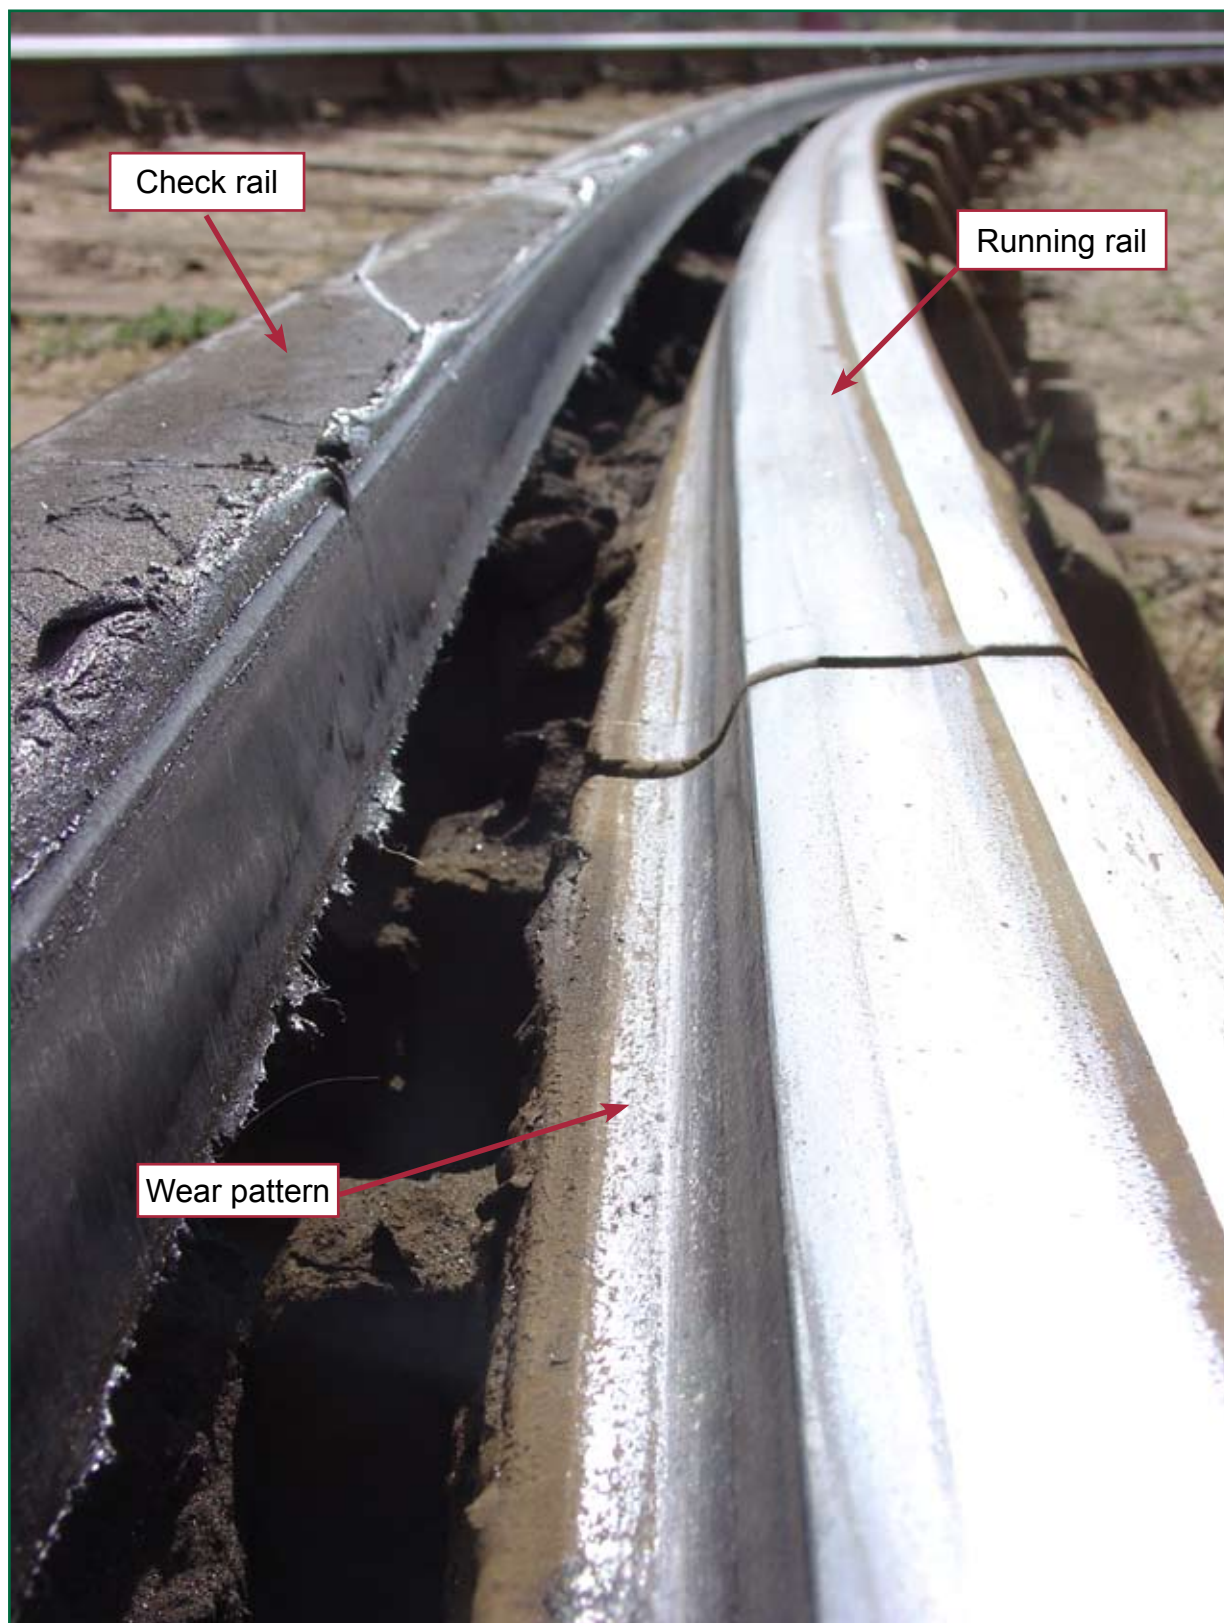
- 33 A *rail joint* was located immediately prior to the place where the wheel flange had started to climb the inner rail. Wear was evident on the gauge face of the rail, see Figure 6.

Figure 6: Pattern of wear observed on the gauge face of the rail

- 41 The Blackpool Tram Track Maintenance Handbook, issued by BBC as their maintenance standard, gives guidance to the maintenance teams responsible for the track on the operational sections of Blackpool Tramway. It identifies rail sidewear as a defect which should be identified during normal track inspection. However, no quantitative limit or guidance is given to determine when sidewear has become so severe that rectification is required. An extract of the part of the handbook relating to sidewear is included in appendix C.

- 46 HMRI has put Tram Power in contact with a specialist consultancy having the capability and experience of analysing the dynamic behaviour of the type of running gear fitted to tram 611. Proposals for a study of the dynamic behaviour tram 611 have been discussed.
- 47 Tram Power has also been in discussion with other tram operators regarding their experience of the behaviour of independent rotating wheels.
- 48 BBC has re-profiled the rail gauge face on the loop by grinding.

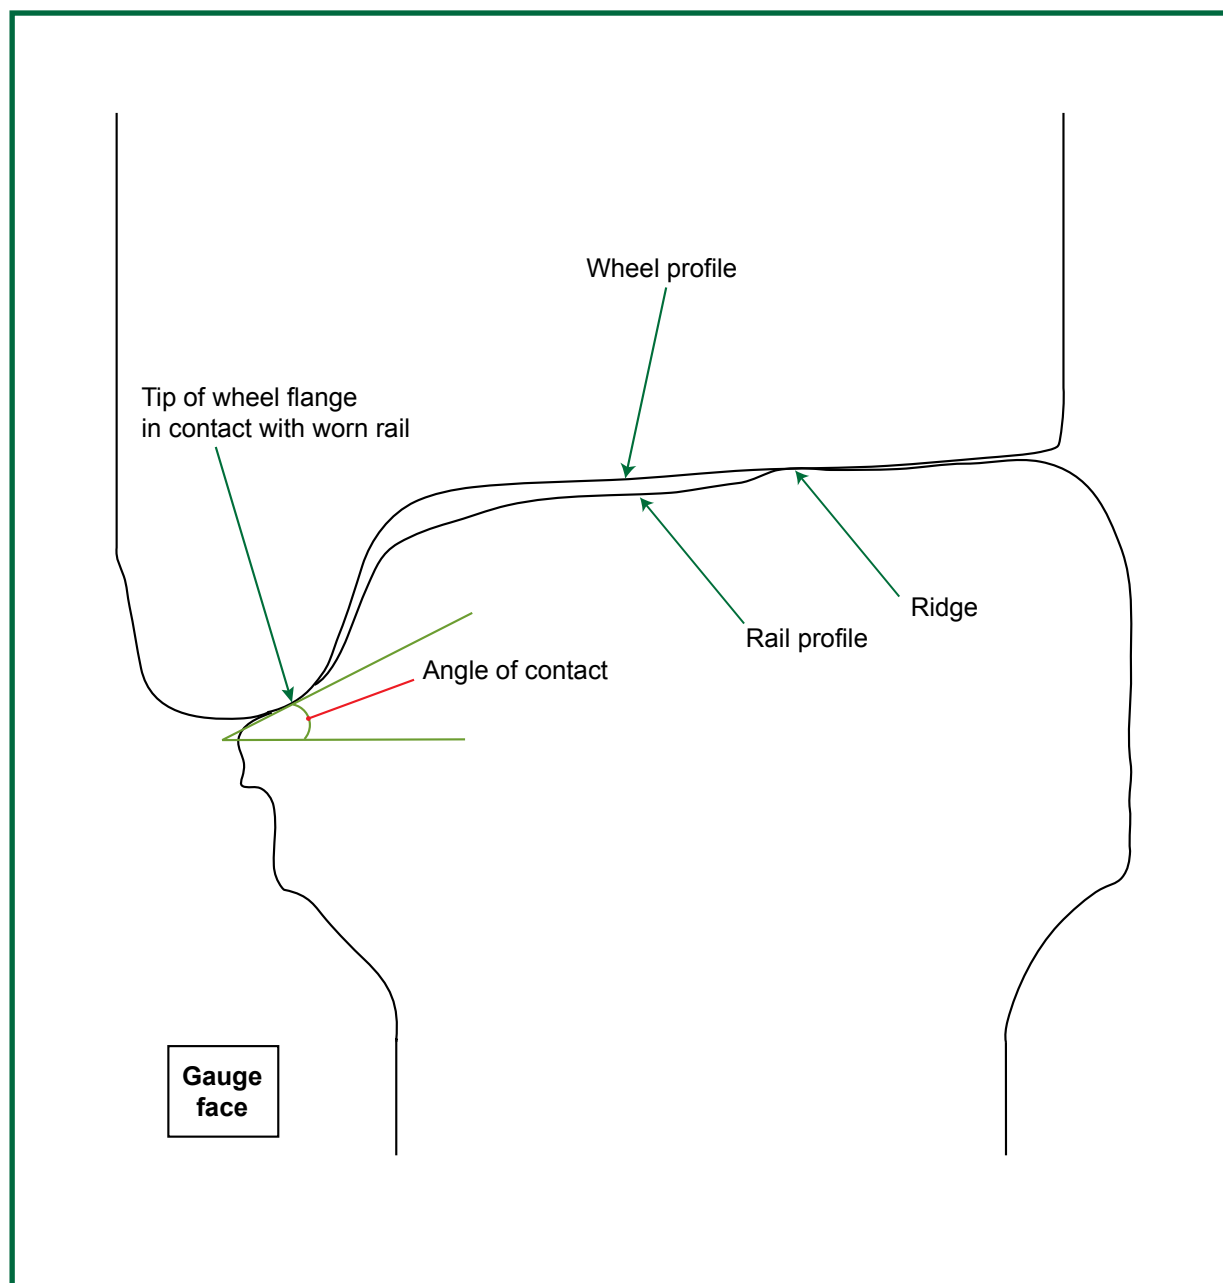
Figure 2: Principal arrangement of the tram

- 18 The tram was originally constructed in 1997 as part of a part of a development project, and early tests were conducted in Blackpool between 1998 and 2000.

Figure 7: Overlay of measured rail and wheel profile showing the potential for wheel flange tip contact

1. BTS, in association with Tram Power and BBC, should undertake an assessment of operational and derailment behaviour of tram 611 in order to identify the mitigation measures necessary to allow its safe operation on the Blackpool Tramway. In conducting this assessment consideration should be given to the combined influence of the tram design (including the configuration of the running gear), operating parameters and the track design and maintenance (including rail head profiles).
2. BBC should take measures to control the pattern of wear on the rail gauge face throughout the Blackpool Tramway. This should include the definition of quantitative limits and guidance for the management of rail sidewear in the relevant track maintenance procedures and documentation.
